# INITIAL FIRE SAFETY INSPECTION REPORT

**Southend Sweater Co Ltd (Extension)**

**RSC ID: 26010**

**Date: 06-Feb-2025**

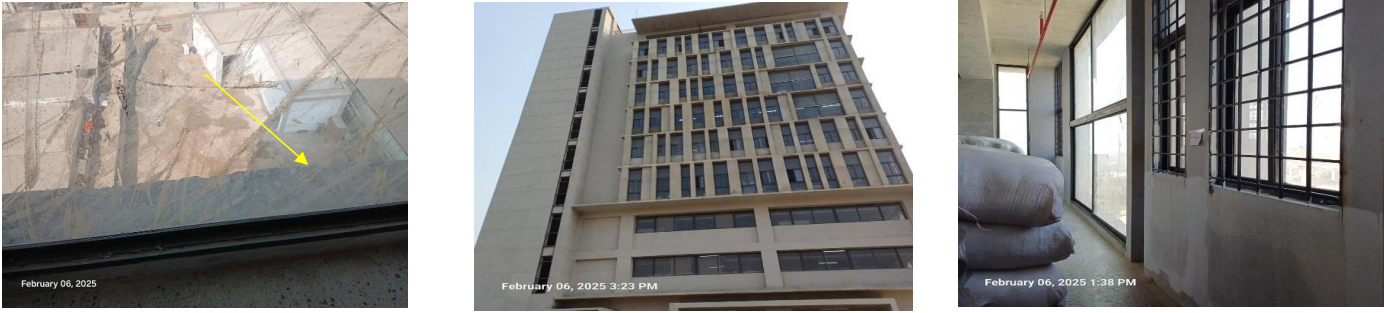
| SI No. | Category | Findings | Required Action | Remediation Time Frame |
|---|---|---|---|---|
| F-01 | Fire Rated Construction | Unprotected openings in the exterior wall in two consecutive floors lying within 1.5 m and vertical spread of fire is not restricted.<br>Location: Main Factory Building. | Permitted unprotected openings in the exterior wall in two consecutive floors lying within 1.5 m laterally or vertically shall be separated with flame barriers as similar as sunshades or cornices or projected wall at least 750 mm from the external face of the exterior wall. The flame barrier shall have a fire resistance rating of not less than three-fourths hour as per BNBC 2020- Part-III Chapter 3: 3.1.9.2. | Within 3 months |

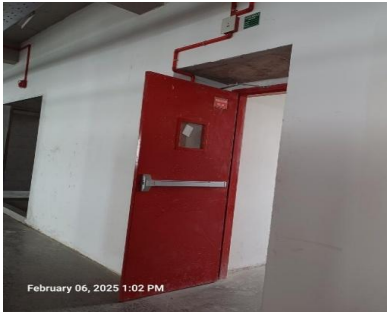
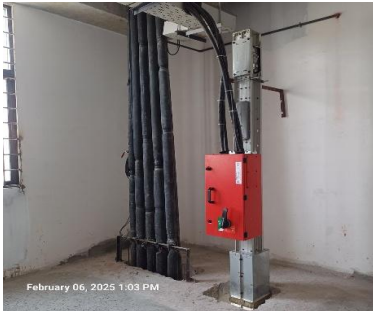
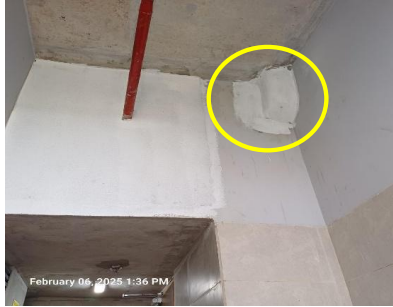
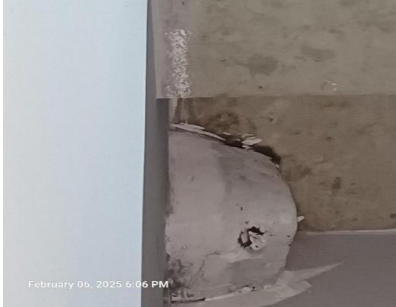
| F-02 | Fire Rated Construction | <p>Unsealed penetrations and openings are located in the fire rated floor/ceiling assemblies (Electrical cables, Toilet pipes). Fire rated doors are installed at BBT cable riser room and doors are found open with magnetic door holder, but fire alarm &amp; detection system is found non-functional during inspection. Gap below fire rated door is found more than maximum allowable limit. In addition, adequate fire rating has not been ensured for toilet pipes.</p> <p>Location: All floors of Main Factory Building</p> | <p>Seal all penetrations and openings in floor/ceiling assemblies to maintain the fire separation at least by 3-hr. If fire stopping materials with proprietary design are used for seal, then it shall be classified for the purpose it is used for. Also the installation shall be as per the proprietary design it has been tested with.</p> <p>Or</p> <p>Provide a minimum 2-hr fire rated shaft to separate the utility risers from each floor if required.</p> <p>Ensure that the fire doors are self-closing and positive latching. If fire doors are required to be held open for functional reasons, provide automatic closing devices tied to the fire alarm system. The clearance under the bottom of a fire rated door shall be a maximum of 3/4 in. (19 mm ).</p> | Within 3 months |

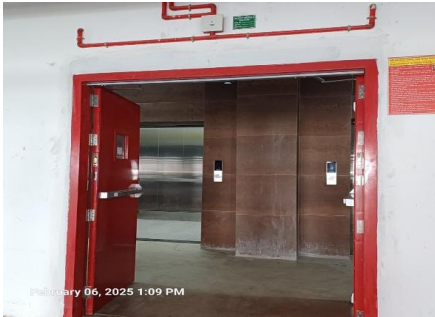
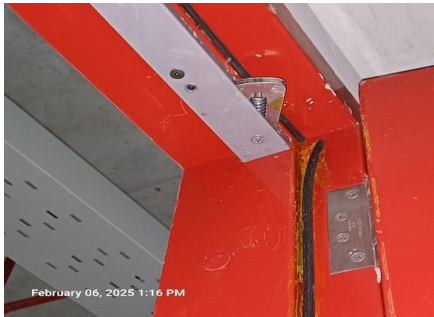
| F-03 | Fire Rated Construction | <p>Lift discharges inside work floors which are located without proper fire rated separation. Fire rated doors are installed at lift shaft area and doors are found open with magnetic door holder, but fire alarm &amp; detection system is found non-functional during inspection. Gap below fire rated door is found more than maximum allowable limit. Smoke seal of fire rated door is found damaged in several locations.</p> <p>Location: All floors of Main Factory Building</p> | <p>Separate the lift from workplace by a minimum 2-hr fire-rated construction. Seal and/or protected all openings to maintain the required fire separations.</p> <p>Ensure that the fire doors are self-closing and positive latching. If fire doors are required to be held open for functional reasons, provide automatic closing devices tied to the fire alarm system. The clearance under the bottom of a fire rated door shall be a maximum of 3/4 in. (19 mm ). Replace/install the non-functional/missing fire door accessories and properly inspect, test &amp; maintain fire door as per NFPA 80.</p> | Within 3 months |

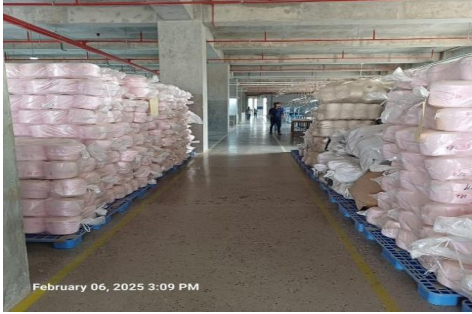
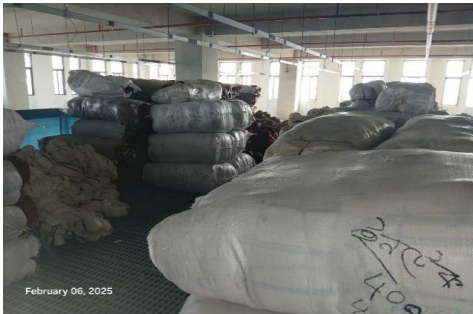
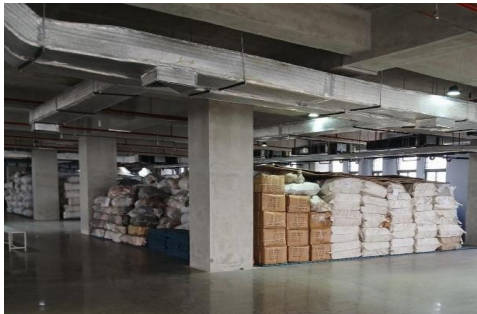
| F-04 | Fire Rated Construction | <p>Areas used for in-process storage of combustible materials are open to the surrounding occupancy.</p> <p>Location: 8th, 1st and Ground floor in Main Factory Building</p> | <p>Provide defined storage areas and limit the storage arrangement as follows:<br/>Maximum height of 2.45 m and maximum area of 23 m<sup>2</sup> and is separated by a minimum 3.0 m (10ft) from other storage areas and they do not exceed 10 percent of the building area of the story in which they occur.</p> <p>or,</p> <p>If sprinkler protected, Maximum height 12 ft (3.66 m) and maximum area of 1000 ft<sup>2</sup> (93 m<sup>2</sup>) and separated by a at least 25 ft (7.62 m) and does not constitute more than 10 percent of the building area or 4000 ft<sup>2</sup> (372 m<sup>2</sup>) of the sprinklered area, whichever is greater.</p> <p>or,</p> <p>Enclose the storage area from the surrounding occupancy with a minimum 1 hour construction.</p> | Within 3 months |

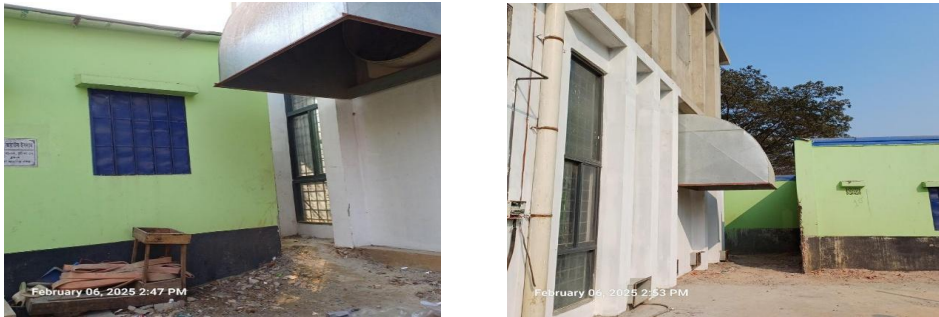
| F-05 | Fire Rated Construction | The required fire separation distance does not comply with the requirements of BNBC 2020 for Main Factory Building with other tenants. | The exterior walls shall have a fire resistance and opening protection as specified in BNBC 2020 Part 3 Table 3.2.2 & 3.2.3 and BNBC 2020 Part 3 Section 2.4.1.3. | Within 4 months |

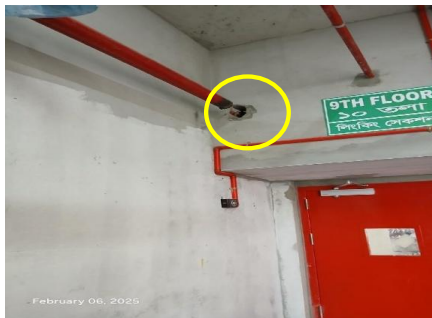
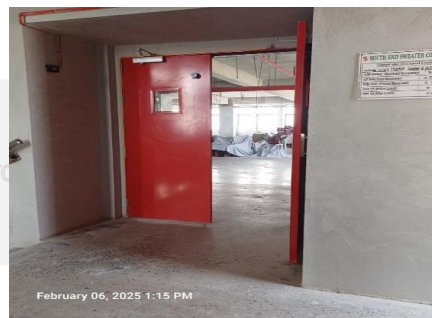
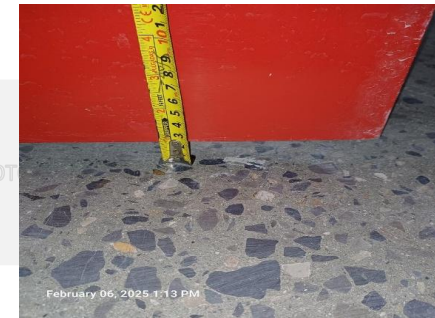
| F-06 | Means of Egress | <p>The exit stair enclosures are not separated from work areas and other spaces on each floor by fire-rated construction in Main Factory Building due to-</p> <ul style="list-style-type: none"> <li>i. Unsealed penetrations are located in exit stair enclosure.</li> <li>ii. Fire rated doors are installed at exit stair enclosure and doors are found open with magnetic door holder, but fire alarm &amp; detection system is found non-functional during inspection.</li> <li>iii. Gap below fire rated door is found more than maximum allowable limit. Smoke seal of fire rated door is found damaged in several locations.</li> </ul> | <p>The exit stair enclosure shall be provided with a minimum 1-hr fire resistance rating for buildings with 3 or fewer stories and a minimum of 2- hr. fire resistance rating for buildings 4 or more stories. Provide 1 hr. fire rated door and seal all penetrations and openings by 1 hr. fire rated fire rated barrier construction for building with 3 or fewer stories. Provide 1.5 hr. fire rated door and seal all penetrations and openings by 2 hr. fire rated fire rated barrier construction for building with 4 or more stories.</p> <p>Provide a fire-resistive rated assembly between the exterior exit stairs and the building up to 10 ft. beyond the end of the stair to achieve the required separation. The rated assembly shall be approved and/or designed by a qualified fire protection engineer.</p> <p>Ensure that the fire doors are self-closing and positive latching and that they are provided with fire exit (panic) hardware where serving production floors. If fire doors are required to be held open for functional reasons, provide automatic closing devices tied to the fire alarm system. The clearance under the bottom of a fire rated door shall be a maximum of 3/4 in. (19 mm ).</p> <p>Replace/install the non-functional/missing fire door accessories and properly inspect, test &amp; maintain fire door as per NFPA 80.</p> | Within 3 months |

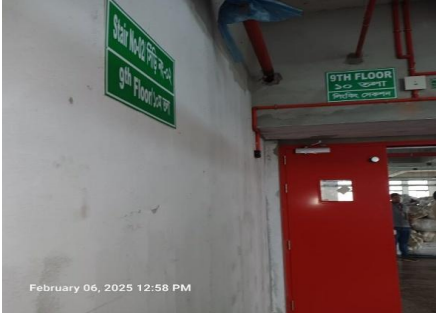
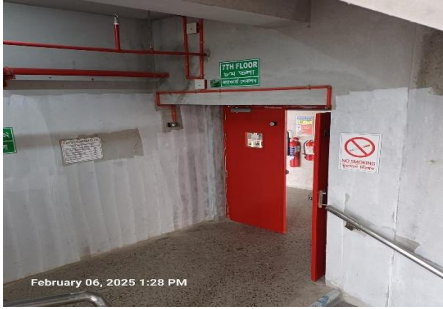
| F-07 | Means of Egress | Building did not have occupant load signs in 9th floor Main Factory Building and assembly and proper stair designation signs at required locations on all floors. | Provide occupant load signs and appropriate stair designation signs at required locations.<br>Post the occupant load for every assembly and production floor in a facility in a conspicuous space near the main exit or exit access doorway for the space. | Within 1 month |

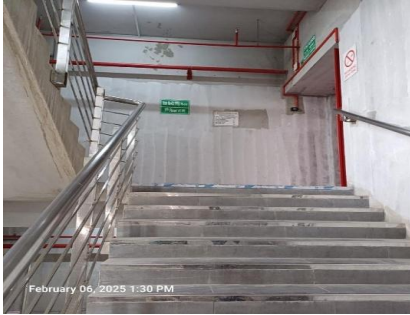
| F-08 | Means of Egress | Fire evacuation maps is not posted at the entrance of all exit stair. | Fire evacuation maps shall be posted at the entrance to each exit stair. | Within 1 month |

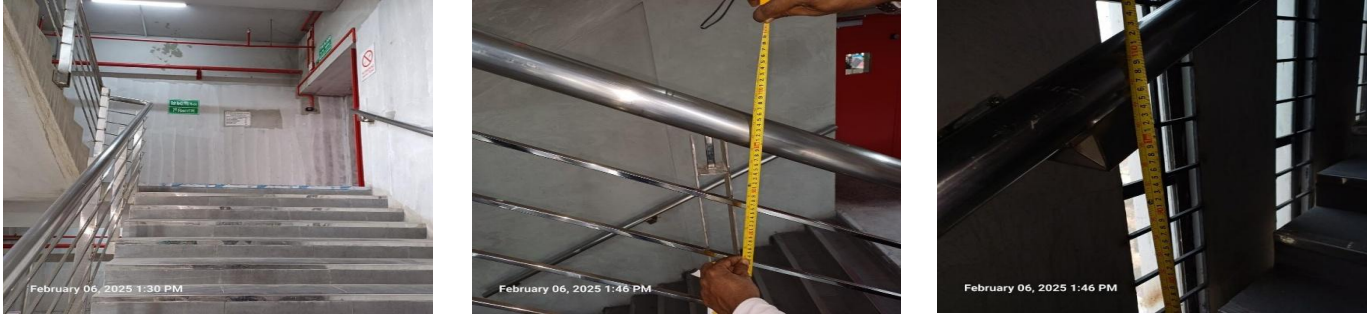
| F-09 | Means of Egress | Handrails are provided on both sides of the exit stair on all floors but handrails height is found more than 38 in. as measured from tread. | New handrails shall have a minimum height of 865 mm (34 in.) and a maximum height of 965 mm (38 in.) as measured from the leading edge of the tread. | Within 3 months |

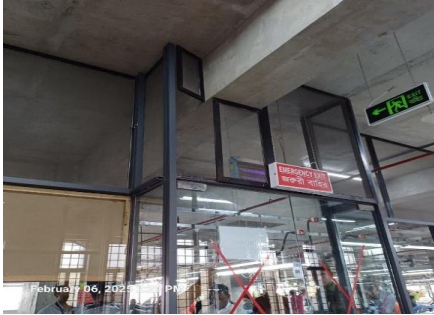
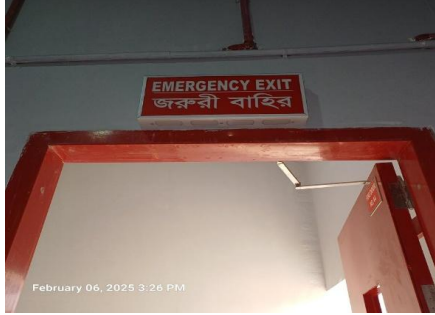
| F-10 | Egress Lighting | Exit signage is not illuminated during testing (burned out, broken, etc.) in Main Factory Building 2nd floor (Packing area), Fire Control Building. | Regularly inspect all exit signage and emergency lighting system as per RSC Technical Guidelines (Standard) and replace/install lights as needed to illuminate signs. | Within 1 month |

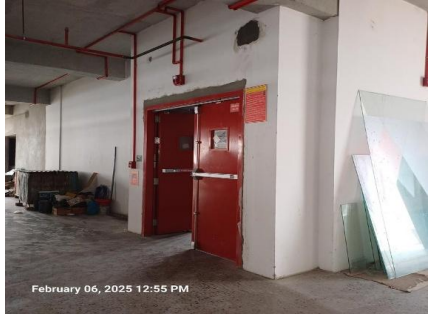
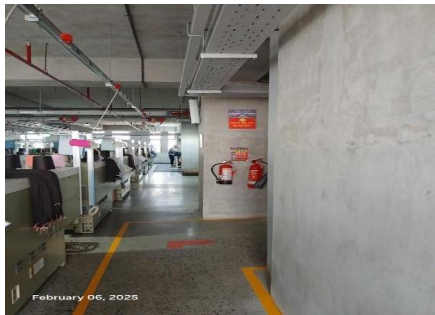
| F-11 | Egress Lighting | <p>Exit signage is not provided along a path of egress. Directional signs are not provided where direction of the path of travel to an exit has changed.</p> <p>Location: 9th floor exits, 6th floor near stair-1 in Main Factory Building</p> | <p>Provide exit signs above all building exits to the exterior, all doors to the exit stairs and along all paths of travel where a change of direction is not obvious.</p> <p>Lighted exit signs shall be provided with either battery backup or uninterruptible power supply systems and shall be continuously illuminated.</p> | Within 1 month |

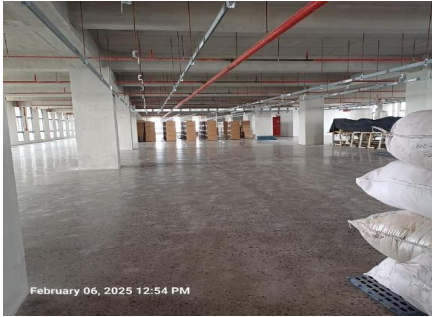
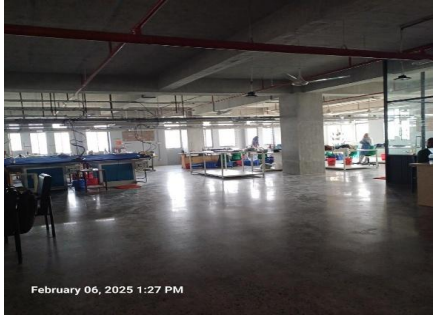
| F-12 | Egress Lighting | <p>Based on the number and location of emergency lights observed, adequate illumination levels are not anticipated along egress routes.</p> <p>Location: Main Factory Building and other ancillary buildings</p> | <p>Test the emergency lighting system on each floor and provide additional emergency fixtures to provide adequate illumination along the means of egress. Provide a minimum illumination of 10 lux at the floor level within exit stairs and exit discharge paths and minimum 2.5 lux along exit access aisles.</p> | Within 2 months |

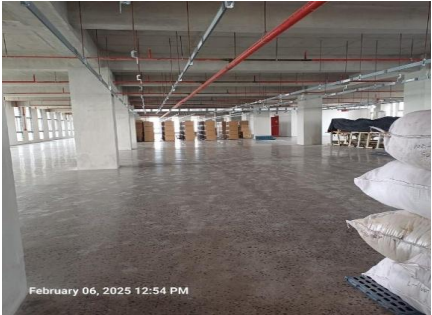
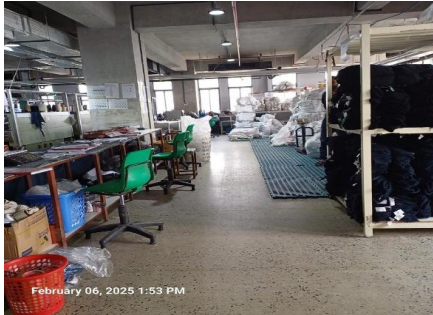
| F-14 | Means of Egress | Aisles mark is missing in several locations of floors in Main Factory Building. | Aisles shall be provided with a minimum unobstructed clear-width of 0.9 m (36 in.). | Within 1 month |

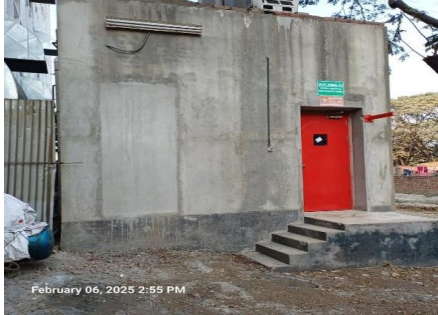
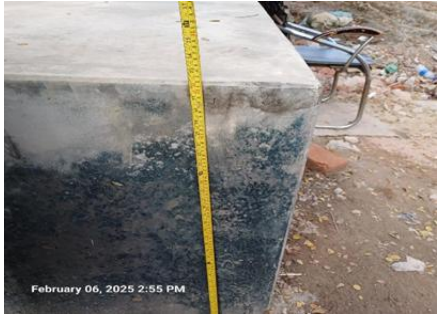
| F-15 | Means of Egress | <p>Guards are not provided at open sides of means of egress that exceed 760 mm (30 in.) above the floor or finished ground below.</p> <p>Location: Utility Building</p> | <p>Guards shall be provided at all open sides of means of egress that exceed 760 mm (30 in.) above the floor or finished ground below.</p> <p>Guards shall have a minimum height of 1067 mm (42 in.). Open guards shall have intermediate rails or pattern such that a sphere 200 mm (8 in.) in diameter cannot pass through any opening up to a height of 865 mm (34 in.).</p> | Within 1 month |

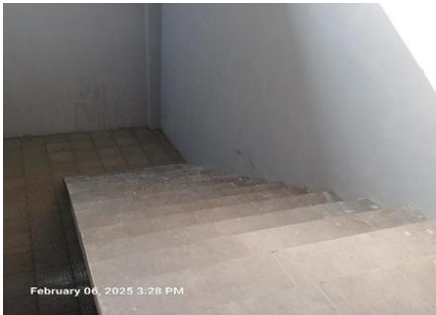
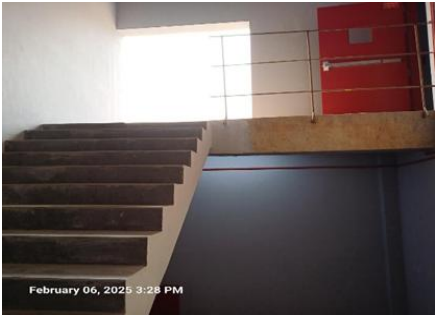
| F-16 | Means of Egress | <p>Handrails are not provided on both sides of the exit stair in Fire Control Building Basement floor.</p> | <p>Provide handrails on both sides of the exit stair. Intermediate handrails shall be provided when the stair width exceeds 2.2 m (87 in. New handrails shall have a minimum height of 865 mm (34 in.) and a maximum height of 965 mm (38 in.) as measured from the leading edge of the tread.</p> | Within 1 month |

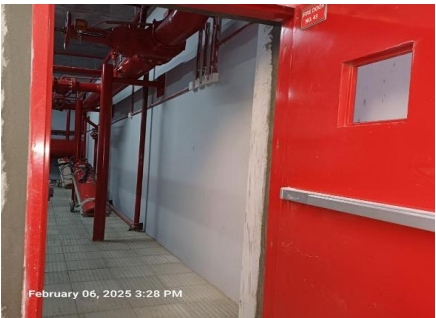
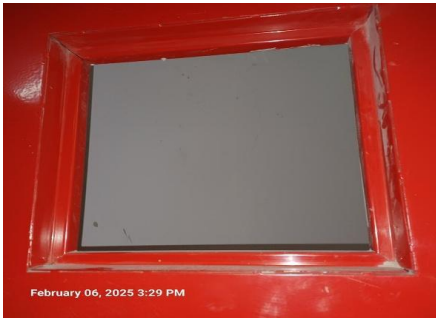
| F-17 | Fire Rated Construction | <p>The fire pump room located in Basement floor in Fire Control Building is not provided with adequate fire separation. Installation of fire rated door is on going.</p> | <p>Provide fire pump room with 2 hr. rated fire separation when not sprinklered and 1 hr rated fire separation when provided with automatic sprinklers in accordance with NFPA 20.</p> <p>Or, Physically separate the pump room from the protected building by a minimum of 50 ft. (15.3 m) in accordance with NFPA 20.</p> <p>Fire pump room shall be directly accessible or it shall be accessible through an enclosed passageway from an enclosed stairway or exterior exit. The enclosed passageway shall have a fire-resistance rating not less than the fire-resistance rating of the fire pump room.</p> | Within 3 months |

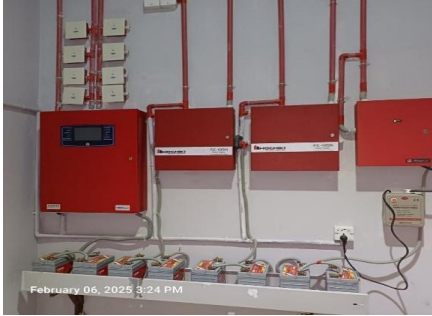
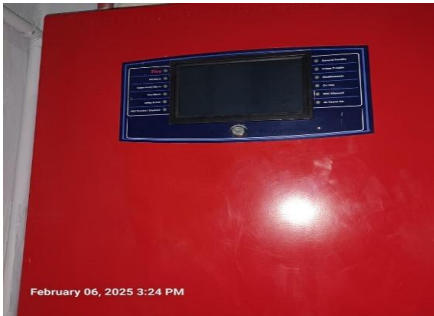
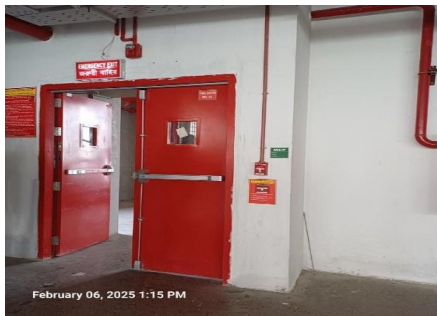
| F-18 | Fire Alarm & Detection System (FADS) | The fire alarm system installation requires detailed review to confirm compliance with NFPA 72 and RSC technical guidelines (Standard) [For all structures]. | <p>Submit as-built drawings, testing records, equipment certification and other relevant documentation to the RSC for review.</p> <p>Once reviewed, install or modify the fire detection and alarm system (where required) throughout the building in accordance with RSC technical guidelines (Standard) and NFPA 72. The factory management shall contact RSC to conduct the final acceptance testing after the installation, testing &amp; commissioning.</p> | <p>Design- within 2 month</p> <p>Modification if required- within 4 months</p> |

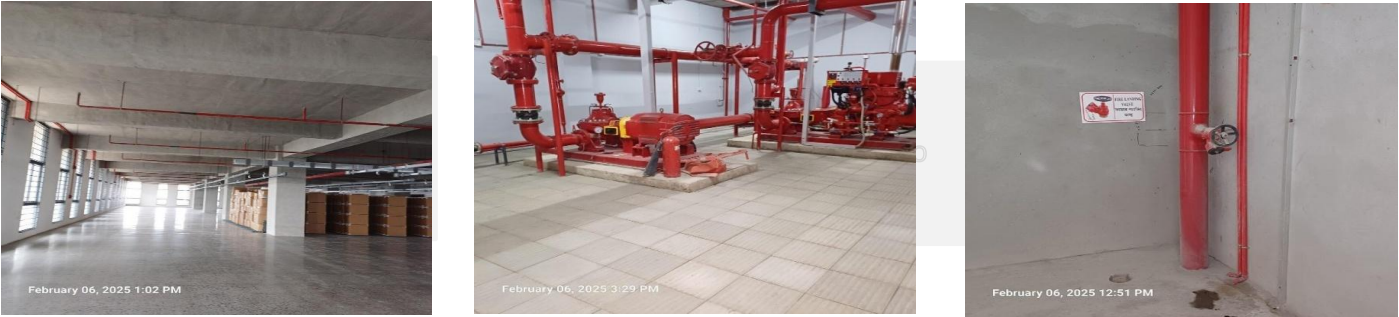
| F-20 | Fire Protection System (Sprinkler) | The high-rise building has an occupied floor greater than 23 meter (75 feet) and installation of automatic sprinkler protection along with standpipe system is ongoing. The automatic sprinkler and standpipe system installation requires detailed review to confirm compliance with NFPA 13, 14, 20, 22, 24 and the RSC Technical Guidelines (Standard) [For Main Factory Building]. | Submit the Automatic Sprinkler, Standpipe and Fire Pump System drawing and documents to RSC for review. Once reviewed, install or modify the Automatic Sprinkler System throughout the building in accordance with RSC Technical Guideline (Standard) and NFPA 13, 14, 20, 22 and 24.<br><br>After installation, the factory shall contact the RSC for witness of conducting the final acceptance testing of the SUPS (Sprinkler with standpipe) system. | Design- within 2 month<br>Modification if required- within 4 months |
