# INITIAL FIRE SAFETY INSPECTION REPORT

## UNITED COSTUME LIMITED (Building - 02)

RSC ID: 26006

# Fire Safety Inspection Report

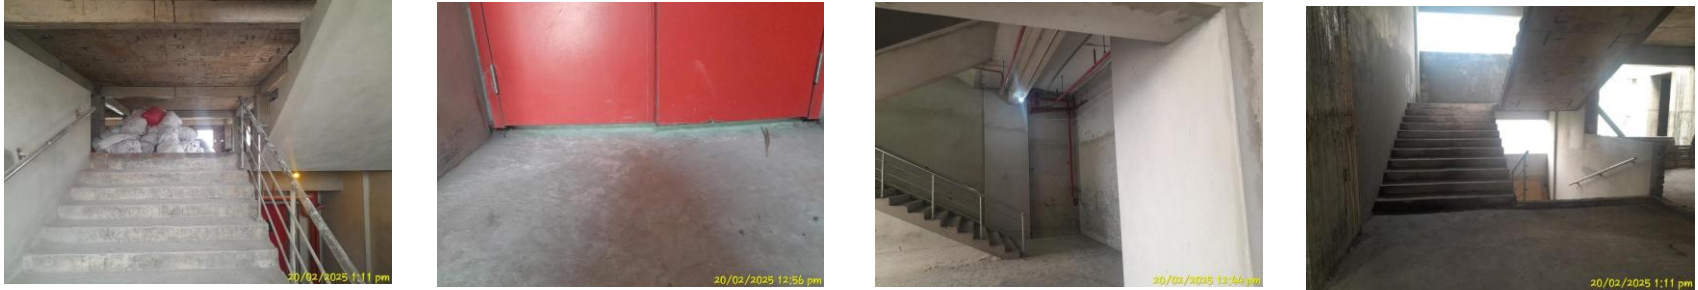
| SI No. | Category | Findings | Required Action | Remediation Time Frame |
|---|---|---|---|---|
| F-1 | Means of Egress | <p>Exit stairs are not separated from work areas &amp; other spaces on each floor by fire-rated construction due to unprotected openings, penetrations &amp; fire doors forcefully open with external objects.</p> <p><b>Location: Building-2: all floors.</b></p> | <p>Separate the exit stairs from work areas and other building spaces on all floor levels by minimum 2- hr. fire-rated construction.</p> <p>Provide a minimum 1.5- hr. fire-rated doors and seal all unprotected openings and penetrations to maintain the fire separation.</p> <p>Ensure that all fire doors are self-closing and positive latching, and are provided with fire exit (panic) hardware where serving production floors or assembly occupancies.</p> <p>If fire doors are required to be held open for functional reasons, provide automatic closing devices tied to the fire alarm system.</p> <p>Once fire doors are installed, every door in a stair enclosure serving more than 5 stories shall be provided with re-entry unless it meets RSC Technical Guidelines (standard) 6.8.3.1.</p> | Within 3 months |

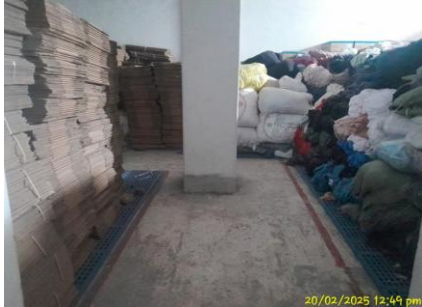
| F-2 | Means of Egress | <p>The width of egress aisles is less than 36-in. on the ground floor.</p> <p><b>Location: Building-2: Ground Floor.</b></p> | <p>Aisles shall be provided with a minimum unobstructed clear-width of 0.9 m (36 in.).</p> | Within 1 month |

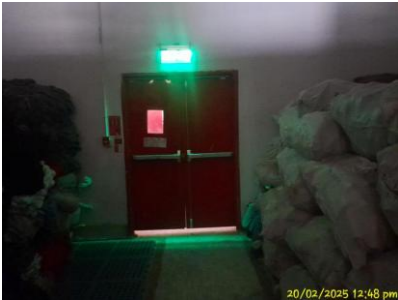
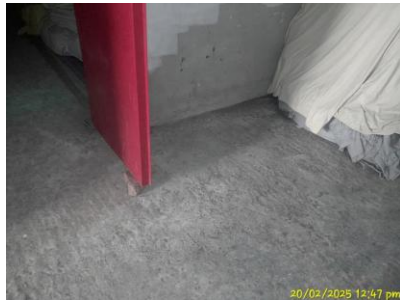
| F-3 | Fire Rated Construction | <p>Rooms used for combustible storage are not separated by fire-rated construction from surrounding occupancies due to gap beneath the fire doors more than 19 mm &amp; opening with external sources.</p> <p><b>Locations: Ground floor (Building-2).</b></p> | <p>Separate the dedicated storage rooms by minimum 1-hr fire-rated construction. However, separated areas shall ensure required means of egress as per RSC Technical Guidelines.</p> | Within 3 months |

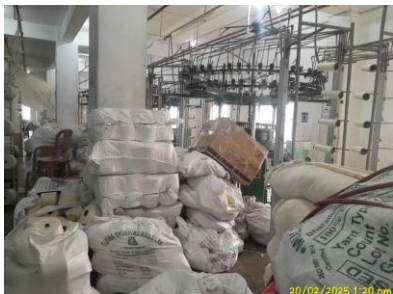
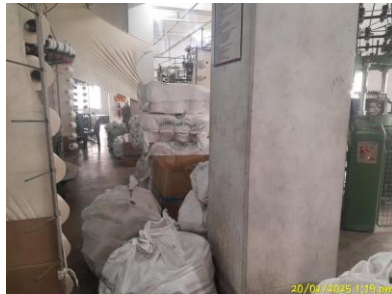
| F-4 | Fire Rated Construction | <p>Areas used for in-process storage open to the factory are not separated by fire-rated construction</p> <p><b>Location: 1st floor. (Building-2).</b></p> | <p>Separate the dedicated storage rooms by minimum 1-hr fire-rated construction. Provide 1-hr. fire rated door and seal all penetrations and openings by 1 hr. fire rated fire rated barrier construction.</p> <p>Where separate storage rooms are not feasible, provide defined storage areas and limit the storage arrangement as follows: -<br/> Maximum height of 2.45m (8ft.) , maximum area of 23m2 (250 ft2) and 3m (10ft.) clear distance from adjacent another unenclosed combustible storage.<br/> - If the building/floor is sprinkler protected: maximum height of 3.66m (12ft.) and maximum area of 93m2 (1000 ft2).<br/> - In-process storage shall not exceeds 10 percent of floor or compartment area.</p> | Within 1 month |

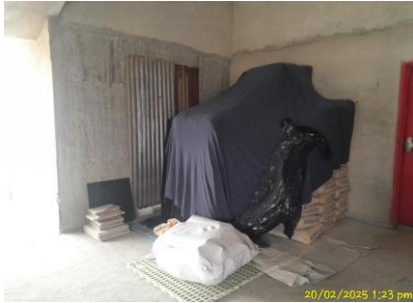
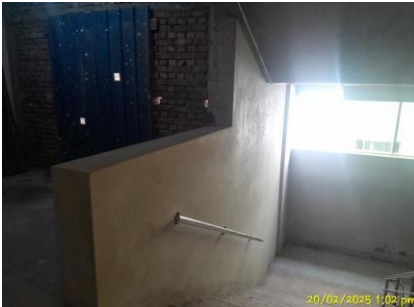
| F-5 | Fire Rated Construction | <p>Elevator shafts (provisions) are directly open into both exit enclosures which is a violation of RSC Technical Guidelines (Standard)-6.14.3.</p> <p><b>Location: All floors, Building-2.</b></p> | <p>Ensure minimum 1.5-hr fire rating for the doors of elevator shafts otherwise close the shafts area with 2-hr fire rated construction barrier and 1.5-hr fire rated opening protective as per RSC Technical Guidelines (Standard) 6.14.3.</p> <p>Factory is recommended to follow RSC published "SUPPLEMENTARY PAPER ON REMEDIATION GUIDANCE ELEVATOR OR LIFT SHAFT OPENING IN EXIT ENCLOSURES" for different solutions.</p> | Within 4 months |

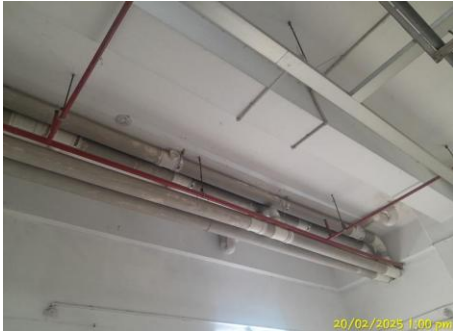
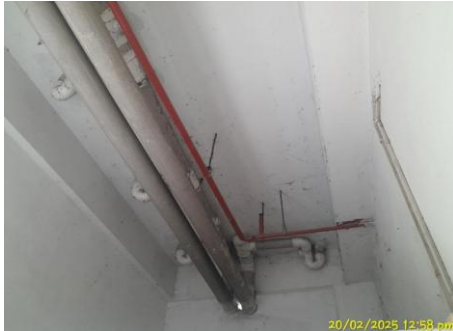
| F-6 | Fire Rated Construction | <p>Unsealed penetrations and openings due to plumbing pipes are located in the fire-rated floor/ceiling assemblies.</p> <p><b>Locations: Floor &amp; toilet areas, Building-2.</b></p> | <p>Seal all penetrations and openings in floor/ceiling assemblies to maintain the fire separation at least by 3-hr. The used sealer shall be 3rd party certified and installation shall be as per manufacturer's guideline.</p> <p>or,</p> <p>Provide a minimum 2-hr fire rated shaft to separate the utility risers from each floor if required. (Type-1 Construction).</p> <p>Factory shall ensure that, all the design, datasheet, certificate, and proposed drawing of installation has been reviewed from the RSC prior to install the passive fire protection system (If required).</p> | Within 3 months |

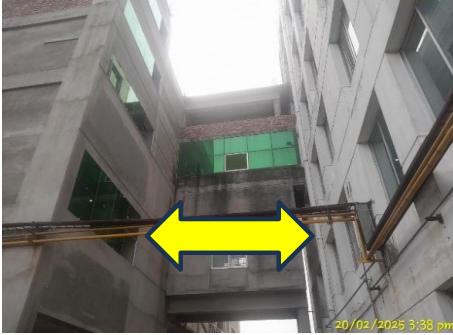
| F-7 | Fire Rated Construction | The required fire separation distance for Building-02 does not comply with the requirements of BNBC 2006. | The exterior walls shall have a fire resistance and opening protection as specified in BNBC 2006, Tables 3.2.2 and Part 3 Section 2.4.1.3. | Within 3 months |

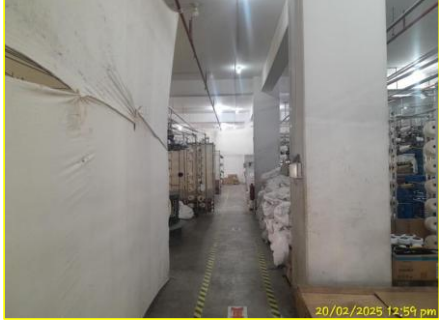
| F-9 | Means of Egress | <p>Directional signs are not provided where the direction of the path of travel to an exit has changed.</p> <p><b>Location: 1st floor, Building-2.</b></p> | <p>Illuminated directional signs shall be provided where there is a change in the direction for the path of travel and the direction to an exit is not obvious.</p> | Within 1 month |

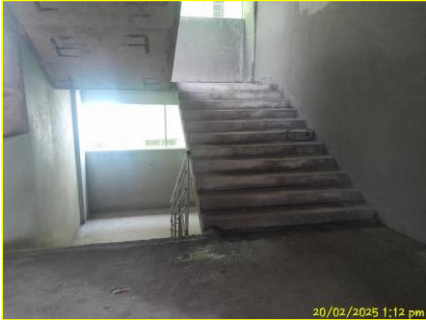
| F-10 | Means of Egress | <p>Handrails and guardrails are not provided on the exit stairs.</p> <p><b>Location: Building-2.</b></p> | <p>Provide handrails on both sides of the exit stairs.</p> <p>New handrails shall have a minimum height of 865 mm (34 in.) and a maximum height of 965 mm (38 in.) as measured from the leading edge of the tread</p> | Within 1 month |

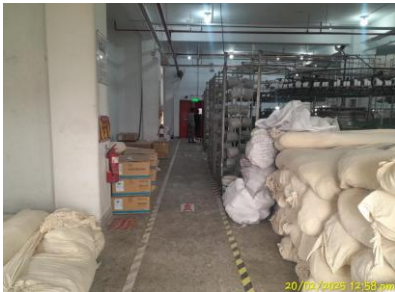
| F-11 | Means of Egress | <p>Based on the number and location of emergency lights observed, adequate illumination levels are not anticipated along egress routes.</p> <p><b>Location: All floors, Building-2.</b></p> | <p>Test the emergency lighting system on each floor and provide additional emergency fixtures to provide adequate illumination along the means of egress. Provide a minimum illumination of 10 lux at the floor level within exit stairs and exit discharge paths and minimum 2.5 lux along exit access aisles.</p> | Within 1 month |

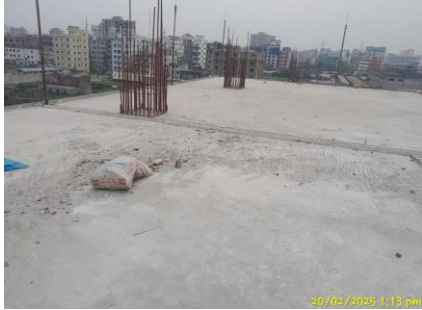
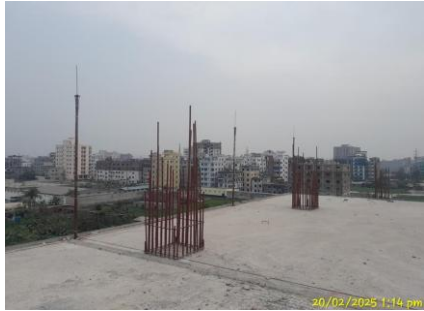
| F-12 | Means of Egress | <p>Parapets or guards are not provided on the occupiable roof.</p> <p><b>Location: Building-2.</b></p> | Provide parapets or guards with a minimum height of 1067mm (42 inch.). | Within 1 month |

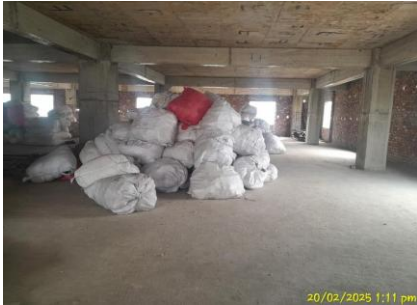
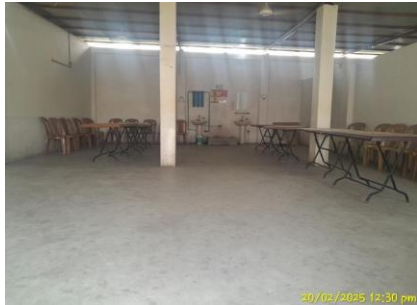
| F-13 | Means of Egress | <p>Aisle marking has not been provided properly.</p> <p><b>Location: 3rd floor (Building-2) &amp; Dining shed.</b></p> | Aisles mark shall be provided at required places with a minimum unobstructed clear-width of 0.9 m (36 in.). | Within 1 month |

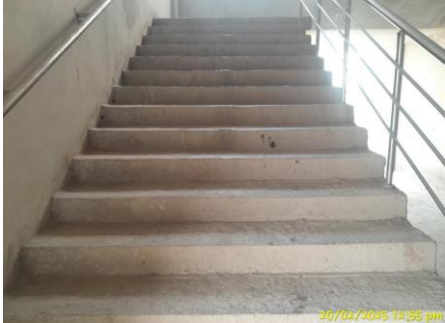
| F-14 | Means of Egress | <p>Stairway treads are not uniform &amp; abrupt changes in elevation exceed 1/4 inch which may lead to a tripping hazard during an emergency. Change in level was also observed on stair discharge from mezzanine &amp; ground floor occupants.</p> <p><b>Location: Production Building-2.</b></p> | <p>Remove the obstructions and Provide an even level walking surface in exit discharge in accordance with 6.3.4 of RSC Technical Guidelines (Standard).</p> <p>Provide adequate number of steps to mitigate tripping hazards where changes in level are observed on exit discharge.</p> | Within 1 month |

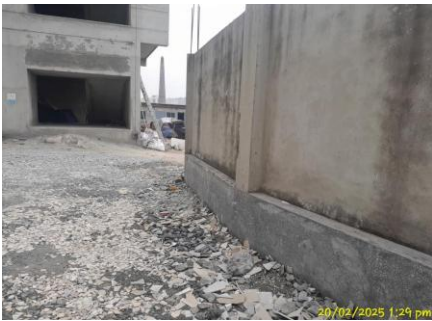
| F-15 | Mean of Egress | <p>Uneven path of travel was observed in the exit discharge path due to construction purposes.</p> <p><b>Locations: West side, Production Building-2.</b></p> | <p>Remove unnecessary items and level exit path to the public way. Means of egress shall be maintained continuously free and clear of all obstructions</p> | Within 3 months |
