# KORMOP CO.LTD

53/1, Block No-C, Ward No-3, Belma Ashulia, Bangladesh

24 February 2025

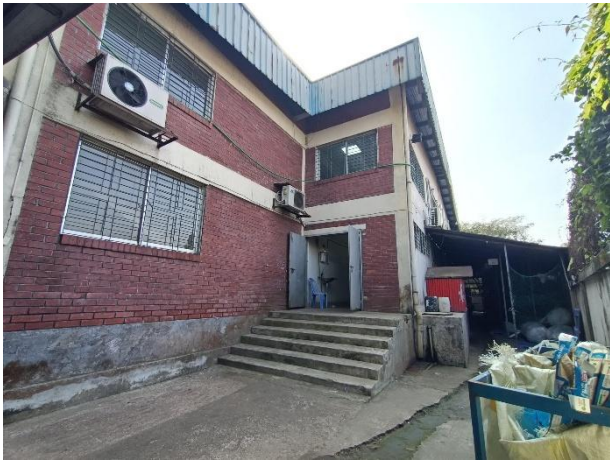
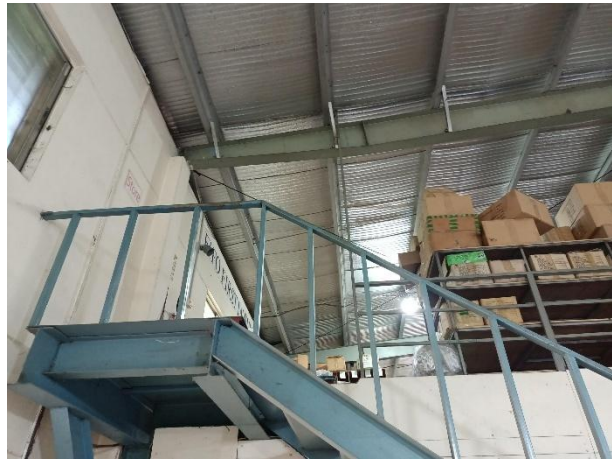
**Observation-1:** Absence of structural drawings. (Factory Building-1).

**Description:** Credible structural drawings were not available at the time of inspection. Building engineer is required to survey the whole structure and produce credible structural drawing for the structure.

| Item No | Observation | Action Plan | Timeline |
|---|---|---|---|
| 01 | Absence of structural drawings. (Factory Building-1) | Building engineer is required to survey the whole structure and prepare as-built drawings with credible foundation details. | within 6 weeks |

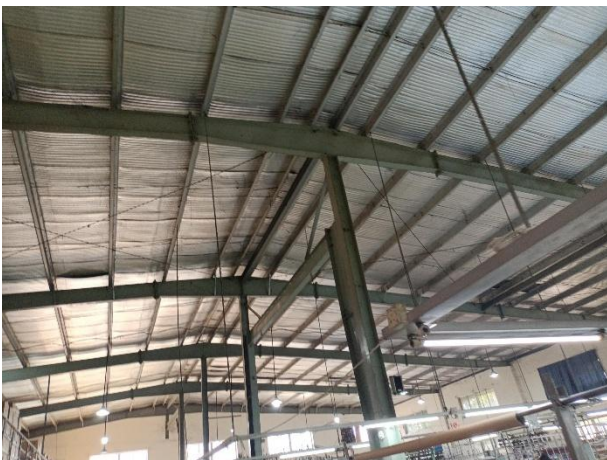
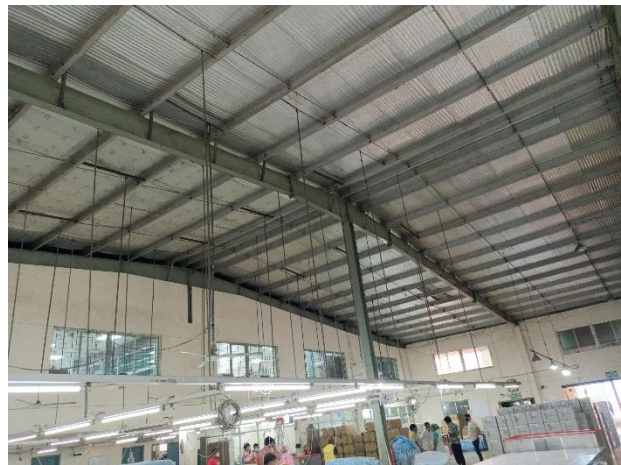
**Observation 2:** Lack of lateral stability and absence of design documents (Factory Building-1).

**Description:** Lateral load transfer media (compression struts) were found missing. So, stability in the long direction is incomplete. The building engineer is required to carry out Detail Engineering Assessment (DEA) to check the stability system for the whole structure and suggest proper remedial measures.

| Item No | Observation | Action Plan | Timeline |
|---|---|---|---|
| 02 | Lack of lateral stability and absence of design documents (Factory Building-1) | The building engineer is required to carry out Detail Engineering Assessment (DEA) to check the stability system for the whole structure and suggest proper remedial measures. | within 6 weeks |
| 03 | Lack of lateral stability and absence of design documents (Factory Building-1) | Produce and actively manage floor load plan for both mezzanine and roof. | within 6 weeks |
| 04 | Lack of lateral stability and absence of design documents (Factory Building-1) | Implement remediation work if required. | within 6 months |
| 05 | Lack of lateral stability and absence of design documents (Factory Building-1) | Implement floor loading plan. | within 6 months |

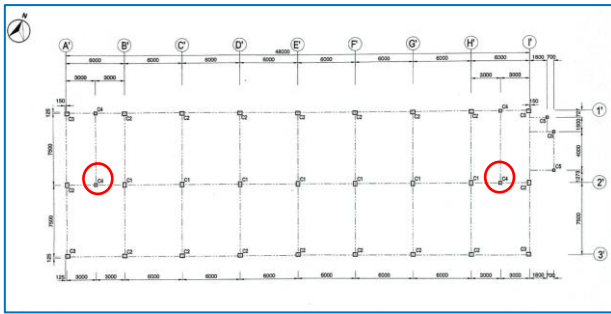
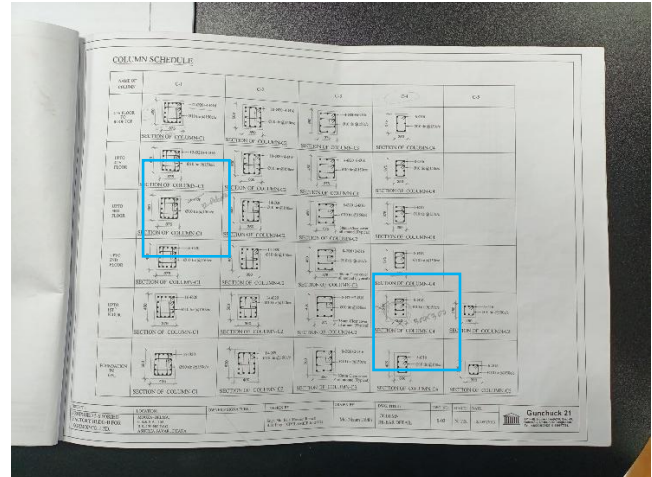
**Observation-3: Mismatches in as-built drawings (Factory Building-2).**

**Description:** Size and amount of rebar in C-4 column did not match with onsite condition. 300x300 mm was found instead of 250x375 and 6 nos of rebars were found instead of 8 nos. Also, the amount of rebar at C-1 column on 3<sup>rd</sup> floor were found less than the drawings. Building engineer is required to survey the whole structure and prepare accurate as-built drawings for the structure.

| Item No | Observation | Action Plan | Timeline |
|---|---|---|---|
| 06 | Mismatches in as-built drawings (Factory Building-2) | Building engineer is required to survey the whole structure and prepare accurate as-built drawings for the structure. | within 6 weeks |

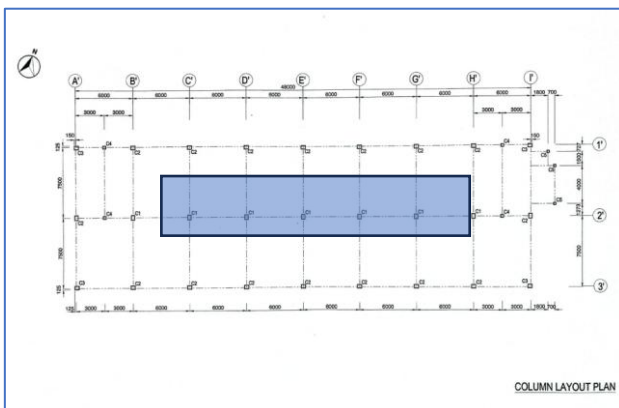
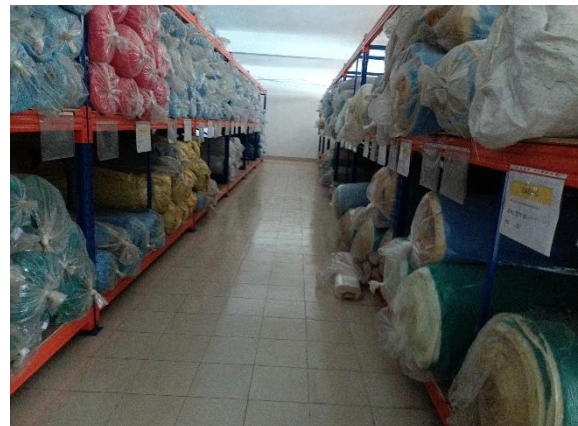
**Observation 4: Columns and footings found to be overstressed. (Factory Building-2).**

**Description:** Cursory calculation indicates the internal columns and footings are stressed above the normal design limit. Column and footing capacity were checked considering the 3 kPa live load for production floor & 6 kPa live load for storage area and minimum concrete strength based on aggregate type. The building engineer is required to review the design load and foundation stresses.

| Item No | Observation | Action Plan | Timeline |
|---|---|---|---|
| 07 | Columns and footings found to be overstressed. (Factory Building-2). | Verify in-situ test from each class of concrete. | Immediate |
| 08 | Columns and footings found to be overstressed. (Factory Building-2). | The building engineer is required to carry out DEA to review the design load, column and foundation stresses. | within 6 weeks |
| 09 | Columns and footings found to be overstressed. (Factory Building-2). | Produce and actively manage floor load plan. | within 6 weeks |
| 10 | Columns and footings found to be overstressed. (Factory Building-2). | Implement remediation work if required. | within 6 months |
| 11 | Columns and footings found to be overstressed. (Factory Building-2). | Implement floor loading plan. | within 6 months |

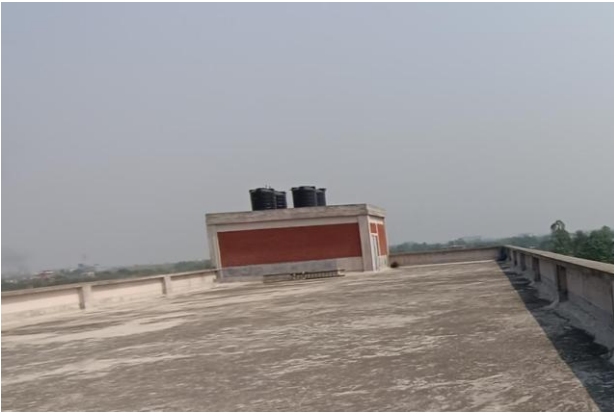
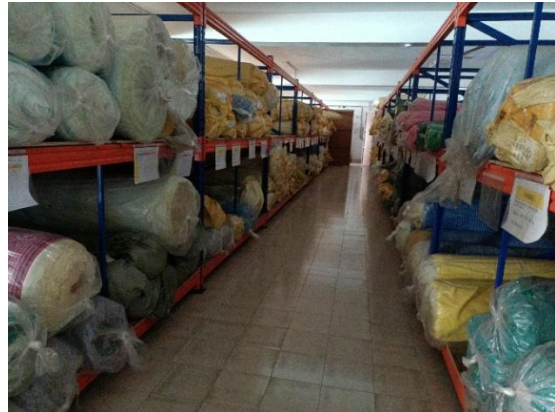
**Observation-5:** Unbraced PVC water tank on the stair roof and racks on floor (Factory Building-2).

**Description:** Unbraced plastic water tanks and storage racks were found on the staircase roof and typical floor. The factory is required to anchor and brace all types of non-structural elements to avoid falling hazards during EQ.

| Item No | Observation | Action Plan | Timeline |
|---|---|---|---|
| 12 | Unbraced PVC water tank on the stair roof and racks on floor (Factory Building-2) | The factory is required to anchor/brace all types of non-structural elements to avoid falling hazards during earthquakes. | within 6 months |

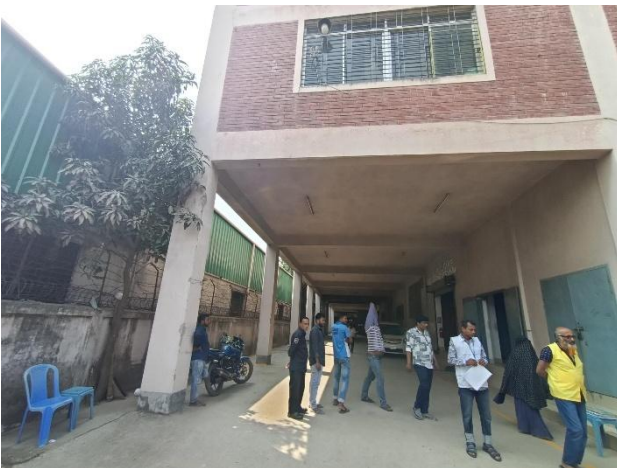
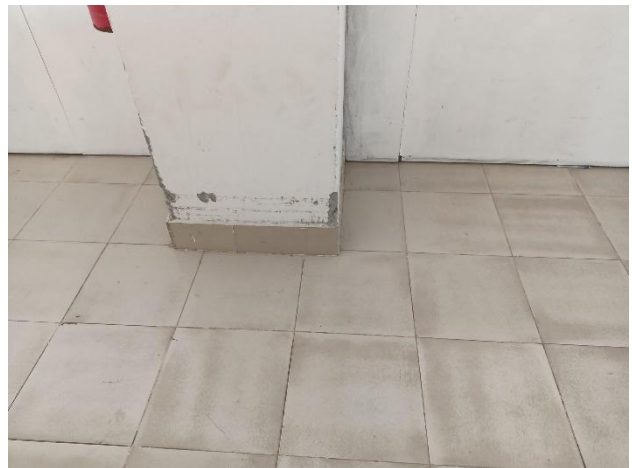
**Observation 6:** Column susceptible to vehicle and trolley impact (Factory Building-2).

**Description:** Columns on loading/unloading area are susceptible to vehicle impact. Also, columns on typical floors are susceptible to trolley impact. Building engineer is required provide guard around the column.

| Item No | Observation | Action Plan | Timeline |
|---|---|---|---|
| 13 | Column susceptible to vehicle and trolley impact (Factory Building-2). | Provide separate barriers around the column to avoid potential vehicle impact | within 6 months |
| 14 | Column susceptible to vehicle and trolley impact (Factory Building-2). | Provide column guard to protect the trolley impact | within 6 months |

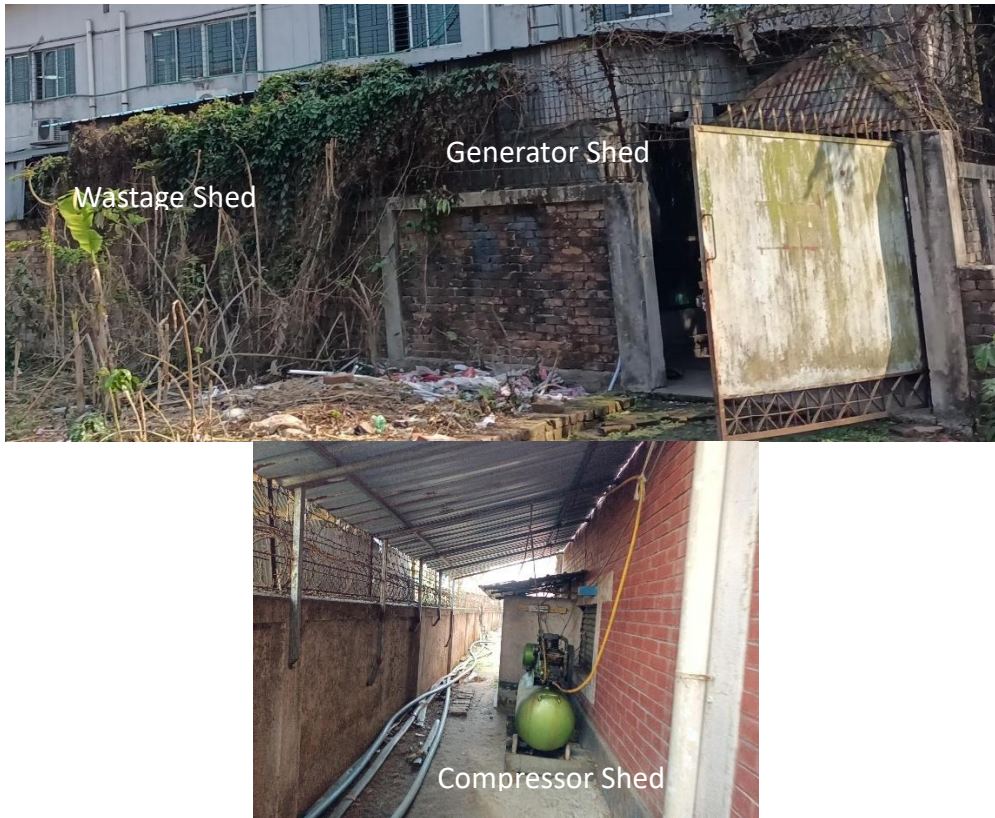
**Observation-7:** Lack of Structural drawings (Generator Shed, Wastage Shed, Compressor Shed).

**Description:** As-built structural drawings were not available for these sheds. Building engineer is required to survey the whole structure and prepares full set of as-built structural drawings.

| Item No | Observation | Action Plan | Timeline |
|---|---|---|---|
| 15 | Lack of Structural drawings (Generator Shed, Wastage Shed, Compressor Shed). | Building engineer is required to survey the whole structure and prepares full set of as-built structural drawings. | within 6 weeks |

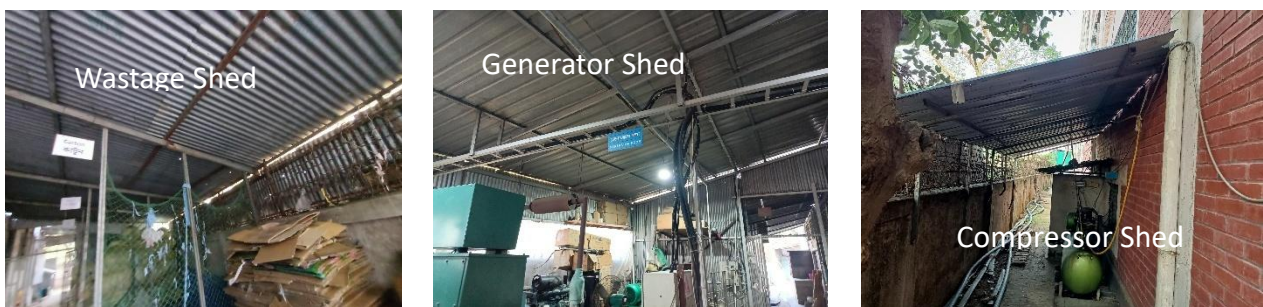
**Observation 8:** Improper connection and inadequate vertical member (Generator Shed, Wastage Shed, Compressor Shed).

**Description:** Inadequate connection, member size was observed in these sheds. The building engineer is required to check the connection & stability system (safety check) of the structure and suggest proper alternatives accordingly following Accord Building Standard.

| Item No | Observation | Action Plan | Timeline |
|---|---|---|---|
| 16 | Improper connection and inadequate vertical member (Generator Shed, Wastage Shed, Compressor Shed). | The building engineer is required to check the connection & member adequacy check (safety check) of the structure and suggest proper alternatives accordingly following Accord Building Standard. | within 6 weeks |
| 17 | Improper connection and inadequate vertical member (Generator Shed, Wastage Shed, Compressor Shed). | Implement remediation work if required. | within 6 months |
