# Hi-Tech Performance Apparels Ltd.

26/3/2 2nd Colony, Mazar Road, Mirpur-1, Dhaka-1216.

11 March 2025

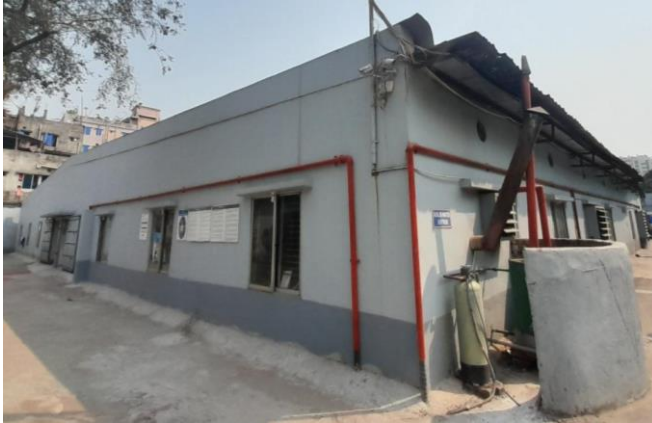
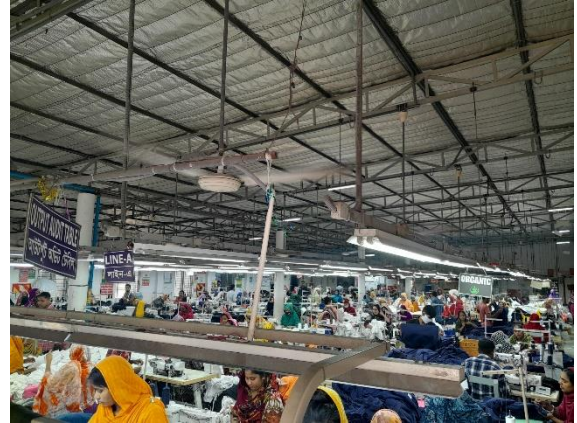
**Observation 1:** Lack of design documents (Shed 1).

**Description:** As per BNBC, every building or structure designed shall have its design documents prepared per the provision of Section 1.9.1. During the inspection, the design report and as-built structural drawing were unavailable on site.

The building engineer is required to prepare a set of design documents including as-built drawings and a design report based on in-situ material strength and software-based analysis which shall be prepared in compliance with section 1.9.1, part-6 of BNBC.

| SL | Observation | Action Plan | Timeline |
|---|---|---|---|
| 1. | Lack of design documents (Shed 1). | The building engineer is required to prepare a set of design documents including as built drawings and a design report based on in-situ material strength and software-based analysis which shall be prepared in compliance with section 1.9.1, part-6 of BNBC. | within 6 weeks |

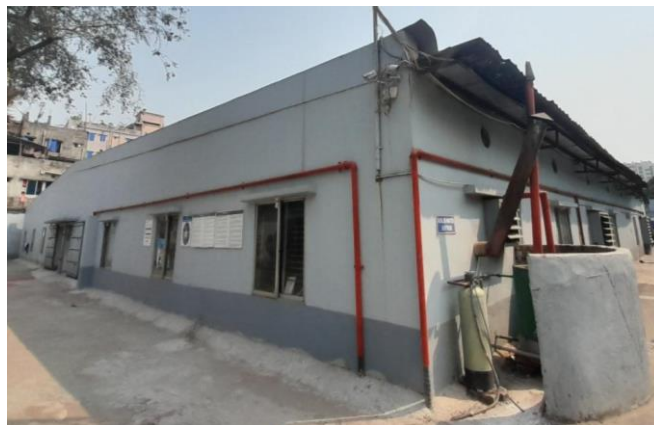
**Observation-2:** Lack of as-built drawings (Shed 1).

**Description:** As-built drawing of the structure was not available on-site. Also, a credible construction drawing of the structure is not available. The building engineer is required to survey the full structure and prepare the as-built drawing based on the as-constructed.

| SL | Observation | Action Plan | Timeline |
|---|---|---|---|
| 3. | Lack of as built drawings (Shed 1). | The building engineer is required to survey the full structure and prepare the as-built drawing based on the as-constructed. | within 6 weeks |

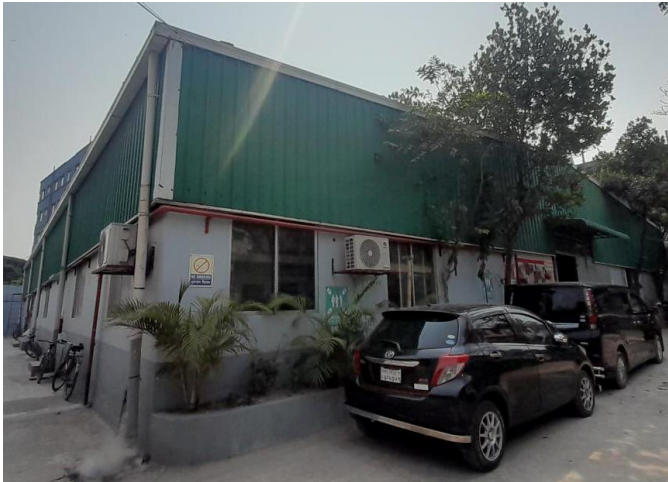
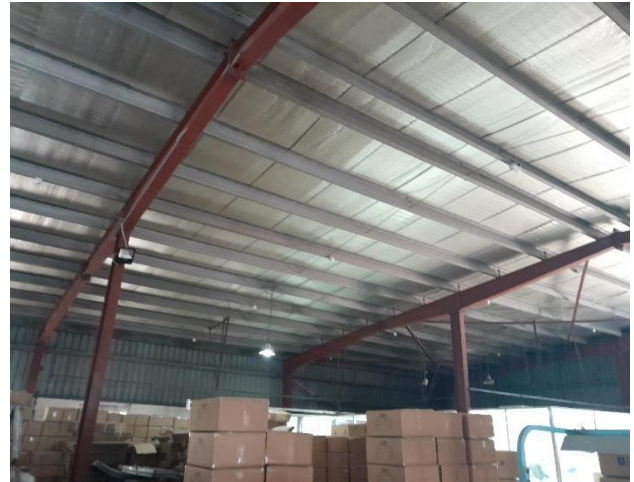
**Observation 3:** Lack of design documents (Shed 2).

**Description:** As per BNBC, every building or structure designed shall have its design documents prepared per the provision of Section 1.9.1. During the inspection, the design report and as-built structural drawing were unavailable on site.

The building engineer is required to prepare a set of design documents including as-built drawings and a design report based on in-situ material strength and software-based analysis which shall be prepared in compliance with section 1.9.1, part-6 of BNBC.

| SL | Observation | Action Plan | Timeline |
|---|---|---|---|
| 4. | Lack of design documents (Shed 2). | The building engineer is required to prepare a set of design documents including as built drawings and a design report based on in-situ material strength and software-based analysis which shall be prepared in compliance with section 1.9.1, part-6 of BNBC. | within 6 weeks |

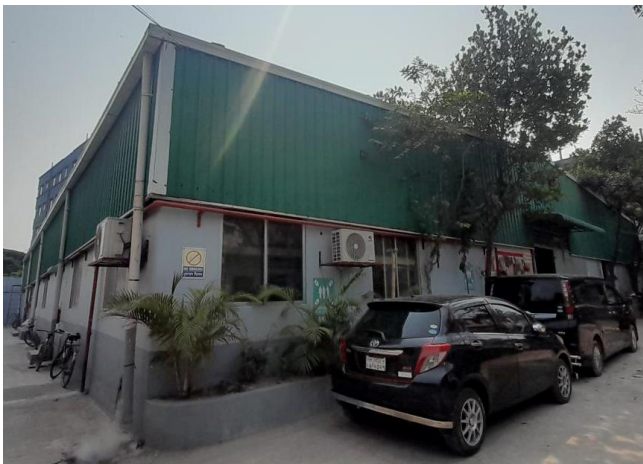
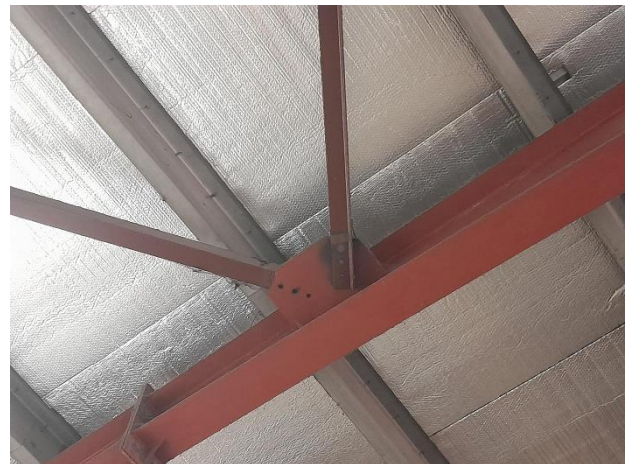
**Observation-4:** Lack of as-built drawings (Shed 2).

**Description:** As-built drawing of the structure was not available on-site. Also, a credible construction drawing of the structure is not available. The building engineer is required to survey the full structure and prepare the as-built drawing based on the as-constructed.

| SL | Observation | Action Plan | Timeline |
|---|---|---|---|
| 6. | Lack of as built drawings (Shed 2). | The building engineer is required to survey the full structure and prepare the as-built drawing based on the as-constructed. | within 6 weeks |

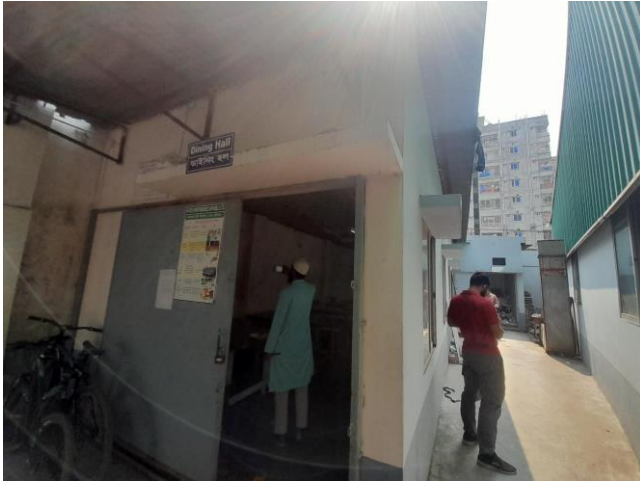
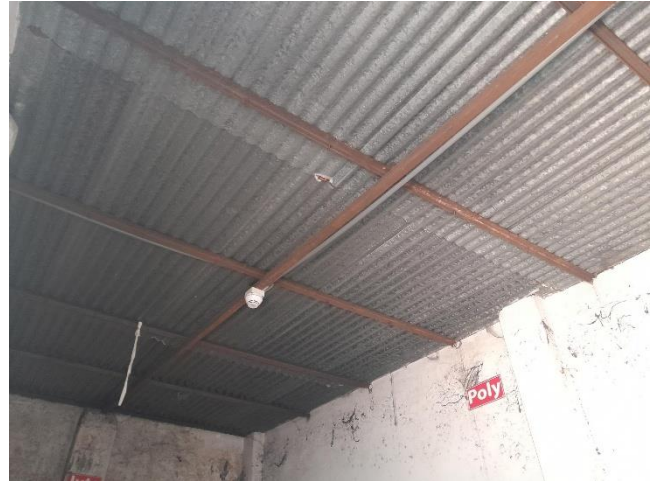
**Observation-5:** Lack of as-built drawing and inadequate connection (Shed 3).

**Description:** During the inspection, the safety check report and as-built structural drawing were not available on site. Also, inadequate connections were observed against the uplift pressure of the wind.

The building engineer is required to check the connection of roof frames for these structures and prepare as-built drawings and safety check reports suggesting proper alternatives following Accord Building Standards.

| SL | Observation | Action Plan | Timeline |
|---|---|---|---|
| 7. | Lack of as built drawing and inadequate connection (Shed 3). | The building engineer is required to check the connection of roof frames for these structures and prepare as-built drawing and safety check reports suggesting proper alternatives following Accord Building Standard. | within 6 weeks |

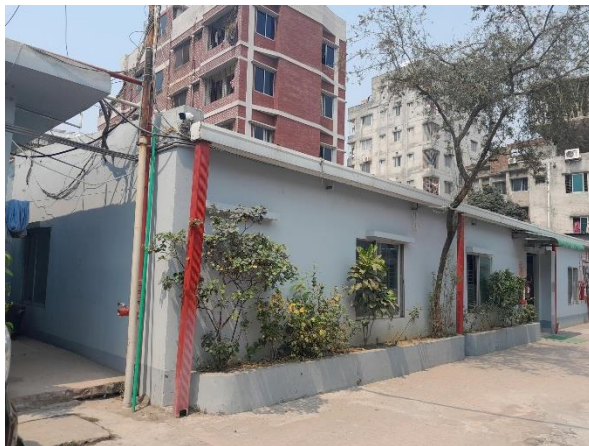
Shed 4

**Observation 6:** Lack of design documents (Shed 4 and Shed 5).

**Description:** As per BNBC, every building or structure designed shall have its design documents prepared per the provision of Section 1.9.1. During the inspection, the design report and as-built structural drawing were not available on site.

The building engineer is required to prepare a set of design documents including as-built drawings, and a design report based on in-situ material strength and software-based analysis which shall be prepared in compliance with section 1.9.1, part-6 of BNBC.

| SL | Observation | Action Plan | Timeline |
|---|---|---|---|
| 9. | Lack of design documents (Shed 4). | The building engineer is required to prepare a set of design documents including as built drawings, and a design report based on in-situ material strength and software-based analysis which shall be prepared in compliance with section 1.9.1, part-6 of BNBC. | within 6 weeks |

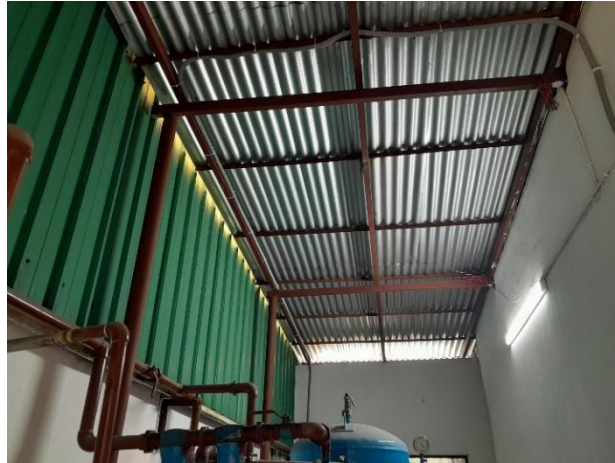
Shed-6

**Observation-7:** Inadequate connection and member. (Shed 6).

**Description:** Lack of lateral stability system (strut and bracing), apparent inadequate members and non-engineered connection were observed. The building engineer is required to check the connection of roof frames for these structures and prepare safety check reports suggesting proper alternatives following the Accord Building Standard.

| 13. | Inadequate connection and member. (Shed 6). | The building engineer is required to check the connection of roof frames for these structures and prepare safety check reports suggesting proper alternatives following Accord Building Standard. | within 6 weeks |

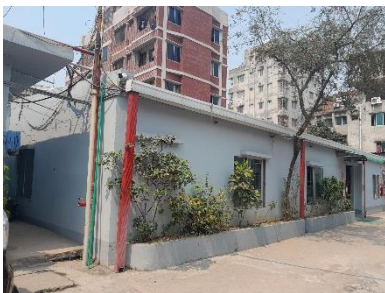
Shed 4

**Observation-8:** Lack of as-built drawings (Shed 4, 5, 6, Toilet Block, Building 1, and Building 2).

**Description:** As-built drawings of the structures were not available on-site. Also, credible construction drawings of the structures are not available. The building engineer is required to survey the full structure and prepare the as-built drawing based on the as-constructed.

| 15. | Lack of as-built drawings (Shed 4, 5, 6, Toilet Block, Building 1, and Building 2). | The building engineer is required to survey the full structure and prepare the as-built drawing based on the as-constructed. | within 6 weeks |

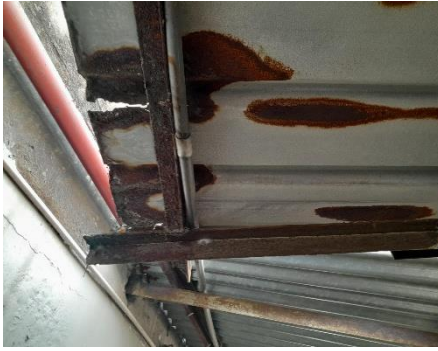
Toilet Block

**Observation-9:** Corrosion observed on steel member.

**Description:** During the inspection, corrosion was observed on steel members at several sheds. The building engineer is required to remove corrosion and provide anti-corrosive coating.

| 16. | Corrosion observed on steel member. | The building engineer is required to remove corrosion and provide anti corrosive coating. | within 6 months |

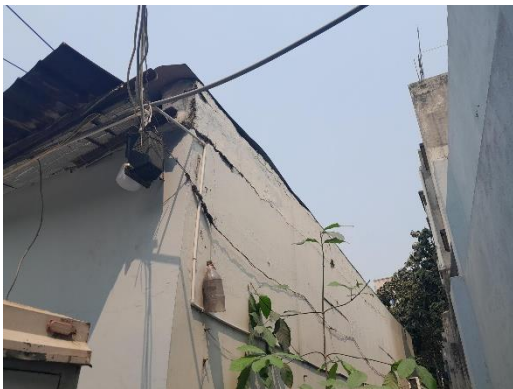
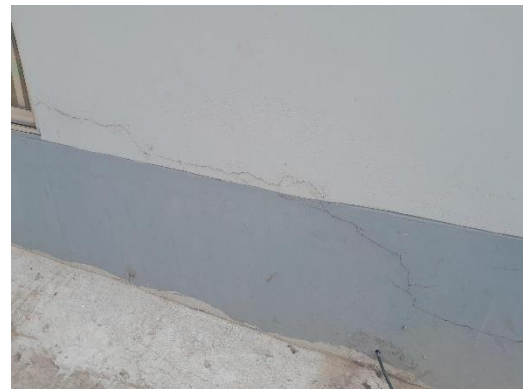
**Observation-10:** Crack on brick wall (Shed 1)

**Description:** During the inspection, cracks in brick walls were observed at several places in Shed 1. The building engineer is required to produce a crack investigation report and suggest proper remedial measures. The factory is required to repair the crack as per the investigation report.

| 17. | Crack on brick wall (Shed 1) | The building engineer is required to produce a crack investigation report and suggest proper remedial measures. The factory is required to repair the crack as per the investigation report. | within 6 weeks |

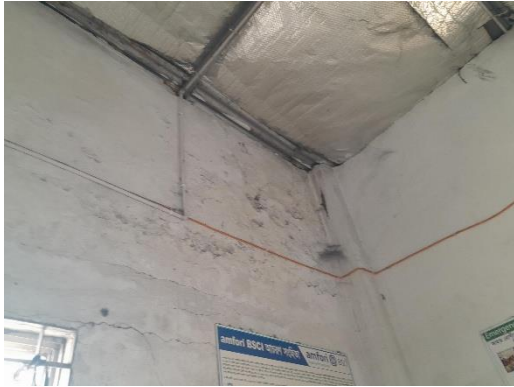
Shed 1

**Observation-11:** Dampness on the brick wall. (Shed 1 and Shed 4)

**Description:** During the inspection, dampness was observed at the brick wall of shed 1 and shed 4. The building engineer is required to investigate the extent of dampness and suggest proper remedial measures.

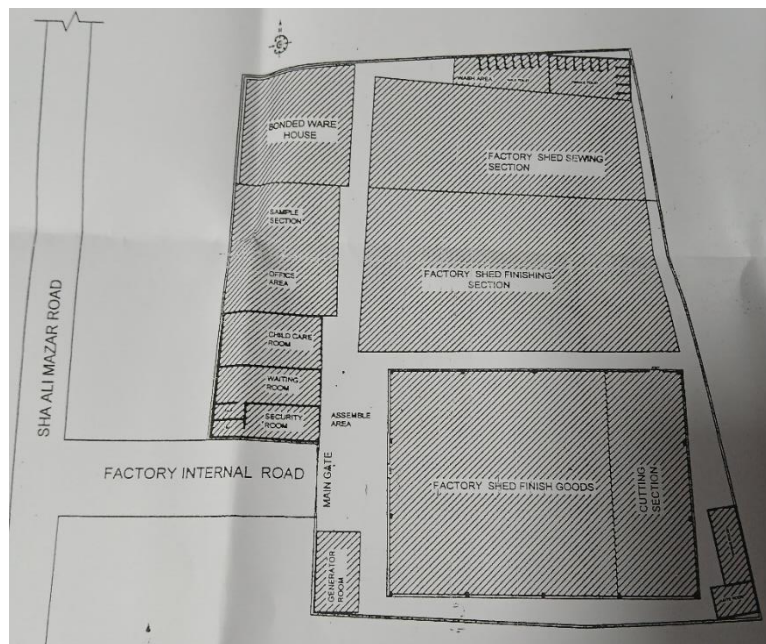
**Observation-12:** Lack of local authority approval drawing.

**Description:** During the inspection, no local authority approval drawings were found on-site. The factory is required to collect local authority-approved drawings for all structures.

| 18. | Lack of local authority approval drawing. | The factory is required to collect local authority-approved drawings for all structures. | within 6 weeks |
