Sakura Dyeing & Garments Ltd. (Extension)

Kutubail, Fatullah, Narayanganj

16 March 2025

- 1. New Warehouse Building

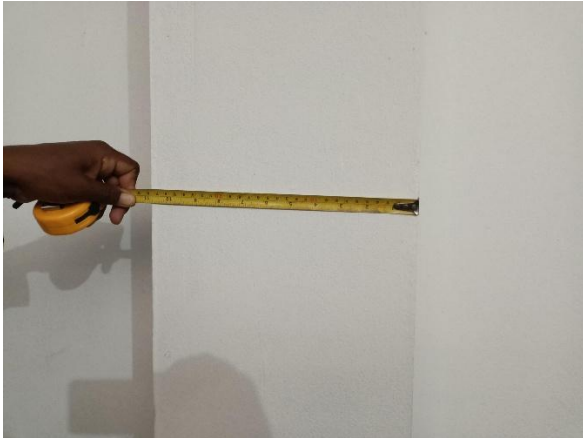
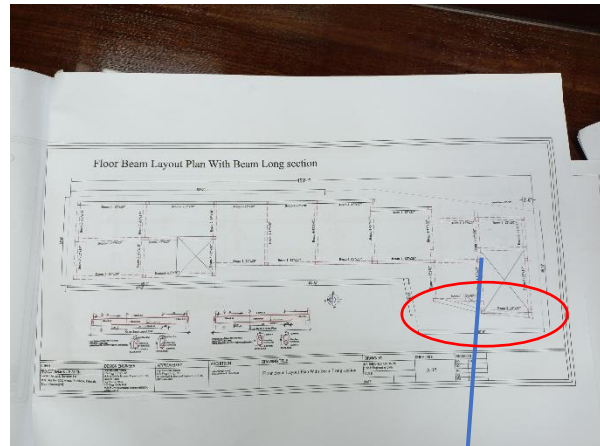
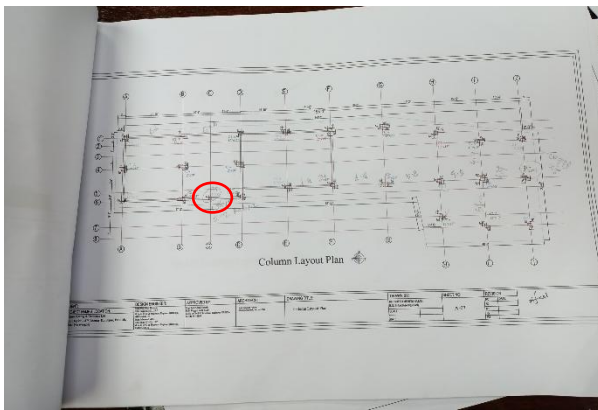
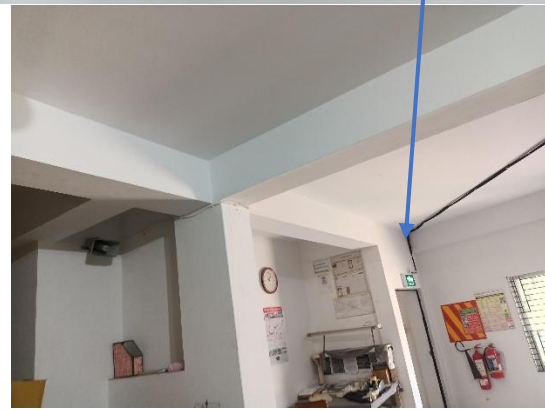
Observation-1: Mismatches in as-built drawings (New Warehouse Building).

Description: Size of C1 column on grid 6-C was found 250x250 mm instead of 300x300 mm and number of rebars were found less than the drawing. Also, the beam layout at South did not fully match onsite conditions. The building engineer is required to survey the whole structure and prepare accurate as-built drawings for the structure.

Item No	Observation	Action Plan	Timeline
1.	Mismatches in as-built drawings (New Warehouse Building).	The building engineer is required to survey the whole structure and prepare accurate as-built drawings for the structure.	within 6 weeks

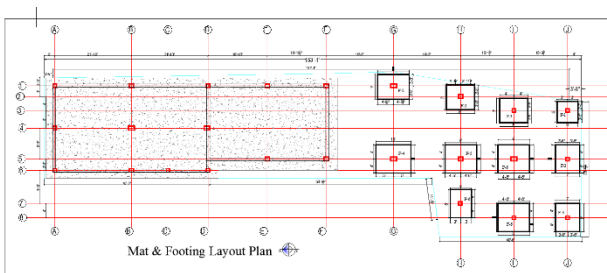
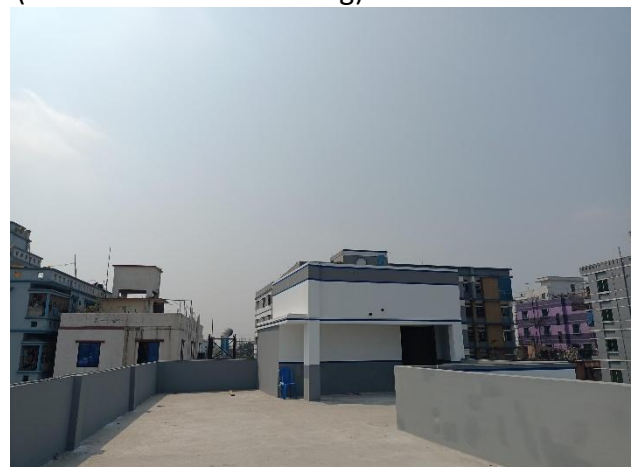
Observation 2: Footings found to be overstressed (New Warehouse Building).

Description: cursory calculation indicates the footings under water tank are stressed above the normal design limit. Footing capacities were checked considering 6 kPa live load for storage area and minimum concrete strength based on aggregate type. The building engineer is required to review the design load and foundation stresses.

2.	Footings found to be overstressed (New Warehouse Building).	Verify in-situ test from each class of concrete.	within 6 weeks
3.	Footings found to be overstressed (New Warehouse Building).	The building engineer is required to carry out Detail Engineering Assessment (DEA) to review the design load, column and foundation stresses.	within 6 weeks

4.	Footings found to be overstressed (New Warehouse Building).	Produce and actively manage floor load plan.	within 6 weeks
5.	Footings found to be overstressed (New Warehouse Building).	Implement remediation work if required.	within 6 months

6.	Footings found to be overstressed (New Warehouse Building).	Implement floor loading plan.	within 6 months
7.	Non-structural elements not anchored or braced. (New Warehouse Building)	The factory is required to anchor/brace all non-structural elements adequately to avoid falling hazard during earthquakes.	within 6 months

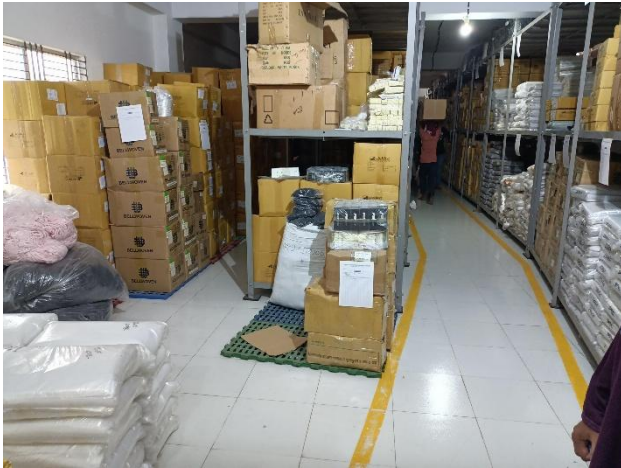
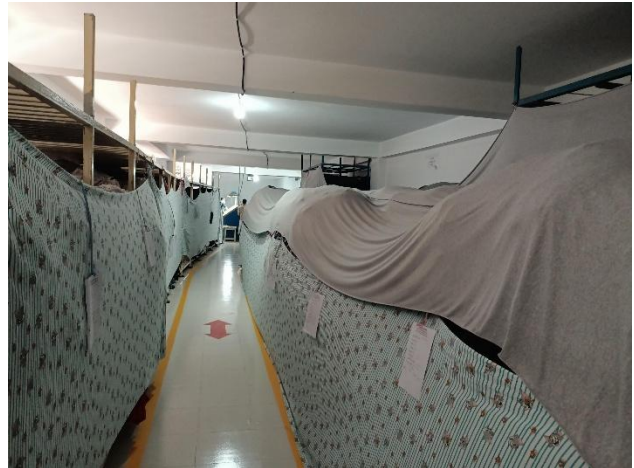
Observation-3: Non-structural elements not anchored or braced (New Warehouse Building).

Description: Unbraced storage racks were found on different floors of the building. The factory is required to anchor and brace all types of non-structural elements to avoid falling hazards.

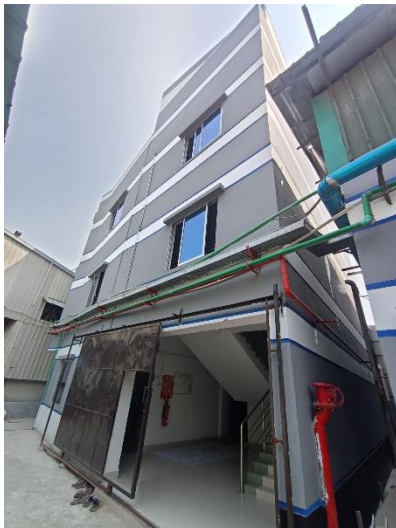
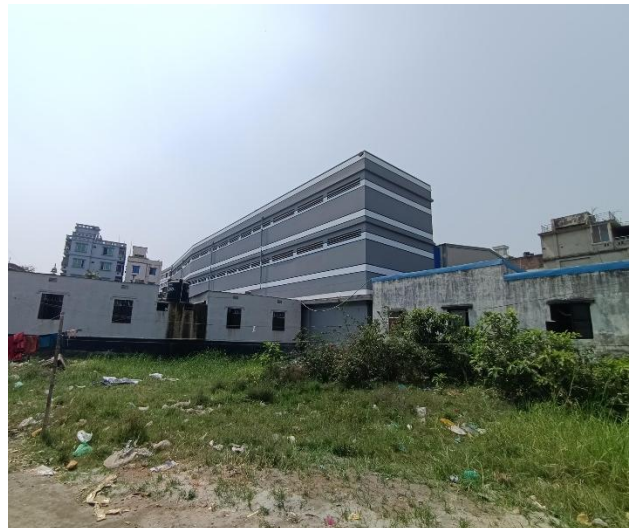
Observation-4: Absence of building approval from govt. authority (New Warehouse Building).

Description: During inspection, building approval drawing was not available. The building engineer is required to take necessary approval from the concern authority and assess the structure following referral BNBC code as per approval.

8.	Absence of building approval from govt. authority (New Warehouse Building).	The building engineer is required to take necessary approval from the concern authority and assess the structure following referral BNBC code as per approval.	within 6 months
