HASAN TANVIR FASHION WEARS LTD. (EXTENSION)

397 Chandana Chowrasta, Joydevpur Road, Gazipur-1702, Bangladesh.

16 March 2025

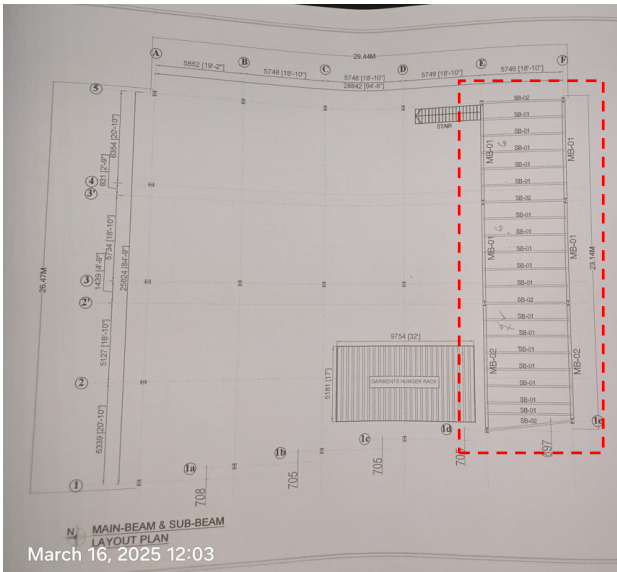
Mezzanine beam layout

Observation-1: Mismatch in as-built drawings. (Finished Goods Store)

Description: According to the as-built drawing, 21 secondary beams were specified, but a total of 23 secondary beams were found on-site.

Building engineer is required to survey the structure and prepare accurate as-built drawings.

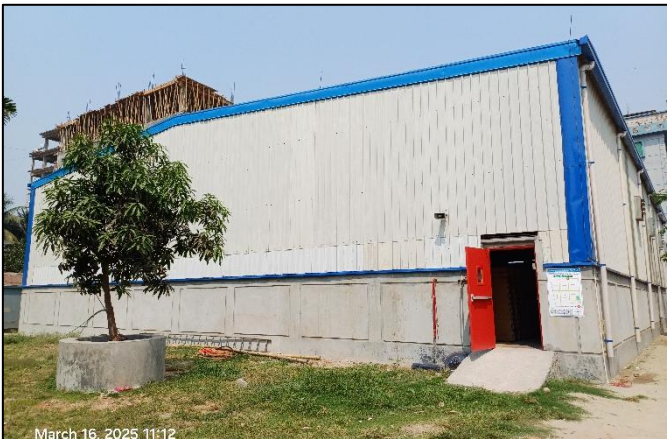
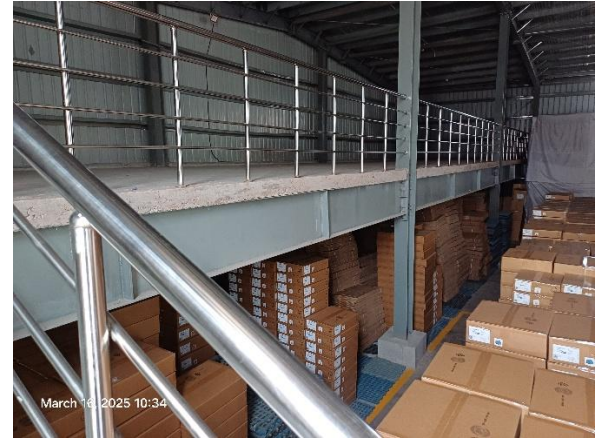
Observation-2: Design report is required to be reviewed by RSC for lateral loading. (Finished Goods Store)

Description: A set of design reports was available for the Finished Goods Store, except mezzanine floor load plan.

The prepared design report needs to be reviewed against lateral forces. Submit the design report to the RSC for detailed review. Also, prepare a loading plan for the mezzanine floor.

2.	Design report is required to be reviewed by RSC for lateral loading. (Finished Goods Store)	Prepare a loading plan for the mezzanine floor.	within 6 weeks

3.		The prepared design report needs to be reviewed against lateral forces. Submit the design report to the RSC for detailed review.	within 6 weeks
4.		Carry out the suggested remedial work if required.	within 6 months

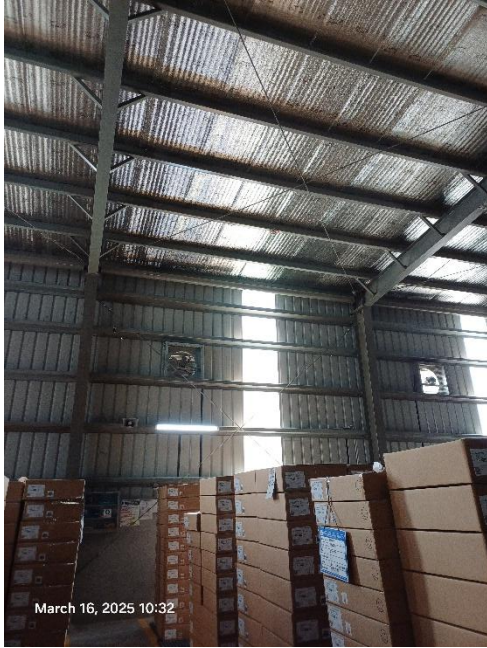
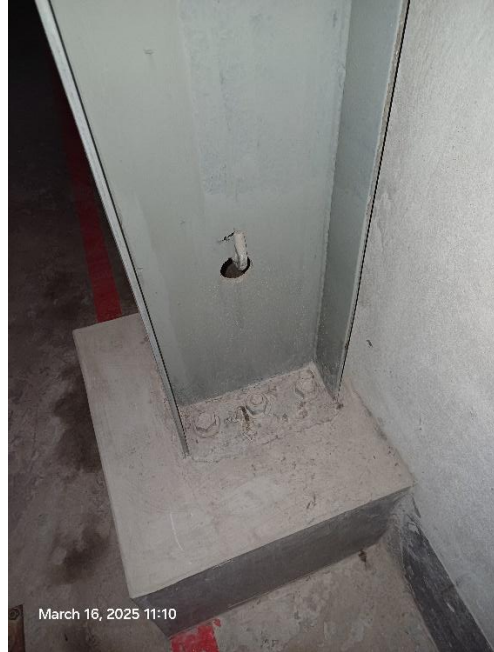
Observation-3: Poorly connected cable bracings on the wall. (Finished Goods Store)

Description: During the inspection, poorly connected cable bracings were found on the northside wall. Building engineer is required to install the bracings properly.

5.	Poorly connected cable bracings on the wall. (Finished Goods Store)	Building engineer is required to install the bracings properly.	within 6 weeks
6.	Lack of design documents (Security & Fire Control Room)	The building engineer is required to prepare design documents (including design reports, material test reports, live load plan) in compliance with section 1.9.1 (part 6, BNBC).	within 6 weeks

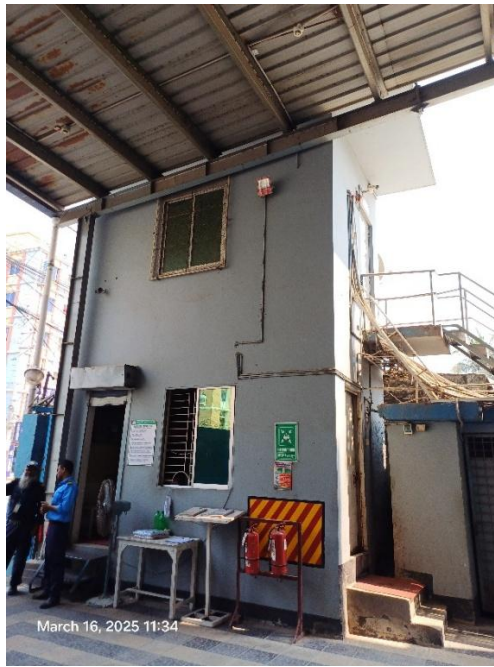
Observation-4: Lack of design documents (Security & Fire Control Room)

Description: As per BNBC, every building or structure designed shall have its design documents prepared following the provision of Section 1.9.1. The design document shall include a design report and a set of structural drawings, which shall be prepared in compliance with sections 1.9.1.1 and 1.9.1.2 as per BNBC.

At the time of inspection, design documents (design report, load plan, and adequate material test reports) were not available, which are required to be prepared in compliance with section 1.9.1 (part-6, BNBC).

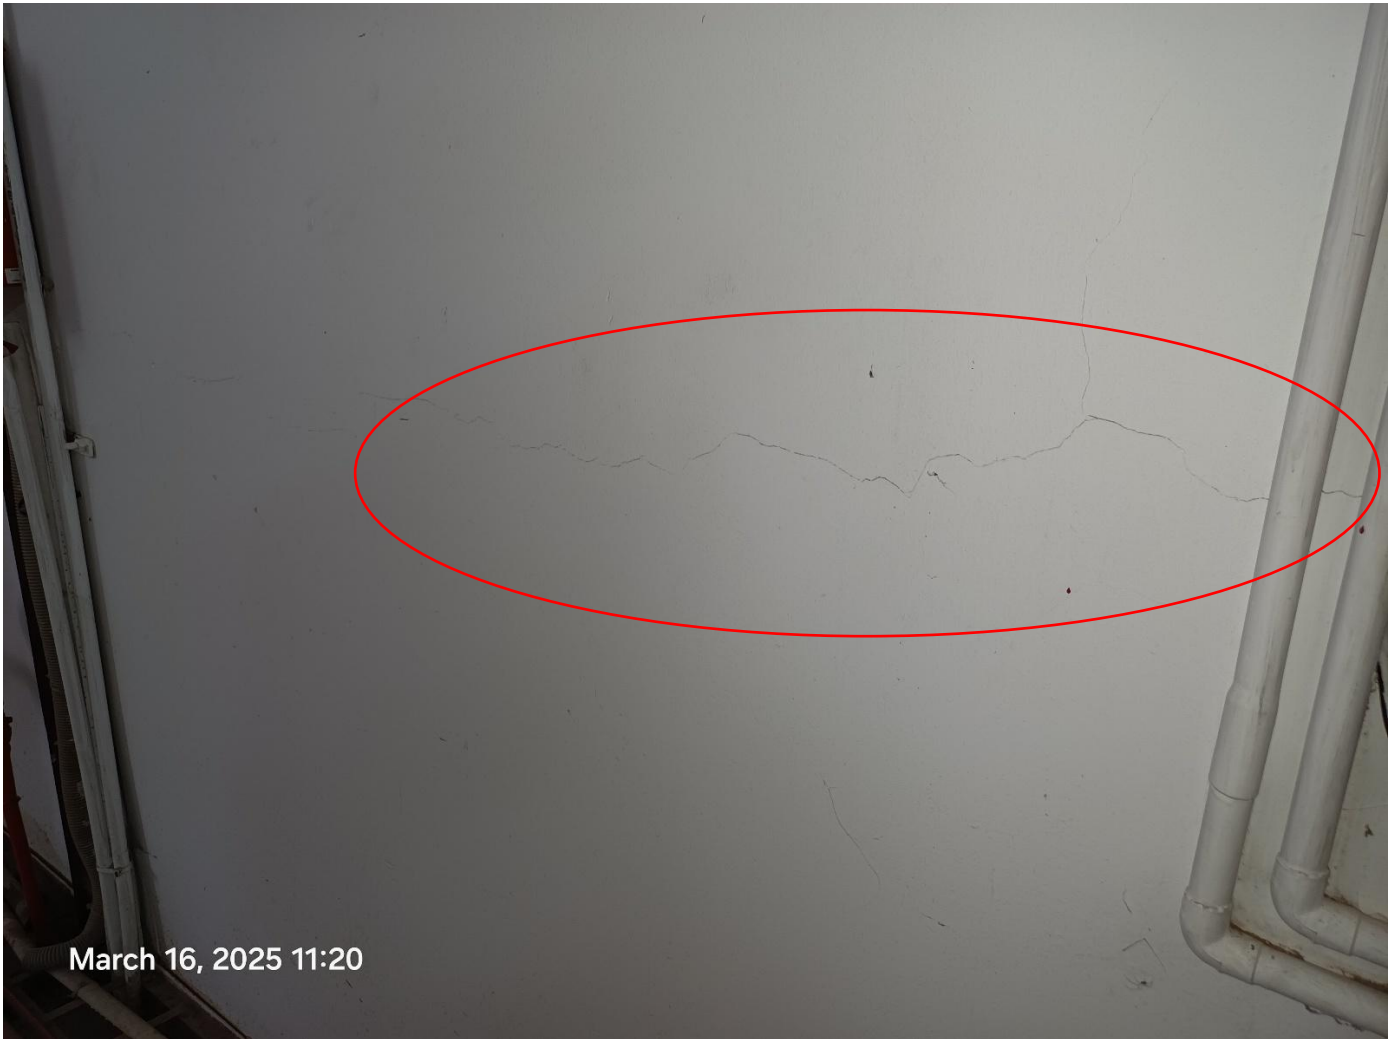
Observation-5: Crack on retaining wall. (Fire Hydrant Room)

Description: Cracks were observed in the retaining wall. Building engineer is required to investigate the reason for the crack and repair as per the suggestion of the investigation report.

7.		Carry out the suggested remedial work if required.	within 6 months
8.	Crack on the retaining wall. (Fire Hydrant Room)	Building engineer is required to investigate the reason for the crack and repair as per the suggestions of the investigation report.	within 6 weeks
