# **The Rose Dresses Ltd. & Islam Garments Ltd. & Islam Dresses Ltd. (Extension)**

17 March 2025

## **Structural Inspection Report**

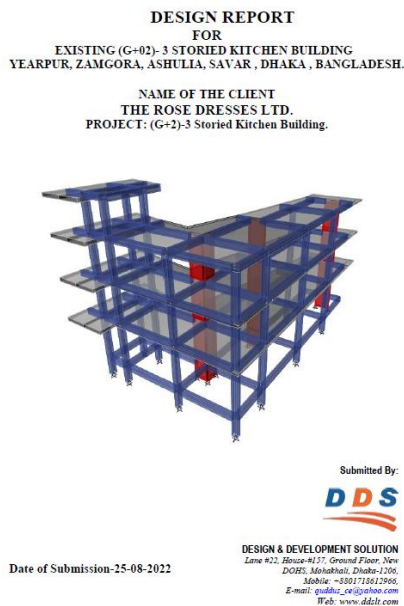
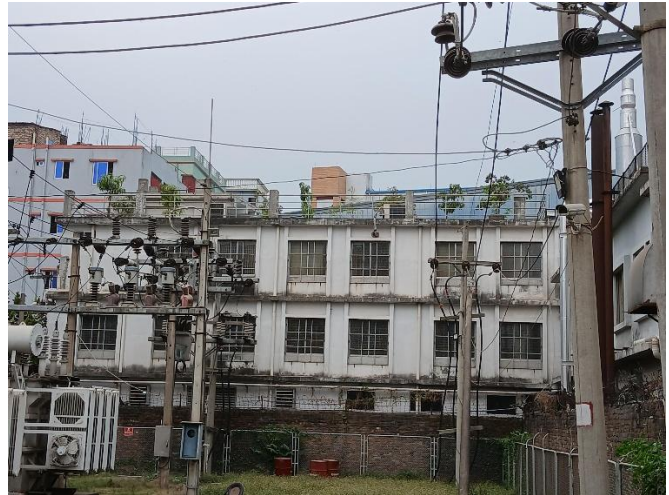
**Observation 01:** Lack of material test report and prepared design report needs to be reviewed against lateral loading. (Building -8)

**Description:** During inspection, no in-situ material strength report was available.

The building engineer is required to perform in-situ material strength testing for the structure and revise the prepared design report based on updated material test report and submit it to RSC for detail review against lateral forces.

| Item No | Observation | Action Plan | Timeline |
|---|---|---|---|
| 1. | Lack of material test report and prepared design report needs to be reviewed against lateral loadings. (Building -8) | Verify in-situ concrete material strength by taking concrete cores (minimum 100 mm diameter) from lower tier building columns & different floors. | within 6 weeks |
| 2. | | The building engineer is required to update the design documents (including design reports, material test reports, live load plan) in compliance with BNBC and submit it to RSC for detail review against lateral forces. | within 6 weeks |
| 3. | | Carry out remedial work if required. | within 6 months |

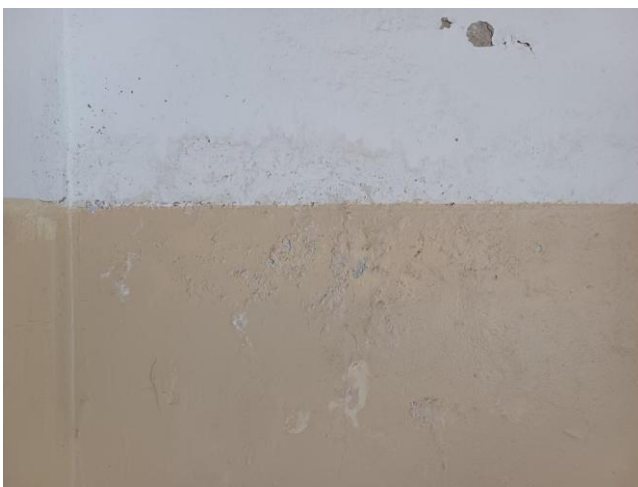
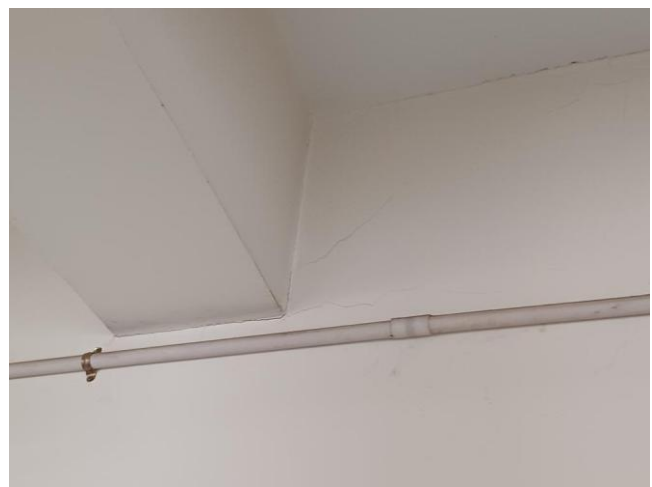
**Observation 2:** Dampness and cracks on masonry walls. (Building -8)

**Description:** Dampness and cracks on masonry walls were observed. The building engineer is required to identify the reason for the dampness and cracks and repair them with a suitable method.

| Item No | Observation | Action Plan | Timeline |
|---|---|---|---|
| 4. | Dampness and cracks on masonry walls. (Building -8) | The building engineer is required to identify the reason for the dampness & cracks and repair them with a suitable method. | within 6 weeks |

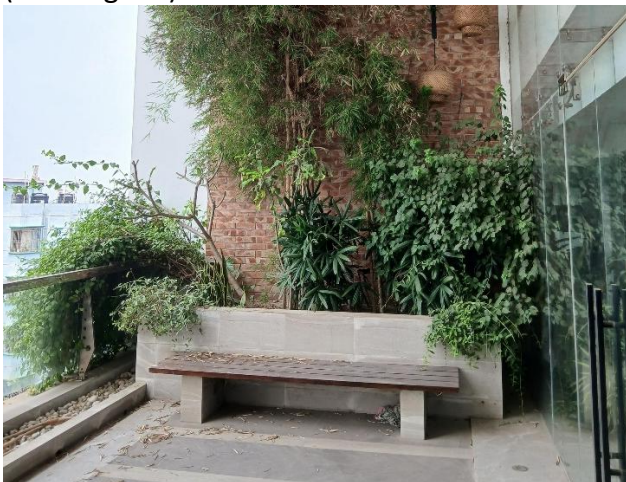
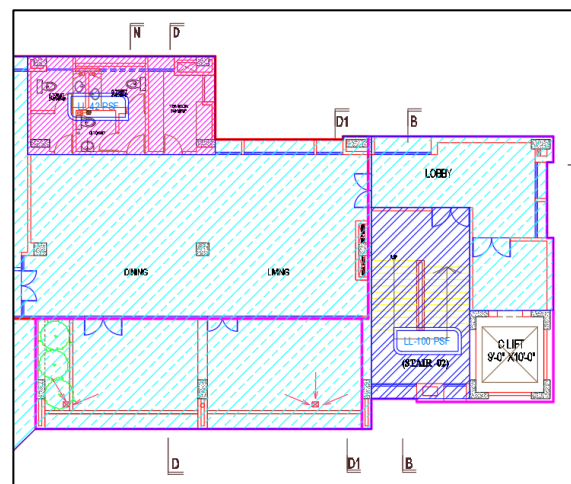
**Observation-4:** Undocumented build-up not mentioned in as-built drawings & floor load plan. (Building -10)

**Description:** During inspection undocumented soil bed was observed in garden area with a depth of around 500 m. However, no build-up thickness was shown in architectural drawing in addition built-up load was not also considered in prepared floor load plan.

The building engineer is required to survey the structure and prepare accurate as-built drawings and revise the load plan considering dead load for soil bed.

| Item No | Observation | Action Plan | Timeline |
|---|---|---|---|
| 8. | Mismatch in as-built drawings. (Building -10) | The building engineer is required to survey the structure and prepare accurate as-built drawings. Mention all build-up loads in the floor load plan. | within 6 weeks |

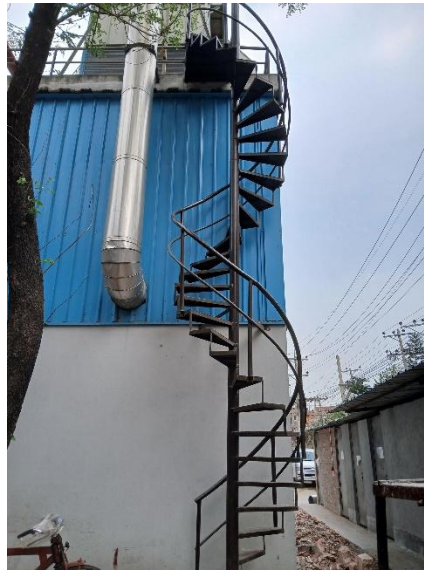
**Observation-5:** Undocumented steel stair with improper connection and inadequate members adjacent to Building-11.

**Description:** During inspection, an undocumented steel stair was observed with improper connection and inadequate members adjacent to Building-11. The building engineer is required to prepare full set of as-built drawings and check the stability system and connection adequacy for the existing structure.

| Item No | Observation | Action Plan | Timeline |
|---|---|---|---|
| 9. | Undocumented steel stair with improper connection and inadequate members adjacent to Building-11. (Building-11) | The building engineer is required to prepare a full set of as-built drawings to the as-constructed status. | within 6 weeks |
| 10. | | The building engineer is required to check the stability system and connection adequacy for the existing structure as part of EA and submit to RSC for review. | within 6 weeks |
| 11. | | Carry out remedial work if required. | within 6 months |
