# Crown Wears (Pvt.) Ltd. (Extension)

Jamirdia, Masterbari, Bhaluka, Mymensingh.  
(24.300775, 90.384717)  
04 and 20 March 2025

## **1. Building Information**

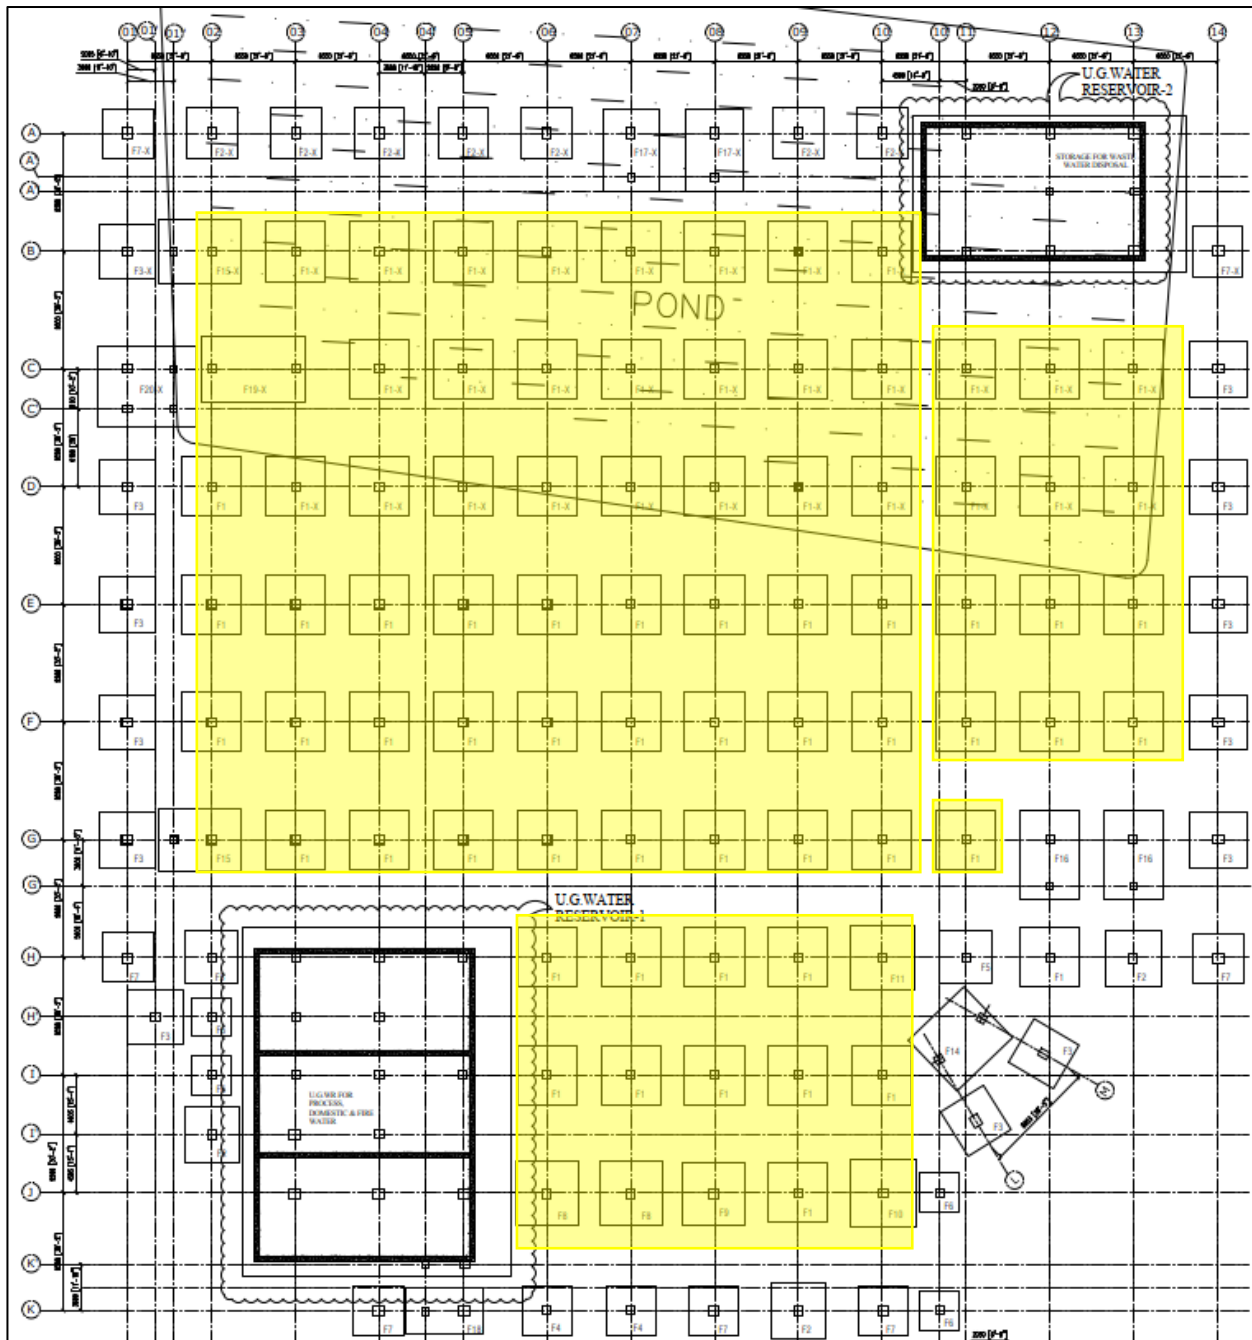
**Observation-01:** High stress in the foundation exceeds the normal design limit. [Building-5]

**Description:** The cursory calculation indicates that foundations are highly stressed above the normal design limit at the March locations considering the observed live load of 3 kPa for the typical production area & 6 kPa for the store area, design strength of concrete & re-bar and bearing capacity from the provided geotechnical investigation report.

The building engineer to review the design, loads and column stresses in the area identified above. A detailed engineering Assessment of the Factory is to be commenced. Produce and actively manage a loading plan for all floor plates within the factory considering floor capacity and foundation capacity. Detail Engineering Assessment to be completed. Continue implementing the load plan.

| Item No | Observation | Action Plan | Timeline |
|---|---|---|---|
| 1. | High stress in the foundation exceeds the normal design limit. [Building-5] | The building engineer to review the design, loads and foundation stresses in the area identified above. | within 6 weeks |
| 2. | High stress in the foundation exceeds the normal design limit. [Building-5] | A Detail Engineering Assessment of the Factory to be commenced. | within 6 weeks |
| 3. | High stress in the foundation exceeds the normal design limit. [Building-5] | Produce and actively manage a loading plan for all floor plates within the factory considering floor capacity and foundation capacity. | within 6 weeks |
| 4. | High stress in the foundation exceeds the normal design limit. [Building-5] | Detail Engineering Assessment to be completed. | within 6 months |
| 5. | High stress in the foundation exceeds the normal design limit. [Building-5] | Continue implementing the load plan. | within 6 months |

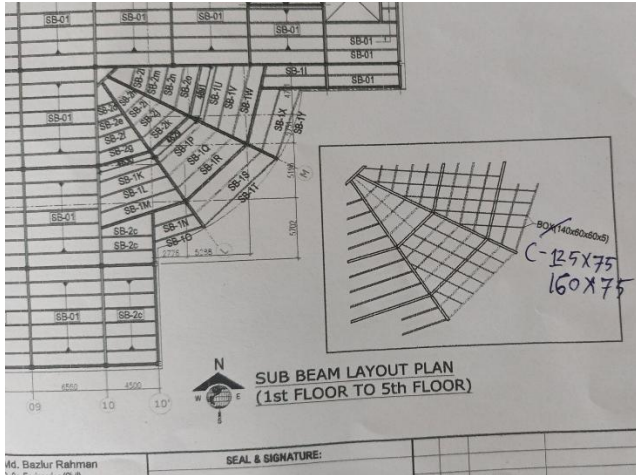
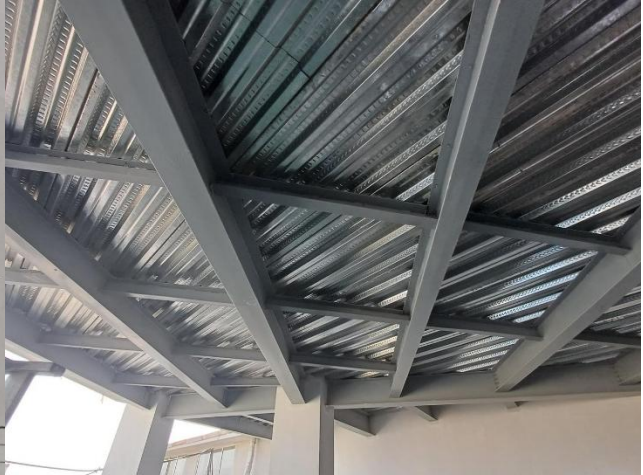
**Observation-02:** Lack of information and discrepancy between the provided drawing and site condition. [Building-5]

Sub-beam sections and sizes do not match the provided drawing

**Description:** During the inspection, discrepancies and lack of information were observed between the provided drawing and on-site conditions. The building engineer is required to survey the whole structure and update the drawing reflecting actual on-site condition.

| Item No | Observation | Action Plan | Timeline |
|---|---|---|---|
| 6. | Lack of information and discrepancy between the provided drawing and site condition. [Building-5] | The building engineer is required to survey the whole structure and update the drawing reflecting actual on-site condition. | within 6 weeks |

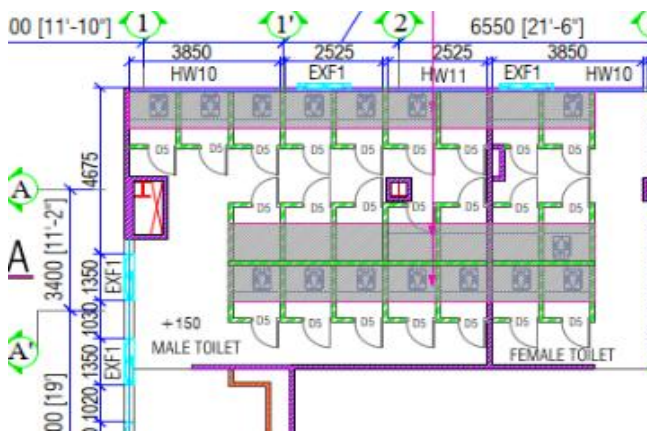
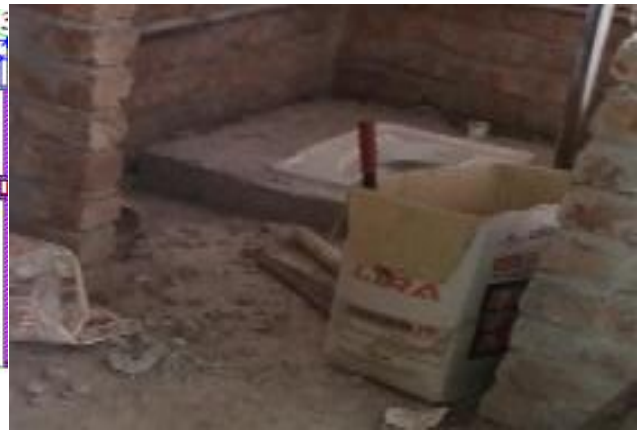
Additional floor raises were found in the toilet zone which were not mentioned in the drawing.

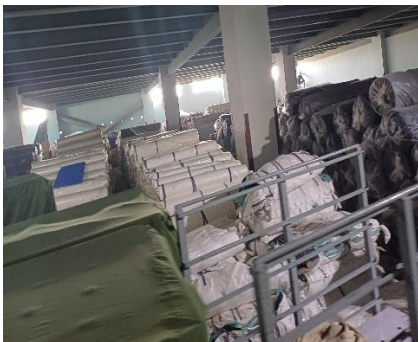
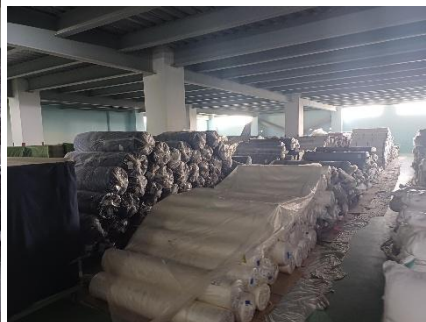
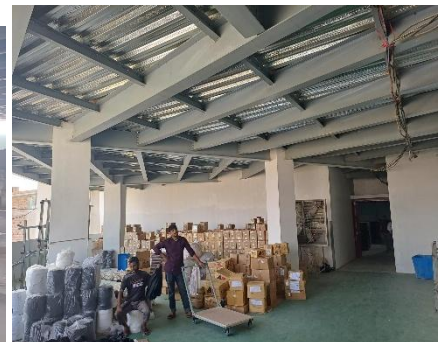
**Observation-03:** Lack of height Marking in the storage area. [Building-5]

**Description:** Load restriction height Marking was not provided in the storage areas. The factory is required to provide load restriction height Marking in the storage areas as per the floor loading capacity and compliance requirement.

| Item No | Observation | Action Plan | Timeline |
|---|---|---|---|
| 7. | Lack of height Marking in the storage area. [Building-5] | The factory is required to provide load restriction height Marking in the storage areas as per the floor loading capacity and compliance requirement. | within 6 weeks |

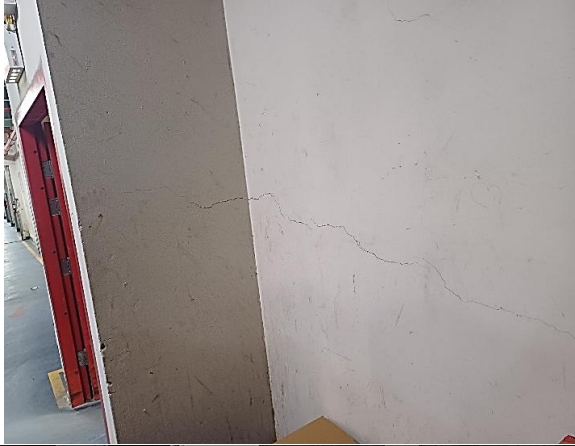
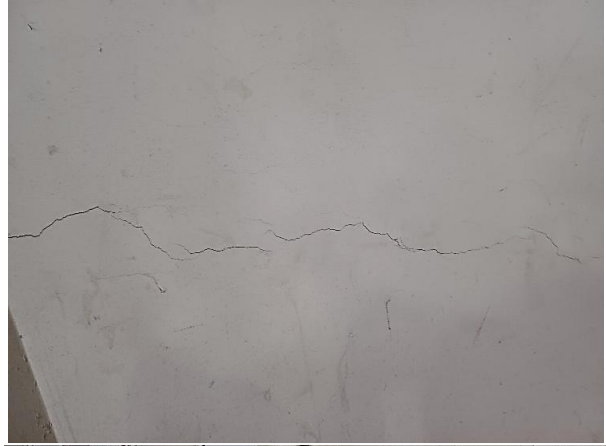
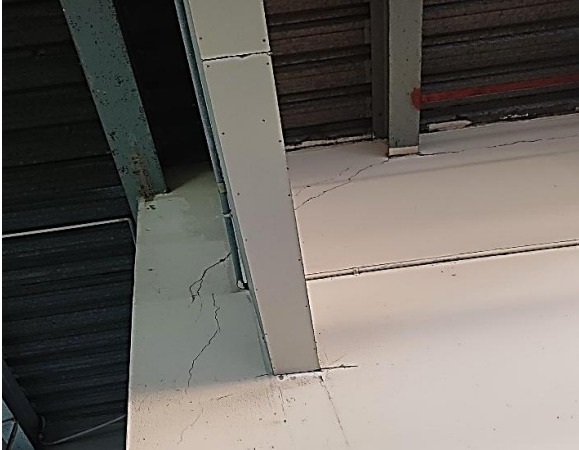
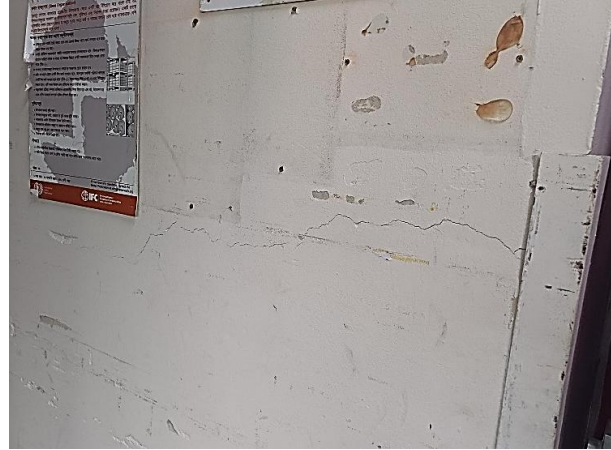
**Observation 04:** Crack on the brick wall. [Building-5]

**Description:** During the inspection, the diagonal crack was observed on several locations of the brick wall. The building engineer is required to investigate the cracks and produce an investigation report including reasons for cracks and repair methodology. The factory is required to repair the cracks as per the recommendation of the investigation report.

| Item No | Observation | Action Plan | Timeline |
|---|---|---|---|
| 8. | Crack on the brick wall. [Building-5] | The building engineer is required to investigate the cracks and produce an investigation report including reasons for cracks and repair methodology. | within 6 weeks |
| 9. | Crack on the brick wall. [Building-5] | The factory is required to repair the cracks as per the recommendation of the investigation report. | within 6 weeks |

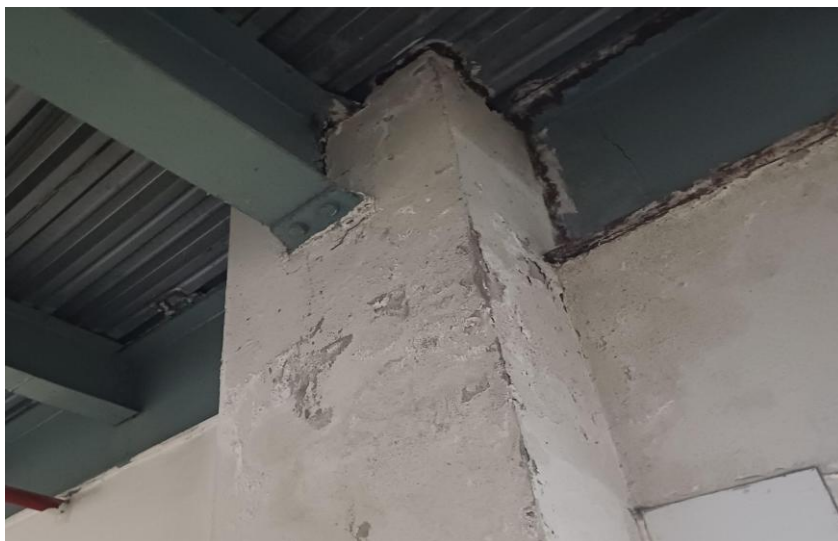
**Observation 05:** Dampness on masonry wall. [Building-5]

**Description:** Dampness on the masonry wall was observed. The building engineer is required to investigate the reason for dampness & cracks; and repair it following suitable method.

| Item No | Observation | Action Plan | Timeline |
|---|---|---|---|
| 10. | Dampness on masonry wall. [Building-5] | The building engineer is required to investigate the reason for dampness & cracks; and repair it following a suitable method. | within 6 weeks |

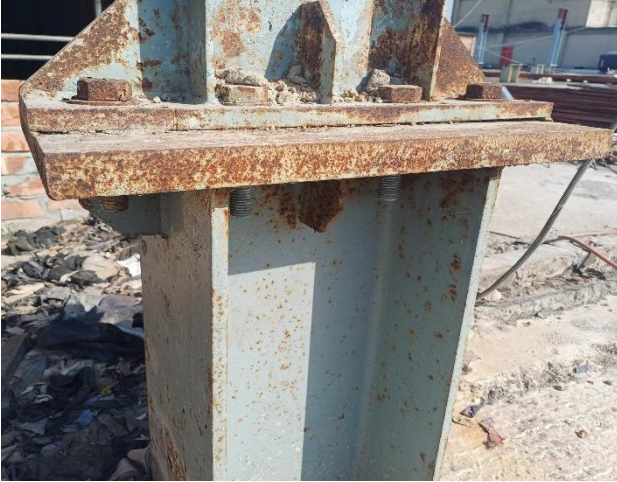
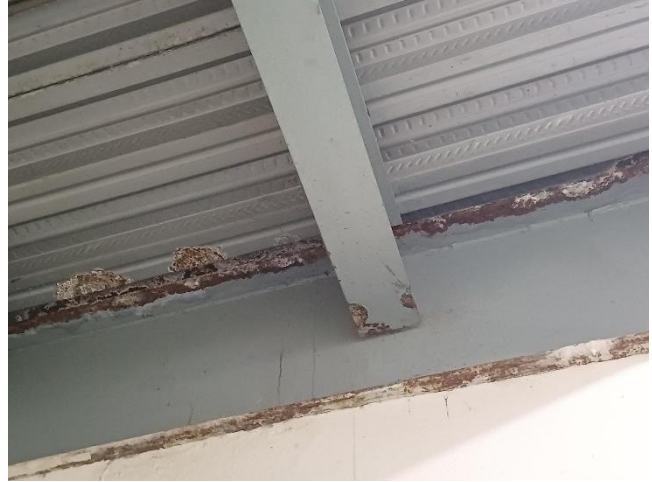
**Observation 06:** Corrosion on steel members. [Building-5]

**Description:** Corrosion was observed on steel members. The building engineer is required to provide rust-proof paint on steel members.

| Item No | Observation | Action Plan | Timeline |
|---|---|---|---|
| 11. | Corrosion on steel members. [Building-5] | The building engineer is required to provide rust-proof paint on steel members. | within 6 weeks |

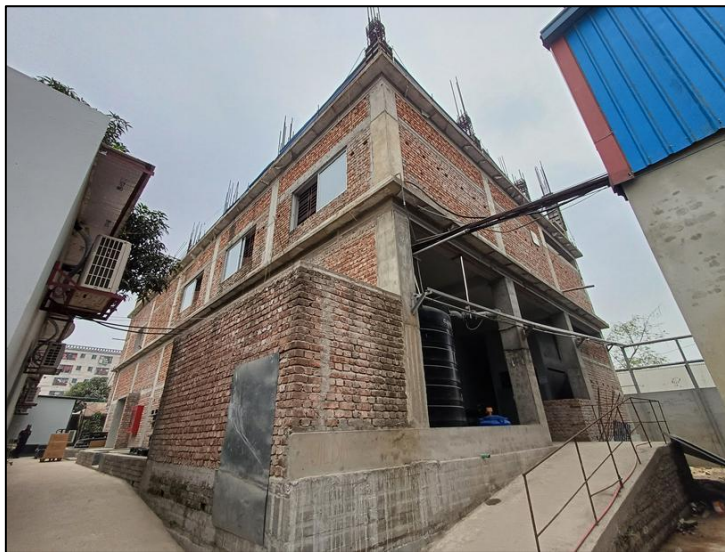
**Observation 07:** Lack of design report. (Building 6)

**Description:** As per BNBC, every building or structure designed shall have its design documents prepared per the provision of Section 1.9.1. The design document shall include a design report, and a set of structural drawings, which shall be prepared in compliance with section 1.9.1.1 and section 1.9.1.2 as per BNBC. At the time of inspection, the design report was not available, which is required to be prepared in compliance with section 1.9.1 (part 6, BNBC).

| Item No | Observation | Action Plan | Timeline |
|---|---|---|---|
| 12. | Lack of design report. (Building 6) | The building engineer is required to prepare in compliance with section 1.9.1 (part 6, BNBC). | within 6 weeks |

| 13. | Lack of design report.<br>(Building 6) | Implement remediation work if required. | within 6 months |

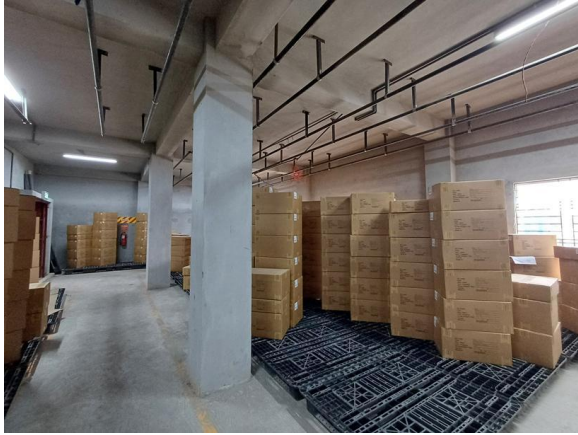
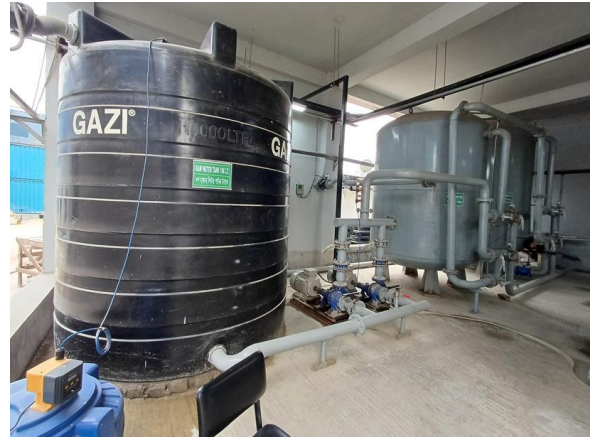
**Observation 08:** Lack of load management program. (Building – 6)

**Description:** During the inspection, dedicated storage was found on the 1<sup>st</sup> floor and heavy loading (10,000-liter water tank) was found on the ground floor. But, no load plan, no load height Marking & no load management program was found for Building – 6. The building engineer is required to post the load plan, and load height marking, and maintain loading accordingly.

| 14. | Lack of load management program. (Building – 6) | The building engineer is required to prepare the load plan & implement the management program (posting, Marking, maintaining). | within 6 weeks |

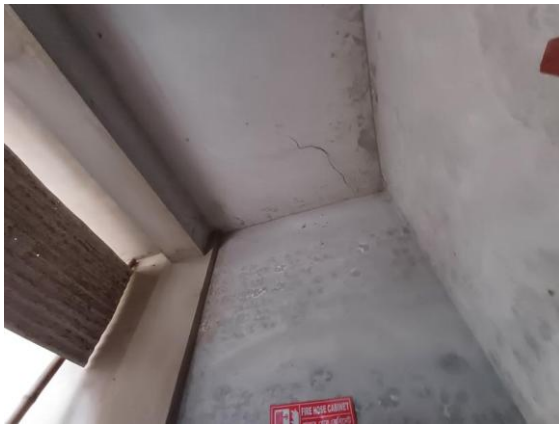
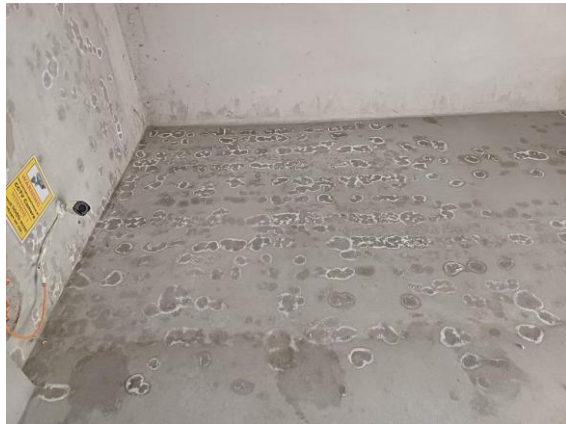
**Observation 09:** Dampness in the brick wall. (Building – 6)

**Description:** During inspection, dampness was found on the brick wall. The building engineer is required to repair dampness with a suitable method.

| 15. | Dampness in the brick wall.<br>(Building – 6) | The building engineer is required to seal the source of water and repair dampness with a suitable method. | within 6 weeks |

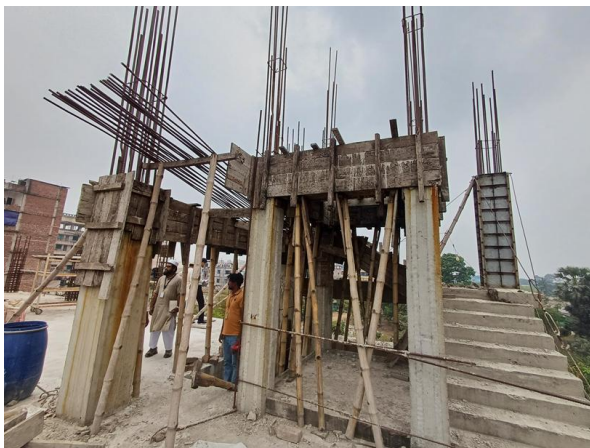
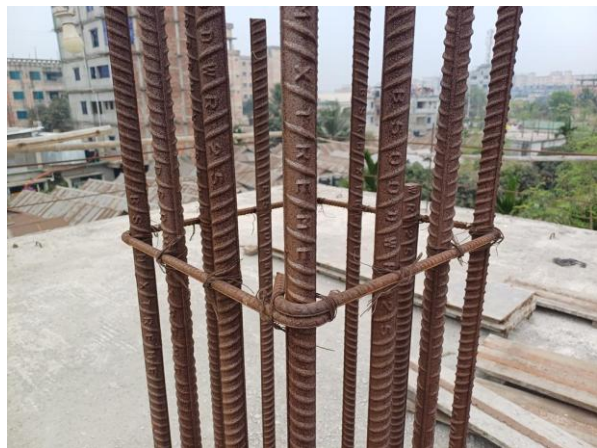
**Observation 10:** Exposed rebar on the 2<sup>nd</sup> floor (existing roof). (Building – 6)

**Description:** Corrosion was observed on exposed rebars. The building engineer is required to provide rust-proof paint on exposed rebars.

| 16. | Exposed rebar on the 2 <sup>nd</sup> floor (existing roof).<br>(Building – 6) | The building engineer is required to provide rust-proof paint on exposed rebars. | within 6 weeks |

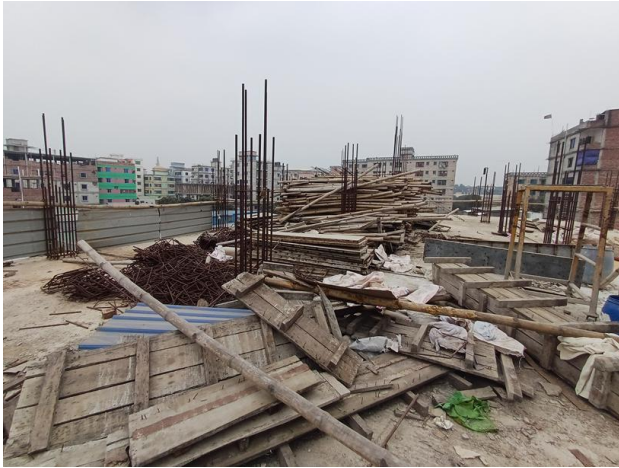
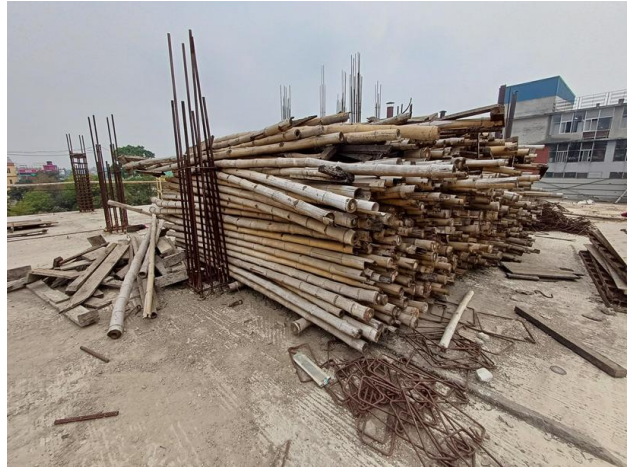
**Observation 11:** Construction debris on the 2nd floor (existing roof). (Building – 6)

**Description:** Construction debris was found on the 2<sup>nd</sup> floor. The building engineer is required to remove the construction debris.

| 17. | Construction debris on the 2nd floor (existing roof).<br>(Building – 6) | The building engineer is required to remove the construction debris. | within 6 weeks |

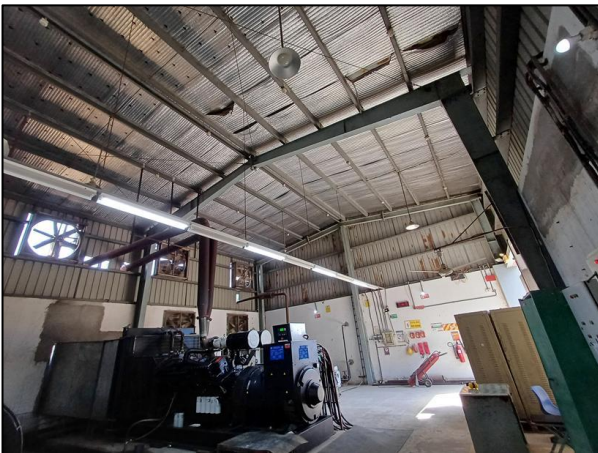
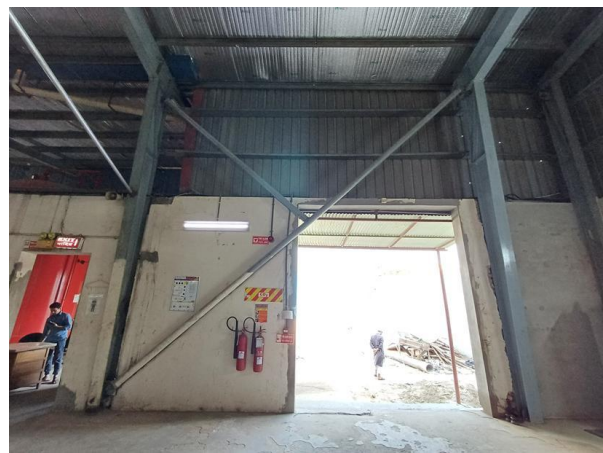
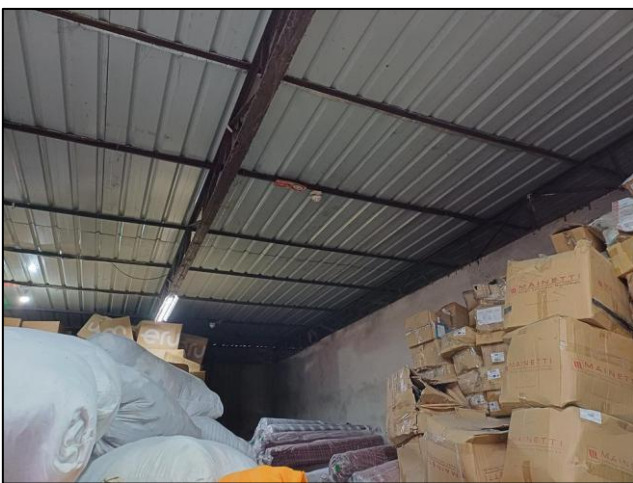
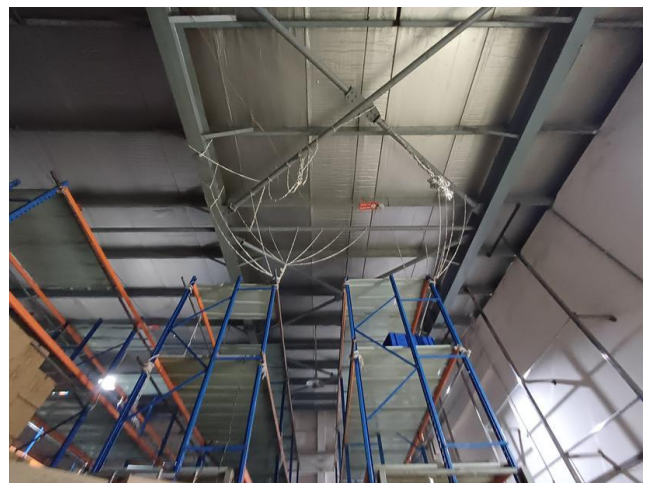
**Observation 12:** Lack of lateral stability. (Generator Shed – 2, Boiler & Compressor Shed – 2, Leftover Go-Down, Warehouse Shed – 1, and Warehouse Shed – 2)

**Description:** No lateral load transfer media (compression strut) is provided to transfer and resist the lateral load. Also, vertical bracing was found incomplete in the Boiler & Compression Shed – 2. The building engineer is required to check the lateral stability of the shed and prepare an Engineering Assessment (EA) report as per 1.9.1 BNBC.

| 18. | Lack of lateral stability.<br>(Generator Shed – 2) | The building engineer is required to check the lateral stability of the structure and suggest suitable remedial measures. | within 6 weeks |
| 20. | Lack of lateral stability.<br>(Boiler & Compressor Shed– 2) | The building engineer is required to check the lateral stability of the structure and suggest suitable remedial measures. | within 6 weeks |
| 22. | Lack of lateral stability.<br>(Leftover Go-Down) | The building engineer is required to check the lateral stability of the structure and suggest suitable remedial measures. | within 6 weeks |
| 24. | Lack of lateral stability.<br>(Warehouse Shed – 1) | The building engineer is required to check the lateral stability of the structure and suggest suitable remedial measures. | within 6 weeks |
| 26. | Lack of lateral stability.<br>(Warehouse Shed – 2) | The building engineer is required to check the lateral stability of the structure and suggest suitable remedial measures. | within 6 weeks |

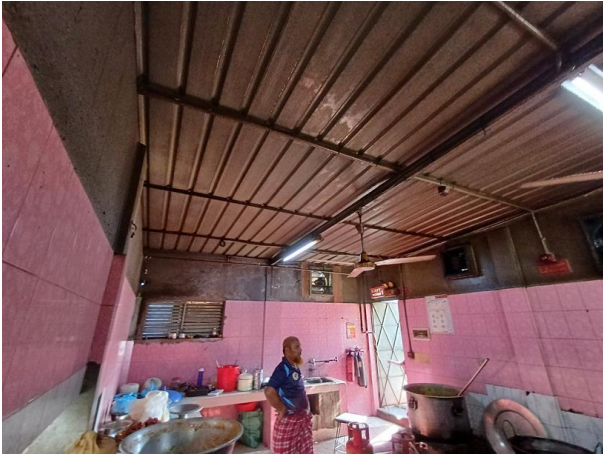
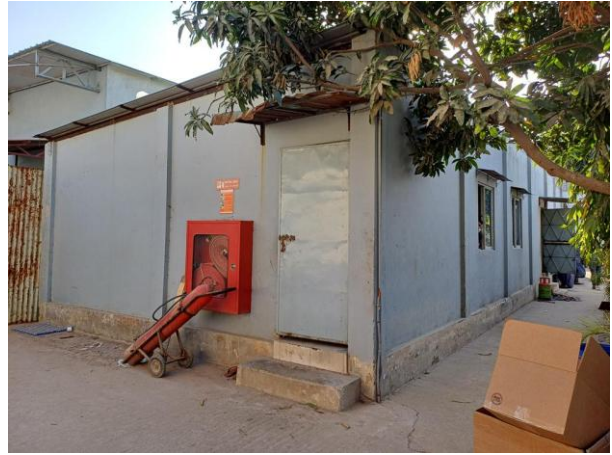
**Observation 13:** Lack of lateral stability and inadequate member size. (Dining Shed).

**Description:** During the inspection, load transfer media along the long direction was found missing. Also, member sizes & their connections were found to be inadequate. The building engineer is required to prepare a safety check report along with the connection and member adequacy and propose remediation accordingly.

| 28. | Lack of lateral stability and inadequate member size.<br>(Dining Shed). | The building engineer is required to prepare a safety check report along with the connection and member adequacy and propose remediation accordingly. | within 6 weeks |

| 29. | Lack of lateral stability and inadequate member size. (Dining Shed). | Implement remediation work if required. | within 6 months |

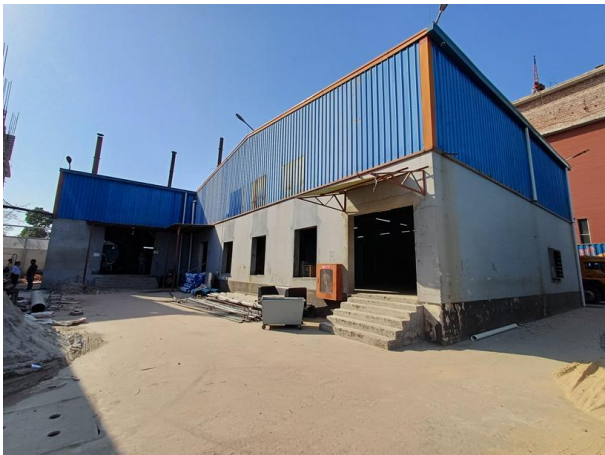
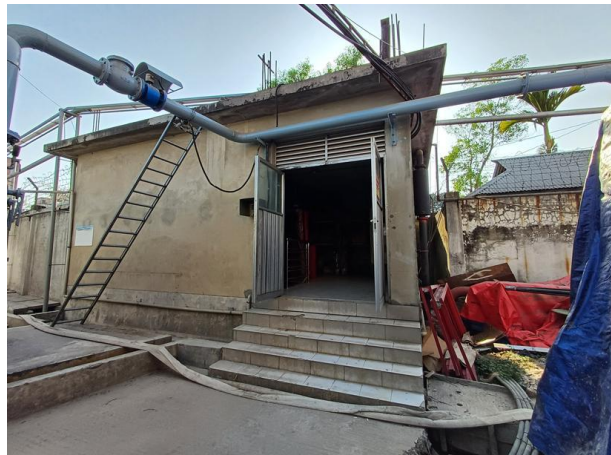
**Observation 14:** Lack of credible as-built drawing. (Boiler & Compression Shed – 2, Fire Pump Room – 2, Leftover Go-Down, and Sub-station Building – 2)

**Description:** During inspection, the as-built drawing was not matched with the on-site condition. Moreover, the as-built drawing was incomplete. The building engineer is required to update the as-built drawing which reflects the credible on-site condition.

| 30. | Lack of credible as-built drawing. (Boiler & Compression Shed – 2, | The building engineer is required to update the as-built drawing for the structure which reflects the actual on-site condition. | within 6 weeks |
| 31. | Lack of credible as-built drawing. (Fire Pump Room – 2,) | The building engineer is required to update the as-built drawing for the structure which reflects the actual on-site condition. | within 6 weeks |
| 32. | Lack of credible as-built drawing. (Leftover Go-Down) | The building engineer is required to update the as-built drawing for the structure which reflects the actual on-site condition. | within 6 weeks |
| 33. | Lack of credible as-built drawing. (Sub-station Building – 2) | The building engineer is required to update the as-built drawing for the structure which reflects the actual on-site condition. | within 6 weeks |

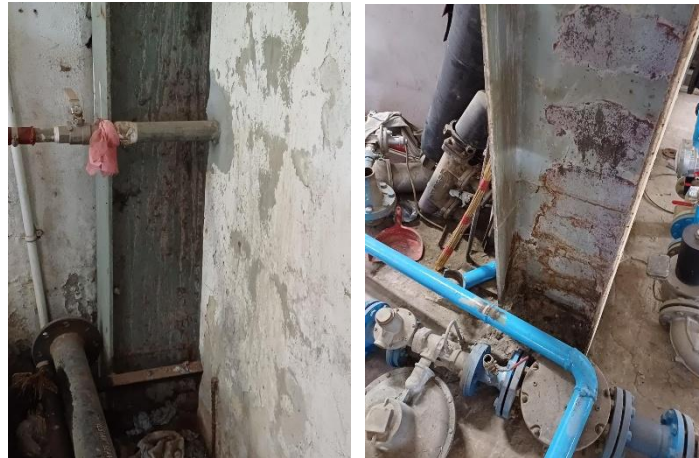
**Observation 15:** Corrosion on steel member. (Generator Shed – 2, Boiler & Compression Shed – 2)

**Description:** During the inspection, corrosion was found in the steel member. The building engineer is required to remove the corrosion and provide anti corrosive coating to the steel members.

| 34. | Corrosion on steel member. (Generator Shed – 2, Boiler & Compression Shed – 2) | The building engineer is required to remove the corrosion and provide anti-corrosive coating to the steel members. | within 6 weeks |

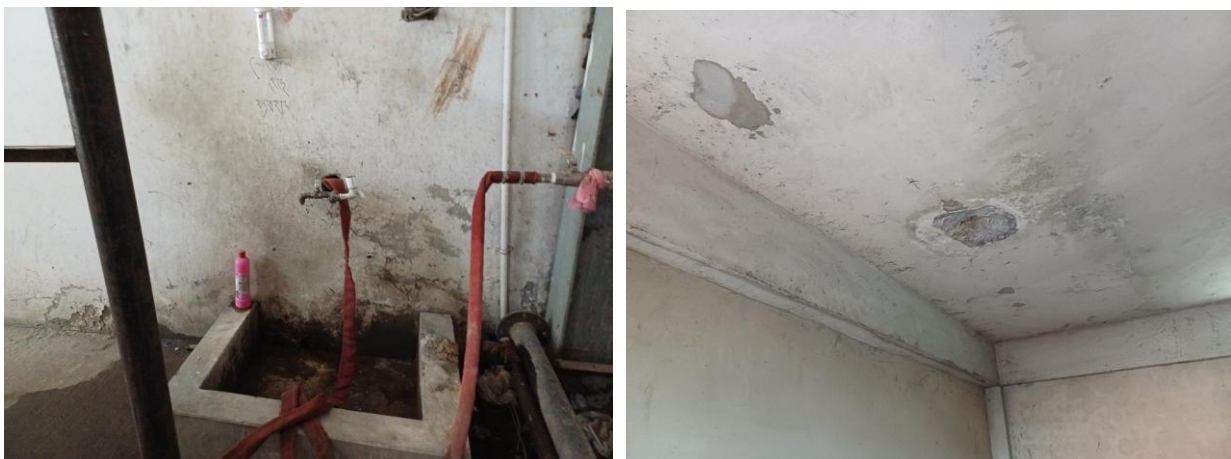
**Observation 16:** Dampness in the brick wall. (Generator Shed – 2, Fire Pump Room – 2)

**Description:** During the inspection, dampness was found on the brick wall in Generator Shed -2 and slab soffit in Fire Pump Room – 2. The building engineer is required to repair dampness with a suitable method.

| 35. | Dampness in the brick wall. (Generator Shed – 2, Fire Pump Room – 2) | The building engineer is required to repair the dampness with a suitable method. | within 6 weeks |

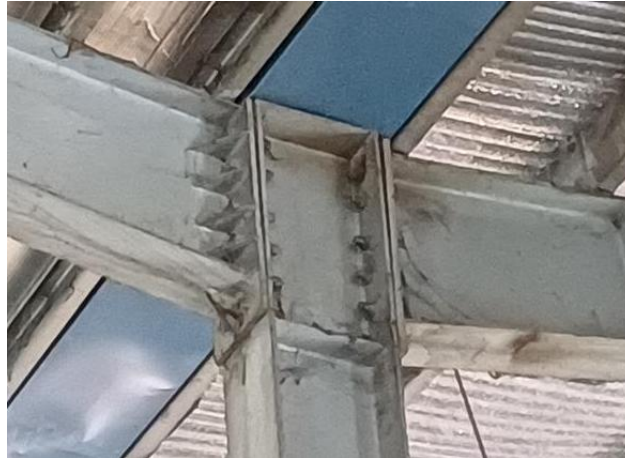
**Observation 17:** Connection gap. (Boiler & Compression Shed – 2)

**Description:** During the inspection, the connection gap was found on the Boiler & Compression Shed – 2. The building engineer is required to survey the whole structure & repair the connection gap where necessary.

| 36. | Connection gap. (Boiler & Compression Shed – 2) | The building engineer is required to survey the whole structure & repair the connection gap where necessary. | within 6 weeks |

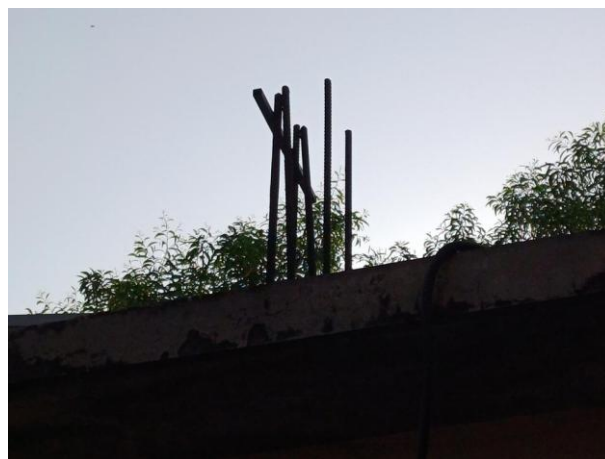
**Observation 18:** Exposed rebar. (Fire Pump Room – 2)

**Description:** During inspection, the exposed rebar was found on the roof slab. The building engineer is required to apply anti-rust proof coating on exposed rebar.

| 37. | Exposed rebar. (Fire Pump Room – 2) | The building engineer is required to apply anti-rust proof coating on exposed rebar. | within 6 weeks |

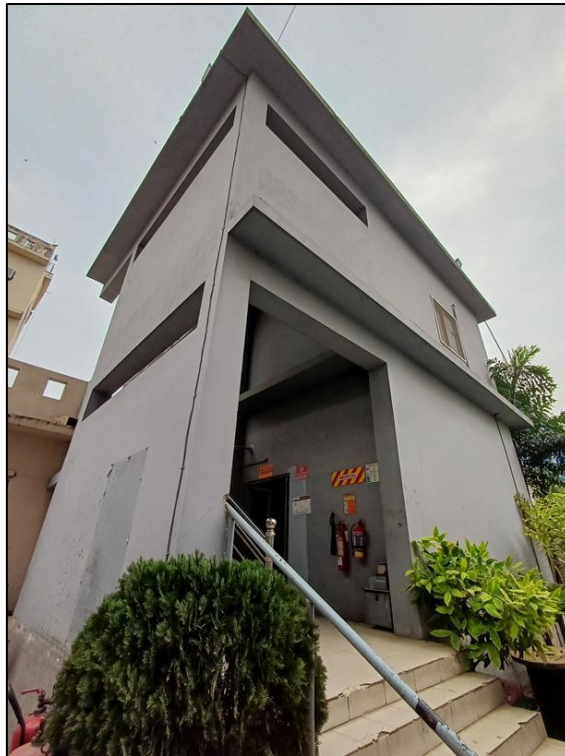
**Observation 19:** Lack of design report. (Sub-Station Building – 2)

**Description:** As per BNBC, every building or structure designed shall have its design documents prepared in accordance with the provision of Section 1.9.1. The design document shall include a design report, and a set of structural drawings, which shall be prepared in compliance with section 1.9.1.1 and section 1.9.1.2 as per BNBC. At the time of inspection, the design report was not available, which is required to be prepared in compliance with section 1.9.1 (part 6, BNBC).

| 38. | Lack of design report. (Sub-Station Building – 2) | The building engineer is required to prepare in compliance with section 1.9.1 (part 6, BNBC). | within 6 weeks |
| 39. | Lack of design report. (Sub-Station Building – 2) | Implement remediation work if required. | within 6 months |

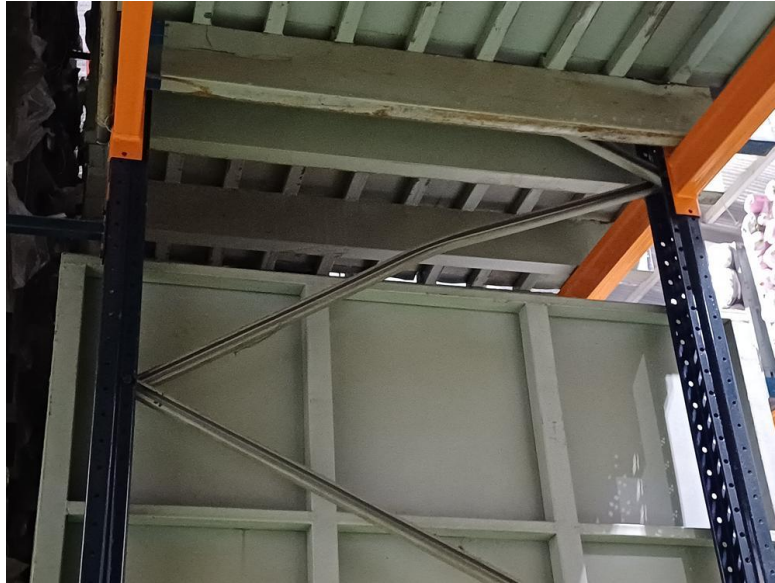
**Observation 20:** Distorted bracing on steel racks (Warehouse Shed – 2).

**Description:** Distorted bracing was found on steel racks at a few locations. The building engineer is required to replace the distorted bracing of steel racks.

| 40. | Distorted bracing on steel racks (Warehouse Shed – 2). | The building engineer is required to replace the distorted bracing of steel racks. | within 6 weeks |

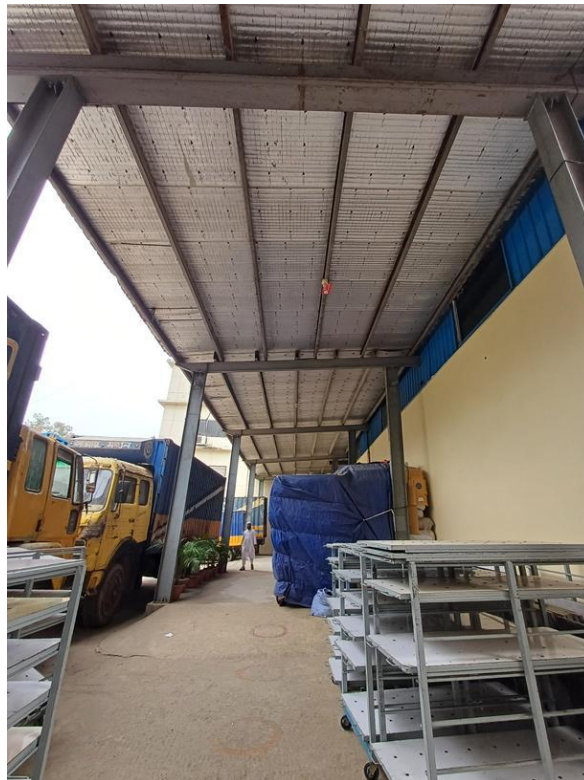
**Observation 21:** Undocumented steel canopy. (Warehouse Shed – 1)

**Description:** During inspection, an adjacent canopy was found at the north side of the warehouse shed – 1. The canopy was structurally connected to the main shed. No detailed drawing was found on-site. The building engineer is required to check the lateral stability of the shed and prepare an Engineering Assessment (EA) report considering the adjacent canopy.

| 41. | Undocumented steel canopy. (Warehouse Shed – 1) | The building engineer is required to check the lateral stability of the shed and prepare an Engineering Assessment (EA) report considering the adjacent canopy. | within 6 weeks |
| 42. | Undocumented steel canopy. (Warehouse Shed – 1) | Implement remediation work if required. | within 6 months |
