Manvill Styles Limited

728 South Shyampur, Hemayetpur, Savar, Dhaka

23 March 2025

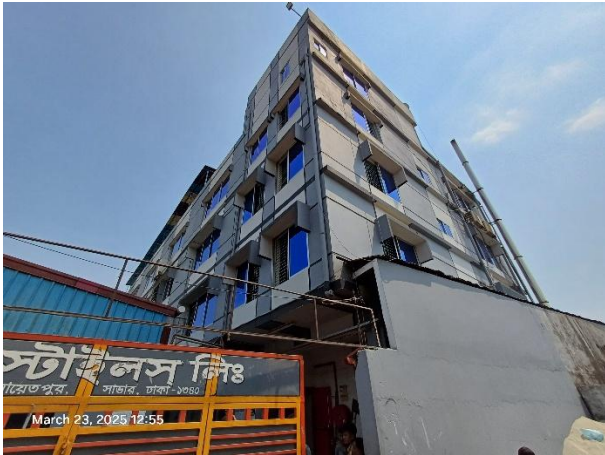
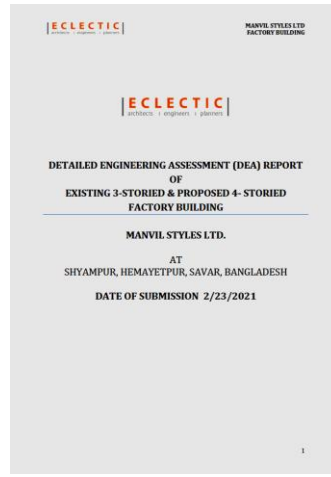
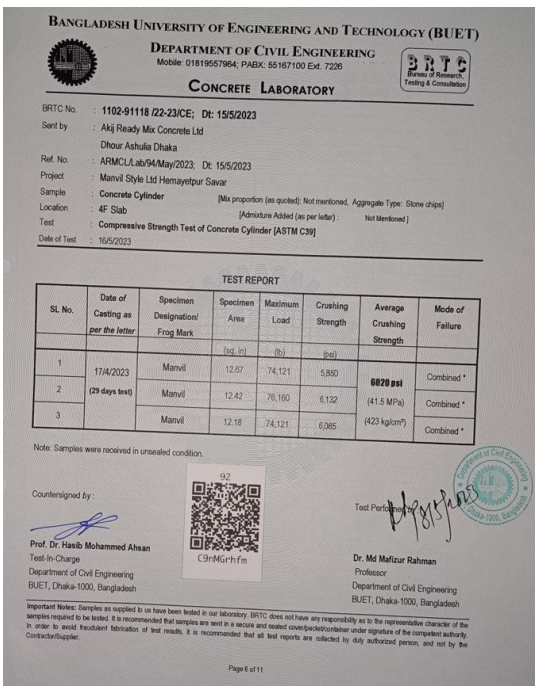
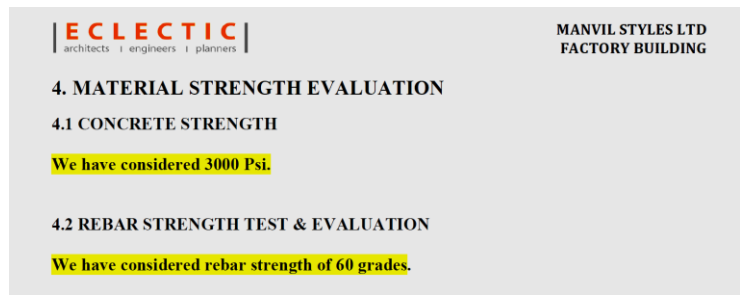
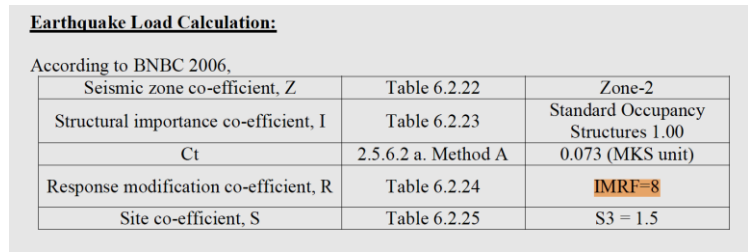
Observation 1: Inconsistencies in the assessment report. (Building-1)

An inadequate number of concrete cylinder test reports were found on site to confirm the design strength of 3000 psi.

Response modification coefficient, R value considered as 8 for IMRF, but no calculation/justification is provided for the

Description: During the inspection, a detailed engineering assessment report was available onsite for the four-storied factory building. Where the building is currently five-storied, including the roof shed. Moreover, no live load plan was found prepared.

Item No	Observation	Action Plan	Timeline
1.	Inconsistencies in the assessment report. (Building-1)	Building engineer is required to address the inconsistencies in the design report and submit revised design documents to RSC to complete the review.	within 6 weeks

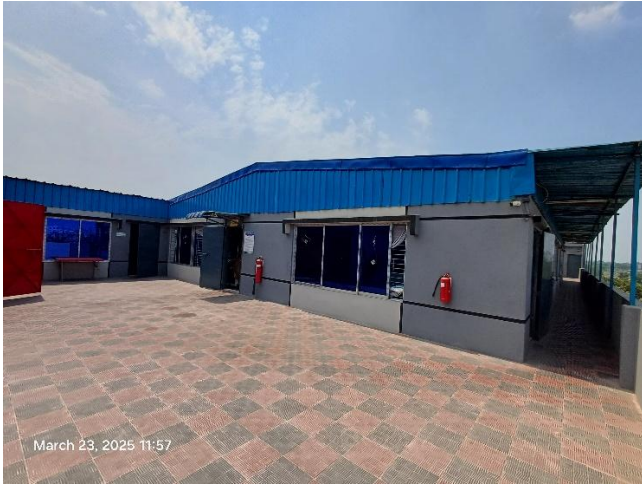
Roof shed

Description: A set of as-built drawings was available for the RC part, where the floor layout did not match the existing condition. Extra concrete built up was found in the toilet zones. Moreover, no drawing was available for the roof shed. The building engineer is required to survey structures and prepare a full set of as-built drawings in compliance with section 1.9, part 6 of BNBC.

5.	Incomplete as-built drawings. (Building-1)	The building engineer is required to survey structures and prepare a full set of as-built drawings in compliance with section 1.9, part 6 of BNBC.	within 6 weeks

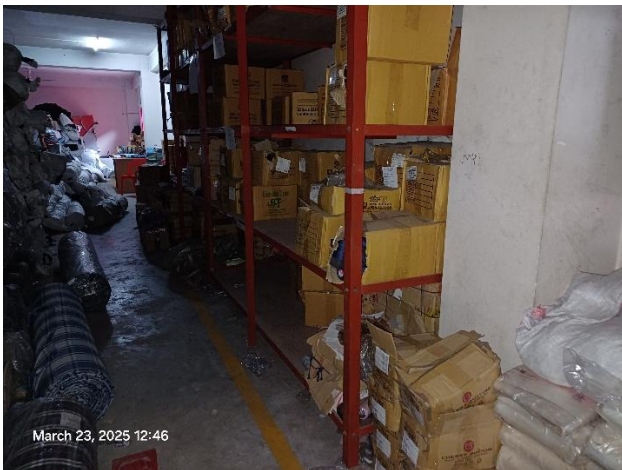
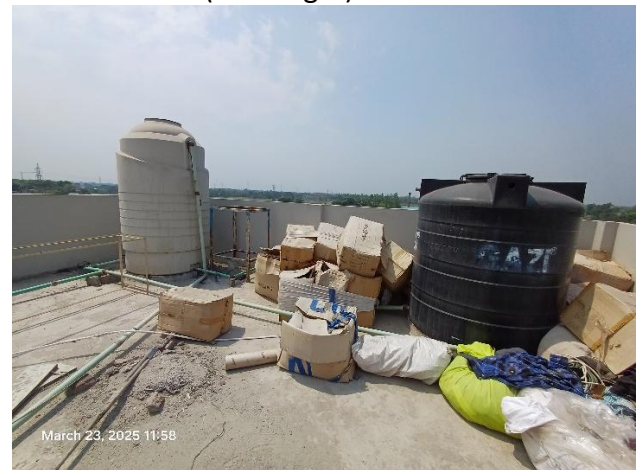
Observation 3: Non-structural elements not anchored or braced. (Building-1)

Description: PVC water tanks on the roof and steel racks on the floors are not anchored or braced to resist lateral (earthquake) forces. The factory is required to anchor/brace all non-structural elements adequately to resist earthquake forces.

6.	Non-structural elements not anchored or braced. (Building-1)	The factory is required to anchor/brace all non-structural elements adequately to resist earthquake forces.	within 6 weeks

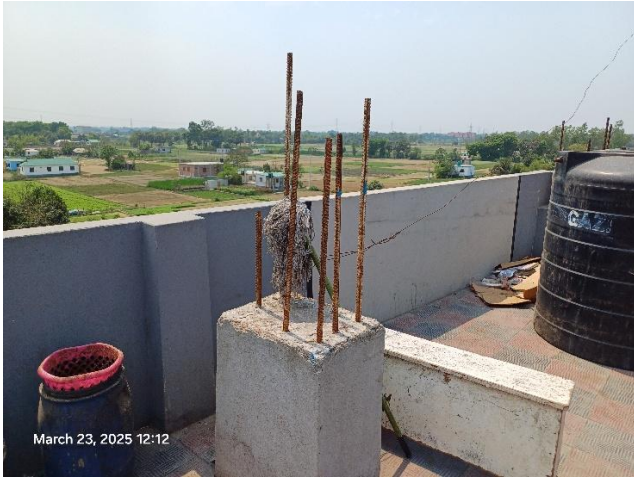
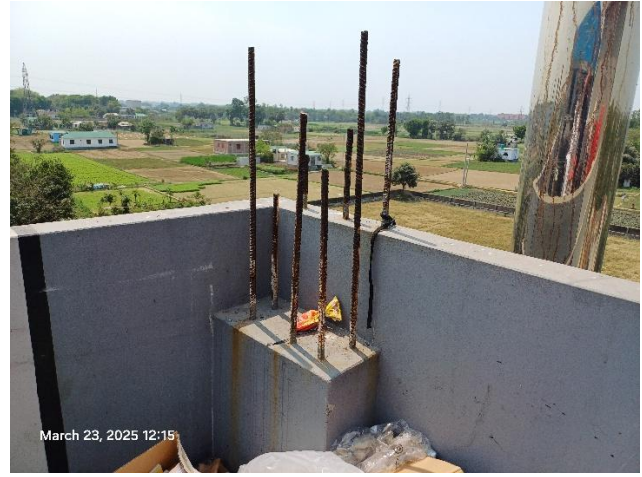
Observation-4: Exposed rebar on the roof level. (Building-1)

Description: Exposed rebar was observed on the roof, which is prone to corrosion. The building engineer is required to provide anti-corrosive coating on the exposed rebar.

7.	Exposed rebar on the roof level. (Building-1)	The building engineer is required to provide anti-corrosive coating on the exposed rebar.	within 6 weeks

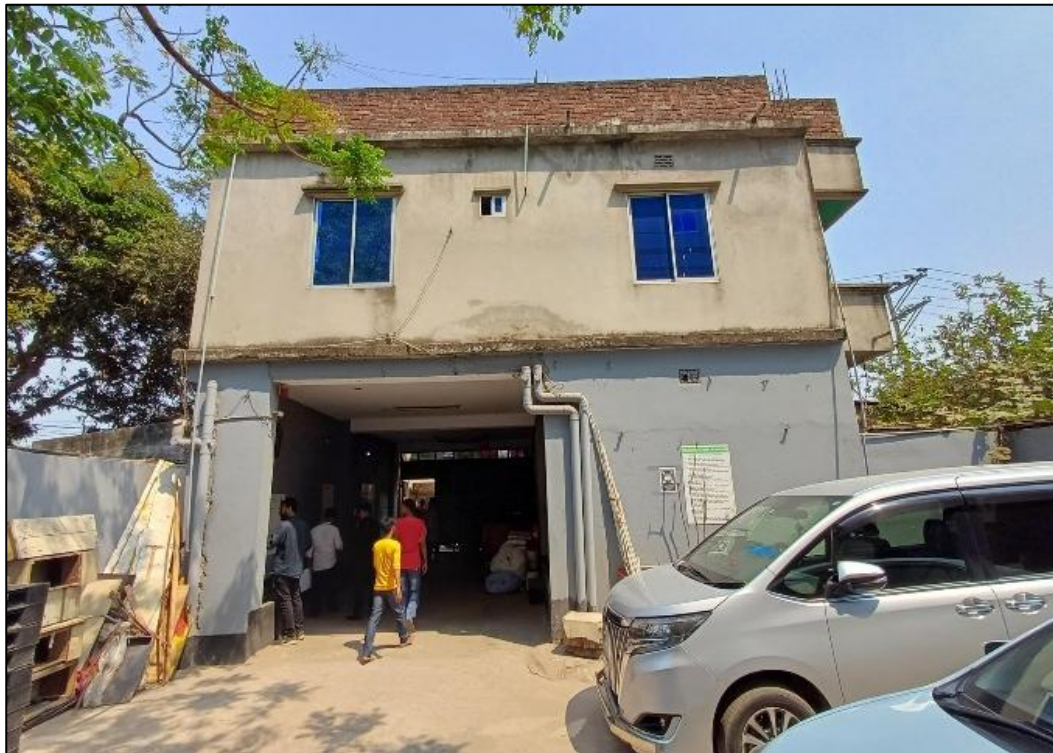
Observation-5: Lack of design documents. (Building-2)

Description: As per BNBC, every building or structure designed shall have its design documents prepared following the provisions of Section 1.9.1. The design document shall include a design report and a set of structural drawings, which shall be prepared in compliance with section 1.9.1.1 and section 1.9.1.2 as per BNBC.

At the time of inspection, design documents (design report, as-built drawings, and material test reports) were not available, which are required to be prepared in compliance with section 1.9.1 (part 6, BNBC).

8.	Lack of design documents. (Building-2)	The building engineer is required to prepare design documents (including design reports, material test reports, live load plan and as-built drawings) in compliance with section 1.9.1 (part 6, BNBC).	within 6 weeks

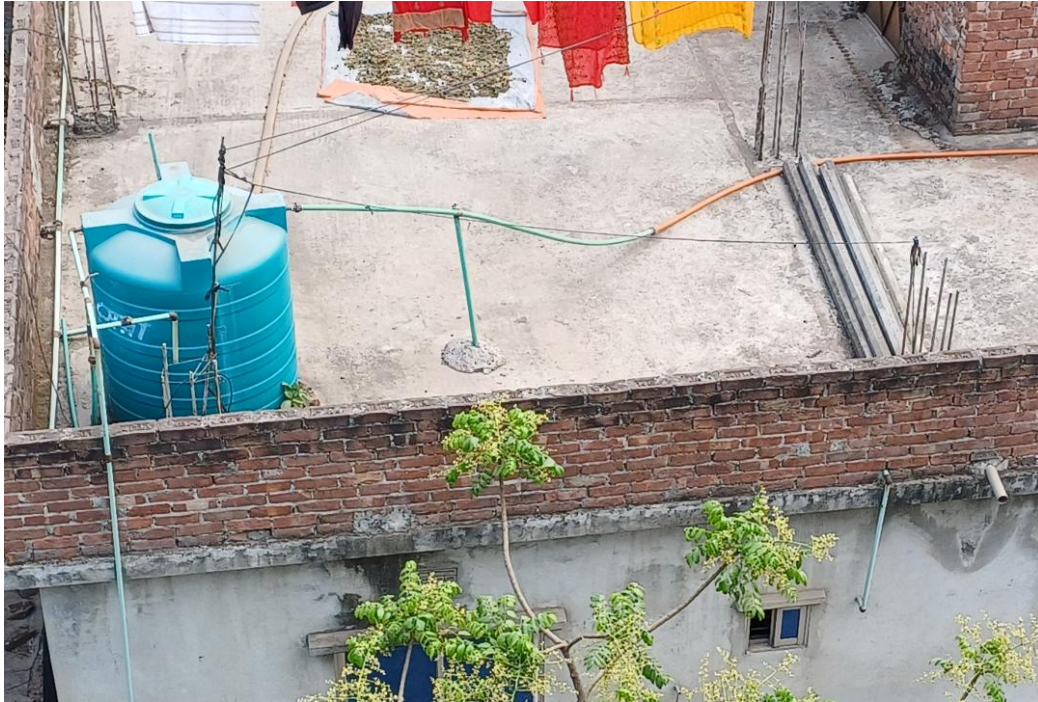
Observation-6: Exposed rebar on the roof level. (Building-2)

Description: Exposed rebar was observed on the roof, which is prone to corrosion. The building engineer is required to provide anti-corrosive coating on the exposed rebar.

9.		Produce accurate as-built drawings.	within 6 weeks
10.		Carry out the suggested remedial works (if any).	within 6 months
11.	Exposed rebar on the roof level. (Building-2)	The building engineer is required to provide anti-corrosive coating on the exposed rebar.	within 6 weeks

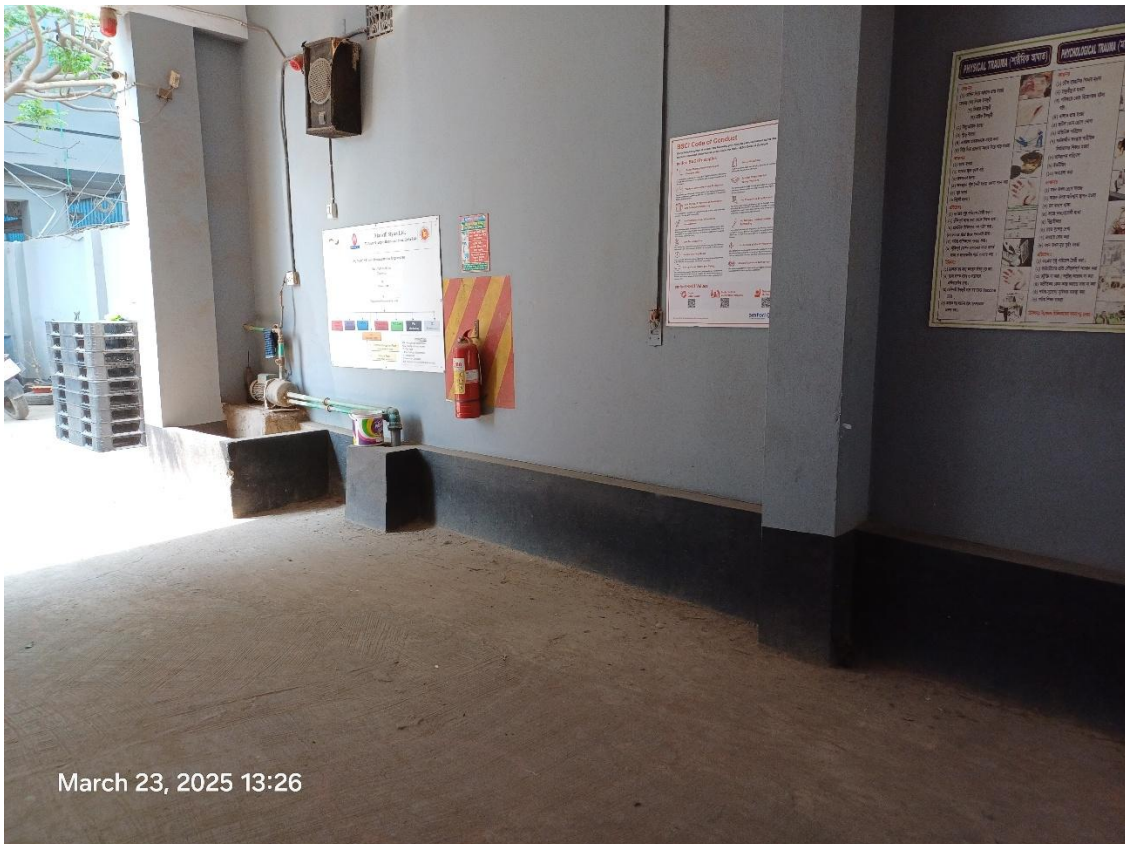
Observation-7: Column susceptible to vehicle impact. (Building-2)

Description: The ground floor of this building is part of an internal road. So, columns in the ground floor area are susceptible to vehicle impact. The building engineer is required to provide separate barriers around the column to prevent vehicle impact.

12.	Column susceptible to vehicle impact. (Building-2)	The building engineer is required to provide separate barriers around the column to prevent vehicle impact.	within 6 weeks

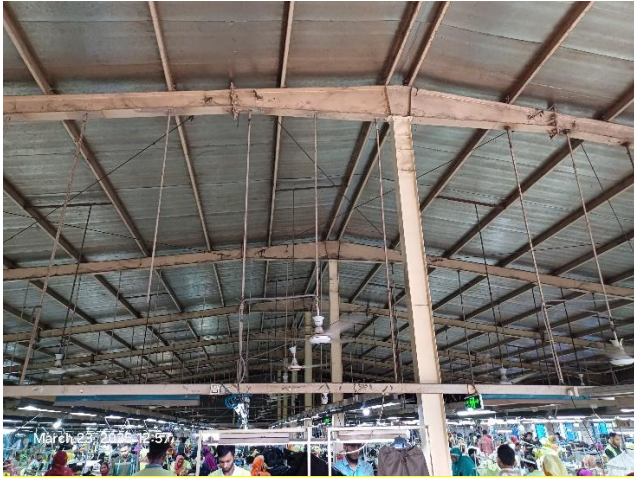
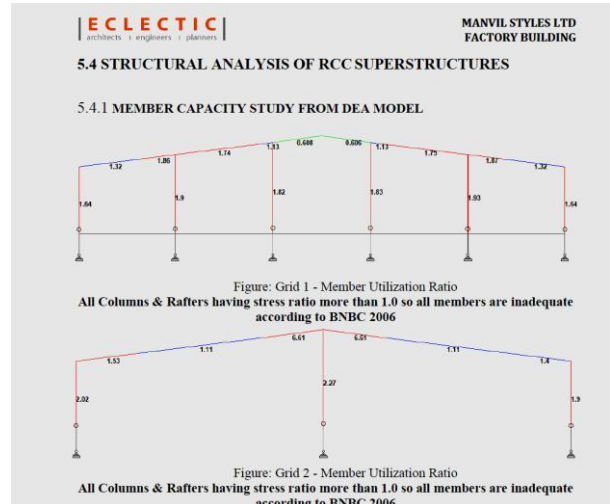
Observation 8: Lack of lateral stability and overstressed steel members in the assessment report. (Shed Building)

- All Steel Columns are inadequate according to BNBC 2006 load combination.
- All Steel Rafters are inadequate according to BNBC 2006 load combination.
- Structure is inadequate in Displacement.

Description: The shed building has no obvious lateral stability system (compression strut). A DEA report was available on site. As per the recommendation of the report, retrofitting was suggested, but no remediation work was found on-site.

Building engineer is required to update the design documents following BNBC for lateral stability and adequacy of structural members and submit to RSC.

13.	Lack of lateral stability and overstressed steel members in the assessment report. (Shed Building)	Building engineer is required to update the design documents following BNBC for lateral stability and adequacy of structural members and submit to RSC.	within 6 weeks
14.		Carry out remedial work if required.	within 6 months
15.	Loose cable bracings on the wall and roof. (Shed Building)	Building engineer is required to tighten all the loose bracings.	within 6 weeks

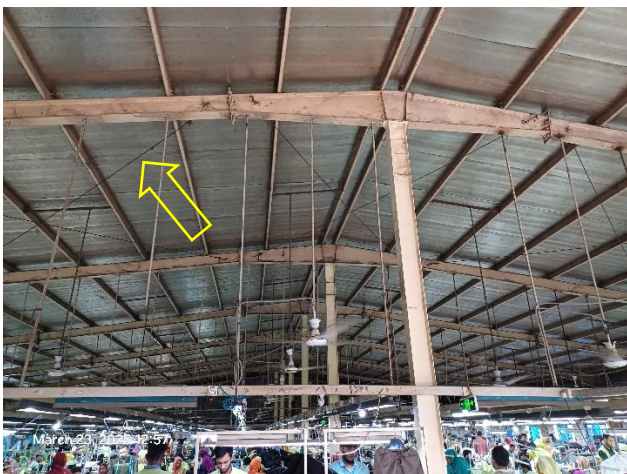
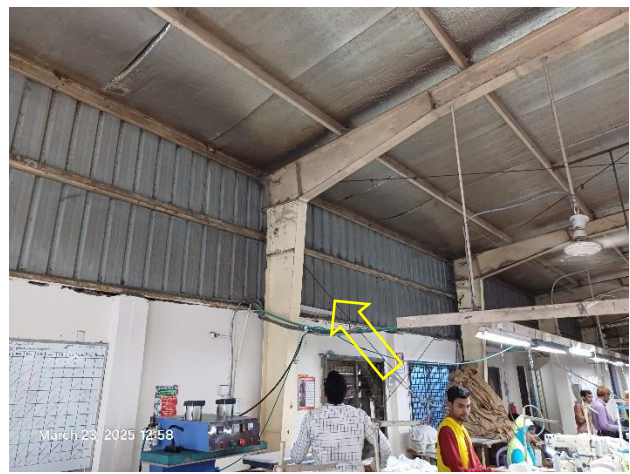
Observation 9: Loose cable bracings on the wall and roof. (Shed Building)

Description: During the inspection, the bracings were found loose. Building engineer is required to tighten all the loose bracings.
