# VERSATILE TEXTILES LTD. (EXTENSION)

89/2, Chaydana, Degerchala Road, National University, Gazipur-1704.

9 April 2025

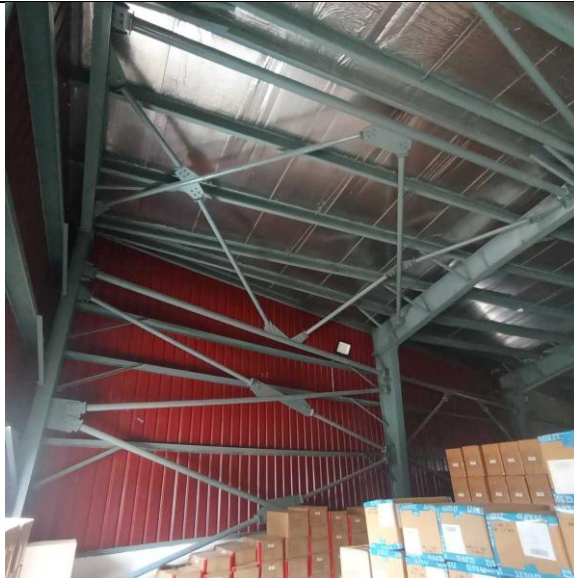
**Observation-01:** Irregular pattern of lateral stability system (Warehouse Shed).

**Description:** Irregular pattern of lateral stability was observed in the shed. Roof bracing is placed inclinedly and directly on the strut. Hence, the lateral load transfer system is questionable. The building engineer is required to review the lateral load transfer system, design of bracing system, and suggest remedial works as required.

| Item No | Observation | Action Plan | Timeline |
|---|---|---|---|
| 1. | Irregular pattern of lateral stability system (Warehouse Shed). | The building engineer is required to review the lateral load transfer system, design of bracing system, and suggest remedial works as required. | within 6 weeks |
| 2. | | Implement remediation work after acceptance from RSC. | within 6 months |

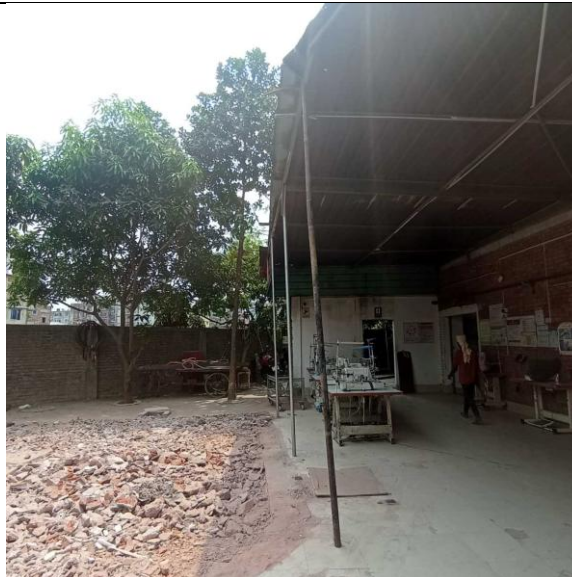
**Observation-02:** Buckling of the steel column (Walkway shed).

**Description:** The steel columns of the shed were slender and found buckled. The building engineer is required to check the buckling of the column and prepare a safety check report. Submit the safety check report to the RSC for review. As per the safety check report, repair the buckled members.

| Item No | Observation | Action Plan | Timeline |
|---|---|---|---|
| 3. | Buckling of the steel column (Walkway shed). | The building engineer is required to check the buckling of the column and prepare a safety check report. Submit the safety check report to the RSC for review. | within 6 weeks |
| 4. | | Implement remediation work as per the safety check report after getting acceptance from RSC. | within 6 months |

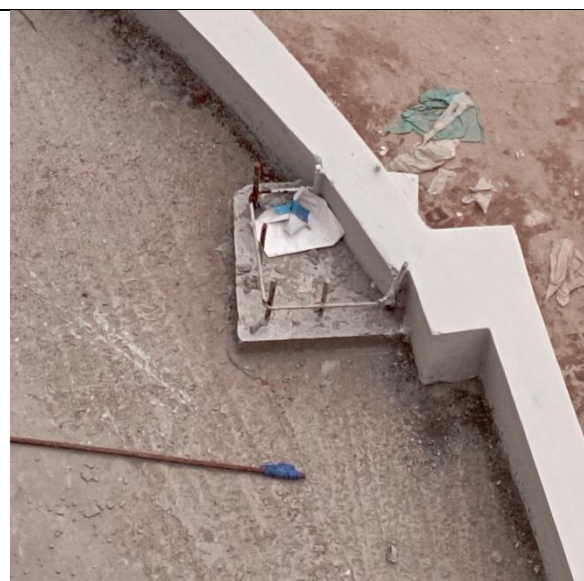
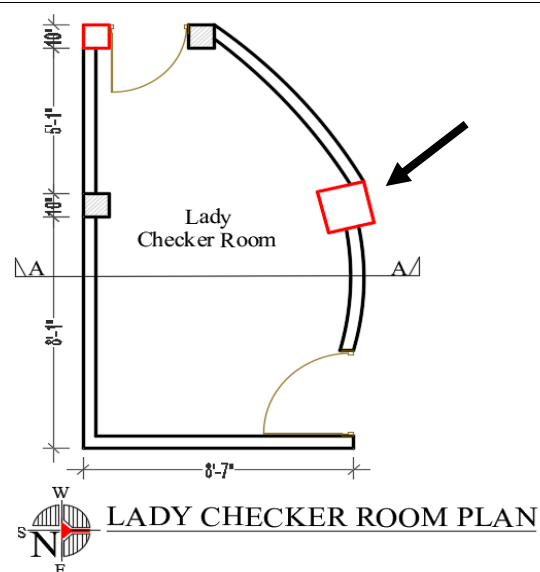
**Observation-03:** Missing information in the as-built drawing (Security checking room (Female)).

**Description:** The marked column was found as RC column, but no information is provided in the drawing. The building engineer is required to produce accurate as-built drawings.

| Item No | Observation | Action Plan | Timeline |
|---|---|---|---|
| 5. | Missing information in the as-built drawing (Security checking room (Female)). | The building engineer is required to produce accurate as-built drawings. | within 6 weeks |

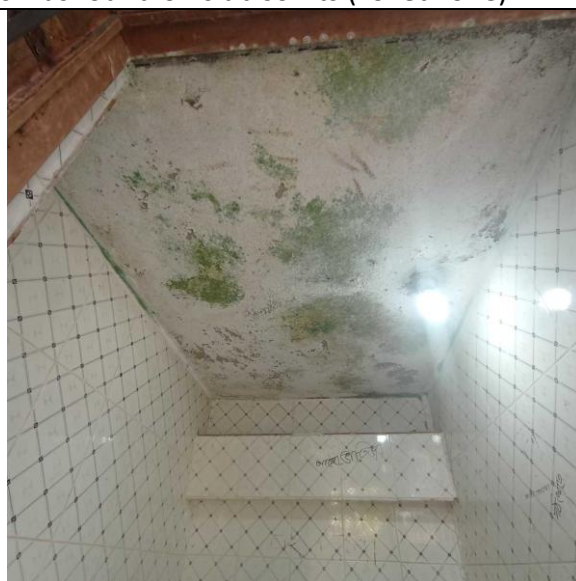
**Observation-04:** Dampness was found on slab soffits (Toilet Zone).

**Description:** Dampness was found on slab soffits. The building engineer is required to repair the dampness with a suitable method.

| Item No | Observation | Action Plan | Timeline |
|---|---|---|---|
| 6. | Dampness was found on slab soffits (Toilet Zone). | The building engineer is required to repair the dampness with a suitable method. | within 6 weeks |
