# Vision Garments Ltd (Extension-2)

B-47, Purbo Razashan, Savar, Dhaka

10 April 2025

## 1. Building Information

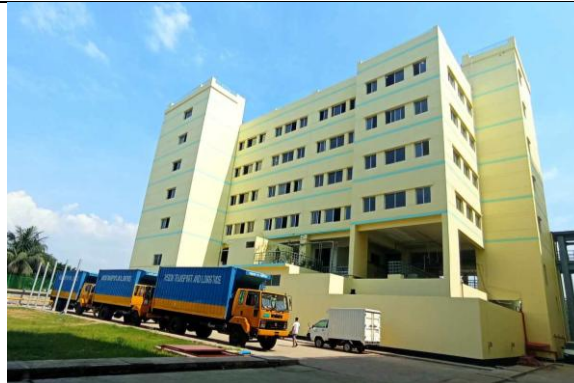
### Observation-02: Lack of design report (ETP Building).

**Description:** As per BNBC, every building or structure designed shall have its design documents prepared in accordance with the provision of Section 1.9.1. At the time of inspection, the design report was not available, which must be prepared in compliance with section 1.9.1 (part-6, BNBC) based on in-situ concrete strength.

| Item No | Observation | Action Plan | Timeline |
|---|---|---|---|
| 2. | Lack of design report (ETP Building). | The building engineer is required to prepare a design report in compliance with section 1.9.1 (part-6, BNBC) based on in-situ concrete strength. | within 6 weeks |

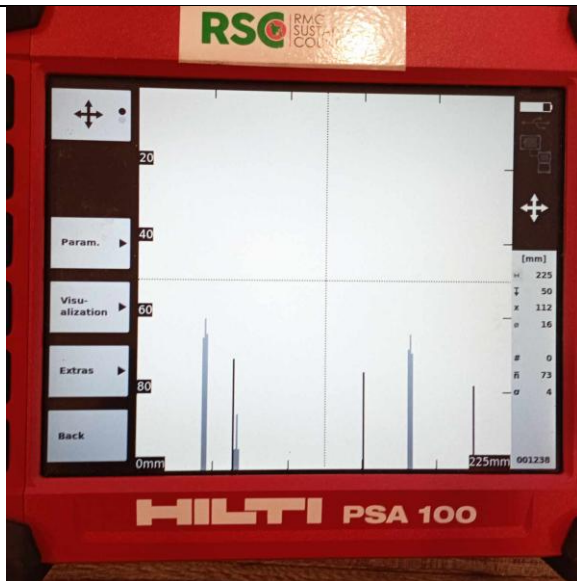
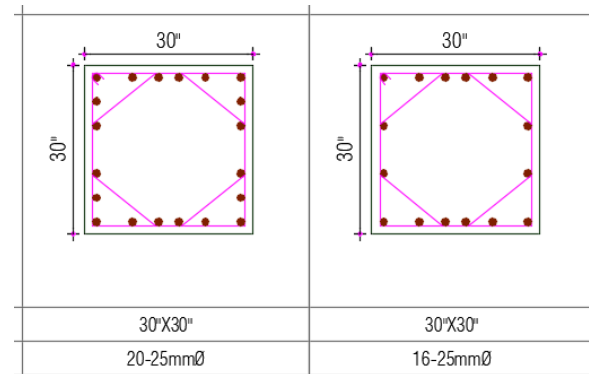
**Observation-03: Discrepancy in as-built drawing. (ETP Building).**

**Description:** Number of rebar was found 3X3 on 4<sup>th</sup> floor instead of 6X6 during ferro scanning in column C3. The building engineer is required to survey the whole structure and prepare accurate as-built drawing with evidence.

| Item No | Observation | Action Plan | Timeline |
|---|---|---|---|
| 4. | Discrepancy in as-built drawing. (ETP Building). | The building engineer is required to survey the whole structure and prepare accurate as-built drawing with evidence. | within 6 weeks |

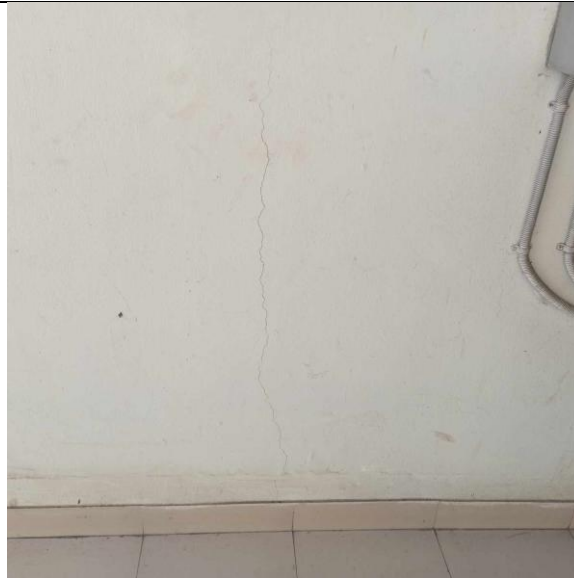
**Observation-04: Crack on brick wall (1st floor) (ETP Building).**

**Description:** Crack was found on brick wall (1st floor). The building engineer is required to identify the reason and repair the crack with a suitable method.

| Item No | Observation | Action Plan | Timeline |
|---|---|---|---|
| 5. | Crack on brick wall (1st floor) (ETP Building). | The building engineer is required to identify the reason and repair the crack with a suitable method. | within 6 weeks |
