# **FIRE SAFETY INSPECTION REPORT**

**AMAN WINTER WEARS LTD**  
**KULASUR, HEMAYETPUR, SAVAR, DHAKA**

**ACCORD**  
on Fire and Building Safety in Bangladesh

June 5, 2014

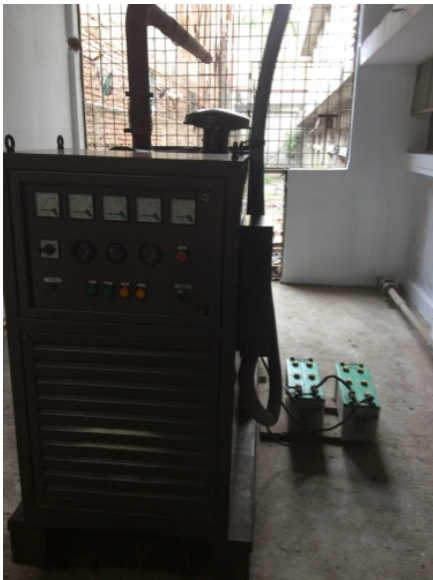
| No. | Category | Finding | Recommendation | Remediation Timeframe |
|---|---|---|---|---|
| F-1 | Fire Rated Construction | The generator room is not separated by fire-rated construction (openings, non-rated doors, penetrations) in the basement. | Separate the generator room by a minimum 2-hr fire-rated construction. Seal and/or protected all openings to maintain the required fire separations | Within 3 months |

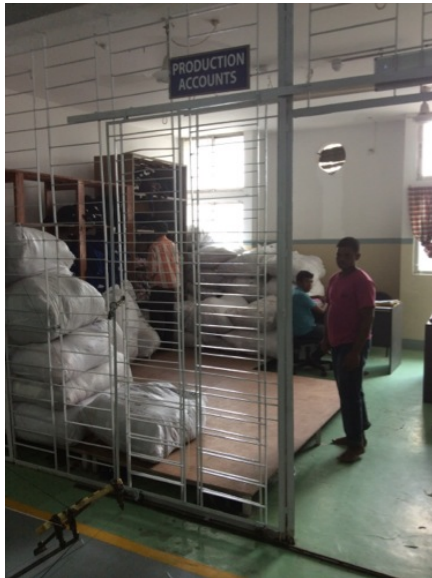
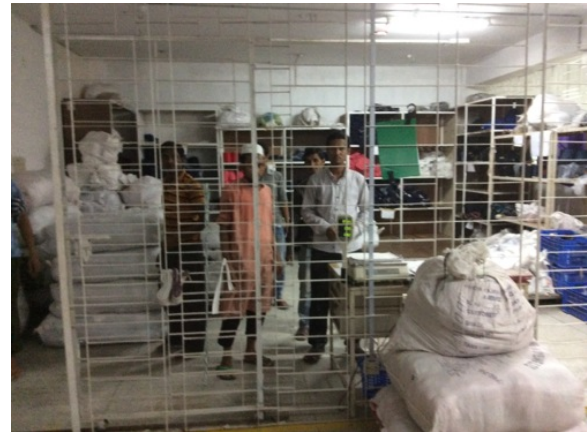
| No. | Category | Finding | Recommendation | Remediation Timeframe |
|---|---|---|---|---|
| F-2 | Fire Rated Construction | Storage rooms used for combustible storage are not separated by fire-rated construction in the basement, ground and 1st floors. | Provide dedicated storage rooms separated by minimum 1-hr fire-rated construction. | Within 3 months |

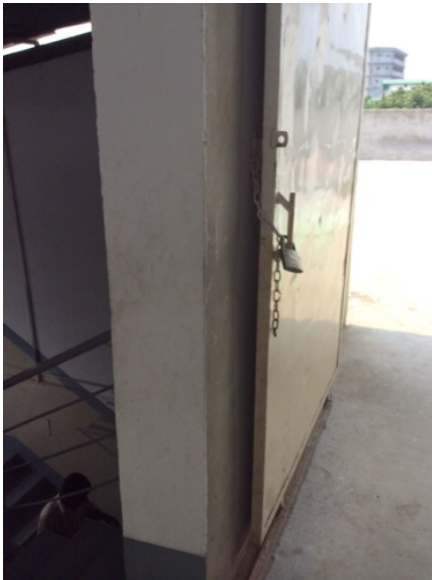
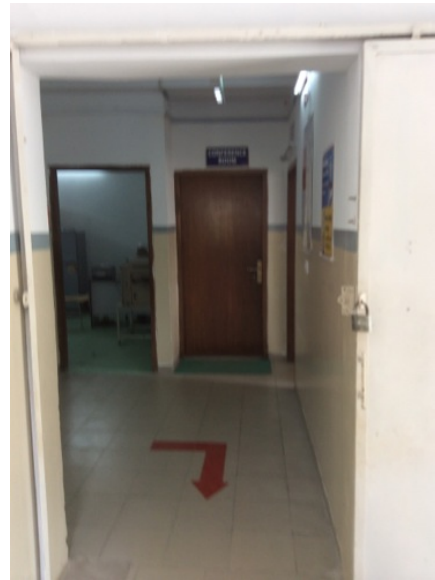
| F-3 | Fire Rated Construction | The exit stairs are not separated from work areas on each floor by fire-rated construction. | <p>Provide minimum 1.5-hr fire rated doors and seal all unprotected openings to separate the exit stairs from work areas and other building spaces on all floor levels. Ensure that the fire doors are self-closing and positive latching and that they are provided with fire exit (panic) hardware where serving production floors.</p> <p>If fire doors are required to be held open for functional reasons, provide automatic-closing devices tied to the fire alarm system.</p> | Within 3 months |

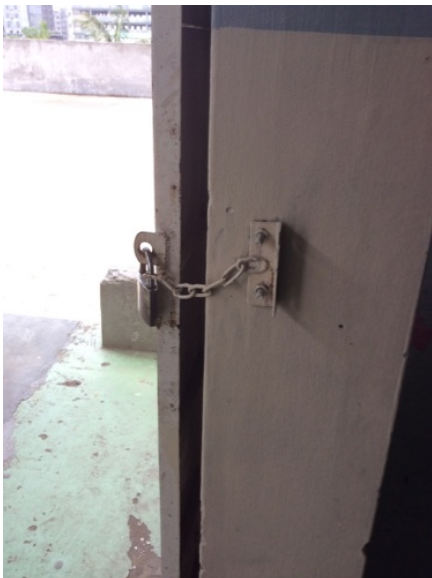
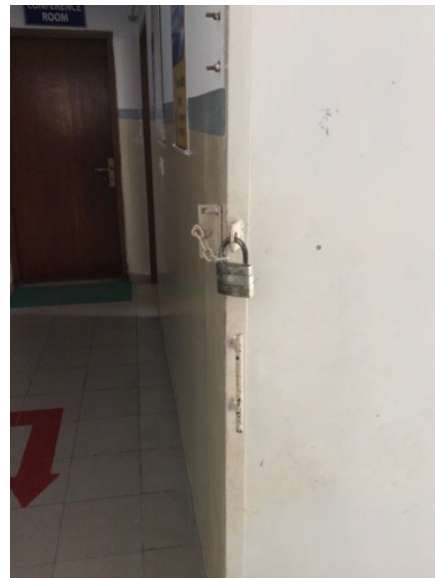
| F-4 | Egress | Egress doors with locking features are provided at exit stairs. | Remove locking features from all egress doors / gates.<br><br>If locks are required for security reasons, utilize special door locking features complying with NFPA 101. | Immediate |

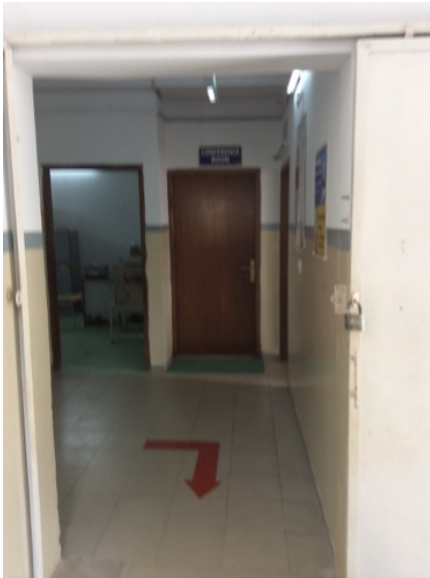
| F-5 | Egress | Sliding doors are provided at exit stairs on every floor. | <p>Replace all gates / sliding doors along the means of egress with side-hinged, swinging egress doors.</p> <p>If locks are required for security reasons, utilize special door locking features complying with NFPA 101.</p> | Within 1 month |
