TOPTEx SWEATERS LTD. (ANNEXE BUILDING)

DhonaId, Norshingpur, Ashulia, Savar, Dhaka

10 April 2025

2. Observation:

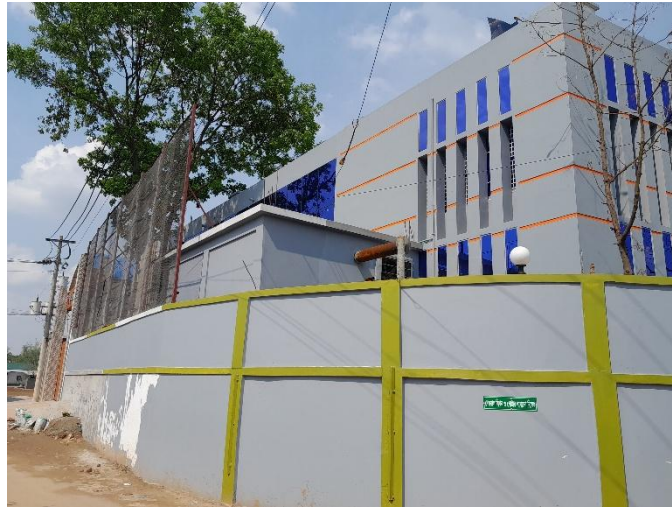
Observation-01: Lack of design report. (Factory Building)

Description: Design report was not available for the factory building. Building engineer is required to prepare the design report as per BNBC 1.9.1 and following the 2020 provision.

Item No	Observation	Action Plan	Timeline
1.	Lack of design report. (Factory Building)	Building engineer is required to prepare the design report based on in-situ material strength following 2020 provision (Part-6, Section 1.9.1).	within 6 weeks

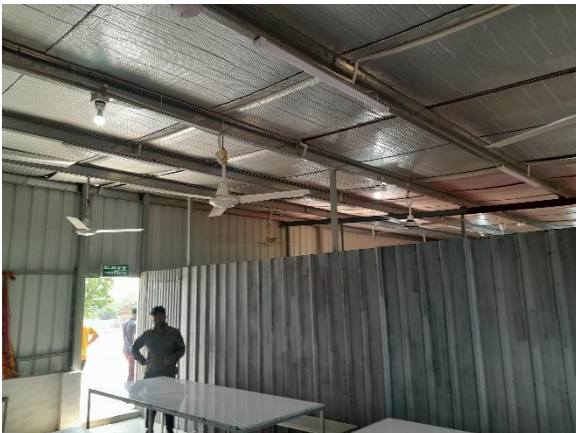
Inadequate members (Roof top shed)

Description: Poor connection, inadequate member was observed on the roof sheds and the staircase roof. Building engineer is required to check the lateral stability of the shed and prepare Engineering Assessment.

2.		Carry out the suggested remedial works if required.	within 6 months
3.	Lack of lateral stability of the roof sheds. (Factory Building)	Building engineer is required to check the lateral stability of the sheds and prepare Engineering Assessment.	within 6 weeks

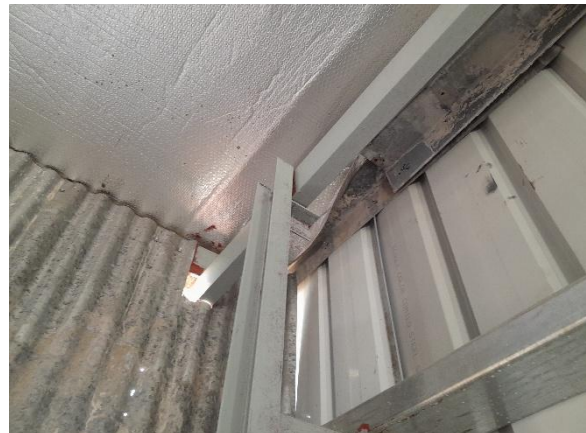
Poor connection details

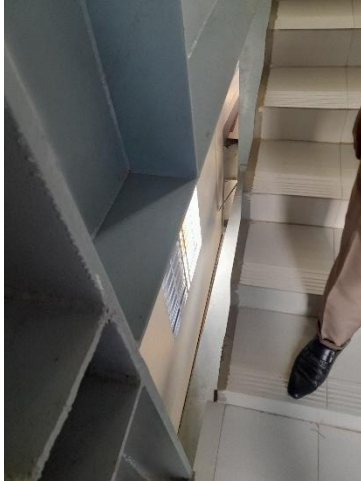
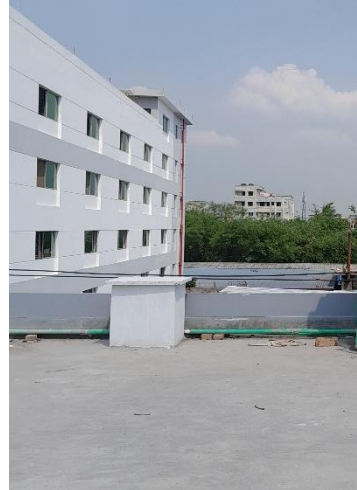
Observation-03: Falling hazard and inadequate parapet height. (Factory Building)

Description: Falling hazard at the stair zone and inadequate parapet height were observed (625 mm). Building engineer is required to increase the parapet height and take appropriate action to mitigate the falling hazard.

4.		Carry out the suggested remedial works if required.	within 6 months
5.	Falling hazard and inadequate parapet height. (Factory Building)	Building engineer is required to increase the parapet height following BNBC and take appropriate action to mitigate the falling hazard.	within 6 weeks

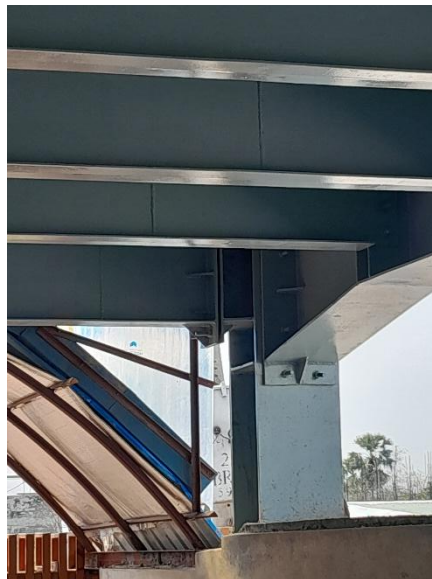
Observation-04: Gaps in steel member connections. (Factory Building)

Description: Gap was identified in the steel member connection. Building engineer is required to repair the gaps with a suitable method.

6.	Gaps in steel member connections. (Factory Building)	Building engineer is required to repair the gaps with a suitable method.	within 6 weeks
7.	Column susceptible to vehicle impact. (Factory Building)	Building engineer is required to provide vehicle impact protection on the column.	within 6 weeks

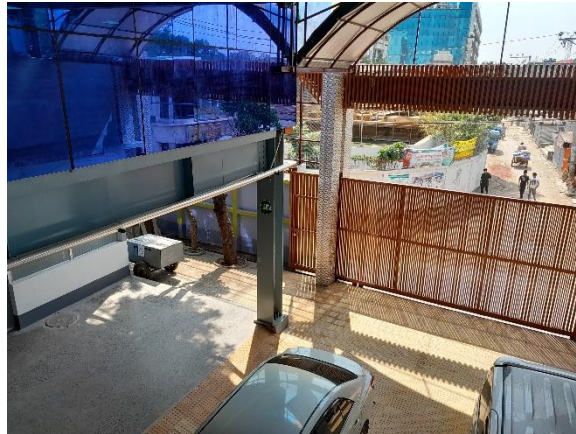
Observation-05: Column susceptible to vehicle impact. (Factory Building)

Description: Column on the ground floor is found susceptible to vehicle impact. Building engineer is required to provide vehicle impact protection on the column.

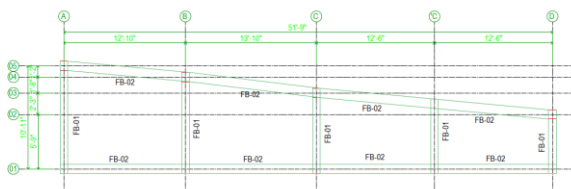
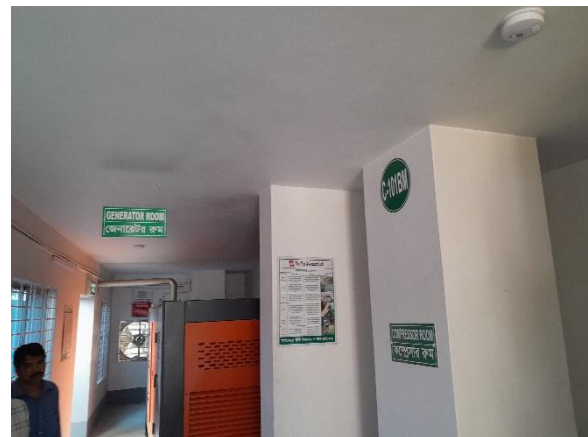
Observation-06: Mismatch in as-built drawing. (Utility Building)

Description: Beam-Column structural system is shown in the as-built drawing. However on-site flat plate-RC column was observed. Building engineer is required to survey the structure and prepare accurate as-built drawings.

8.	Mismatch in as-built drawing. (Utility Building)	Building engineer is required to survey the structure and prepare accurate as-built drawings.	within 6 weeks

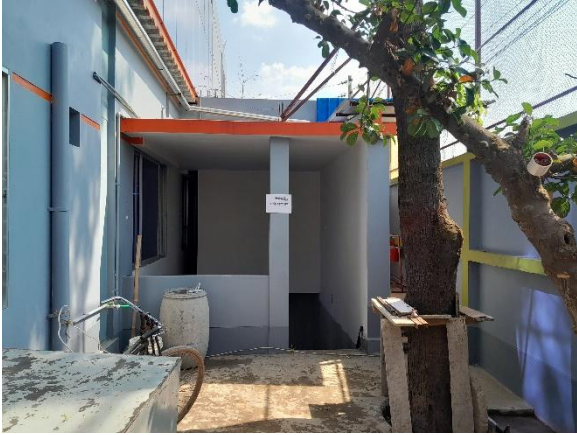
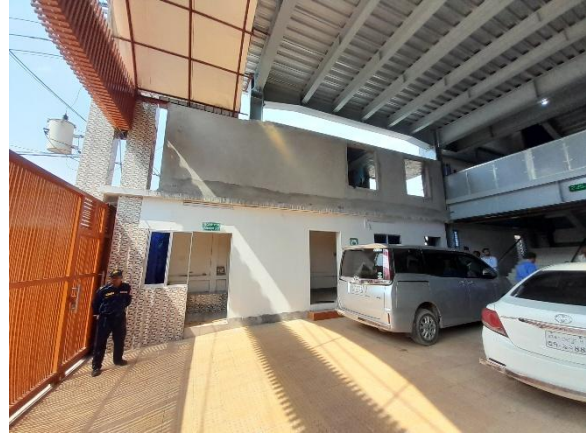
Observation-07: Lack of as-built drawing. (Boiler Building and Security Post & Fire Command Room)

Description: As-built drawings were not available on-site for the buildings.

The one side of the Security Post & Fire Command Room rests on the boundary wall, so the building engineer is required to check the load plan and adequacy for the vertical support as well as lateral support.

Building engineer is required to survey the structure and prepare accurate as-built drawings.

9.	Lack of as-built drawing. (Boiler Building and Security Post & Fire Command Room)	Building engineer is required to survey the structure and prepare accurate as-built drawings.	within 6 weeks

10.		Building engineer is required to check the load plan and adequacy for the vertical support as well as lateral support.	within 6 weeks
11.		Carry out the suggested remedial works if required.	within 6 months
