Advanced Composite Textile Ltd (Extension)

Kashor, Masterbari, Valuka, Mymensingh

18 March 2025

Structural Inspection Report

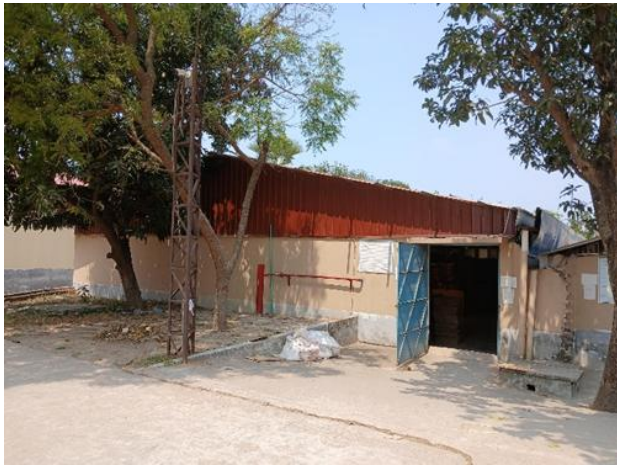
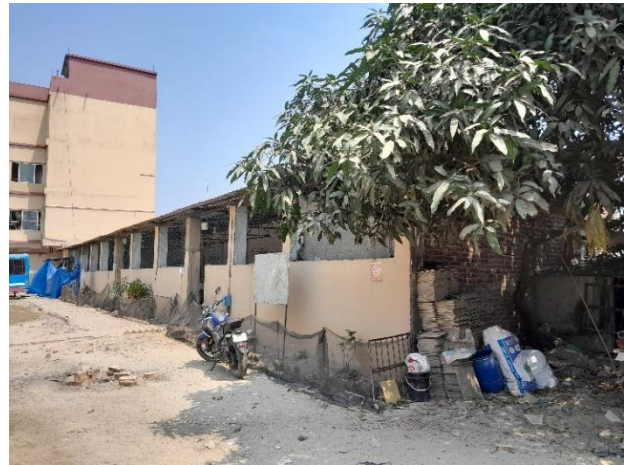
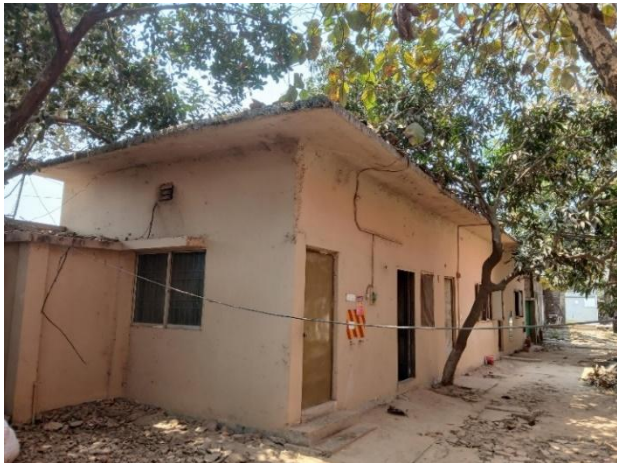
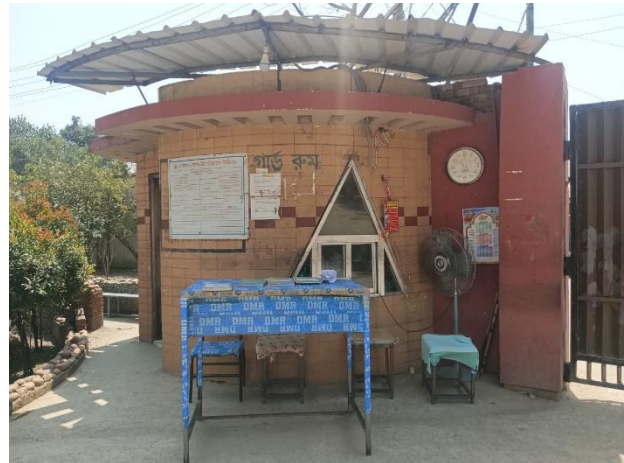
Observation-01: Lack of as-built drawings for all structures.

Description: As-built drawings were not available on-site. The building engineer is required to prepare the as-built drawings for all the structures.

Item No	Observation	Action Plan	Timeline
1.	Lack of as-built drawings for all structures.	The building engineer is required to prepare detailed and accurate as-built drawings for all the structures.	within 6 weeks

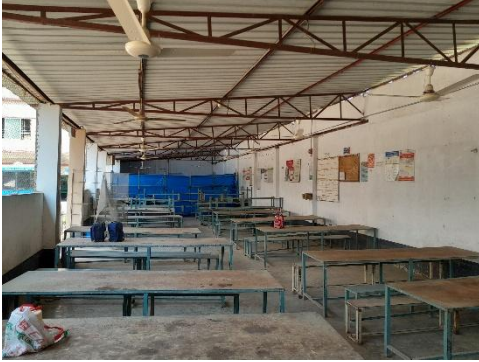
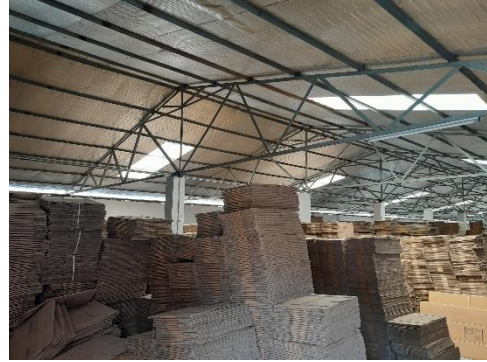
Dining & Canteen Shed

Observation-02: Lack of lateral stability system and poor connection details. (Finished Cartoon Godown, Dining & Canteen)

Description: Lack of lateral stability system (bracing & strut) and poor connection detailing were observed. As part of Engineering Assessment (EA), the building engineer is required to check the lateral stability and connection adequacy. Prepare design report with proper remedial methodology according to BNBC 1.9.1. Submit EA documents to the RSC for review. `

3.		Carry out the suggested remedial works.	within 6 months
4.	Lack of lateral stability systems and poor connection details. (Dining & Canteen)	As part of Engineering Assessment (EA), the building engineer is required to check the lateral stability and connection adequacy. Prepare design report with proper remedial methodology according to BNBC 1.9.1. Submit EA documents to the RSC for review.	within 6 weeks

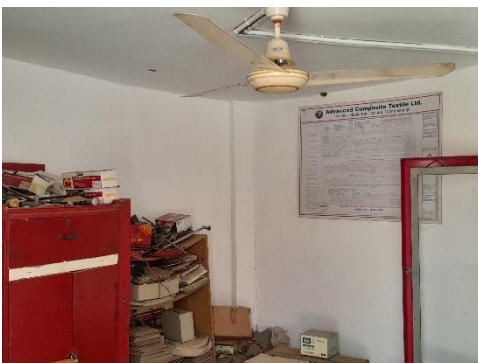
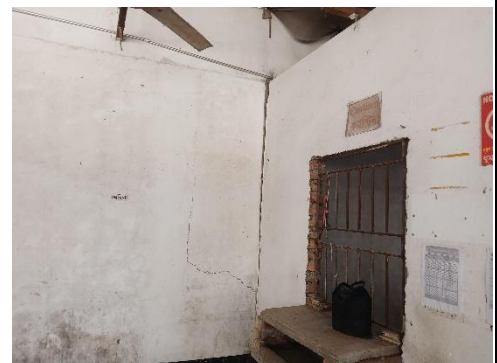
Observation-03: Crack on brick wall (Fire Control Room and Dining & Canteen Shed)

Description: Crack was observed on the Fire Control Room and Dining & Canteen Shed. The building engineer is required to identify the reason for the crack and repair with suitable method.

5.		Carry out the suggested remedial works.	within 6 months
6.	Crack on brick wall (Fire Control Room)	The building engineer is required to identify the reason for the crack and repair with suitable method.	within 6 months

7.	Crack on brick wall (Dining & Canteen Shed)	The building engineer is required to identify the reason for the crack and repair with suitable method.	within 6 weeks
