# Kaixi Lingerie Bangladesh Co Ltd

Plot# 183-188 and 189A-193, BEPZA Economic Zone -01, Mirsharai, Chattogram.

21 April 2025

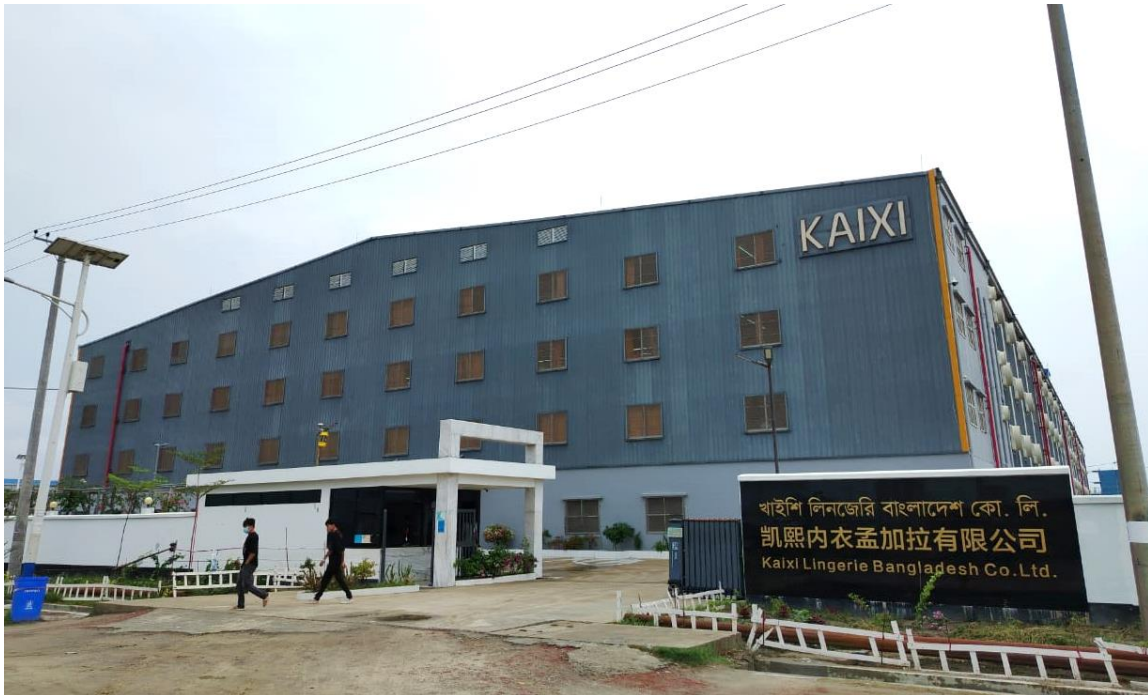
### Observation 01: Lack of design documents and load plan (Main Production Building)

**Description:** As per BNBC, every building or structure designed shall have its design documents prepared under the provisions of Section 1.9. The design document shall include a design report and a set of structural drawings, which shall be prepared in compliance with sections 1.9.2 and 1.9.3 as per BNBC 2020.

The design report and floor load plan were not available at the time of inspection. The building engineer is required to prepare a set of design documents, including a design report, as-built drawings, and a floor load plan, in compliance with BNBC.

| SL | Observation | Action Plan | Timeline |
|---|---|---|---|
| 1. | Lack of design documents and load plan (Main Production Building) | Produce floor live load plan for all floor plates following BNBC requirements and based on column & foundation capacity. | within 6 weeks |
| 2. | | The building engineer is required to prepare a set of design documents in compliance with BNBC 2020 based on the floor load plan and in-situ material strength. | within 6 weeks |
| 3. | | Carry out suggested remedial works if required | within 6 months |

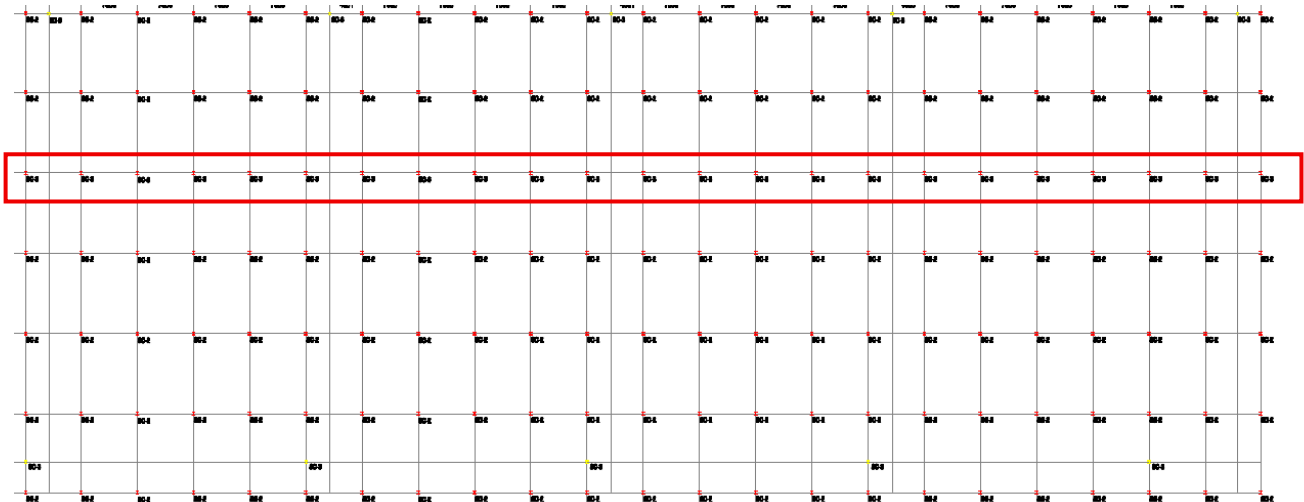
## Observation 02: Discrepancies in the as-built drawings (Main Production Building)

**Description:** At grid F (highlighted in red in the image above), the drawings specified SC3 columns (Web 300×10, Flange 300×16) from the 1st to 3rd floor; however, SC2 columns (Web 350×10, Flange 350×16) were found in place.

| SL | Observation | Action Plan | Timeline |
|---|---|---|---|
| 4. | Discrepancies in the as-built drawings (Main Production Building) | The building engineer is required to survey the whole structure and prepare accurate as-built drawings as per onsite conditions. | within 6 weeks |

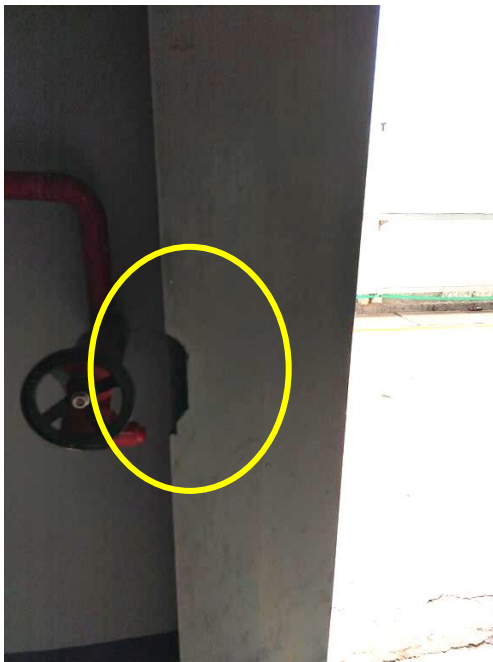
Cut off the flange in the steel column

**Description:** Flanges were cut in several beams and columns, potentially compromising their structural integrity.

| SL | Observation | Action Plan | Timeline |
|---|---|---|---|
| 5. | Cut off flange in steel column & beams (Main Production Building) | The building engineer is required to repair the cut portion with a suitable method or check the adequacy of the member for the net area of the flange. | within 6 weeks |

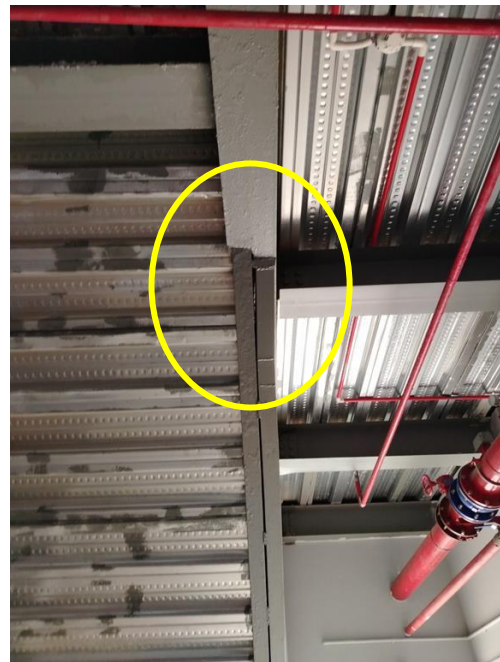
Cut out the flange in the steel beam

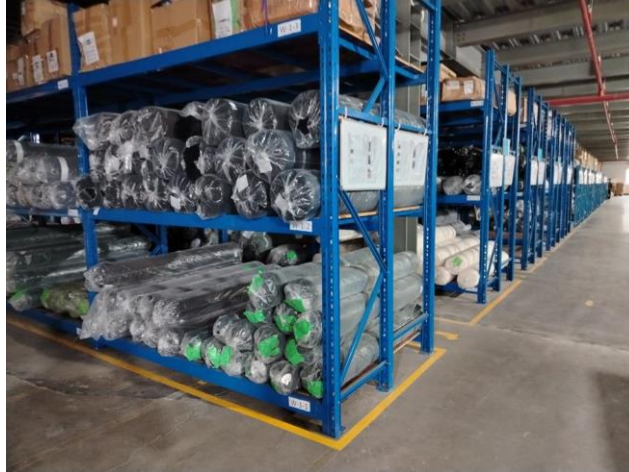
**Observation 04:** Non-structural elements found unbraced/not anchored (Main Production Building)

**Description:** Unbraced and unanchored steel storage racks were found on several floors.

| SL | Observation | Action Plan | Timeline |
|---|---|---|---|
| 6. | Non-structural elements found unbraced/not anchored (Main Production Building) | The factory is required to brace/anchor all non-structural elements (storage racks) to prevent falling during earthquake. | within 6 months |

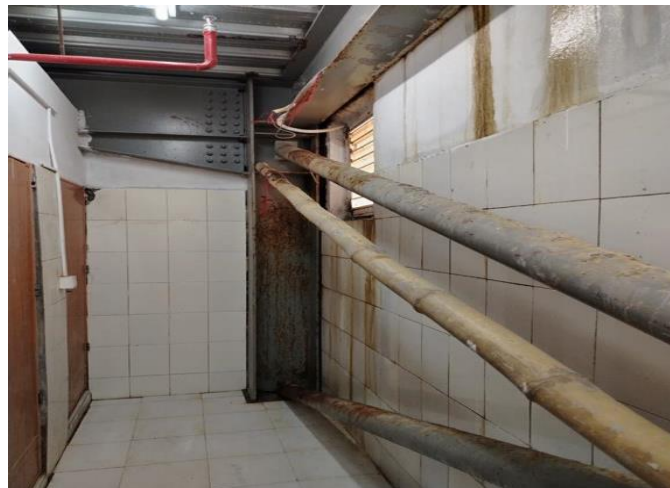
**Observation 05:** Corrosion of steel member (Main Production Building)

**Description:** Corrosion was found on steel members at several locations.

| SL | Observation | Action Plan | Timeline |
|---|---|---|---|
| 7. | Corrosion of steel members (Main Production Building) | The factory is required to remove the rust and apply anti-corrosive paint to the steel member | within 6 weeks |

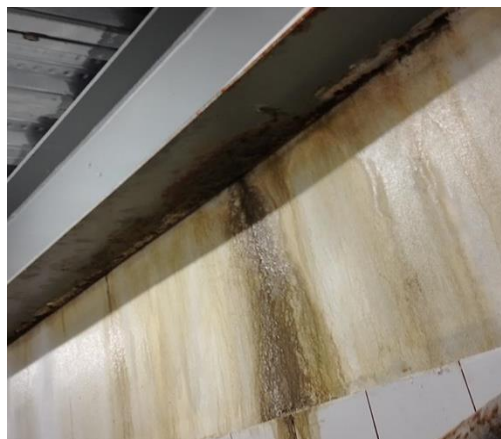
**Observation 06:** Dampness on brick wall (Main Production Building)

**Description:** Dampness was found on the masonry wall in the toilet area.

| SL | Observation | Action Plan | Timeline |
|---|---|---|---|
| 8. | Dampness on the brick wall (Main Production Building) | The factory is required to repair the dampness with suitable measures. | within 6 weeks |

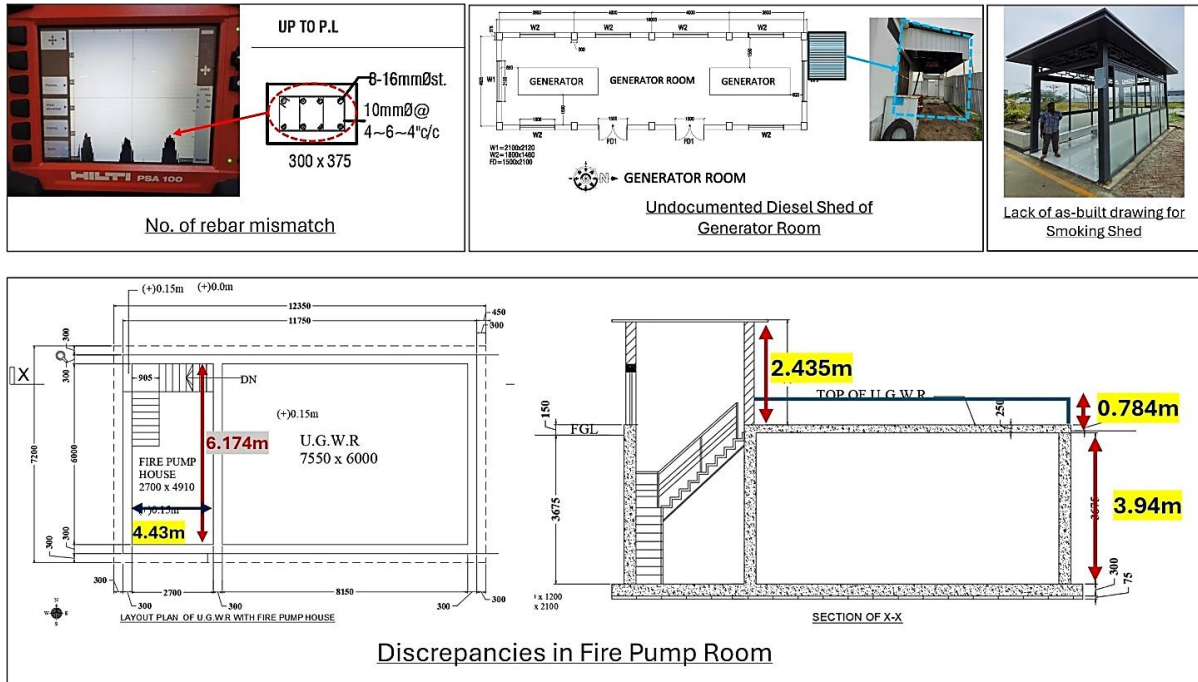
**Observation 07:** Discrepancies in the as-built drawings of all the ancillary structures.

**Description:** Discrepancies were found in the Fire Pump room regarding the dimension of the structure, elevation of the pump room roof slab, and height from EGL to the top. Also, an undocumented diesel shed adjacent to the Generator Room was found, which is not incorporated in the as-built drawing. Moreover, a mismatch was found in the number of rebars and directional sign of Security Room 01, Substation & Transformer Room, Solar Substation & Maintenance Room, Generator Room, Security Room 02, Canteen & Childcare Room, Medical Room, Wastage Room and Compressor Room. The building engineer is required to survey the whole structure and prepare accurate as-built drawings as per onsite conditions.

| SL | Observation | Action Plan | Timeline |
|---|---|---|---|
| 9. | Discrepancies in the as-built drawings of all the ancillary structures. | The building engineer is required to survey the all structure, prepare accurate as-built drawings as per onsite conditions and submit to RSC for review. | within 6 weeks |
