FIRE SAFETY INSPECTION REPORT

DELUXE FASHIONS LTD.

178/179 BAIZID, BOSTAMI ROAD, P. S. BAIZID

June 5, 2014

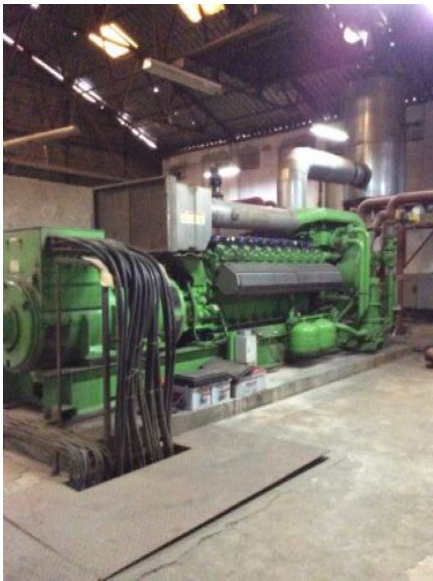
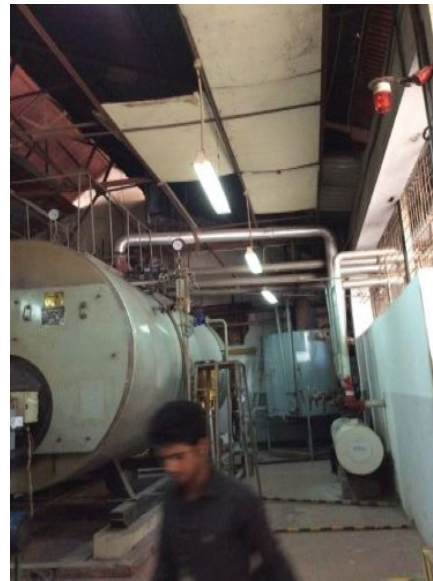
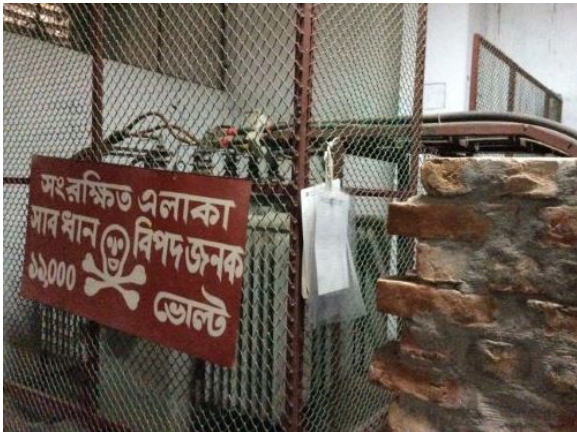
No.	Category	Finding	Recommendation	Remediation Timeframe
F-1	Fire Rated Construction	The boiler, generator, and transformer room is not separated by fire-rated construction that is openings, non-rated doors, penetrations on ground floor.	Separate the boiler, generator, and transformer room by a minimum 2-hr fire-rated construction. Seal and/or protected all openings to maintain the required fire separations	Within 3 months

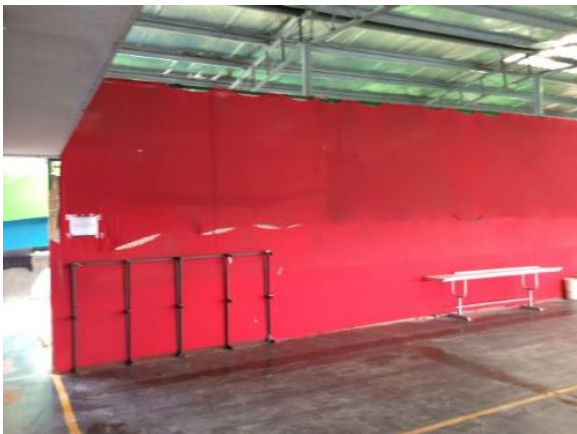
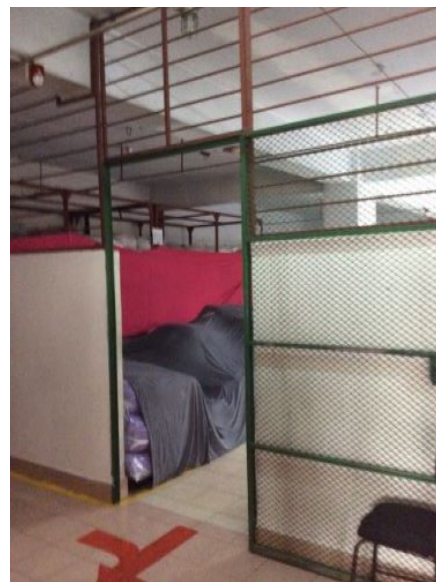
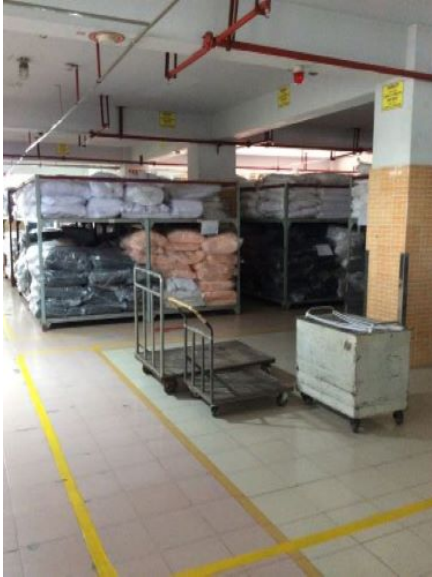
F-2	Fire Rated Construction	Areas used for combustible storage are not separated by fire-rated construction on ground, 1st, 2nd, 3rd, 4th and 5th floors .	Provide dedicated storage rooms separated by minimum 1-hr fire-rated construction.	Within 3 months
-----	-------------------------	--	--	-----------------

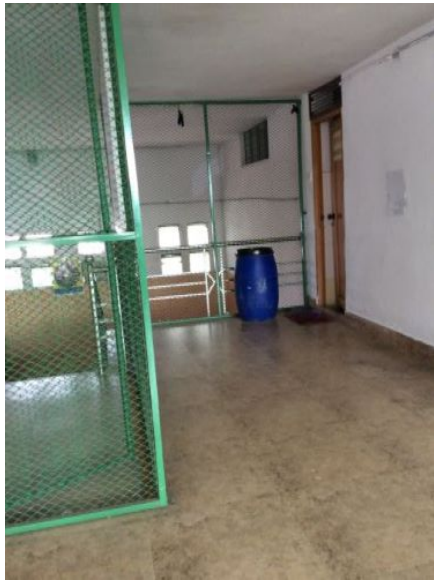
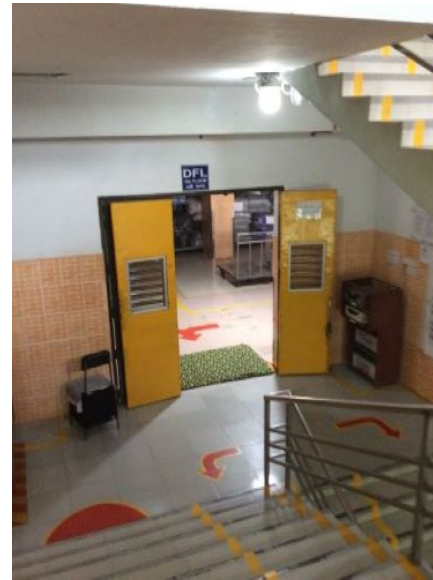
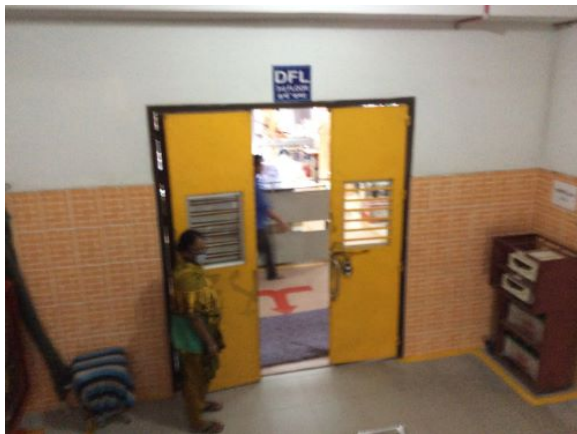
F-3	Fire Rated Construction	The exit stairs are not separated from work areas, and other spaces on each floor by fire-rated construction in the north exit stair on all floors.	Provide minimum 1.5-hr fire rated doors and seal all unprotected openings to separate the exit stairs from work areas and other building spaces on all floor levels. Ensure that the fire doors are self-closing and positive latching and that they are provided with fire exit (panic) hardware where serving production floors.	Within 3 months
			If fire doors are required to be held open for functional reasons, provide automatic-closing devices tied to the fire alarm system.

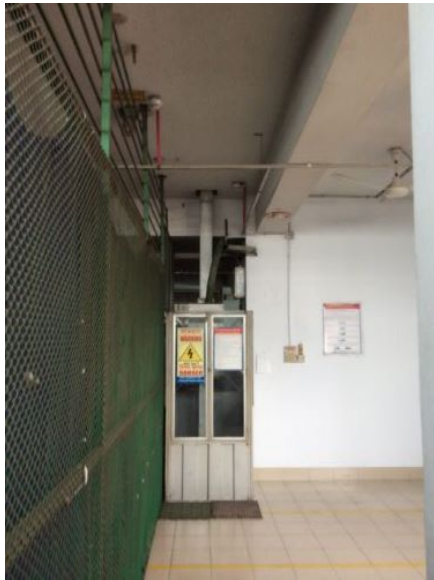
F-4	Fire Rated Construction	Unsealed penetrations and openings are located in the fire-rated floor/ceiling assemblies.	Provide a minimum 2-hr fire-rated shaft to separate the utility risers from each floor level.	Within 3 months
			Seal all penetrations and openings in floor/ceiling assemblies to maintain the fire separation.

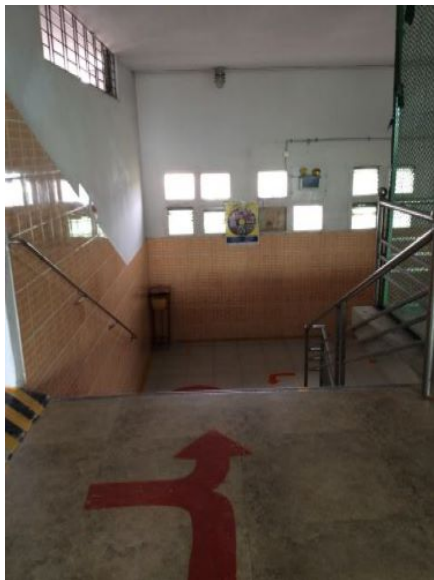
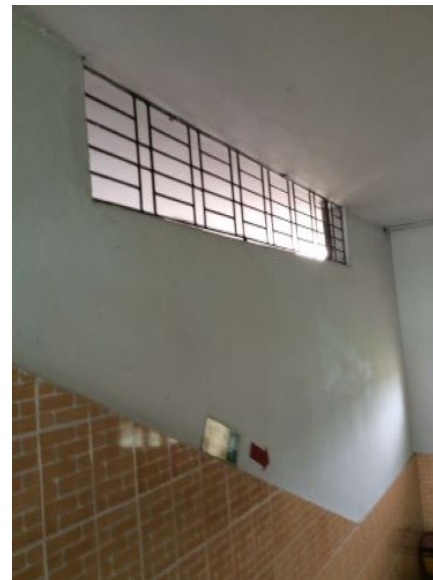
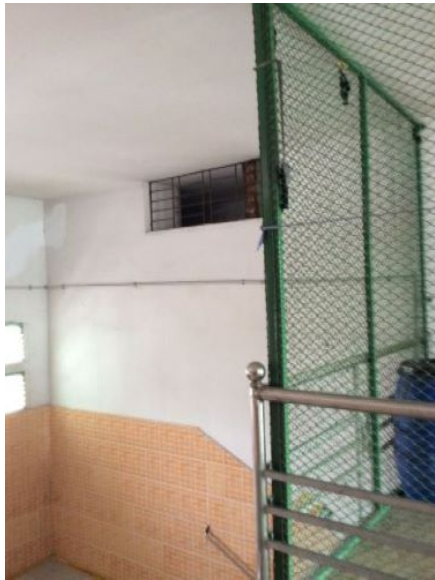
F-5	Fire Rated Construction	Unsealed penetrations and openings are located in exit stair enclosures.	Seal all penetrations and openings in exit stair enclosure walls to maintain the fire separation.	Within 3 months
-----	-------------------------	--	---	-----------------

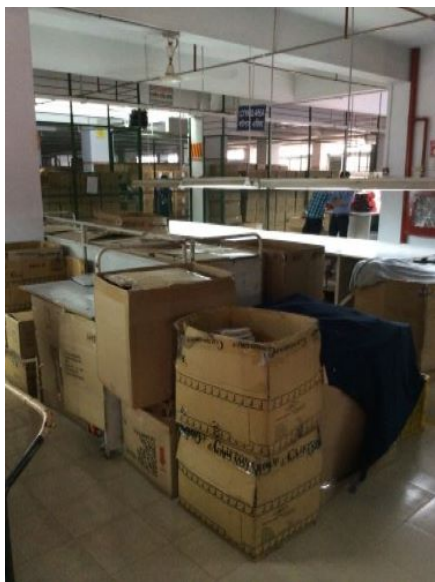
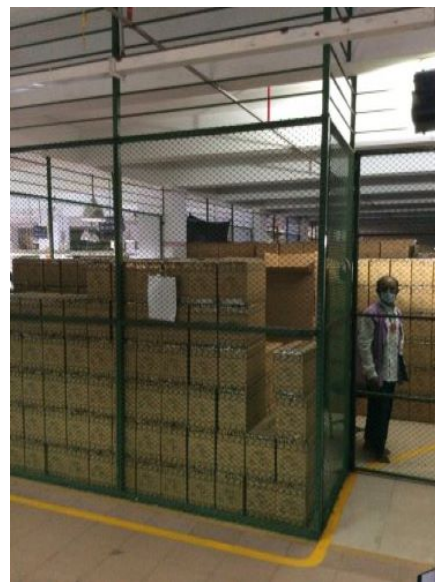
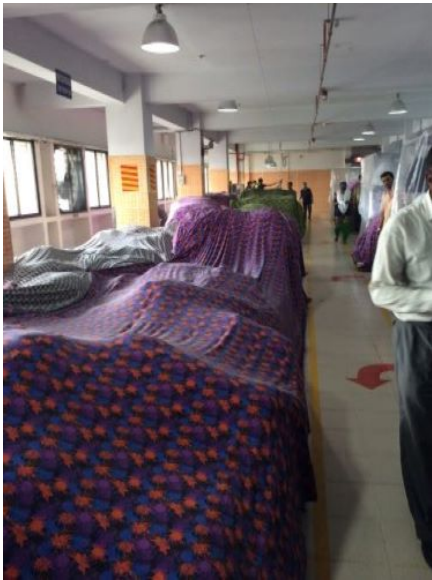
F-6	Fire Rated Construction	Areas used for combustible storage are not separated by fire-rated construction on ground, 1st, 2nd, 3rd, 4th and 5th floors .	Provide dedicated storage rooms separated by minimum 1-hr fire-rated construction.	Within 3 months
-----	-------------------------	--	--	-----------------

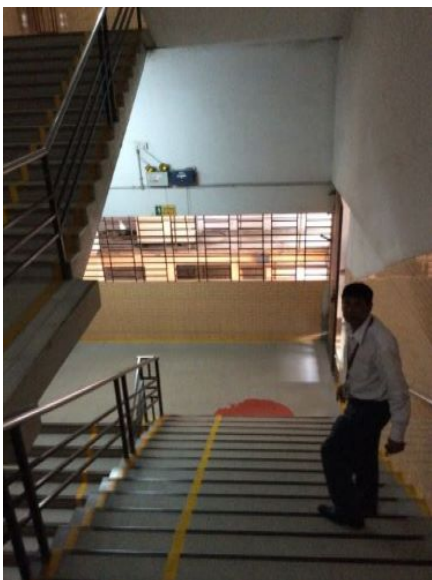
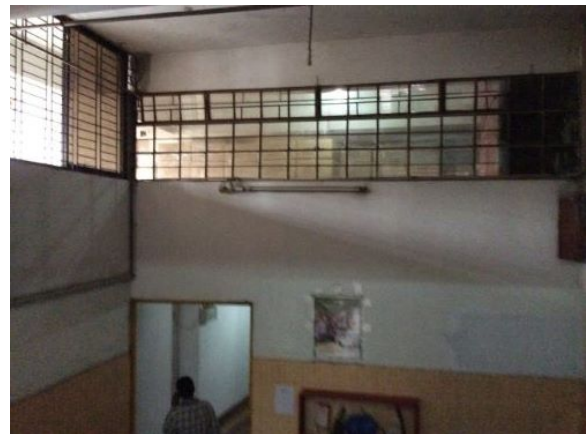
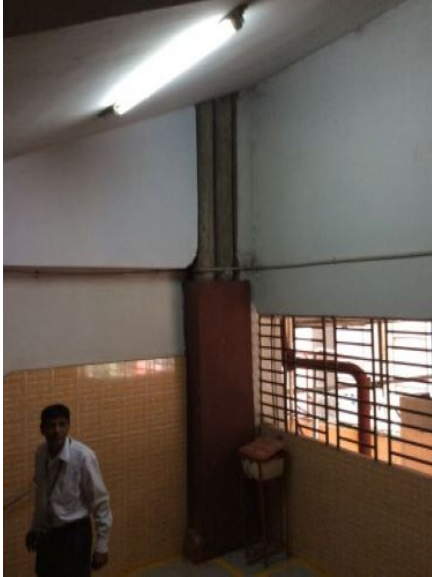
F-7	Fire Rated Construction	Unsealed penetrations and openings are located in exit stair enclosures.	Seal all penetrations and openings in exit stair enclosure walls to maintain the fire separation.	Within 3 months
-----	-------------------------	--	---	-----------------

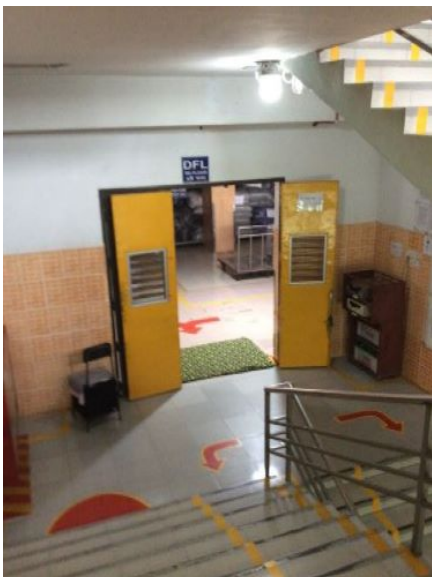
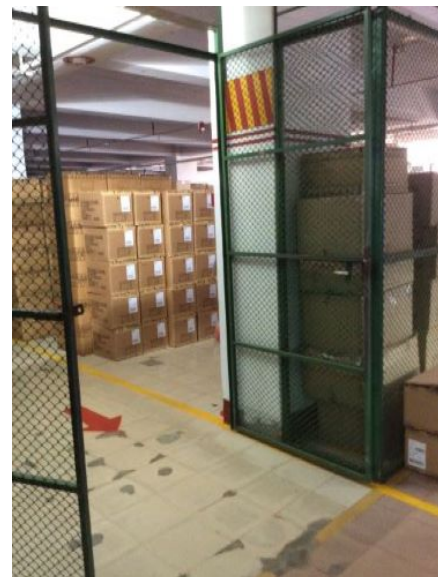
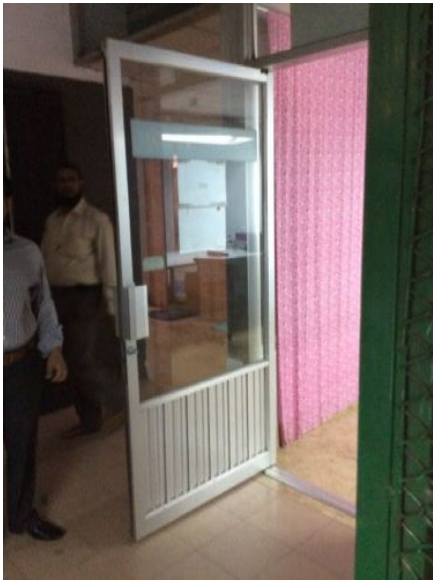
F-8	Egress	Egress doors / gates with locking features are provided at building exits, exit stairs, along egress routes, exit discharge in the north exit stairs on all floors. All gates/doors are open and unlocked during inspection.	Remove locking features from all egress doors / gates. If locks are required for security reasons, utilize special door locking features complying with NFPA 101.	Immediate
-----	--------	--	--	-----------

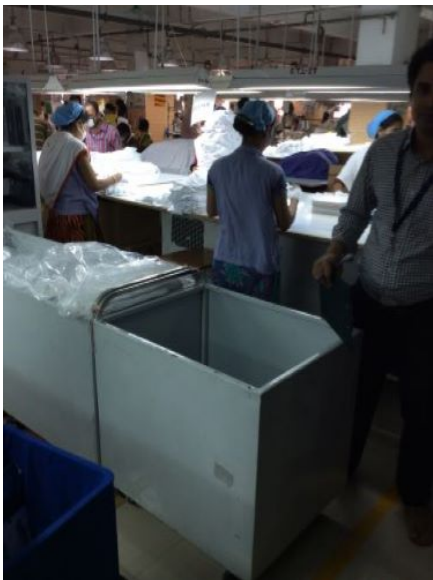
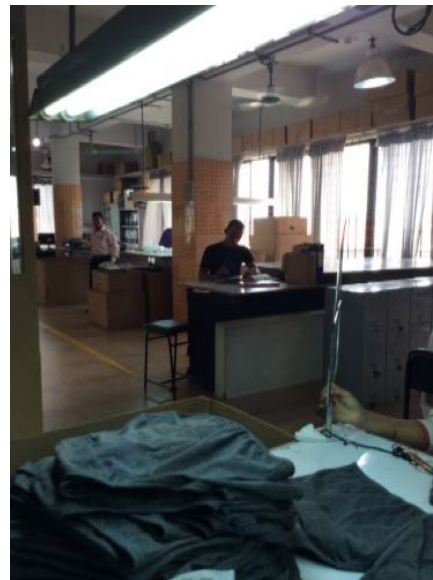
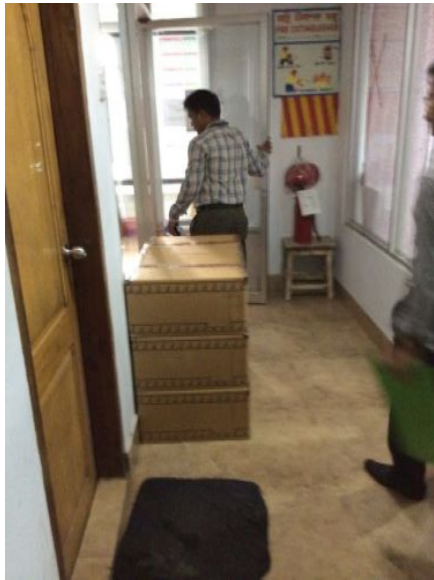
F-9	Egress	Storage was located in the egress path on 1st, 2nd, 3rd, 4th and 5th floors.	Keep egress paths and stairs clear of storage.	Immediate
-----	--------	--	--	-----------

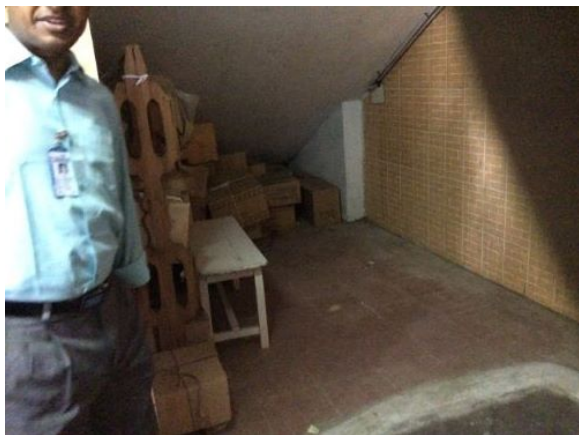
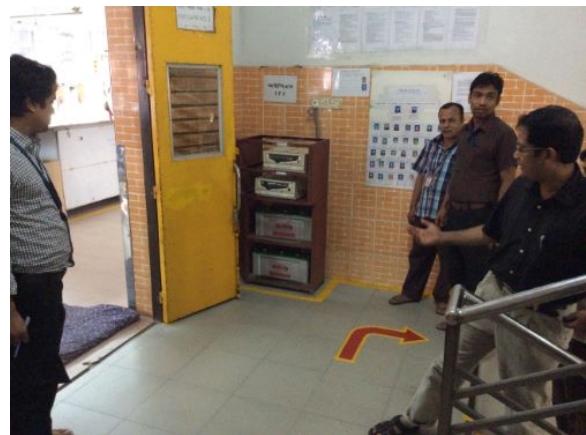
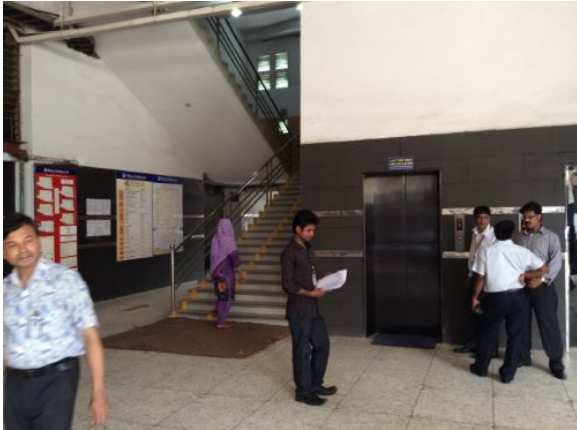
F-10 Egress

Storage was located in the north exit stair on ground and first floor.

Remove all storage from exit stairs and egress paths.
