# Radisson Casual Wear (Extension)

Sreerampur, Kalampur, Dhamrai, Dhaka.

2 March 2025

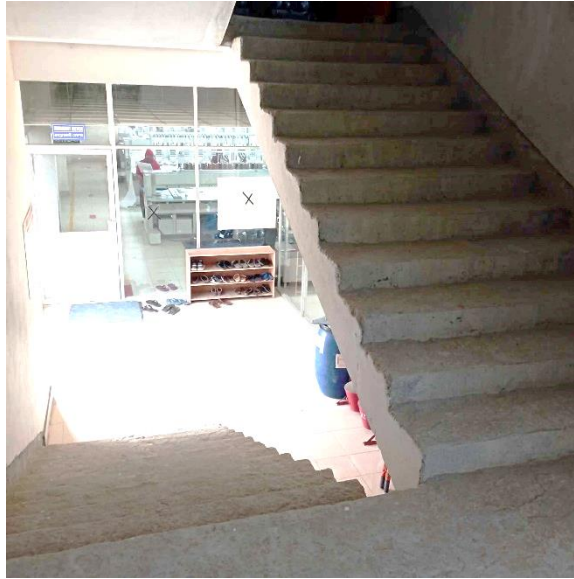
**Observation-3:** Falling hazard at the staircase (New Building).

**Description:** No railing was found at the staircase, which is prone to a falling hazard. The building engineer is required to install railing to avoid a falling hazard.

| Item No. | Observation | Action Plan | Timeline |
|---|---|---|---|
| 5. | Falling hazard at the staircase (New Building). | The building engineer is required to install railing to avoid a falling hazard. | Immediate |

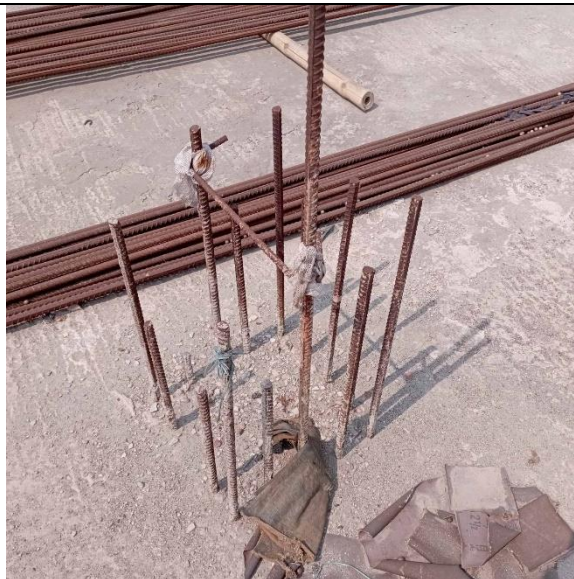
**Observation 4:** Exposed rebar at roof Level (New Building).

**Description:** Exposed reinforcement is left at roof level, which was prone to corrosion. The building engineer is required to provide rust-proof paint on exposed reinforcement to protect from corrosion.

| Item No. | Observation | Action Plan | Timeline |
|---|---|---|---|
| 6. | Exposed rebar at roof Level (New Building). | The building engineer is required to provide rust-proof paint on exposed reinforcement to protect from corrosion. | within 6 months |

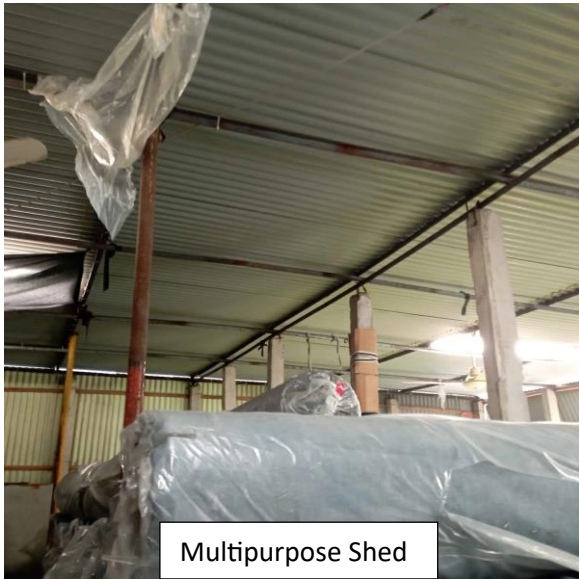
Multipurpose Shed

**Observation-5:** Lack of lateral stability and foundation details (Multipurpose Shed, Staff Dining & Kitchen).

**Description:** No bracing system is provided for these structures (strut, vertical & horizontal bracing). Also, poor connection was observed. Also, no foundation detail and as-built drawing was available. The building engineer is required to check the lateral stability with connection adequacy check and prepare a design report as per 1.9.1 BNBC.

| Item No. | Observation | Action Plan | Timeline |
|---|---|---|---|
| 7. | Lack of lateral stability and foundation detail details (Multipurpose Shed, Staff Dining & Kitchen). | The building engineer is required to check the lateral stability with connection adequacy check and prepare a design report as per 1.9.1 BNBC. | within 6 weeks |
| 8. | | Prepare as-built drawing with foundation and connection details. | within 6 weeks |
| 9. | | Implement remediation work if required. | within 6 months |

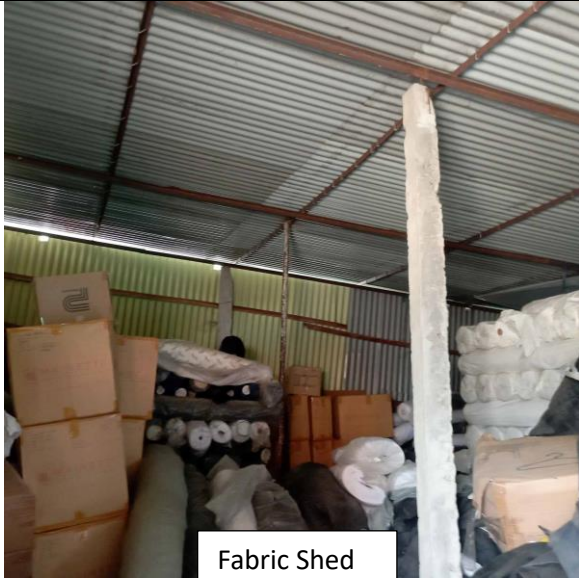
Fabric Shed

**Observation-6:** Absence of bracing system and foundation details (Fabric Shed, Wastage Shed, Leftover Store Shed).

**Description:** No bracing system is provided for these structures (strut, vertical & horizontal bracing). Poor connection was observed. Also, no foundation detail and as-built drawing was available. The building engineer is required to check the bracing requirement with connection adequacy check and prepare a safety check report.

| Item No. | Observation | Action Plan | Timeline |
|---|---|---|---|
| 10. | Absence of bracing system and foundation details (Fabric Shed, Wastage Shed, Leftover Store Shed). | The building engineer is required to check the bracing requirement, connection & foundation adequacy and prepare a safety check report. | within 6 weeks |
| 11. | | Prepare as-built drawing with foundation and connection details. | within 6 weeks |
| 12. | | Implement remediation work if required. | within 6 months |

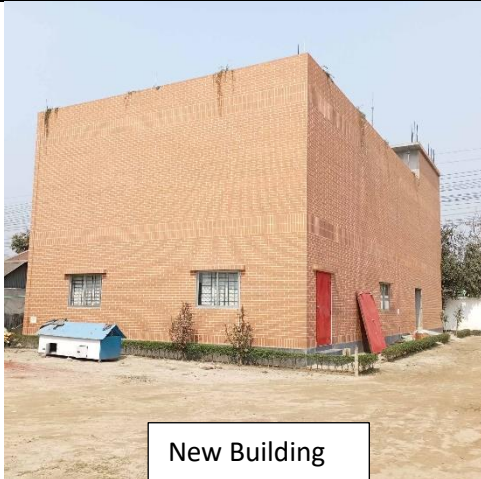
New Building

**Observation 7:** Lack of building permit layout/drawing from local authority. (All structures).

**Description:** No permit drawing was available from the local authority for any of the structure. The factory is required to collect building permits from the relevant local authority for all structures within the factory.

| Item No. | Observation | Action Plan | Timeline |
|---|---|---|---|
| 13. | Lack of building permit layout/drawing from the local authority. (All structures). | The factory is required to collect building permit layout/drawing from the relevant local authority for all structures within the factory. | within 6 months |
