# Technical Apparels (Pvt.) Limited.

Plot 01, Sector 7, CEPZ, Chattogram

15 April 2025

## 2. Observations

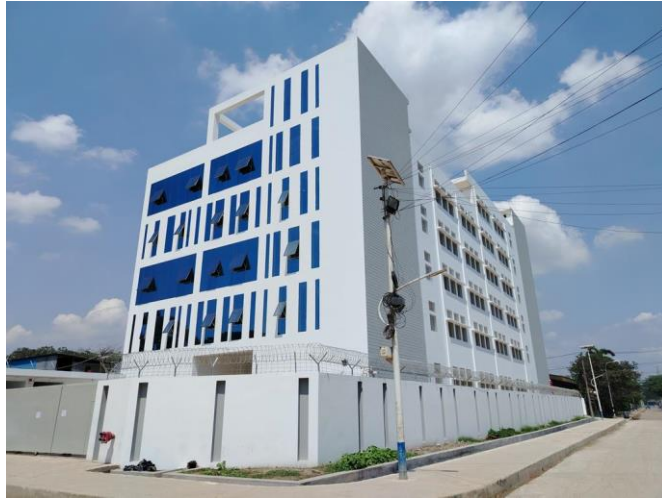
### Observation-1: Lack of design documents and load plan (Factory Building)

**Description:** As per BNBC, every building or structure designed shall have its design documents prepared under the provisions of Section 1.9. The design document shall include a design report and a set of structural drawings, which shall be prepared in compliance with section 1.9.2 and section 1.9.3 as per BNBC 2020.

At the time of inspection, the design report, floor load plan & sufficient material test report were not available. Building engineer is required to prepare a set of design documents, including design report, as-built drawings and a floor load plan in compliance with BNBC based on in-situ material strength.

| Item No. | Observation | Action Plan | Timeline |
|---|---|---|---|
| 1. | Lack of design documents and load plan (Factory Building) | Verify in-situ material strength for concrete by taking 100 mm diameter minimum 4 nos. from columns and 4 nos. from beam/slab. | within 6 weeks |
| 2. | | Produce floor live load plan for all floor plates following BNBC requirements and based on column & foundation capacity. | within 6 weeks |
| 3. | | The building engineer is required to prepare a set of design documents in compliance with BNBC 2020 based on the floor load plan and in-situ material strength. | within 6 weeks |
| 4. | | Carry out suggested remedial works if required | within 6 months |

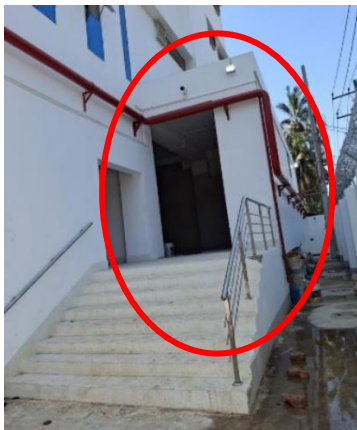
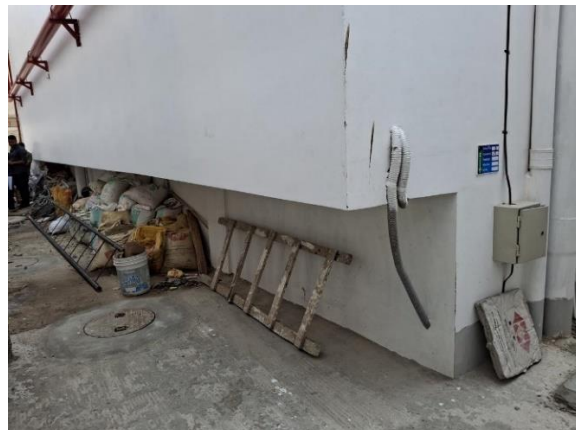
### Observation-2: Connection between extension part and septic tank walls (Factory Building)

**Description:** The stair and substation portion of the building has been constructed as an extension, projecting outward from the main building structure. This extension is connected to the adjacent septic tank using reinforced concrete (RC) walls and short columns.

The extension's grade beam is supported by RC short columns that extend down to the ground level (GL).

However, the vertical building columns above this grade beam are not aligned with these short columns; instead, they are supported either from different locations or from a cantilever slab.

Given this unconventional structural configuration, particularly the reliance on the septic tank structure for support, the connection between the building extension and the RC walls of the septic tank must be thoroughly investigated and structurally evaluated to ensure safety, stability, and compliance.

| Item No. | Observation | Action Plan | Timeline |
|---|---|---|---|
| 5. | Connection between the extension part and the septic tank walls (Factory Building) | Incorporate the adequacy check of the connection between the extension part and the septic tank walls (Factory Building) | within 6 weeks |
| 6. | | Carry out suggested remedial works if required | within 6 months |

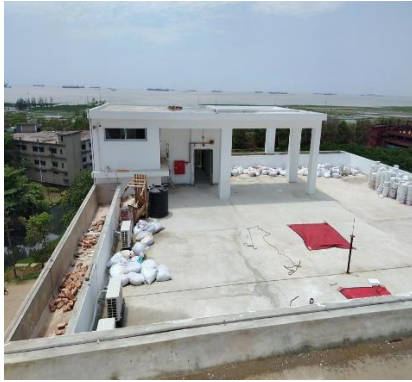
Additional brick wall & build-up for roof gardening provision

**Description:** Additional brick walls at the roof gardening and build up at the roof gardening & toilet area, two PVC water tanks (1000 litre at 5<sup>th</sup> floor dining, 2000 litre near RC OHWR) were not mentioned in the as-built architectural drawing.

| Item No. | Observation | Action Plan | Timeline |
|---|---|---|---|
| 7. | Discrepancies in the as-built drawing (Factory Building) | The building engineer is required to survey the whole structure and update the as-built drawings as per site conditions. | within 6 weeks |

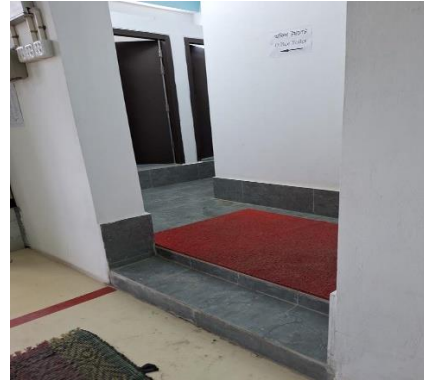
Buildup at the toilet zone

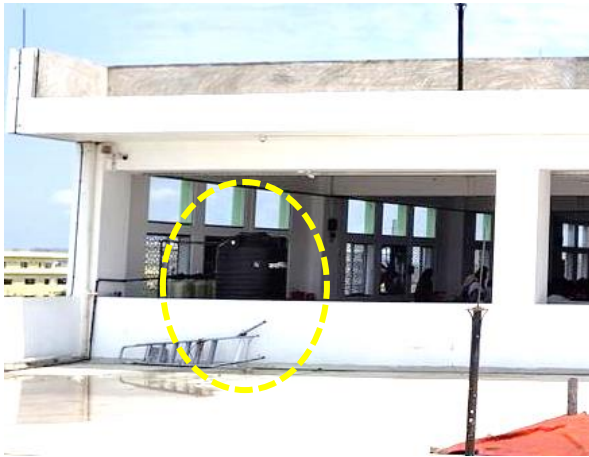
1000 litre PVC water tank

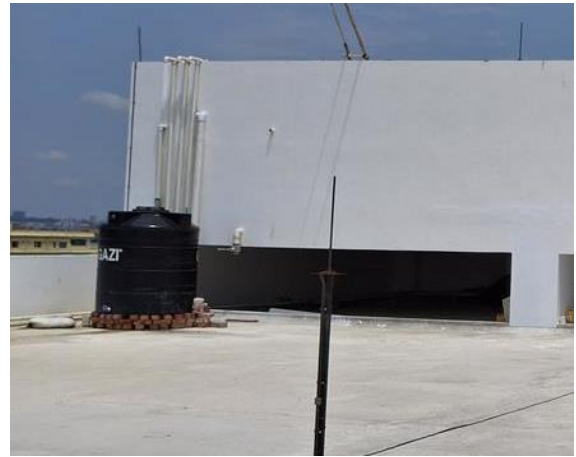
2000 litre PVC water tank

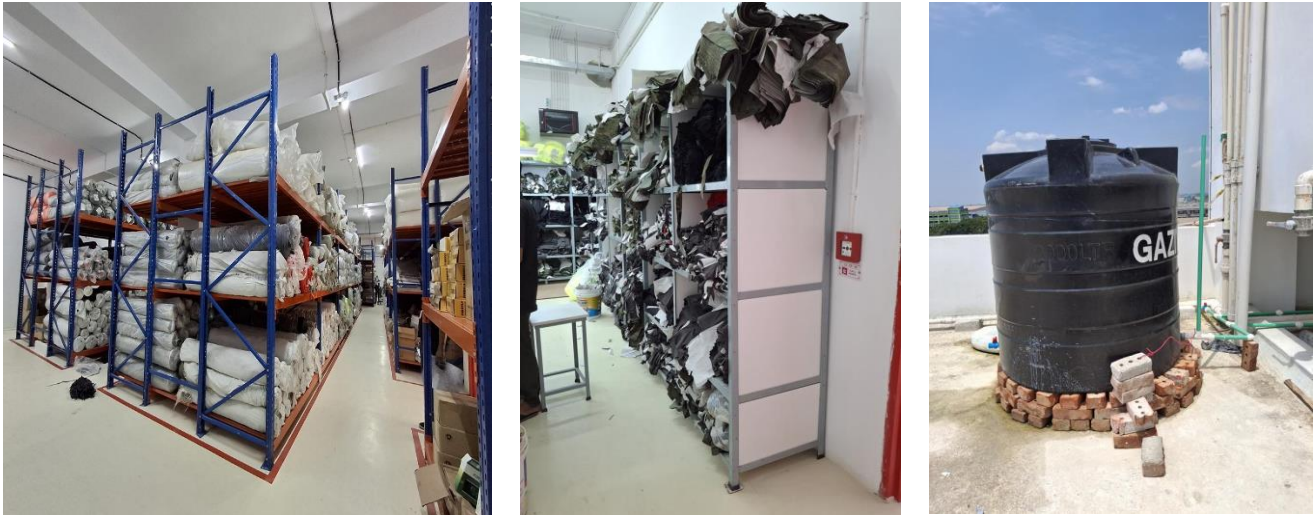
**Observation-4: Non-structural elements found unbraced/not anchored (Factory Building)**

**Description:** Unbraced and unanchored steel storage racks were found on several floors, and PVC water tanks were found unbraced on the 5<sup>th</sup> floor dining area and beside the RC overhead water tank.

| Item No. | Observation | Action Plan | Timeline |
|---|---|---|---|
| 8. | Non-structural elements found unbraced/not anchored (Factory Building) | The factory is required to brace/anchor all non-structural elements (storage racks) to prevent falling during earthquake. | within 6 months |

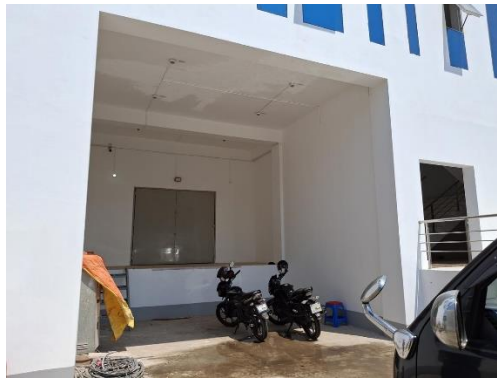
**Observation-5: Column susceptible to vehicle impact (Factory Building)**

**Description:** The columns at the ground floor loading-unloading zone are susceptible to vehicle impact. The factory is required to provide separate safety barriers around the columns to protect from possible vehicle impact.

| Item No. | Observation | Action Plan | Timeline |
|---|---|---|---|
| 9. | Column susceptible to vehicle impact (factory Building) | The building engineer is required to provide separate barriers around the column to protect the column from possible vehicle impact. | within 6 months |

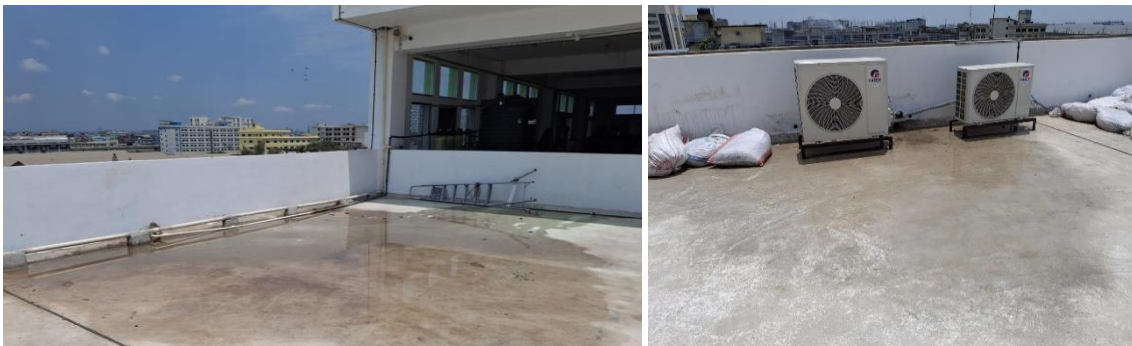
**Observation-6: Water ponding (Factory Building)**

**Description:** Water ponding was found on the roof. The building engineer is required to improve the roof drainage system by providing an adequate number of outlets and developing adequate slope.

| Item No. | Observation | Action Plan | Timeline |
|---|---|---|---|
| 10. | Water ponding (Factory Building) | The building engineer is required to improve the roof drainage system by providing an adequate number of outlets and developing a proper slope. | within 6 months |

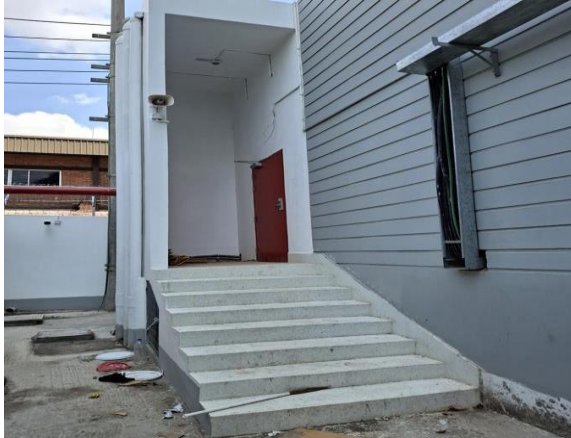
Factory Building

**Description:** The ground floor stairs were found without railings. The factory is required to install appropriate railings to prevent fall hazards.

| Item No. | Observation | Action Plan | Timeline |
|---|---|---|---|
| 11. | Falling hazard/lack of railing (Both structures) | The factory is required to install appropriate railings to prevent fall hazards. | within 6 weeks |

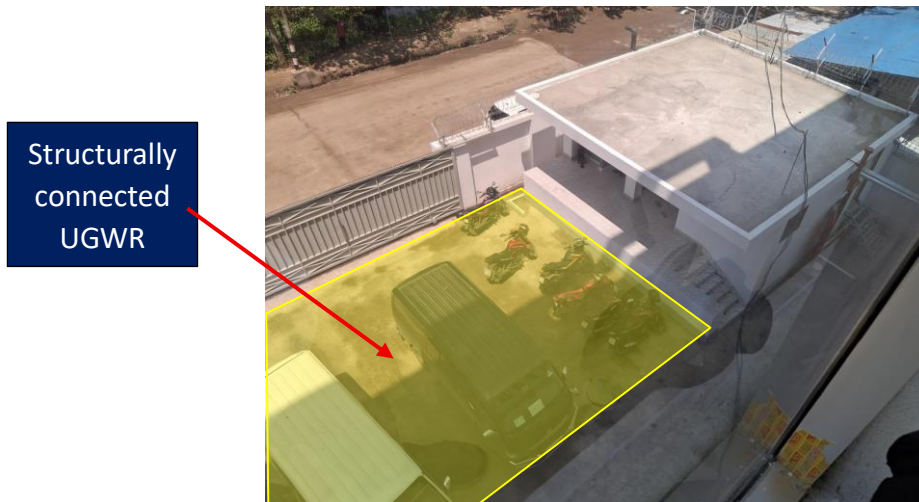
Structurally  
connected  
UGWR

**Description:** As per BNBC, every building or structure designed shall have its design documents prepared in accordance with the provisions of Section 1.9. The design document shall include a design report and a set of structural drawings, which shall be prepared in compliance with section 1.9.2 and section 1.9.3 as per BNBC 2020.

At the time of inspection, as-built drawings and design report were not available. The building engineer is required to prepare a set of design documents in compliance with BNBC based on current loading conditions.

| Item No. | Observation | Action Plan | Timeline |
|---|---|---|---|
| 12. | Lack of design documents (Security & Fire Pump Room) | The building engineer is required to prepare a set of design documents in compliance with BNBC based on the vehicle loading conditions. | within 6 weeks |
| 13. | | Carry out suggested remedial works if required | within 6 months |
