# BOILER SAFETY REPORT

**Four H Apparels Ltd.**

**Factory ID: 10377**

**Boiler Registration Numbers** : BB 13128, BB 13129

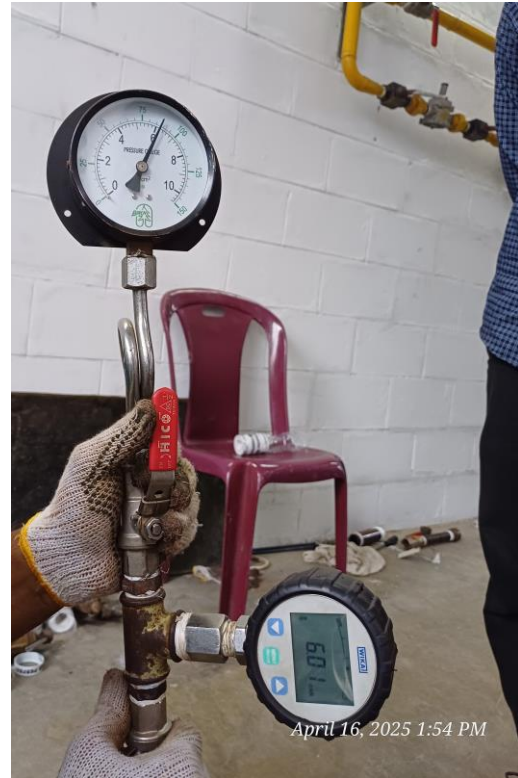
| <b>FINDING NO:</b> | B-3 |

| <b>FINDING:</b><br><br>The steam pressure gauge range was insufficient. | |

| <b>RECOMMENDATION:</b><br><br>The boiler pressure gauge range should be at least twice the boiler's maximum allowable working pressure mentioned in the boiler license or in accordance with any recognized international standard. | |

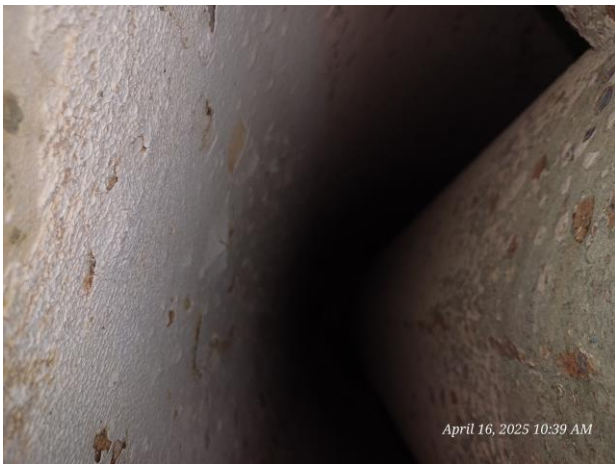
| FINDING NO: | | B-4 | |

| FINDING:<br><br>Salt and thin scale (2 mm) formation was observed on the waterside on shell surface. | | | |

| RECOMMENDATION:<br><br>Cleaning is required. A water treatment station is to be used. Feed and boiler water quality and conditioning should be verified and monitored. The boiler operator should operate the boiler with proper blowdown. | | | |
