RGR Sweater Ltd (Extention-02)

Madhokala, Sreepur, Gazipur 1740

17 April 2025

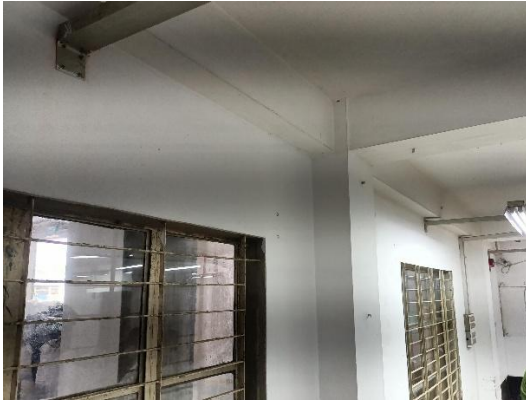
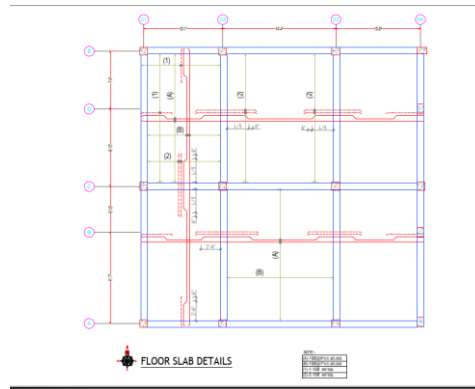
Observation 01: Lack of information in drawings. (Yarn Distribution Counter part-1,)

Description: Slab thickness was not found in the provided as-built drawings. Building engineer is required to revise the drawings with complete structural details and submit to RSC.

Item No	Observation	Action Plan	Timeline
1.	Lack of information in drawings. (Yarn Distribution Counter part-1)	Building engineer is required to revise the drawings with complete structural details and submit to RSC.	within 6 weeks

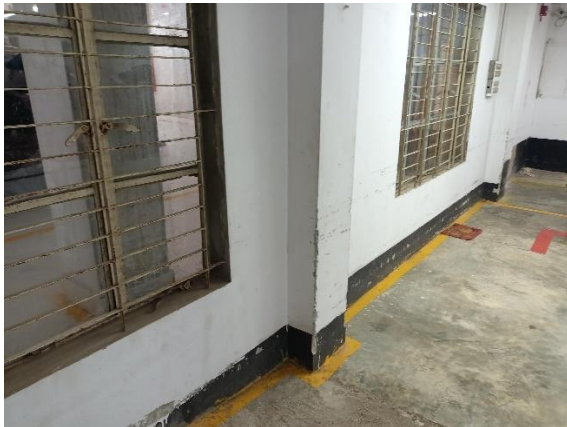
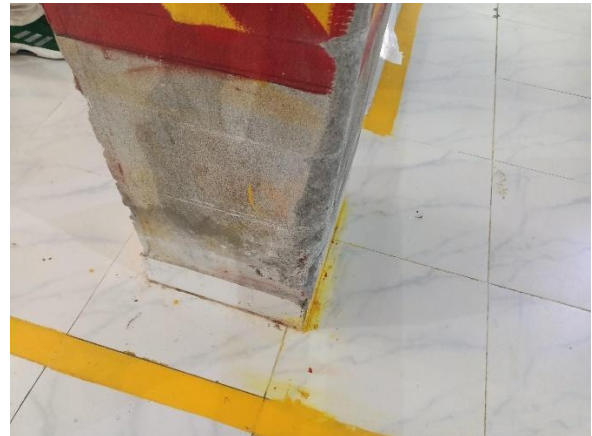
Observation 02: Trolley impact on columns. (Yarn Distribution Counter part-1, 2)

Description: Column surfaces were damaged due to trolley movement. Building engineer is required to provide guard to protect columns from trolley impact.

2.	Trolley impact on columns. (Yarn Distribution Counter part-1, 2)	Building engineer is required to provide guard to protect columns from trolley impact.	within 6 weeks

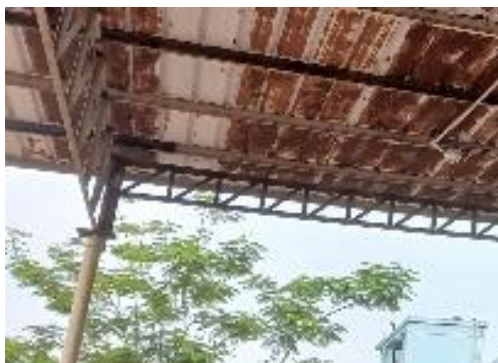
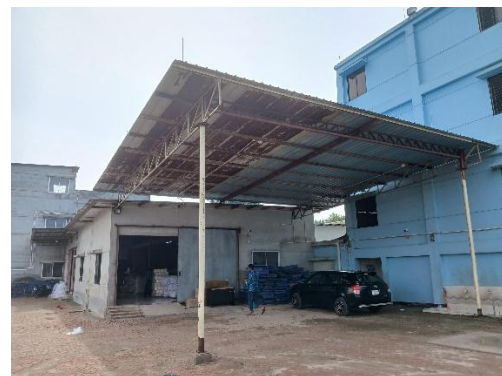
Observation 03: Improper connection of truss. (Canopy-1)

Description: Improper connection between truss and steel column was found. Building engineer is required to check the connection adequacy as part of a safety check report and submit to RSC.

3.	Improper connection of truss. (Canopy-1)	Building engineer is required to check the connection adequacy as part of safety check report and submit to RSC.	within 6 weeks

4.	Improper connection of truss. (Canopy-1)	Carry out remedial work if required.	within 6 months
5.	Mismatch in as-built drawings. (Yarn Distribution Counter part-2)	The building engineer is required to revise the as-built drawings and submit to RSC.	within 6 weeks

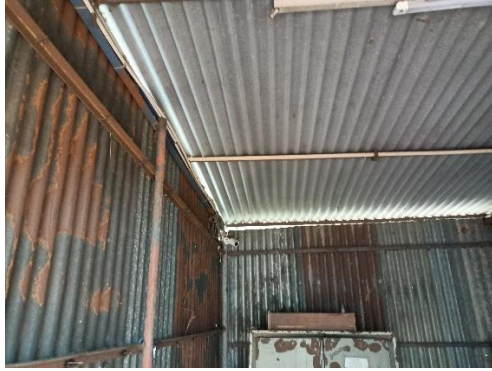
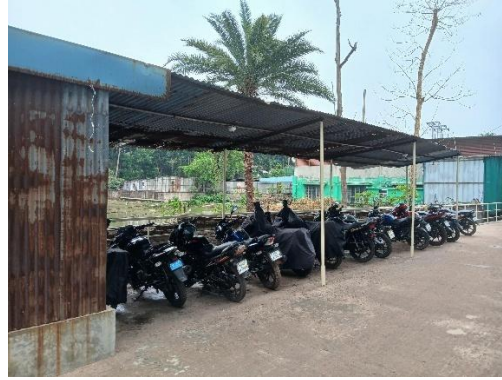
Observation 07: Improper connection between angle and pipe column. (Wastage Store Shed)

Description: Improper connection between angle and pipe column was found in several locations. Building engineer is required to check the connection adequacy as part of safety check report and submit to RSC.

9.	Improper connection between angle and pipe column. (Wastage Store Shed)	Building engineer is required to check the connection adequacy as part of safety check report and submit to RSC.	within 6 weeks

10.	Improper connection between angle and pipe column. (Wastage Store Shed)	Carry out remedial work if required.	within 6 months
11.	Incomplete as-built drawings. (Staff/Workers dining & kitchen Shed)	The building engineer is required to revise the as-built drawings and submit to RSC.	within 6 weeks

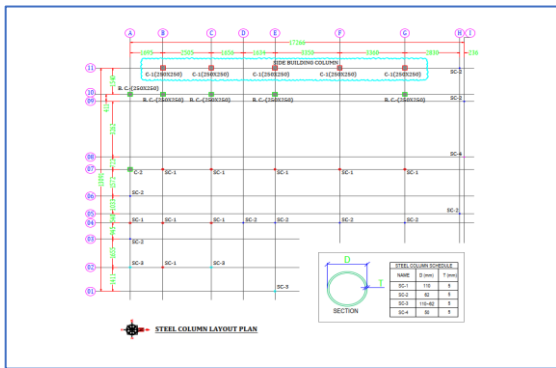
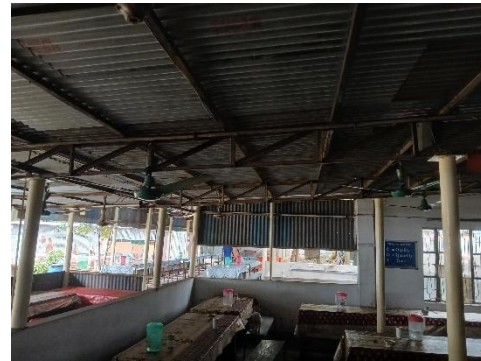
Observation 08: Incomplete as-built drawings. (Staff/Workers dining & kitchen Shed)

Description: Full area of the shed was not covered in the structural drawings. Also, connection details were not found in drawings. The building engineer is required to revise the as-built drawings and submit to RSC.

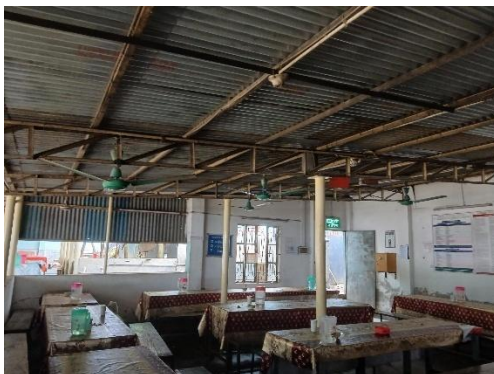
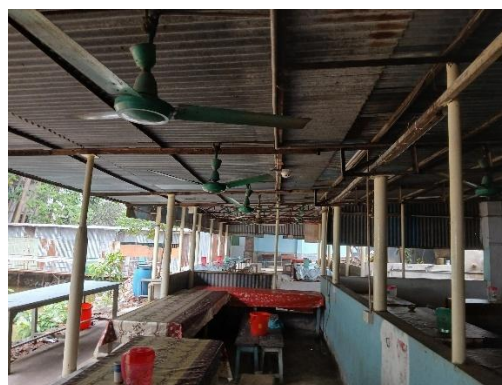
Observation 09: Improper connection between truss and pipe column (Staff/Workers dining & kitchen Shed)

Description: Improper connection between angle and pipe column was found in several locations. Building engineer is required to check the connection adequacy as part of engineering assessment and submit to RSC.

12.	Improper connection between truss and pipe column (Staff/Workers dining & kitchen Shed)	Building engineer is required to check the connection adequacy as part of engineering assessment and submit to RSC.	within 6 weeks

13.	Improper connection between truss and pipe column (Staff/Workers dining & kitchen Shed)	Carry out remedial work if required.	within 6 months
14.	Mismatch in as-built drawings. (Fire pump room)	The building engineer is required to revise the as-built drawings and submit to RSC.	within 6 weeks

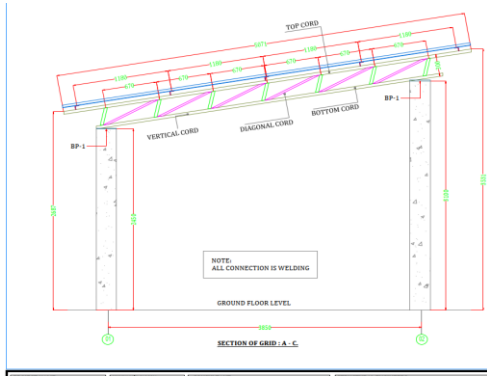
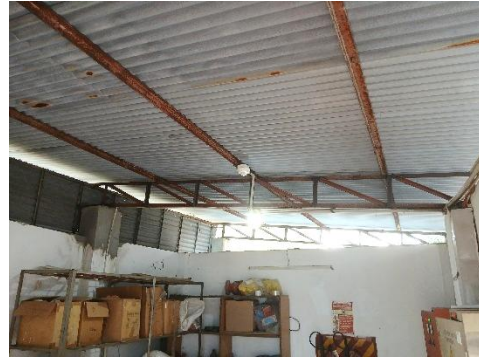
Observation 10: Mismatch in as-built drawings. (Fire pump room)

Description: All sectional and connection details were not found in drawings. The building engineer is required to revise the as-built drawings and submit to RSC.

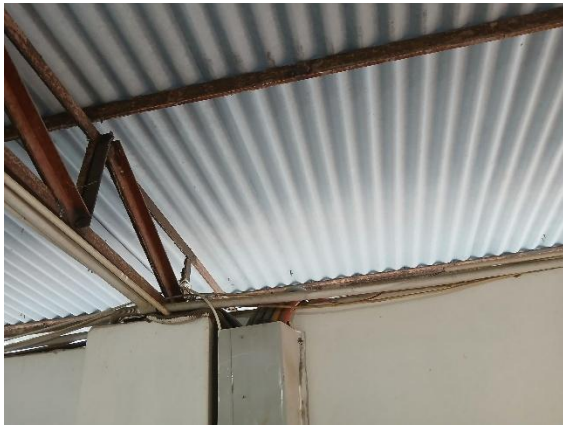
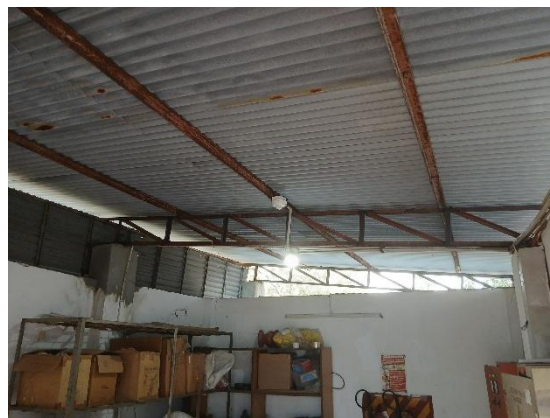
Observation 11: Improper connection between truss and RC column. (Fire Pump Room)

Description: Improper connection between angle and pipe column was found in several locations. Building engineer is required to check the connection adequacy as part of safety check report and submit to RSC.

15.	Improper connection between truss and RC column. (Fire Pump Room)	Building engineer is required to check the connection adequacy as part of safety check report and submit to RSC.	within 6 weeks

16.	Improper connection between truss and RC column. (Fire Pump Room)	Carry out remedial work if required.	within 6 months
17.	Load plan and design report does not comply with BNBC. (Linking Building)	Building engineer is required to update the floor load plan along with design report and submit to RSC.	within 6 weeks

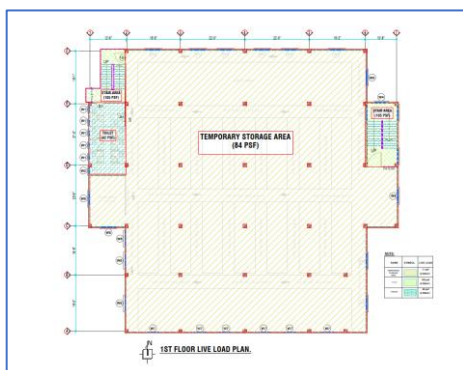
Observation 12: Load plan and design report does not comply with BNBC. (Linking Building)

Description: In storage areas floor loading was consider 84 psf which is not comply with BNBC 2020. Also, concrete material strength was considered 3500 psi but sufficient test report was not found. Building engineer is required to update the floor load plan along with design report and submit to RSC.

18.	Load plan and design report does not comply with BNBC. (Linking Building)	Verify in-situ test from each class of concrete.	within 6 weeks
19.	Load plan and design report does not comply with BNBC. (Linking Building)	Carry out remedial work if required.	within 6 months

20.	Load plan and design report does not comply with BNBC. (Linking Building)	Implement floor load plan.	within 6 months
21.	Lack of drawings for adjacent Steel stair and Fire Control Room. (Linking Building)	The building engineer is required to prepare a full set of as-built drawings and submit to RSC.	within 6 weeks

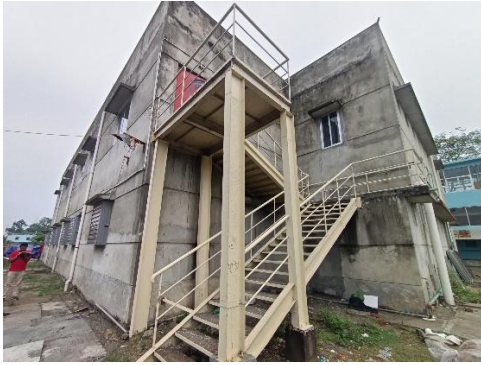
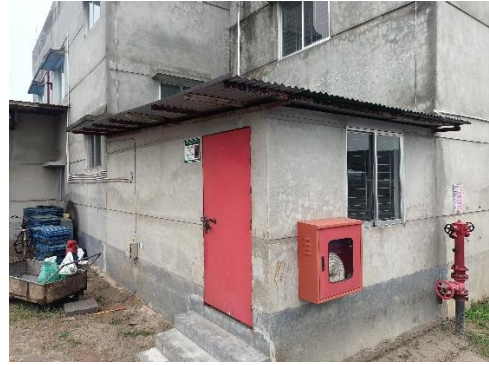
Observation 13: Lack of drawings for adjacent Steel stair and Fire Control Room. (Linking Building)

Description: As-built drawings were not found for adjacent external steel stair and Fire Control Room. The building engineer is required to prepare a full set of as-built drawings and submit to RSC.

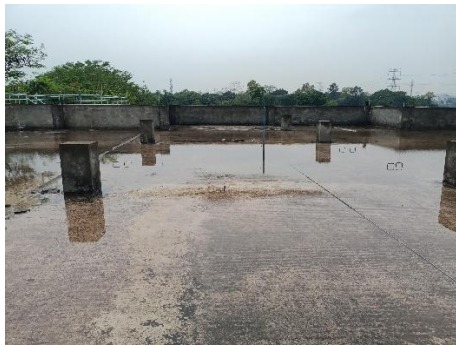
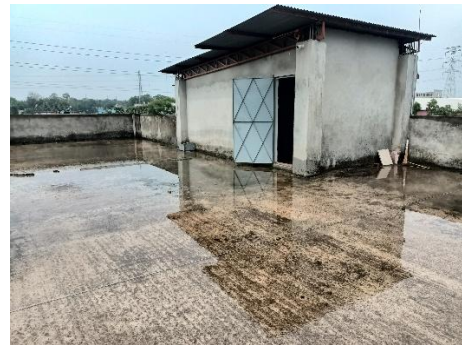
Observation 14: Water clogging on roof. (Linking Building)

Description: Stagnant water on the roof was found during the inspection. The roof was constructed by MCAC. Building engineer is required to provide water proofing layers and improve drainage system.

22.	Water clogging on roof. (Linking Building)	Building engineer is required to provide water proofing layers and improve drainage system.	within 6 months

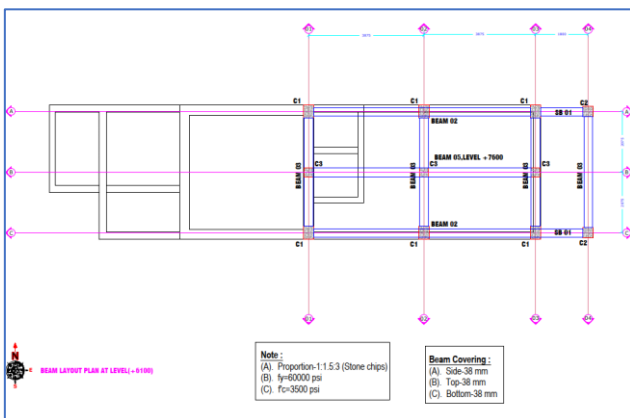
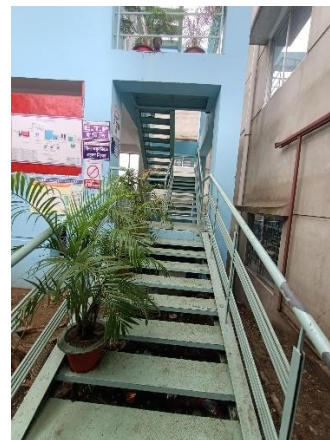
Observation 15: Lack of information in as built drawings. (ETP Building)

Description: Beam layout do not fully match with the as-built conditions. Also, no details were found for the steel portion stair. The building engineer is required to prepare a full set of as-built drawings and submit to RSC.

23.	Lack of information in as built drawings. (ETP Building)	The building engineer is required to prepare a full set of as-built drawings and submit to RSC.	within 6 weeks

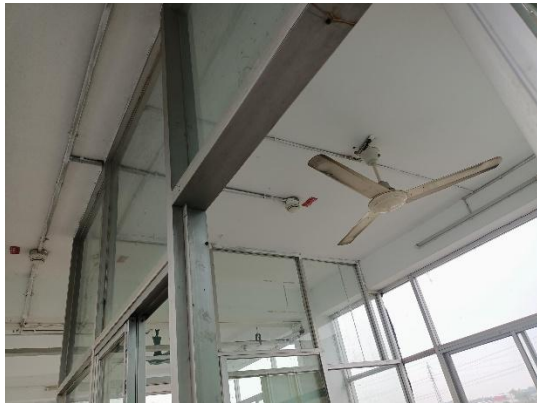
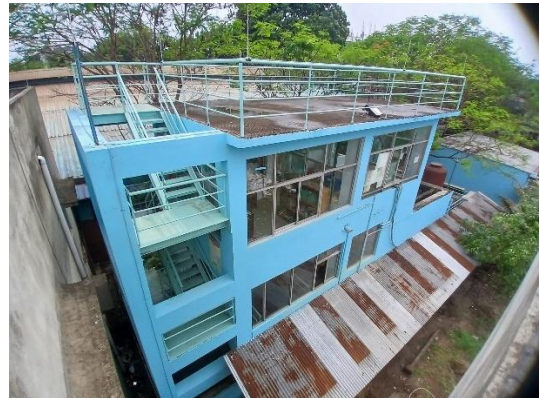
Observation 16: Lack of design report. (ETP Building)

Description: As per BNBC, every building or structure designed shall have its design documents prepared following the provision of Section 1.9.1. The design document shall include a design report and a structural drawing. At the time of inspection, no design reports were available which are required to be prepared in compliance with section 1.9.1.1 and section 1.9.1.2 (part 6, BNBC).

24.	Lack of design report. (ETP Building)	Prepare design report for the structure as per section 1.9.1 of BNBC.	within 6 weeks
25.	Lack of design report. (ETP Building)	Implement the recommendations of the design report.	within 6 months
