Genesis Fashions Ltd. (Extension-2)

Madhokala, Sreepur, Gazipur 1740

21 April 2025

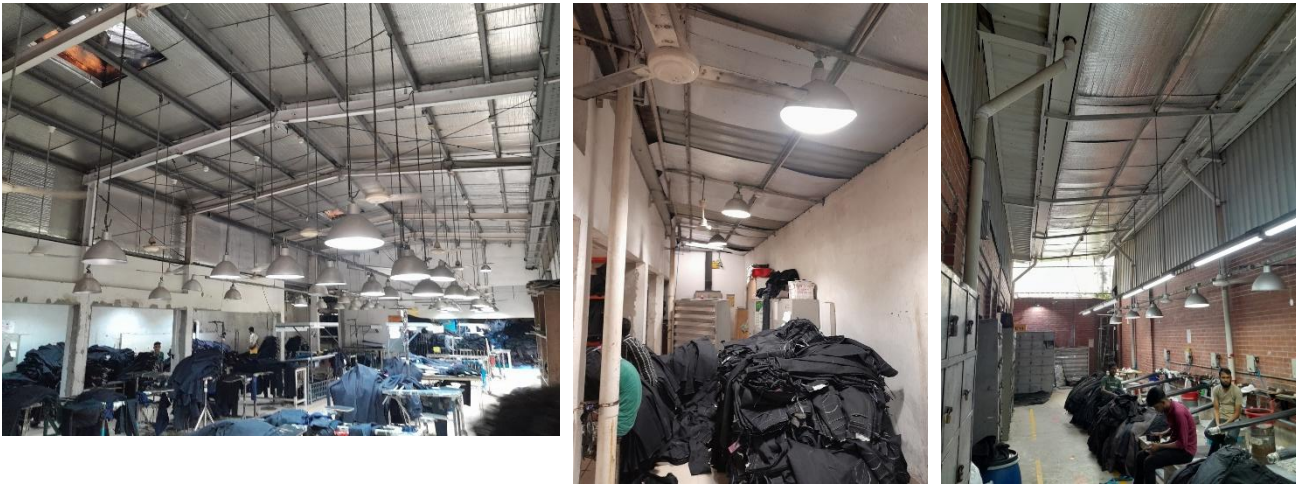
Observation-01: Lack of Stability System. (Whisker Shed)

Description: Lack of lateral stability system observed in the shed (Missing Compression Strut, inadequate bracing), also a non-engineered extension observed.

Building engineer is required to check the lateral stability of the shed as per the Detailed Engineering Assessment (DEA)

Item No	Observation	Action Plan	Timeline
1.	Lack of Stability System. (Whisker Shed)	Building engineer is required to check the lateral stability of the shed as per of the Detailed Engineering Assessment (DEA)	within 6 weeks

2.		Carry out the suggested remedial works if required.	within 6 months
3.	Lack of As-built drawing. (Whisker Shed)	Building engineer is required to survey the structure and prepare a detailed, accurate as-built drawing.	within 6 weeks

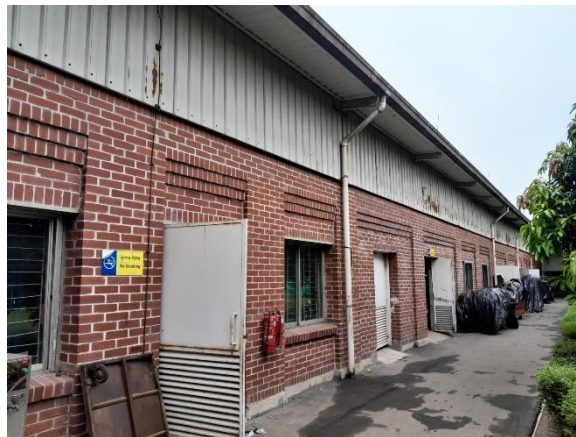
Observation-02: Lack of As-built drawing. (Whisker Shed)

Description: No as-built drawings were available onsite. Building engineer is required to prepare detailed and accurate as-built drawings.

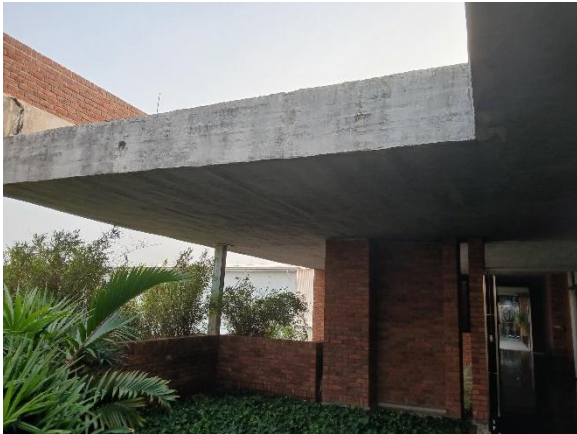
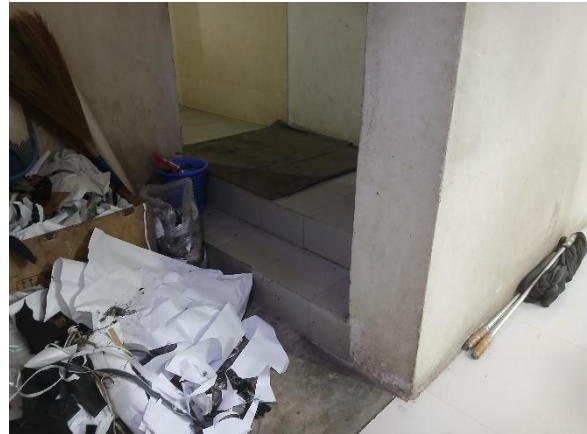
Observation-03: Lack of information in the as-built drawing. (Annex Building)

Description: Lack of information on the as-built drawings (Mismatch in roof column layout plan, floor built not shown). Building engineer is required to prepare accurate and detailed as-built drawings, including a column layout plan, toilet build-up on the floor.

4.	Lack of information in the as-built drawing. (Annex Building)	Building engineer is required to prepare accurate and detailed as-built drawings, including a column layout plan, toilet build-up on the floor.	within 6 weeks

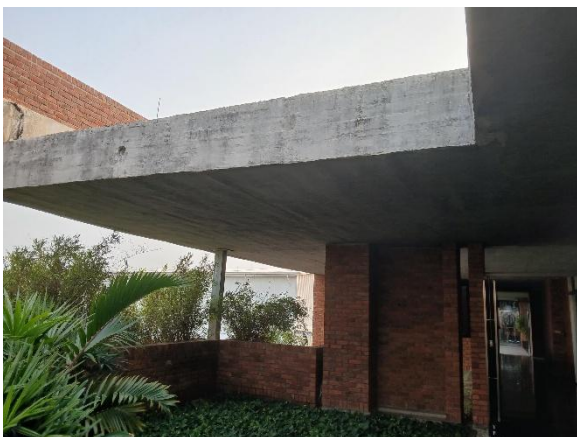
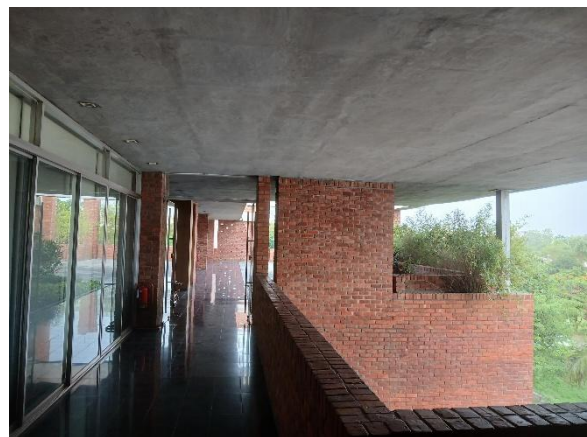
Observation-04: Deflection of Roof slab (Long Span column cut for Architectural purposes). (Annex Building)

Description: Column cut for Architectural purposes, long span found on the roof. Building engineer is required to check the deflection of the long-span beam and slab.

5.	Deflection of Roof slab (Long Span column cut for Architectural purposes). (Annex Building)	Building engineer is required to check the deflection of the long-span beam and slab.	within 6 weeks

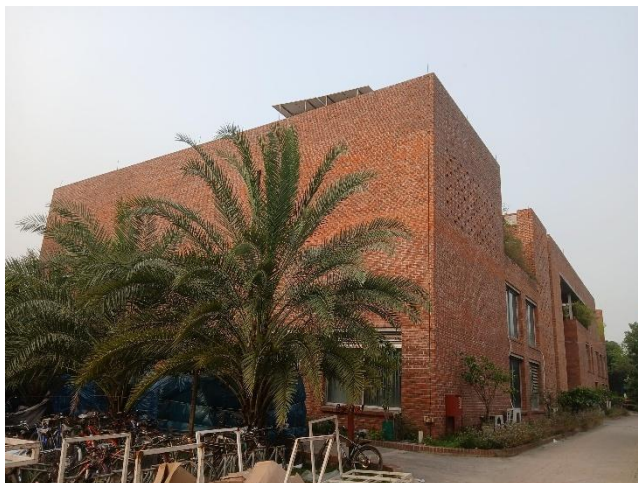
Observation-05: Lack of Design Report and Material Test Report. (Annex Building)

Description: Lack of design report and material test report observed. The building engineer is required to prepare the design report as per BNBC 1.9.1 and check the availability of the material test report to confirm the design report. For the concrete, follow BNBC 5.12.1.

6.		Carry out the suggested remedial works if required.	within 6 months
7.	Lack of Design Report and Material Test Report. (Annex Building)	The building engineer is required to prepare the design report as per BNBC 1.9.1 and check the availability of the material test report to confirm the design report. For the concrete, follow BNBC 5.12.1.	within 6 weeks

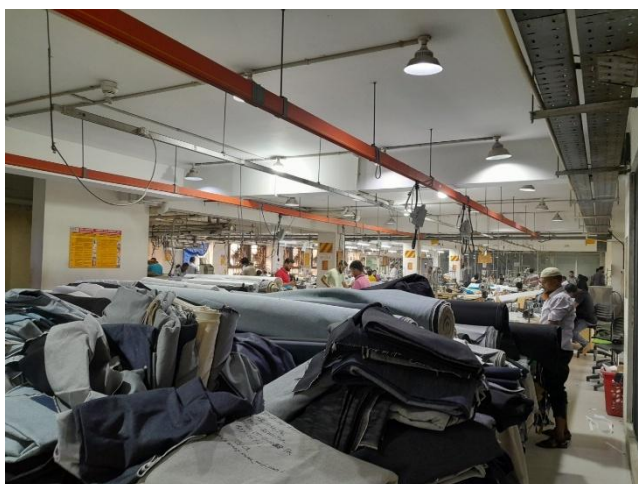
Observation-06: Load Plan Post and Implementation. (Annex Building)

Description: Load plan not posted, load restriction height marking not found on the storage area. Building engineer is required to implement floor load management program, including posting load plan, height marking on the storage area.

8.		Carry out the suggested remedial works if required.	within 6 months
9.	Load Plan Post and Implementation. (Annex Building)	Building engineer is required to implement floor load management program, including posting load plan, height markings on the storage area.	within 6 weeks

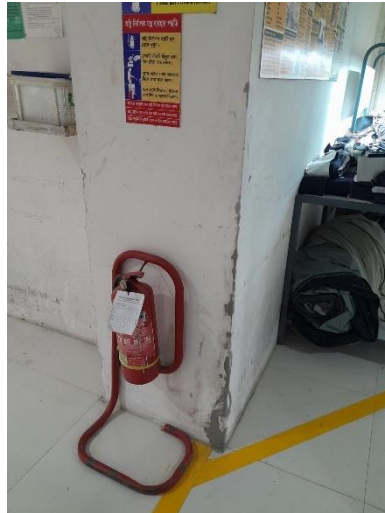
Observation-07: Trolley Impact on the column on the ground floor. (Annex Building)

Description: Trolley impact observed on the ground floor column. Building engineer is required to repair the damage and protect the columns from trolley impact.

10.	Trolley Impact on the column at the ground floor. (Annex Building)	Building engineer is required to repair the damage and protect the columns from trolley impact.	within 6 weeks

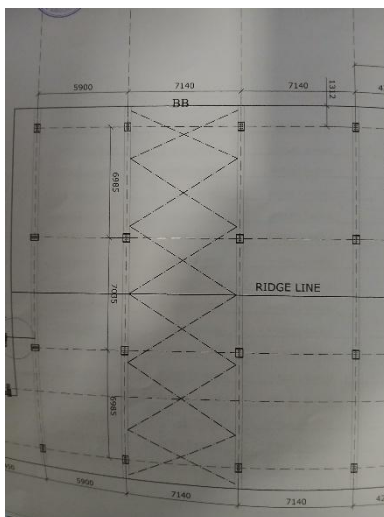
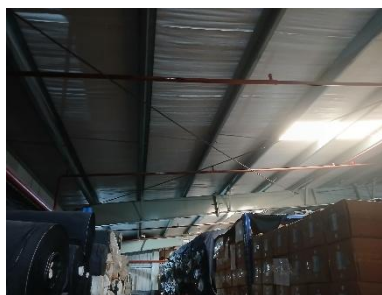
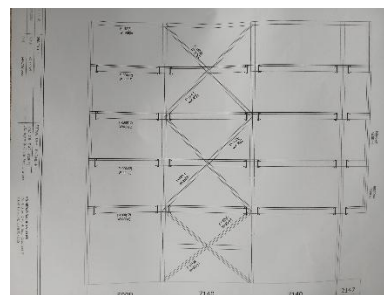
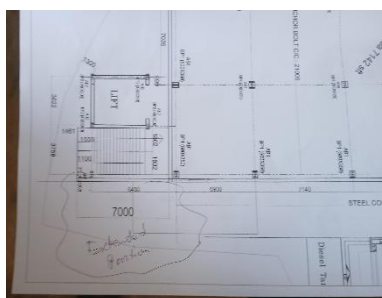
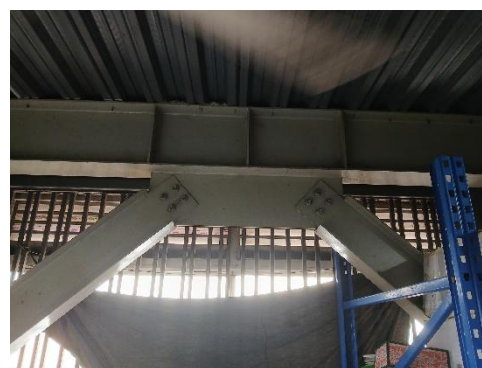
Observation-08: Lack of information in the as-built drawing. (Store Building 1)

Description: Roof bracing number and wall bracing pattern not matched with the drawing; extended portion is not shown in the drawing. Building engineers are required to prepare accurate and detailed as-built drawings including extended portions, section elevations, and bracing details.

11.	Lack of information in the as-built drawing. (Store Building 1)	Building engineer is required to prepare accurate and detailed as-built drawings, including extended portions, section elevations, and bracing details.	within 6 weeks

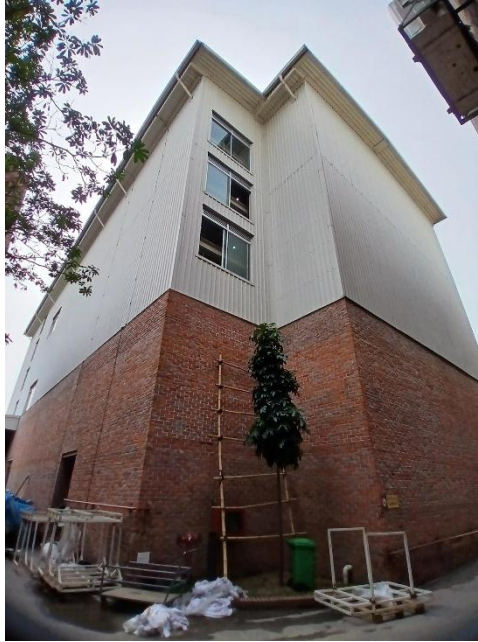
Observation-09: Lack of Design Report and Material Test Report. & Soil Test report. (Store Building 1)

Description: Design report not available, detailed design report and the structural system consideration are required to be addressed.

- The building engineer is required to prepare the design report as per BNBC 1.9.1 and check the availability of the material test report to confirm the design report. For the concrete, follow BNBC 5.12.1.
- Geotechnical investigation report is required to be prepared, and the foundation seems overstressed marginally, considering the minimum bearing capacity.

12.	Lack of Design Report and Material Test Report. & Soil Test report. (Store Building 1)	The building engineer is required to prepare the design report as per BNBC 1.9.1 and check the availability of the material test report to confirm the design report. For the concrete, follow BNBC 5.12.1.	within 6 weeks

13.		Building engineer is required to review the design load and foundation stresses.	within 6 weeks
14.		Carry out the suggested remedial works if required.	within 6 months

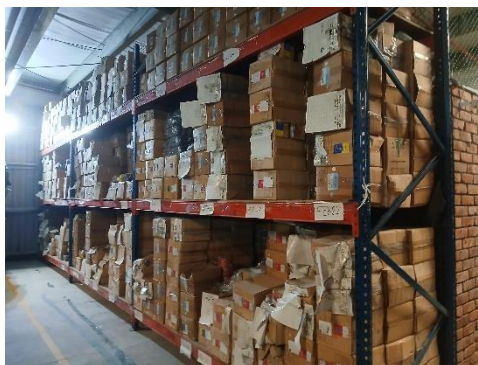
Observation-10: Load Plan Post and Implementation. (Store Building 1)

Description: Load plan not posted, load restriction height marking not found on the storage area. Building engineer is required to implement floor load management program, including posting load plan, height markings on the storage area.

15.	Load Plan Post and Implementation. (Store Building 1)	Building engineer is required to implement floor load management program, including posting load plan, height markings on the storage area.	within 6 weeks

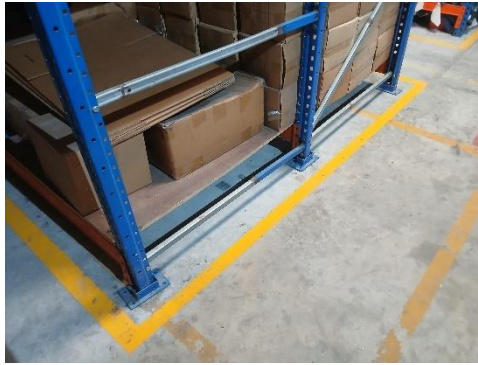
Observation-11: Anchorage of non-structural elements. (Store Building 1)

Description: Lack of anchorage was found on the storage racks. Provide anchorage on the non-structural elements.

16.	Anchorage of non-structural elements. (Store Building 1)	Provide anchorage on the non-structural elements.	within 6 weeks
17.	Lack of information in the as-built drawing. (Store Building 2)	Building engineer is required to prepare accurate and detailed as-built drawings, including column layout plan and section, bracing information, and Jack beam details.	within 6 weeks

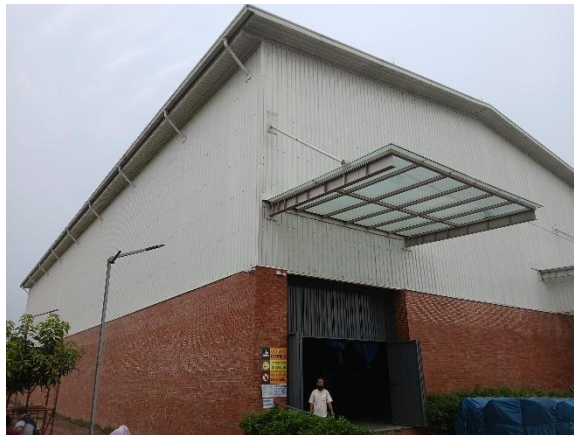
Observation-12: Lack of information in the as-built drawing. (Store Building 2)

Description: Building engineer is required to prepare accurate and detailed as-built drawings, including column layout plan and section, bracing information, and Jack beam details.

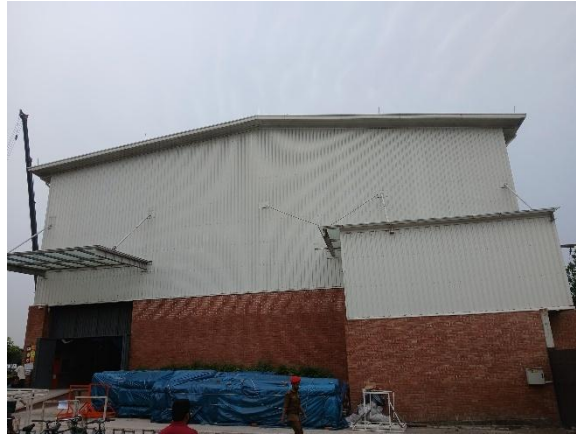
Observation-13: Lack of Design Report and Material Test Report. (Store Building 2)

Description: Design report not available, detailed design report and the structural system consideration are required to be addressed.

- The building engineer is required to prepare the design report as per BNBC 1.9.1 and check the availability of the material test report to confirm the design report. For the concrete, follow BNBC 5.12.1.

18.	Lack of Design Report and Material Test Report. (Store Building 2)	The building engineer is required to prepare the design report as per BNBC 1.9.1 and check the availability of the material test report to confirm the design report. For the concrete, follow BNBC 5.12.1.	within 6 weeks

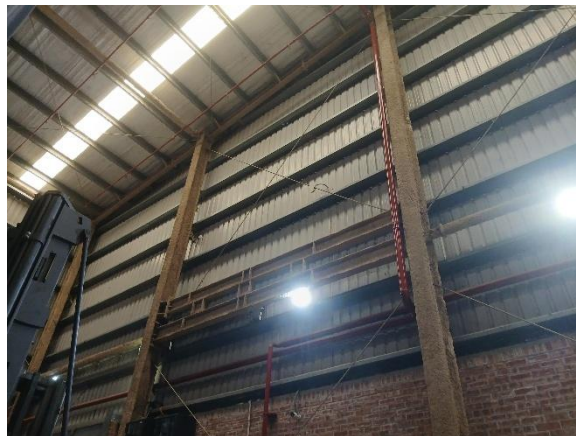
Observation-14: Loose Cable Bracing. (Store Building 2)

Description: Loose bracing was observed. Building engineer is required to tighten the loose braces.

19.		Carry out the suggested remedial works if required.	within 6 months
20.	Loose Cable Bracing. (Store Building 2)	Building engineer is required to tighten the loose bracings.	within 6 weeks

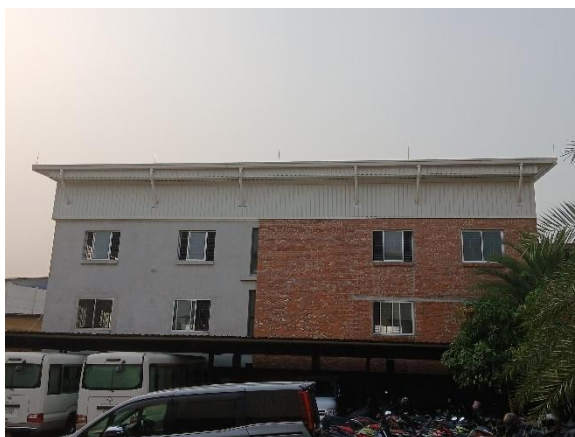
Observation-15: Lack of design report. (Childcare Medical, Dining Building)

Description: Design report was not available for the Childcare Medical, Dining Building. The building engineer is required to prepare the design report as per BNBC 1.9.1 and check the availability of the material test report to confirm the design report. For the concrete, follow BNBC 5.12.1.

21.	Lack of design report. (Childcare Medical, Dining Building)	The building engineer is required to prepare the design report as per BNBC 1.9.1 and check the availability of the material test report to confirm the design report. For the concrete, follow BNBC 5.12.1.	within 6 weeks
22.		Carry out the suggested remedial works if required.	within 6 months
