# ECHOKNITS LTD (EXTENSION 2)

A-99/1, Baktarpur, Kaliakoir. Gazipur

29 April 2025

## **1. Building Information**

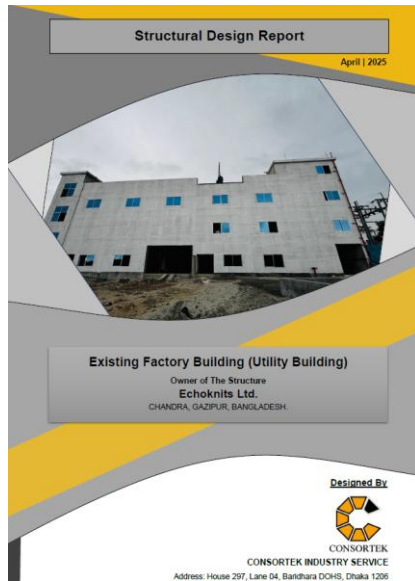
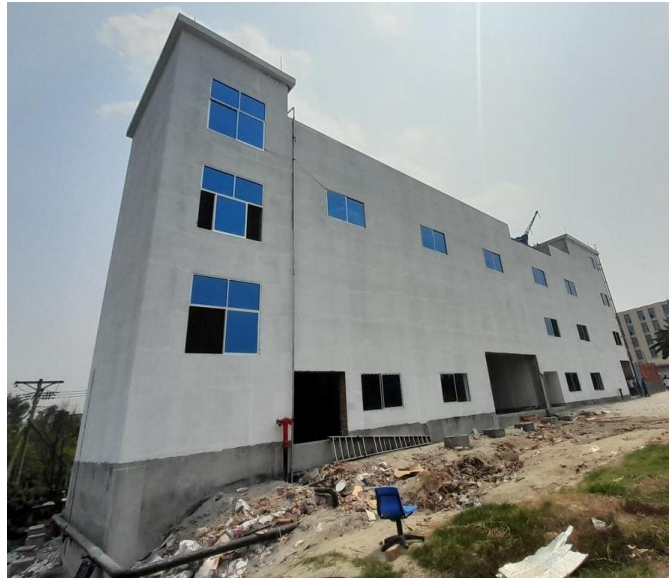
**Observation-1:** Design report needs to be reviewed against lateral forces (Utility Building).

**Description:** A design report has been prepared for the three storied Utility Building. The prepared design report needs to be reviewed against lateral forces. However, no floor load plan was found prepared. The building engineer is required to submit the design report to the RSC for detailed review.

| Item No | Observation | Action Plan | Timeline |
|---|---|---|---|
| 1. | Design report needs to be reviewed against lateral forces (Utility Building). | The building engineer is required to submit the design report to the RSC for detailed review. | within 6 weeks |
| 2. | | Produce floor load plan | within 6 weeks |
| 3. | | Carry out remedial work if required. | within 6 months |

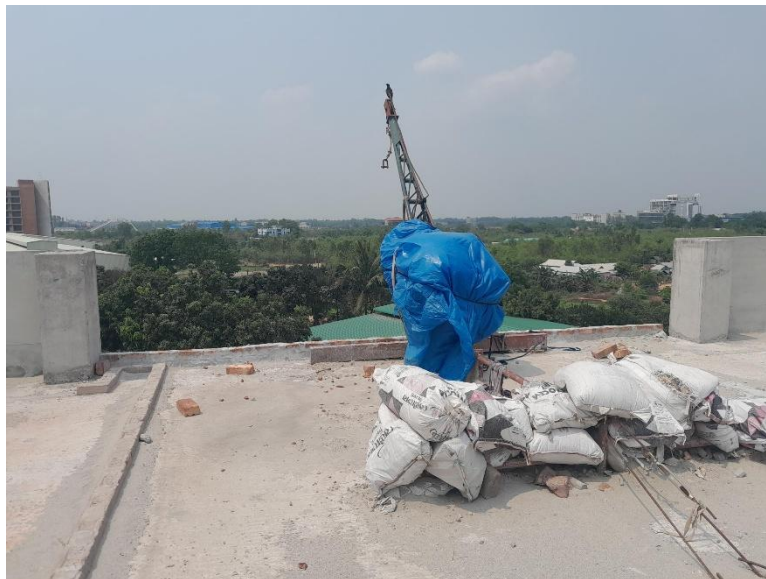
**Observation-2:** Possible falling hazard at roof. (Utility Building)

**Description:** During inspection, few portion of parapet wall was found missing. Building engineer is required to provide the parapet walls at missing area to avoid possible falling hazard.

| Item No | Observation | Action Plan | Timeline |
|---|---|---|---|
| 5. | Possible falling hazard at roof. (Utility Building) | Building engineer is required to provide the parapet walls at missing area to avoid possible falling hazard. | within 6 weeks |

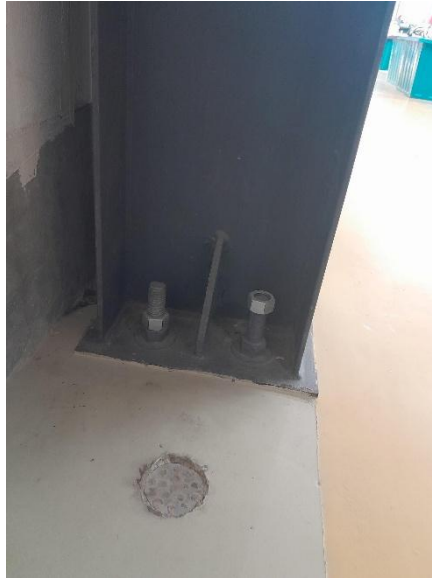
**Observation-3:** Loose nut bolts at base plates. [Production Shed (Shed 14)]

**Description:** During the inspection, several nut bolts at the base plates were found loose. The building engineer needs to check all base plate connections, identify the loose nut bolts, and tighten them properly.

| Item No | Observation | Action Plan | Timeline |
|---|---|---|---|
| 6. | Loose nut bolts at base plates. [Production Shed (Shed 14)] | The building engineer needs to check all base plate connections, identify the loose nut bolts, and tighten them properly. | within 6 months |

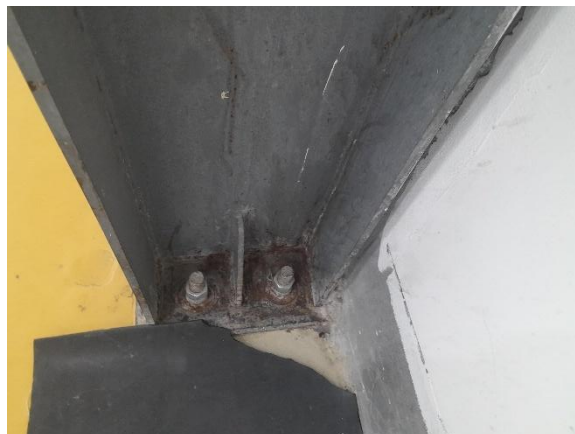
**Observation-4:** Corrosion on steel member. [Production Shed (Shed 14)]

**Description:** During inspection, corrosion was found on base plate of steel column. The building engineer is required to repair the corroded steel members by apply protective coating.

| Item No | Observation | Action Plan | Timeline |
|---|---|---|---|
| 7. | Corrosion on steel member. [Production Shed (Shed 14)] | The building engineer is required to repair the corroded steel members by apply protective coating. | within 6 months |

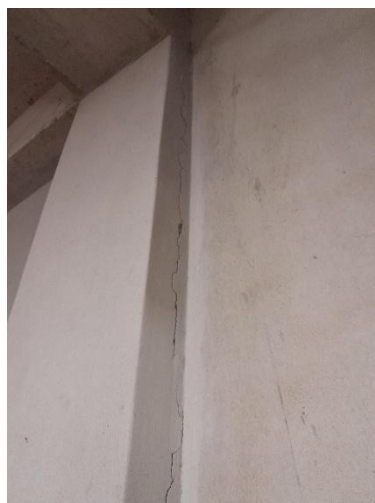
**Observation-5:** Brick wall crack at toilet block. [Production Shed (Shed 14)]

**Description:** During inspection, crack was found at brick wall. The building engineer is required to check the extent & reason of the crack and repair accordingly.

| Item No | Observation | Action Plan | Timeline |
|---|---|---|---|
| 8. | Brick wall crack at toilet block. [Production Shed (Shed 14)] | The building engineer is required to check the reason & extent of the crack and repair accordingly. | within 6 weeks |
