# AMC Knit Composite Ltd. (Extension - 2)

## Structural Inspection Report

6 storied Chemical Building      6-storied (G+5) RC building.

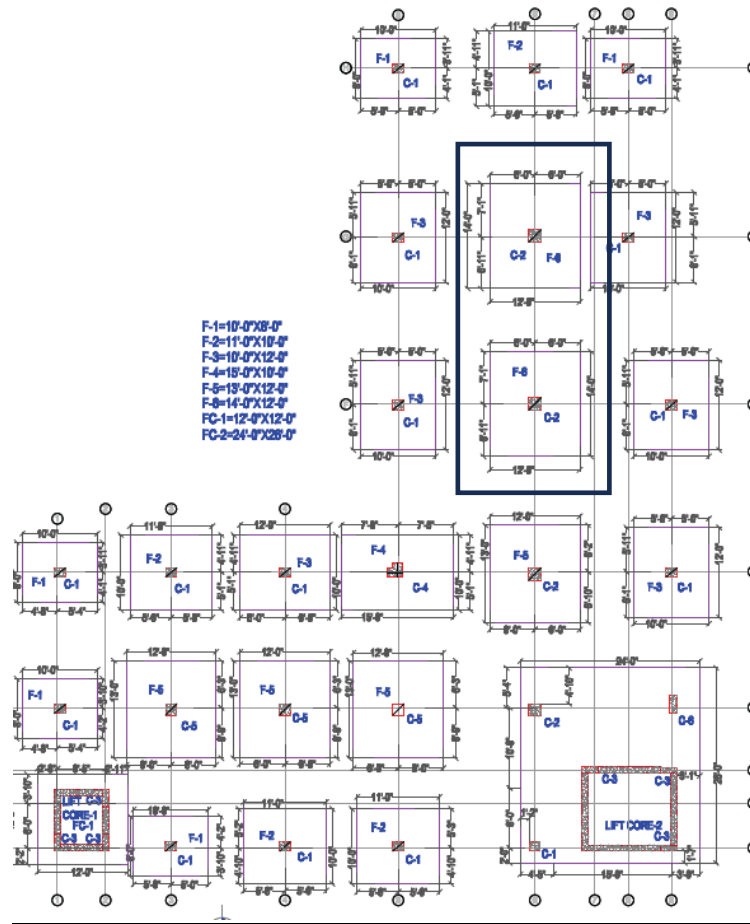
**Observation 01:** Marginally stressed above normal design limit in foundation (6-storied Chemical Building).

**Description:** cursory calculation indicates that stress in the foundation exceeds the normal design limit in the highlighted foundation (marked in the layout) for the 6-storied structure. At the time of inspection, design documents (design report, load plan, and adequate material test reports) were also unavailable.

Building engineer is required to perform in-situ material strength, review the design of the foundation stress and prepare a Detail Engineering Assessment (DEA) report with a proper remediation plan and submit to RSC for review.

| Item No | Observation | Action Plan | Timeline |
|---|---|---|---|
| 1. | Marginally stressed is above the normal design limit in the foundation. (6 storied Chemical Building) | Verify in-situ concrete material strength by taking concrete cores (minimum 4 nos and 100 mm diameter) from lower-tier building columns. | within 6 weeks |
| 2. | | Building engineer is required to review, design of the foundation stress and prepare a Detail Engineering Assessment (DEA) report with proper remediation plan and submit to RSC for review. | within 6 weeks |
| 3. | | Produce and actively manage a loading plan for all floor plates, considering floor, column and foundation capacity. | within 6 weeks |
| 4. | | Carry out remedial work if required. | within 6 months |

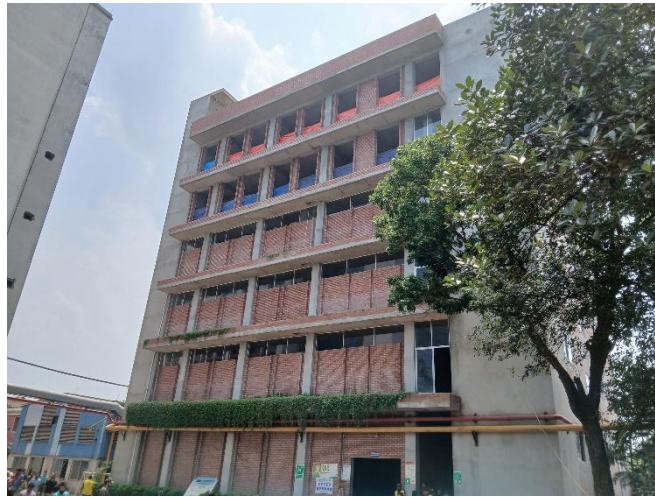
**Observation-02:** Lack of as-built architectural drawings. (6 storied Chemical Building)

**Description:** During inspection, no architectural drawing was available on site.

The building engineer is required to survey the structure and prepare accurate as-built drawings reflecting on site condition.

| Item No | Observation | Action Plan | Timeline |
|---|---|---|---|
| 5. | Lack of as-built architectural drawings. (6 storied Chemical Building) | The building engineer is required to survey the structure and prepare accurate as-built drawings reflecting on on-site condition. | within 6 weeks |

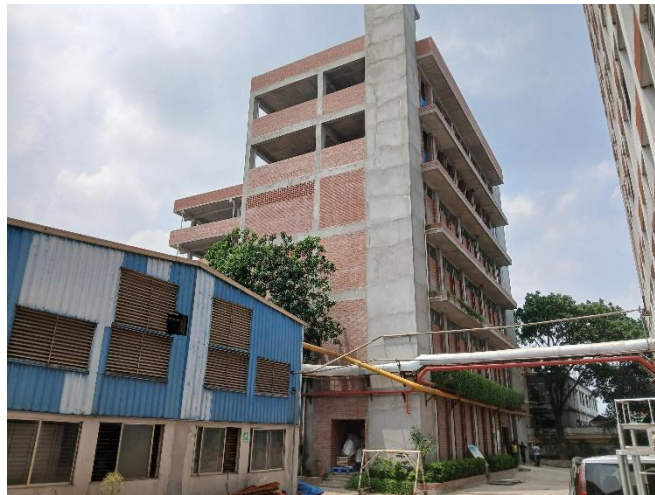
**Observation 03:** Lack of approval drawing (6 storied Chemical Building).

**Description:** During inspection, no approval drawing was available for 6 storied Chemical Building. The building engineer is required to arrange necessary approval drawings for this structure from concern authority.

| Item No | Observation | Action Plan | Timeline |
|---|---|---|---|
| 6. | Lack of approval drawing (6 storied Chemical Building). | The building engineer is required to arrange the necessary approval drawings for this structure from the concerned authority. | within 6 months |

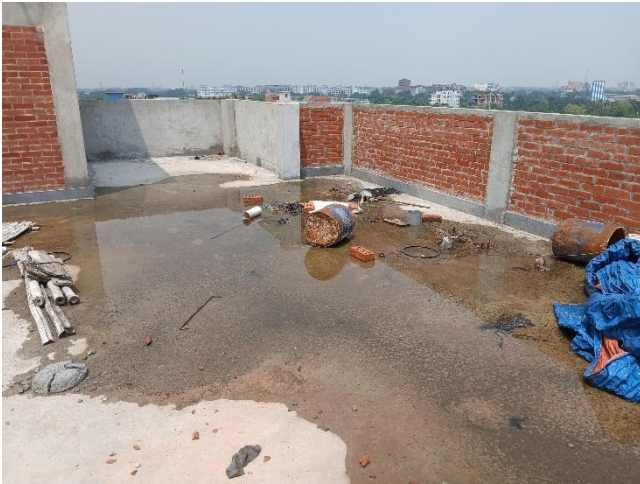
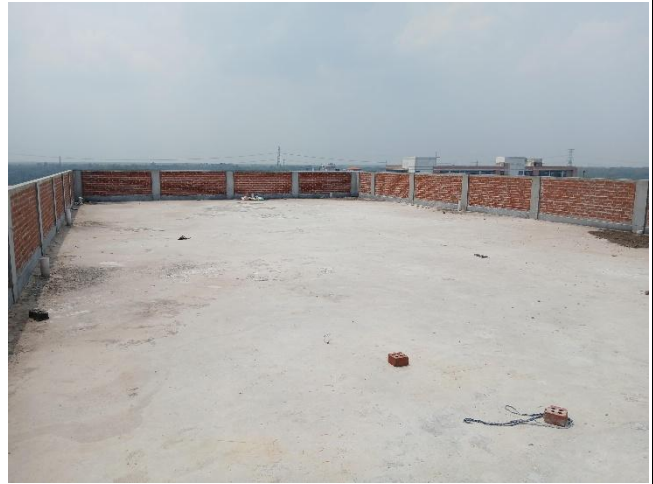
**Observation 04:** Water ponding on the roof lacks drainage system (6-storied Chemical Building).

**Description:** During inspection, water ponding was observed on the roof. The building engineer is required to provide water waterproofing layer on the roof and improve the drainage system.

| Item No | Observation | Action Plan | Timeline |
|---|---|---|---|
| 7. | Water ponding on the roof lacks a drainage system (6-storied Chemical Building). | The building engineer is required to provide water waterproofing layer on the roof and improve the drainage system. | within 6 months |

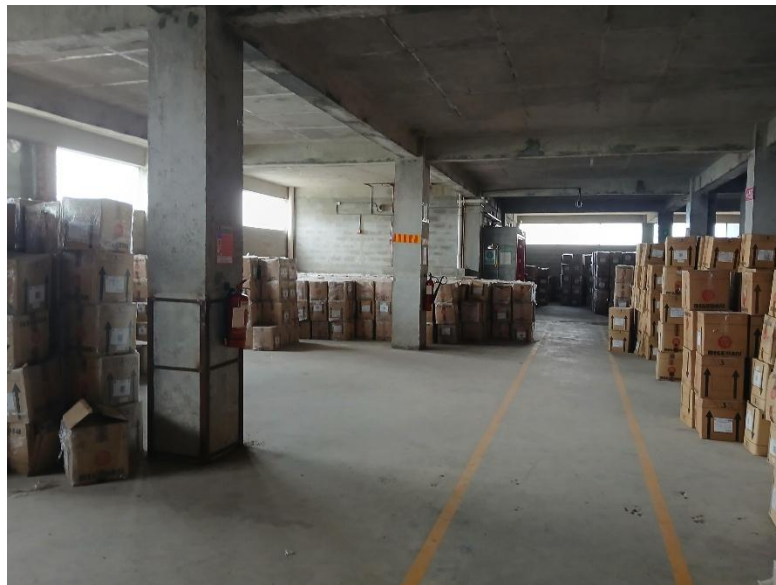
**Observation 05:** Trolley impact and surface damage (6 storied Chemical Building).

Trolley impact and surface damage on columns

**Description:** Surface damage due to trolley impact was observed on some columns. The building engineer is required to provide column guard to protect from trolley impact.

| Item No | Observation | Action Plan | Timeline |
|---|---|---|---|
| 8. | Trolley impact and surface damage (Production & Utility Building). | The building engineer is required to provide column guard to protect from trolley impact. | within 6 months |
