# Texworld Knitwear Ltd.

Sutipara, Kalampur, Dhamri,  
(23.922191, 90.139861)  
7 May 2025

## Structural Inspection Report

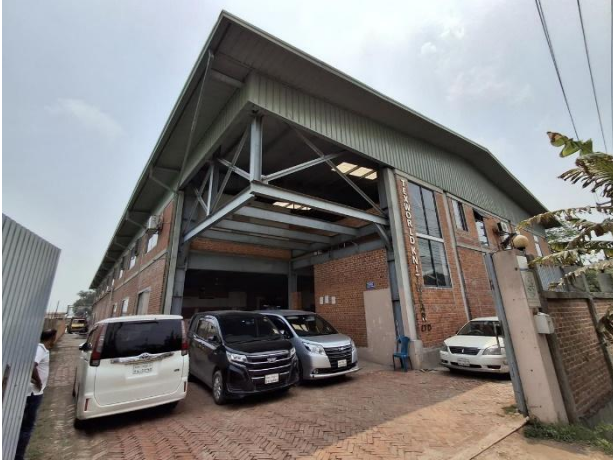
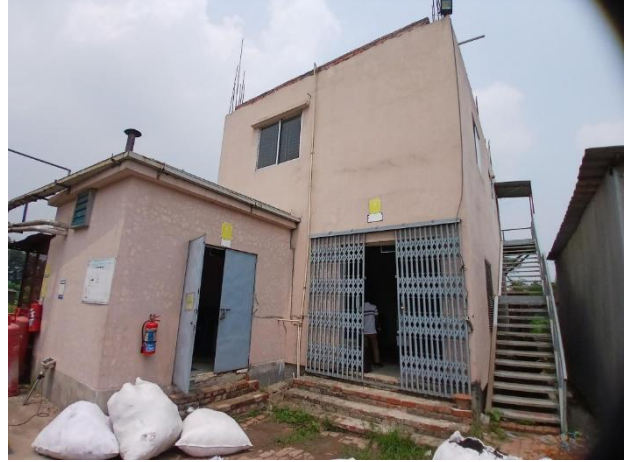
**Observation 01:** Lack of building permit drawings for all structures.

**Description:** During inspection, building permit drawing from local authority and machine layout drawings from DIFE were not found for any structures.

Item No	Observation	Action Plan	Timeline
1.	Lack of building permit drawings for all structures.	Collect building permit drawing from concern local authority.	within 6 months

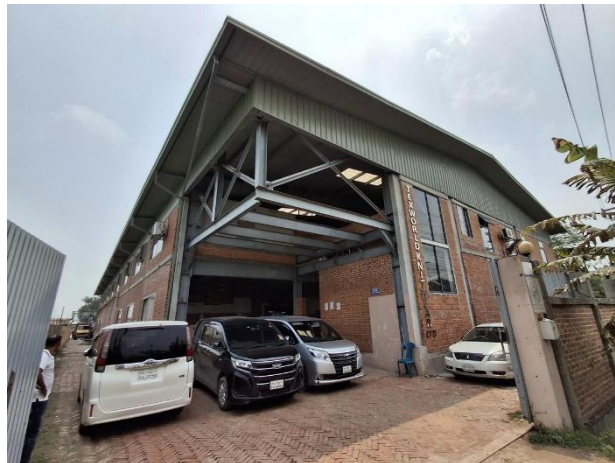
**Observation 02:** Lack of as-built steel superstructural drawings, load management plan, design report, concrete/steel material test report and soil test report. (Building -1 (Production Building))

**Description:** During inspection, only sub-structural RC drawings were available. No as-built drawing was found for steel super structure and there was no design report for the building. Also, there was no in-situ steel/concrete material test report and soil test report for the building.

The building engineer is required to carry out Detail Engineering Assessment (DEA) for the structure to verify the foundation details, in-situ concrete/steel/soil material strength, and prepare assessment report and load management plan. Prepare a full set of DEA documents with detailed remedial action plan. Submit the DEA documents to the RSC for review.

2.	Lack of as-built steel superstructural drawings, load management plan, design report, concrete/steel material test report and soil test report. (Building -1 (Production Building))	Survey the structure and prepare as-built drawings with foundation and connection details.	within 6 weeks

3.		Verify in-situ material (concrete & steel) material strength by taking sample from existing building members.	within 6 weeks
4.		Conduct onsite soil investigation and prepare soil test report with necessary information.	within 6 weeks

5.		Carry out Detail Engineering Assessment (DEA) report with remedial actions considering as-built structural system and in-situ material strength. Submit DEA documents to the RSC for review.	within 6 weeks

6.		Produce and actively manage a loading plan for all floor plates considering floor, column and foundation capacity.	within 6 weeks
7.		Carry out suggested remedial works if required.	within 6 months

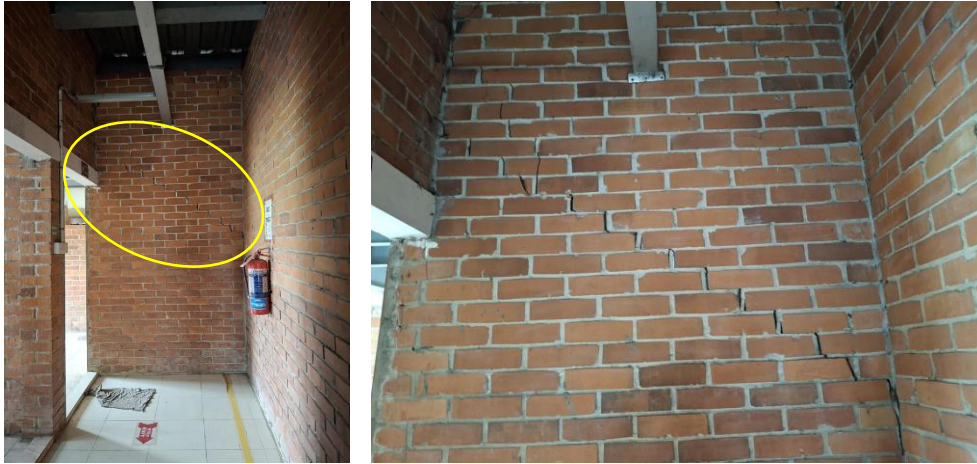
**Observation 03:** Crack on brick walls. [Building -1 (Production Building)]

**Description:** Diagonal crack observed on brick wall of toilet zone of the building.

8.		Crack on brick walls. [Building - 1 (Production Building)]	Identify the reason & extent of the crack and repair the crack accordingly.
9.	Corrosion on steel member. [Building -1 (Production Building)]	Identify the locations, remove the rusting and apply anti-corrosive coating with suitable method.	within 6 weeks

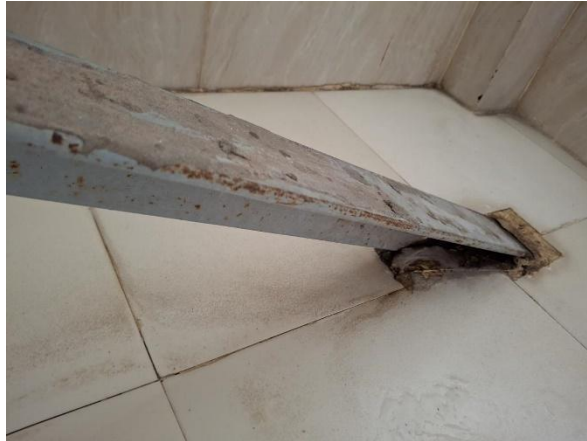
**Observation 04:** Corrosion on steel member. (Building -1 (Production Building))

**Description:** Corrosion observed on steel bracing member in the toilet zone.

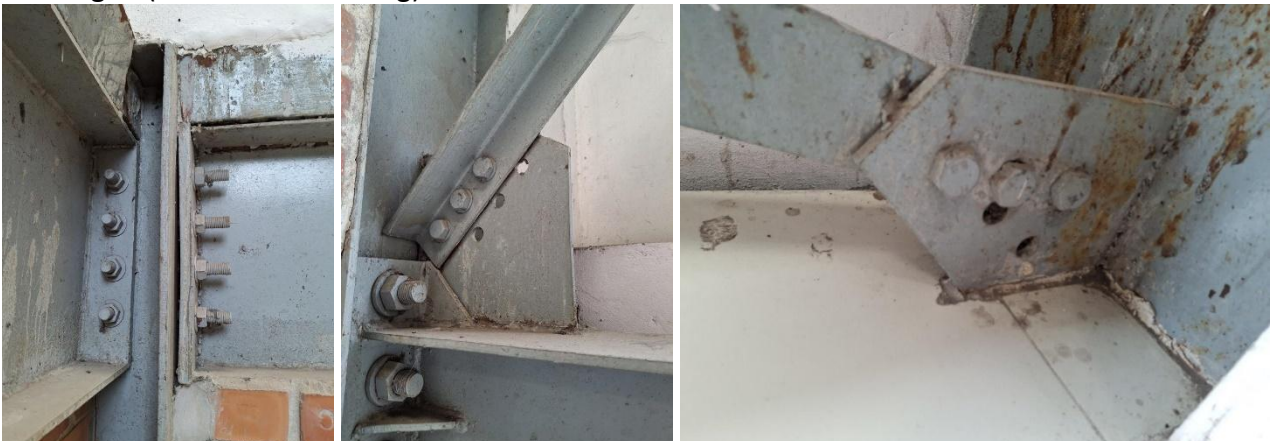
**Observation 05:** Connection gap between joint plates and extra punch on bracing gusset plate. (Building -1 (Production Building))

**Description:** Connection gap between joint plates and extra punch on bracing gusset plate observed.

10.	Connection gap between joint plates and extra punch on bracing gusset plate. (Building -1 (Production Building))	Repair the connection gap and gusset plate punch with suitable method.	within 6 weeks

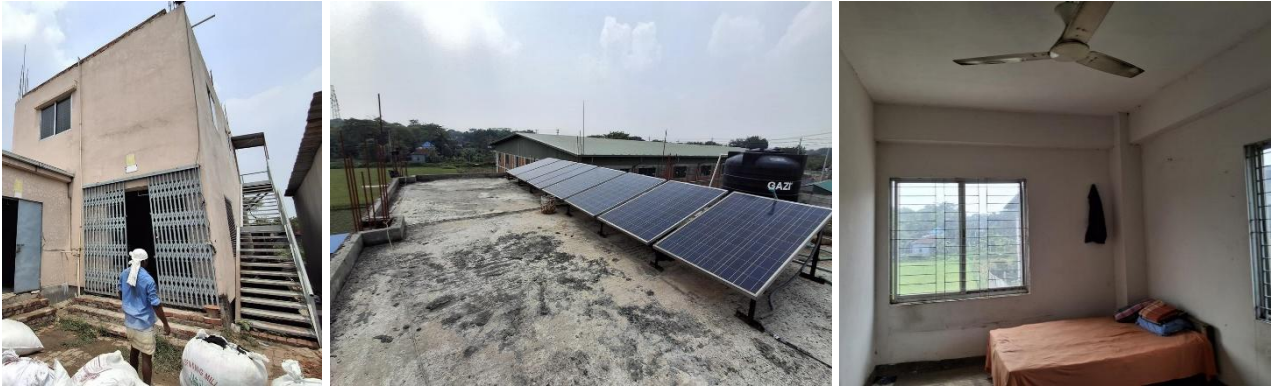
**Observation 06:** Lack of as-built drawings, material test report and design documents. [Building -2 (Utility Building)]

**Description:** During inspection, No as-built drawing was found for the building. Also, there was no in-situ steel/concrete material test report and soil test report for the building. The building engineer is required to carry out Detail Engineering Assessment (DEA) for the structure to verify the foundation details, in-situ concrete/steel/soil material strength, and prepare assessment report. Prepare a full set of DEA documents with detailed remedial action plan. Submit the DEA documents to the RSC for review.

11.	Lack of as-built drawings, material test report and design documents. [Building -2 (Utility Building)]	Survey the structure and prepare as-built drawings with foundation and connection details.	within 6 weeks

12.		Verify in-situ material concrete/steel material strength by taking sample from existing building members.	within 6 weeks
13.		Conduct onsite soil investigation and prepare soil test report with necessary information.	within 6 weeks

14.		Carry out Detail Engineering Assessment (DEA) report with remedial actions	within 6 weeks

considering as-built structural system and in-situ material strength. Submit DEA documents to the RSC for review.	
15.		Produce and actively manage a loading plan for all floor plates considering floor, column and foundation capacity.	within 6 weeks

16.		Carry out suggested remedial works if required.	within 6 months
17.	Crack on brick walls. [Building - 2 (Utility Building)]	Identify the reason & extent of the crack and repair the crack accordingly.	within 6 weeks

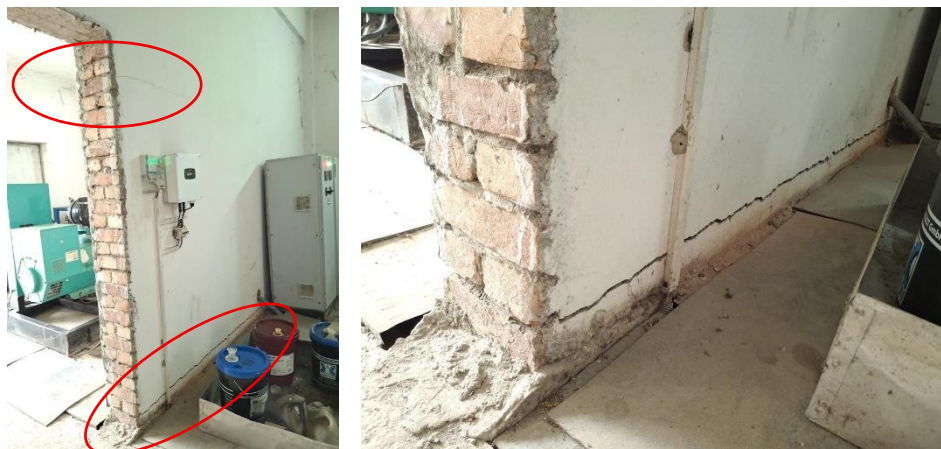
**Observation 07:** Crack on brick walls. [Building -2 (Utility Building)]

**Description:** Horizontal crack observed on internal brick wall of the building.

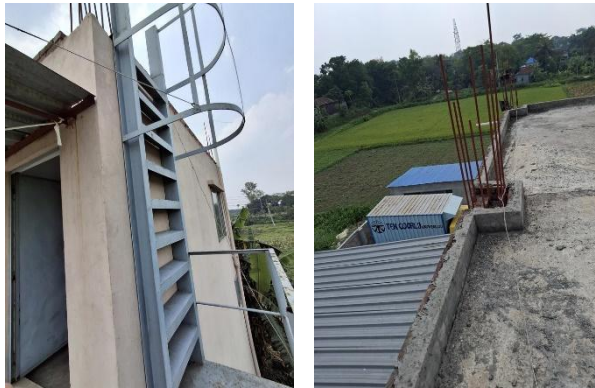
**Observation 08:** Falling hazard on roof. [Building -2 (Utility Building)]

**Description:** Horizontal crack observed on internal brick wall of the building.

18.	Falling hazard on roof. [Building -2 (Utility Building)]	Provide barriers/parapet to avoid falling hazard.	within 6 weeks
19.	Lack of as-built drawing and connection details. [Building -3 (Dining Building)]	Survey the structure and prepare as-built drawings with foundation and connection details.	within 6 weeks

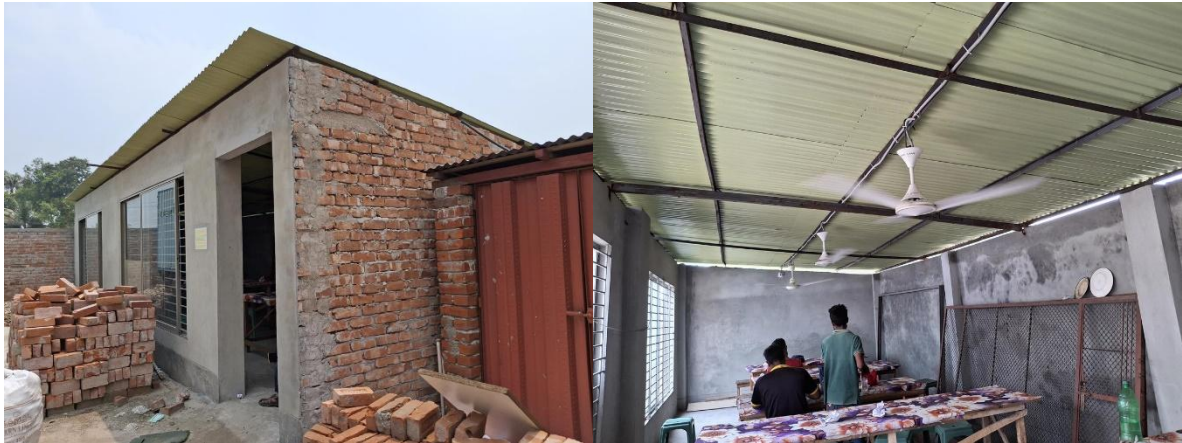
**Observation 09:** Lack of as-built drawing and connection details. [Building -3 (Dining Building)]

**Description:** As-built drawings were not available for the structure.

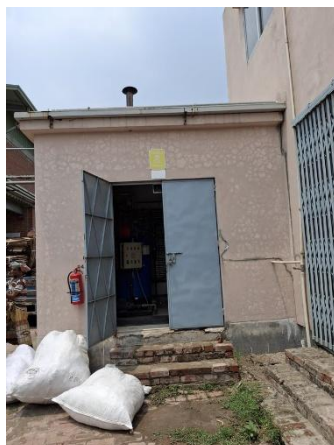
**Observation 10:** Lack of as-built drawings. [Building -4 (Boiler Building)]

**Description:** As-built drawings were not available for the structure.

20.	Lack of as-built drawings. [Building -4 (Boiler Building)]	Survey the structure and prepare as-built drawings with foundation and connection details.	within 6 weeks

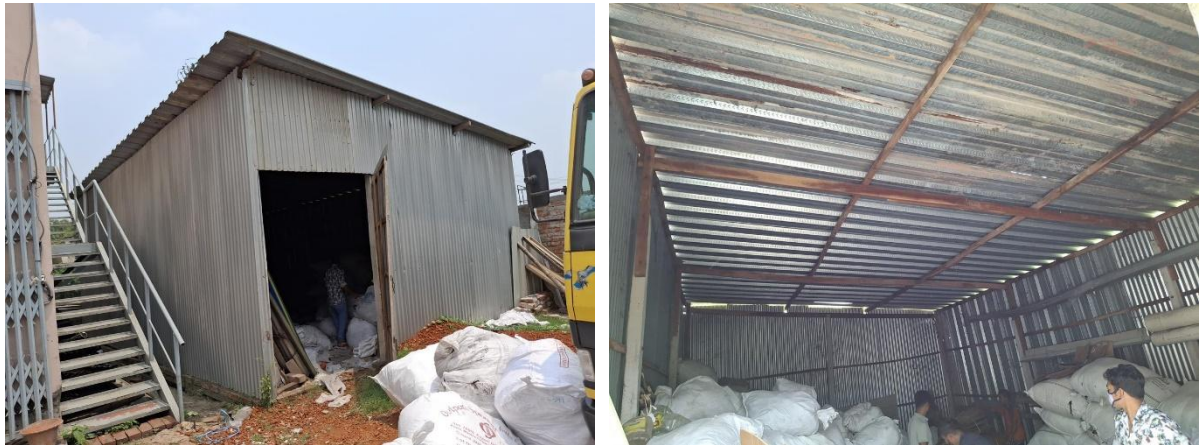
**Observation 11:** No engineered wooden Wastage Shed.

**Description:** The inadequate size of wooden member and frame arrangement doesn't comply with safety requirement.

21.	No engineered wooden Wastage Shed.	Check the adequacy of the framing members and prepare an assessment report and submit it to RSC for review. Otherwise, replace it with an engineered structure.	within 6 weeks

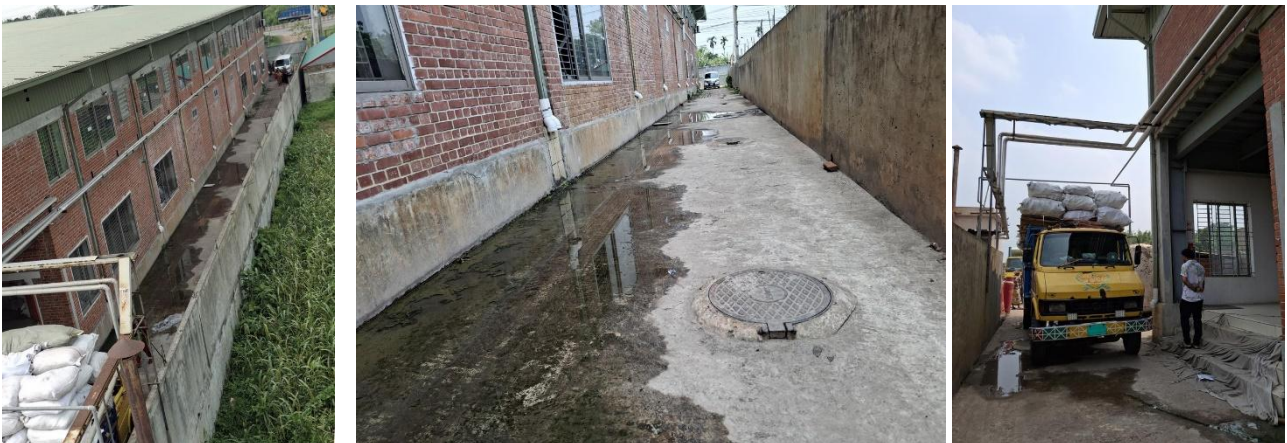
**Observation 12:** Heavy vehicle movement on UGWR top slab adjacent to Building-1.

**Description:** During inspection, Heavy vehicle movement on UGWR top slab adjacent to Building-1. The UGWR top slab details were not available in the provided drawings.

22.	Heavy vehicle movement on UGWR top slab adjacent to Building-1.	Prepare as-built drawings and check the adequacy of the UGWR top slab.	within 6 weeks
