# Orient Allure Lingerie Ltd. (Unit - 2)

Hijalhati, Baroipara, Kaliakoir, Gazipur

14 May 2025

## 2. Observation:

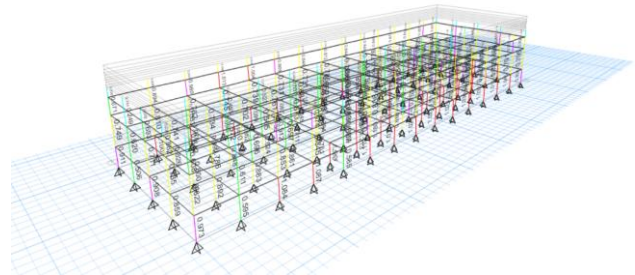
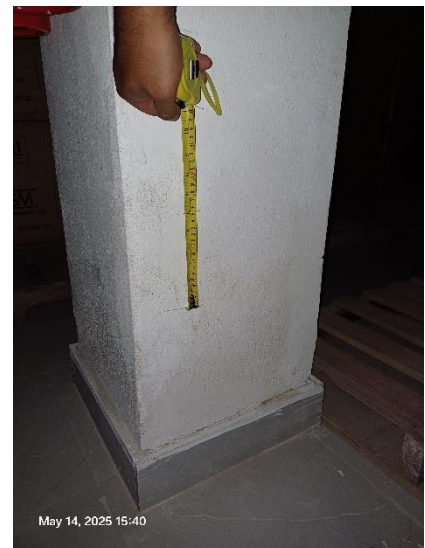
### Observation-01: Inconsistencies in the design report & design seismic base shear. (Production Building)

No information on Column Tie Bar in Column Schedule

Considering R=5 OMRF, Columns found overstressed

**Description:** Inconsistencies were found in the design report and design seismic base share considering the framing system. As per the drawing and on-site observation, columns do not meet the IMRF requirements. On-site column tie bar spacing at the support was found to be 6 inches (150 mm) instead of 5 inches (125 mm). Considering the OMRF, several columns were found to be overstressed.

Building engineer is required to check the onsite conditions and address all the inconsistencies in the design report.

| Item No | Observation | Action Plan | Timeline |
|---|---|---|---|
| 1. | Inconsistencies in the design report & design seismic base shear. (Production Building) | The building engineer is required to check the onsite conditions and address all the inconsistencies in the design report. | within 6 weeks |

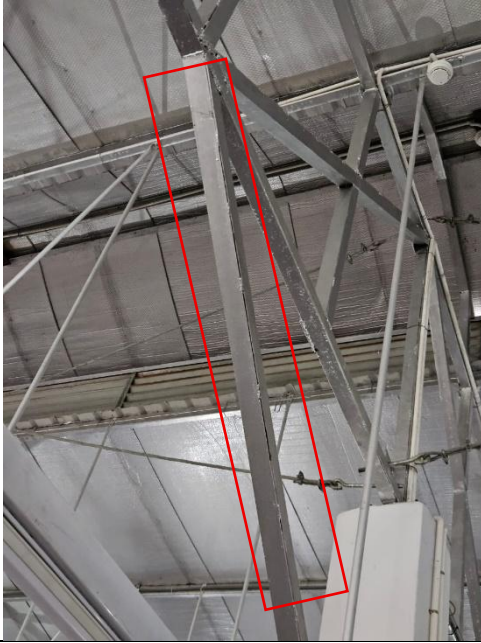
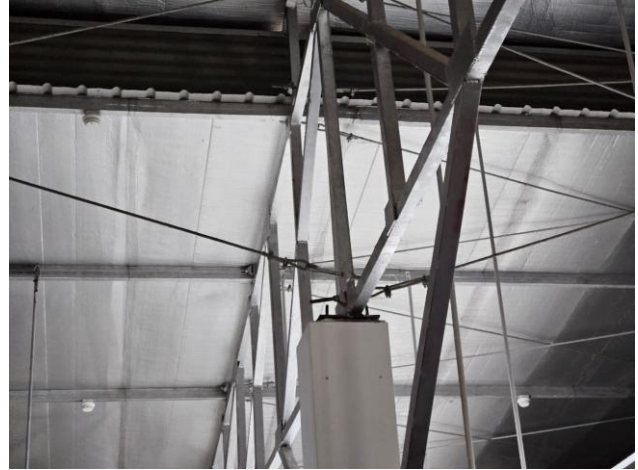
**Observation-02:** Discontinuity of welding in the retrofitting members. (Production Building)

**Description:** During the inspection, a gap in welding was found in the retrofitting structural member. To make a section compact, the building engineer is required to carry out local remedial (continuous welding) works as required.

| Item No | Observation | Action Plan | Timeline |
|---|---|---|---|
| 3. | Discontinuity of welding in the retrofitting members. (Production Building) | To make a section compact, the building engineer is required to carry out local remedial (continuous welding) work as required. | within 6 weeks |

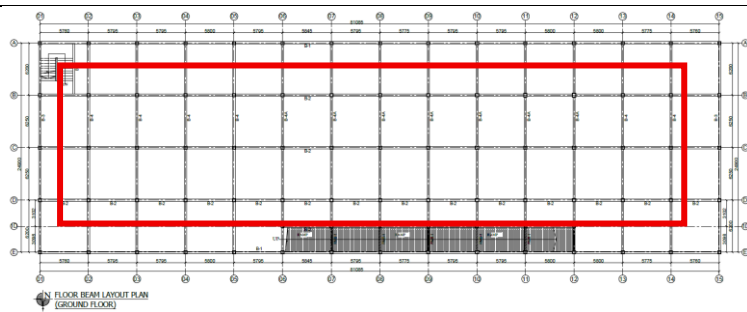
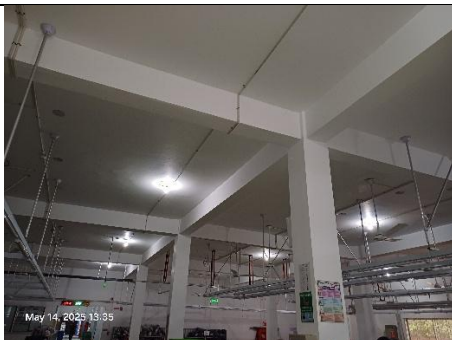
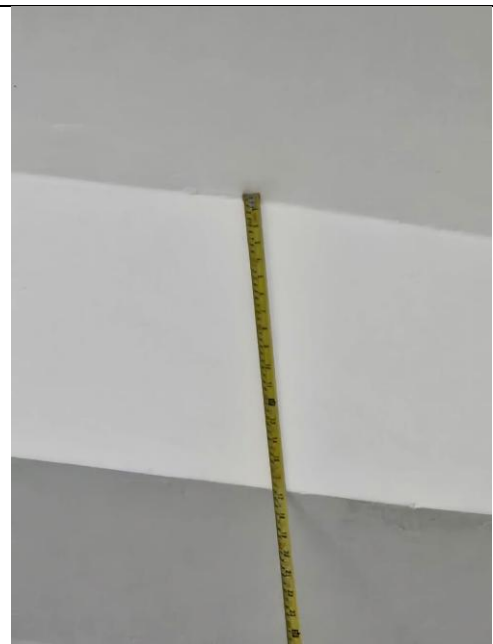
**Observation-03:** Mismatch in the as-built drawing. (Production Building)

**Description:** The marked beam's down stand found 400 mm instead of 550 mm. The building engineer is required to survey the structure and update the as-built drawing as per onsite conditions.

| Item No | Observation | Action Plan | Timeline |
|---|---|---|---|
| 4. | Mismatch in the as-built drawing. (Production Building) | The building engineer is required to survey the structure and update the as-built drawing as per onsite conditions. | within 6 weeks |

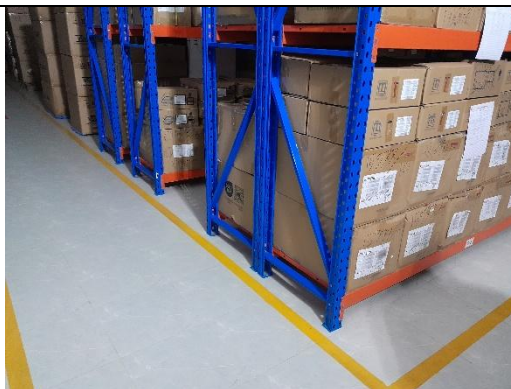
**Observation-04:** Anchorage of non-structural elements (Production Building)

**Description:** Lack of anchorage was found on the storage racks. Provide anchorage on the non-structural elements.

| Item No | Observation | Action Plan | Timeline |
|---|---|---|---|
| 5. | Anchorage of non-structural elements (Production Building) | Provide anchorage on the non-structural elements. | within 6 months |

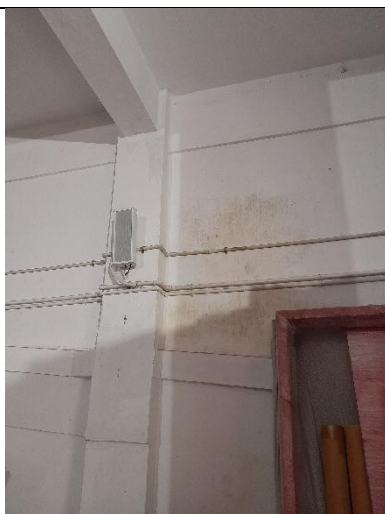
**Observation-05:** Dampness on the brick wall (Production Building)

**Description:** Dampness was found on the brick wall. Building engineer is required to remove the dampness and repair it with a suitable method.

| Item No | Observation | Action Plan | Timeline |
|---|---|---|---|
| 6. | Dampness on the brick wall (Production Building) | Building engineer is required to remove the dampness and repair with a suitable method. | within 6 weeks |

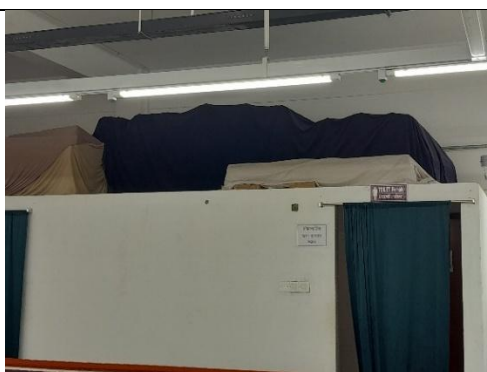
**Observation-06:** Loading on the false slab. (Production Building)

**Description:** Storage loading observed on the false slab. Building engineer is required to remove the loading from the false slab. Otherwise, check the design of false slab & load-bearing walls for loadings.

| Item No | Observation | Action Plan | Timeline |
|---|---|---|---|
| 7. | Loading on the false slab. (Production Building) | Building engineer is required to remove the loading from the false slab. Otherwise, check the design of false slab & load-bearing walls for loadings. | within 6 weeks |

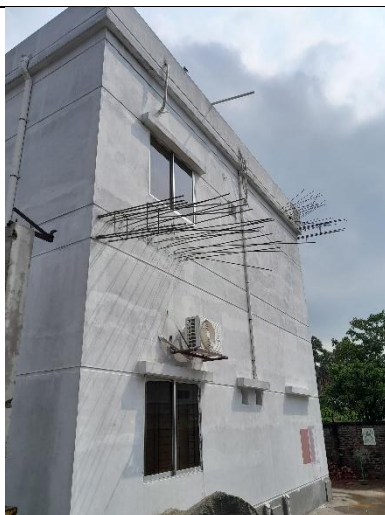
**Observation-07:** Exposed rebar. (Office Building)

**Description:** Exposed rebar observed on the office building is prone to corrosion. Building engineer is required to remove the rust and provide an anti-corrosive coating.

| Item No | Observation | Action Plan | Timeline |
|---|---|---|---|
| 8. | Exposed rebar (Office Building) | The building engineer is required to remove the rust and provide an anti-corrosive coating. | within 6 weeks |

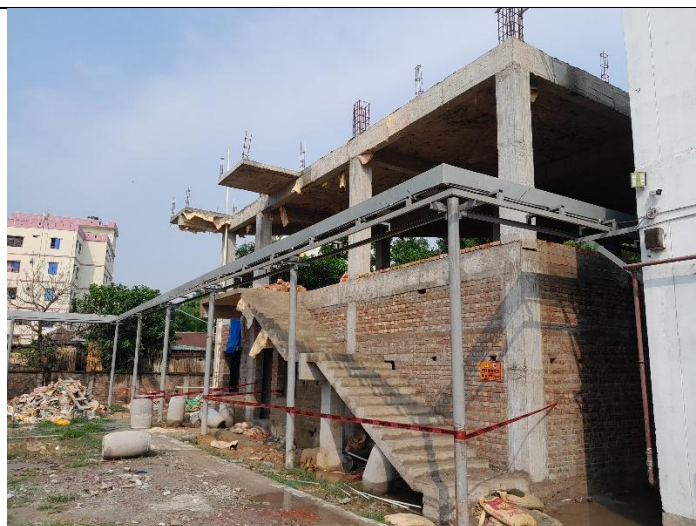
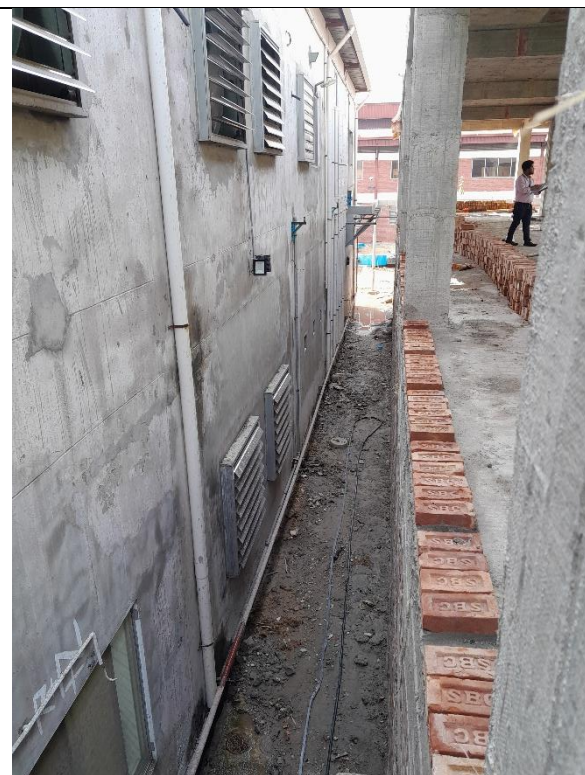
**Observation-08:** Construction safety around the building. (Dining Building)

**Description:** Lack of construction safety practice observed around the dining building and the walking way around the building. The building engineer is required to immediately implement construction safety practices around the building as per BNBC Part 7, Chapter 3.

| Item No | Observation | Action Plan | Timeline |
|---|---|---|---|
| 9. | Construction safety around the building. (Dining Building) | The building engineer is required to immediately implement construction safety practices around the building as per BNBC Part 7, Chapter 3. | Immediate |

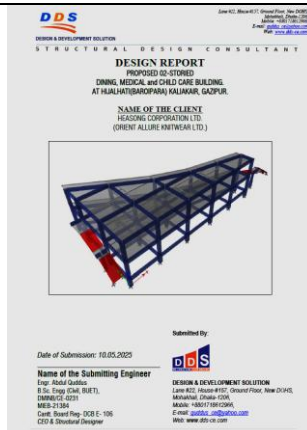
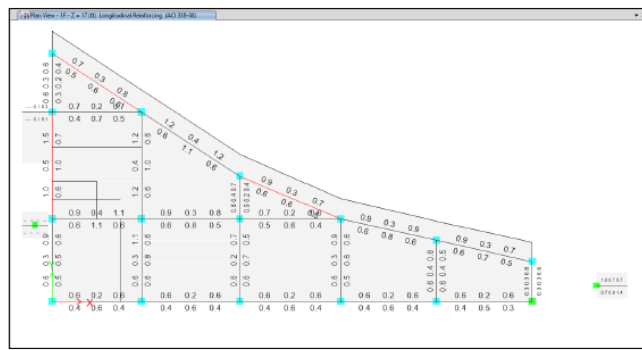
Fig- 1st Floor Beam Reinforcement

**Description:** The shape of the building is irregular. A design report was available considering BNBC 2020. But different types of irregularity checks were not provided in the report. The building engineer is required to address the inconsistencies in the design report and submit revised design documents to RSC for review.

| Item No | Observation | Action Plan | Timeline |
|---|---|---|---|
| 10. | Inconsistencies in the design report. (Dining Building) | The building engineer is required to address the inconsistencies in the design report and submit revised design documents to RSC for review. | within 6 weeks |

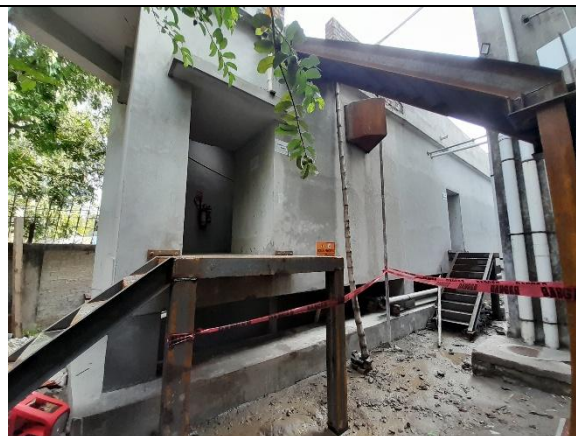
### Observation-10: Falling Hazard (ETP Building)

**Description:** Falling Hazard observed on the ETP building. The building engineer is required to provide safety guard/ handrails.

| Item No | Observation | Action Plan | Timeline |
|---|---|---|---|
| 12. | Falling Hazard (ETP Building) | The building engineer is required to provide safety guards/ handrails. | within 6 weeks |

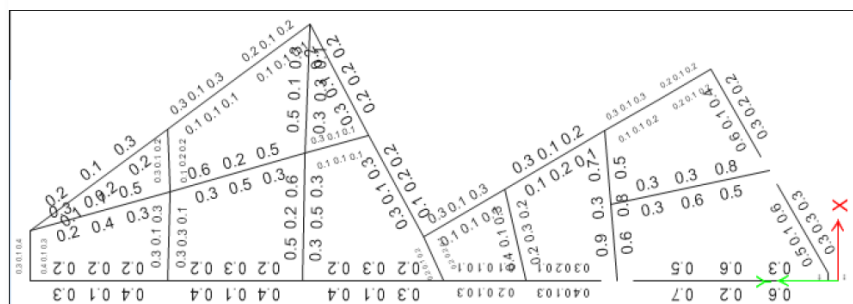
### Observation-11: Inconsistencies in the design report. (ETP Building)

**Description:** The shape of the building is irregular. A design report was available considering BNBC 2020. But different types of irregularity checks were not provided in the report. The building engineer is required to address the inconsistencies in the design report and submit revised design documents to RSC for review.

| 13. | Inconsistencies in the design report. (ETP Building) | Building engineer is required to address the inconsistencies in the design report and submit revised design documents to RSC for review. | within 6 weeks |

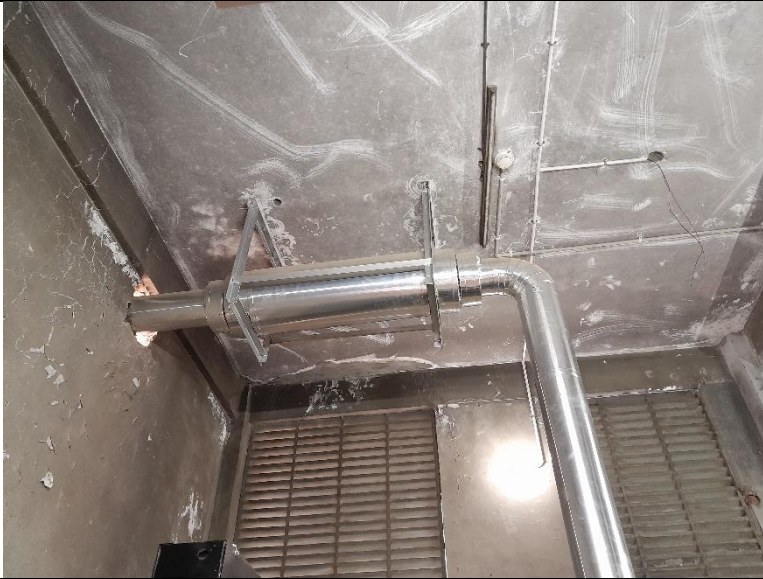
**Observation-12:** Dampness on the slab (Sub-Station Building)

**Description:** Dampness was observed on the slab of the substation building. Building engineer is required to prepare an Investigation report with repair methodology. Repair the dampness as per the recommendation of the investigation report.

| 15. | Dampness on the slab (Sub-Station Building) | Building engineer is required to prepare an Investigation report with repair methodology. Repair the dampness as per the recommendation of the investigation report. | within 6 weeks |
