Styrax Fashions Ltd Plot 180

PLOT NO-180, DEPZ-EXTN GANAKBARI, SAVAR, DHAKA

14 May 2025

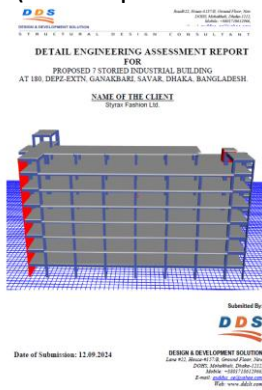
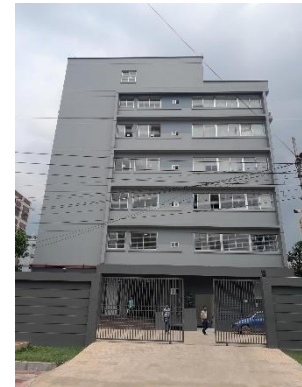
Observation 1: Inadequate number of material test reports and lack of adequacy checks in the design report. (Main Operation Building).

Description: A design report was available at the time of inspection. However, all types of adequacy checks, including punching check, differential settlement check, and flexure check, are not provided for the mat foundation in the design report. Furthermore, the number of concrete cylinder test reports provided does not meet the frequency of testing requirement as per BNBC (Section- 5.6 and 5.12). The building engineer is required to revise the design report based on in-situ concrete strength and submit the revised design report to RSC for review.

Item No	Observation	Action Plan	Timeline
1.	Inadequate number of material test reports and lack of adequacy checks in the design report. (Main Operation Building).	The building engineer is required to revise the design report based on in-situ concrete strength and submit the revised design report to RSC for review.	within 6 weeks

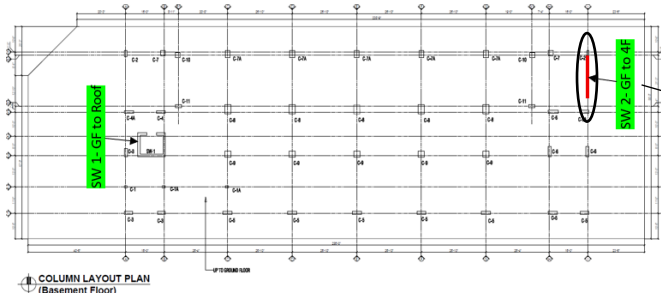
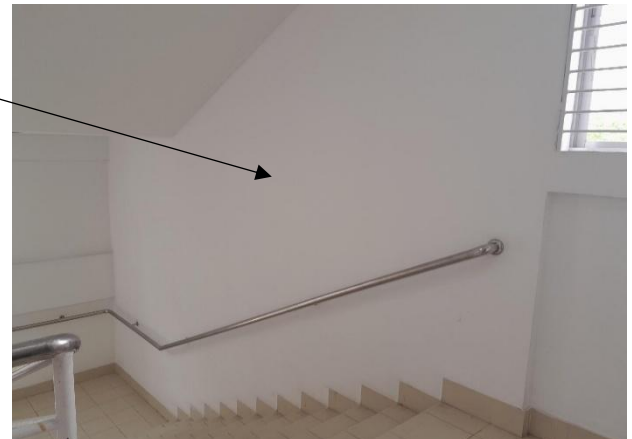
Observation 2: Discrepancy between the as-built drawing and onsite condition (Main Operation Building).

Description: During the inspection, it was observed that SW 2 is shown in the provided as-built drawing only up to the 2nd floor, where it extends to the 4th floor. The building engineer is required to survey the full structure and update the drawing and design documents based on the as-constructed structure.

2.		Implement remedial action if required.	within 6 months
3.	Discrepancy between drawing and onsite condition (Main Operation Building).	The building engineer is required to survey the structure and update the as-built drawings.	within 6 weeks

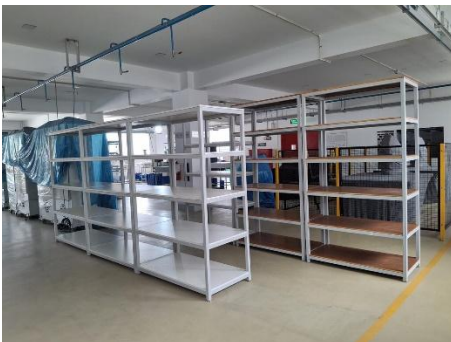
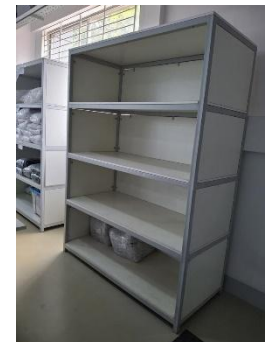
Observation 3: Non-structural elements are not anchored. (Main Operation Building).

Description: Non-structural elements are not anchored at several places on the floor. The building engineer is required to anchor or brace all the non-structural elements (Racks/water tank) adequately.

4.	Non-structural elements are not anchored. (Main Operation Building)	The building engineer is required to anchor or brace all the non-structural elements (Racks/water tank) adequately.	within 6 months

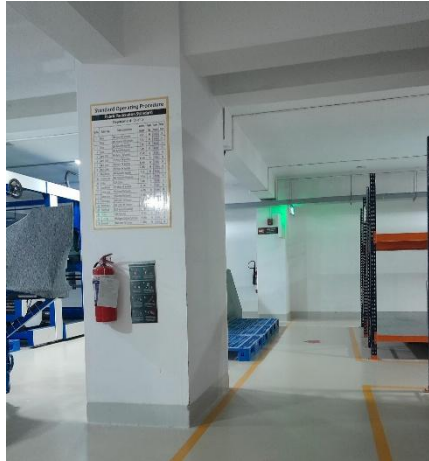
Observation-4: Trolley impact on structural members. (Main Operation Building).

Description: Damaged column surface was observed due to trolley impact. Repair the damaged column plaster and provide column guard to protect from trolley impact.

5.	Trolley impact on structural members. (Main Operation Building).	Repair the damaged column plaster and provide column guard to protect from trolley impact.	within 6 months

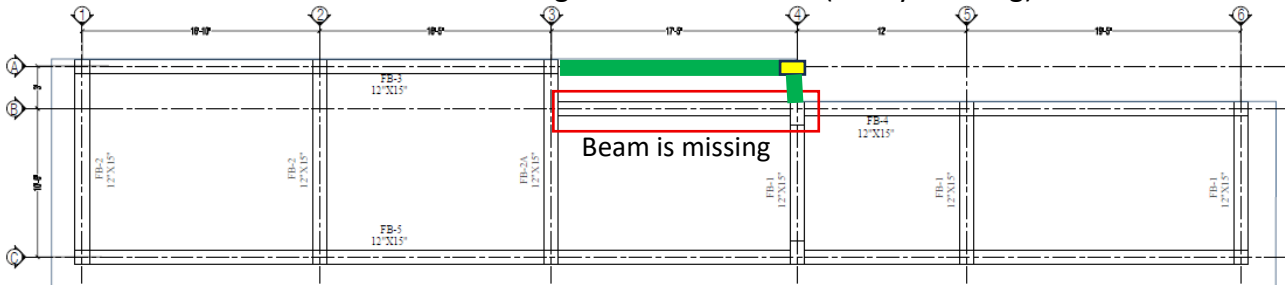
Observation-5: Mismatch between drawing & onsite condition (Utility Building).

Description: During inspection, a mismatch was found in the column layout and column schedule in the structure.

- Mismatches were found in the beam and column layout shown in the figure.
- C2 column size was found to be 375X300 mm instead of 300X300 mm.

The building engineer is required to update the drawing and design documents based on the as-constructed structure.

6.	Mismatch between drawing & onsite condition (Utility Building).	The building engineer is required to survey the structure and update the as-built drawings.	within 6 weeks

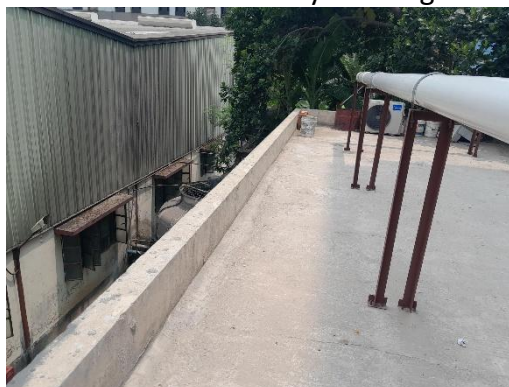
Observation-6: Falling Hazard at the roof of the Utility Building.

Description: During inspection, a falling hazard was found on the roof of the Utility Room. The building engineer is required to provide adequate parapet walls at the falling hazard area.

7.	Falling Hazard on the roof of the Utility Building.	The building engineer is required to provide adequate parapet walls at the falling hazard area.	within 6 weeks

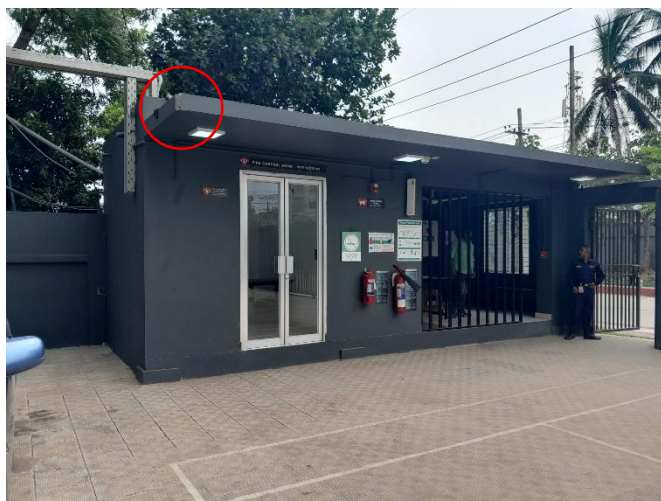
Observation-7: Vehicle impact on structural member/roof slab. (Security and Fire Command Room).

Description: Damaged slab was observed due to vehicle impact. The building engineer is required to repair the damaged surface of the slab as per the engineer's suggestion and provide barriers to protect from possible vehicle impact.

8.	Vehicle impact on structural member/roof slab. (Security and Fire Command Room).	The building engineer is required to repair the damaged surface of the slab as per the engineer's suggestion and provide barriers to protect from possible vehicle impact.	within 6 months
