# **Global Specialised Garments Ltd Unit 02**

12-13P Kalurghat Heavy Industrial Area, Chittagong  
(22.383726N, 91.868526E)

28<sup>th</sup> November 2015

# Observations

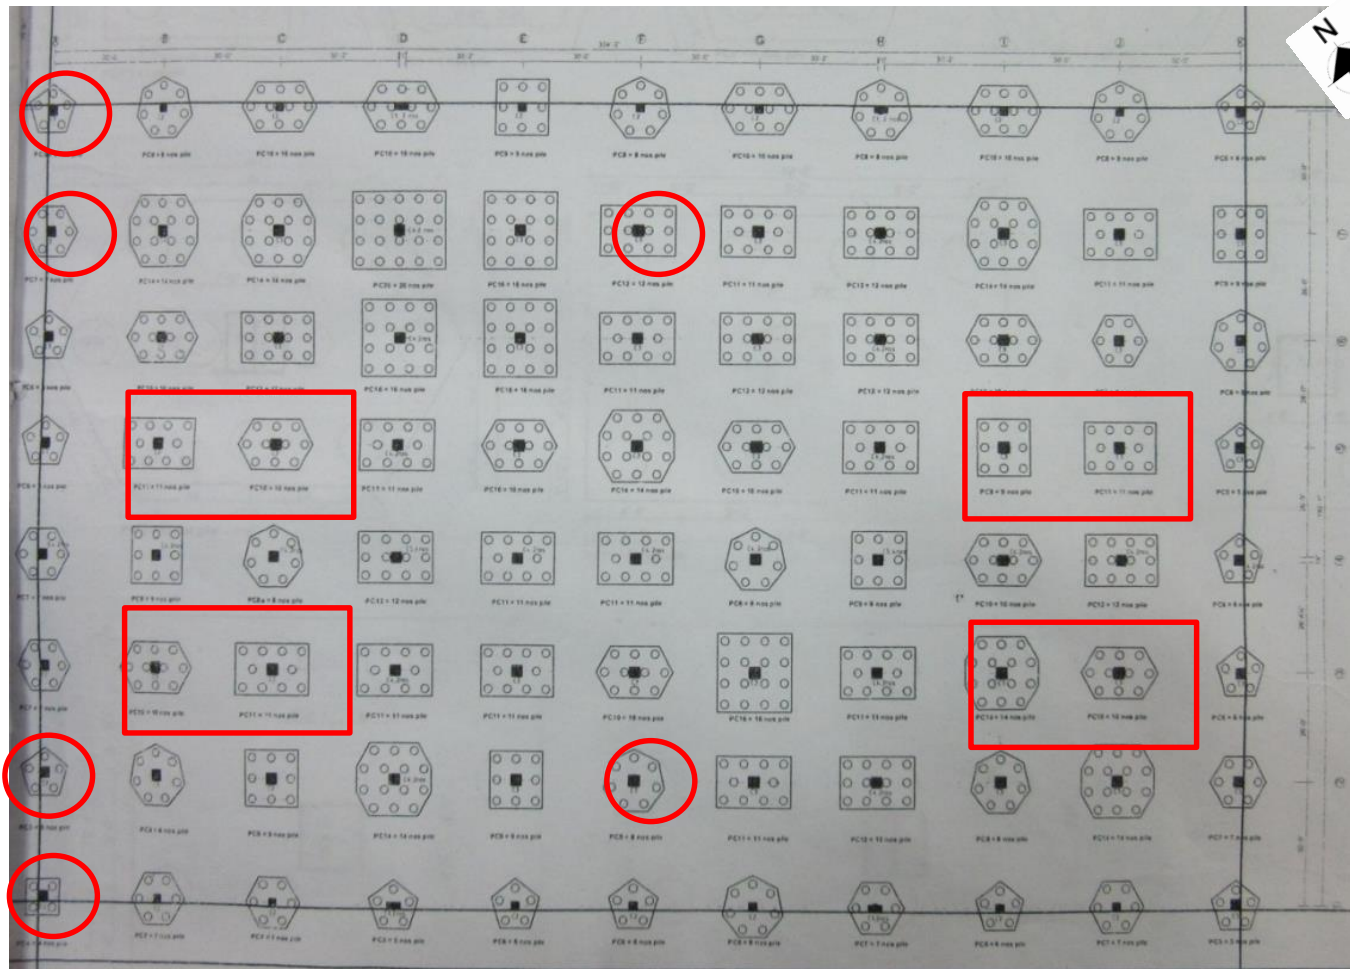
Apparent high stresses in some columns

Apparently high stress column in the event that the building were to be built up to 8 storey as per building permission.

Observation: Apparent high stresses for some columns

| Item No. | Observation | Recommended Action Plan | Recommended Timeline |
|---|---|---|---|
| 1 | Apparent high stresses in some columns | Building Engineer to verify actual concrete strength in columns with documented proof | 6-weeks |
| 2 | Apparent high stresses in some columns | Building Engineer to check that adequacy of concrete to resist the design stresses in the columns | 6-weeks |
| 3 | Apparent high stresses in some columns | In the event that actual concrete strength is inadequate, Building Engineer to advise on measures to reduce stresses in the columns to achieve an adequate FoS | 6-months |

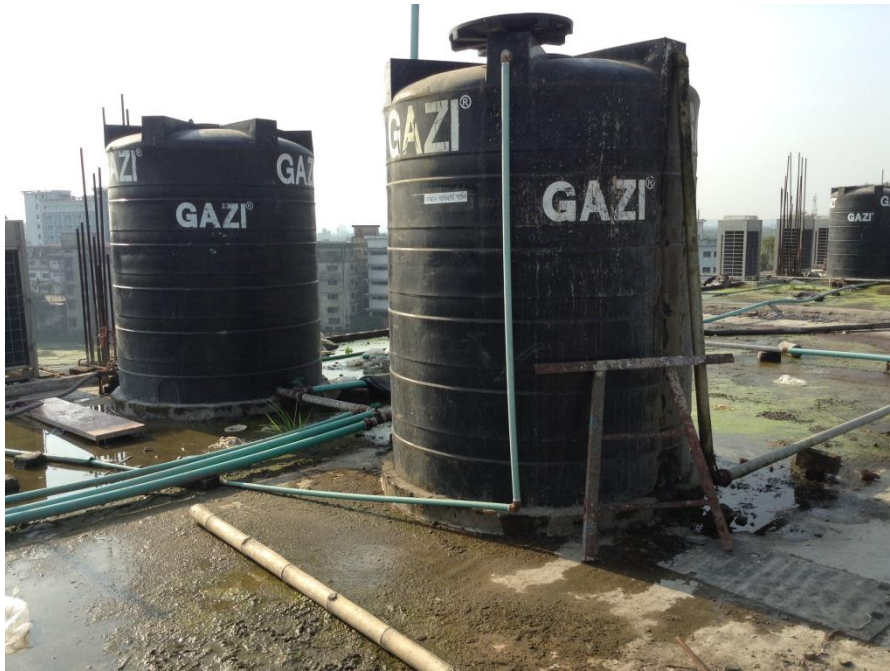
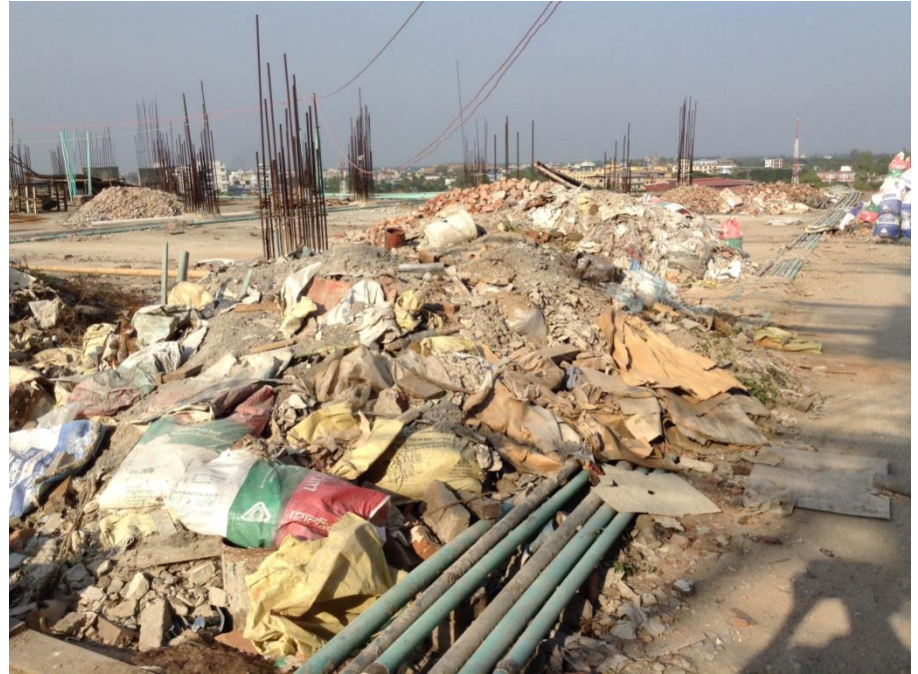
# Uncontrolled building material loading on the roof

**Water stagnation and heavy loads from construction materials and rubbles observed on the roof (6<sup>th</sup> floor)**

**Observation: Water stagnation & uncontrolled Construction materials and rubble**

| Item No. | Observation | Recommended Action Plan | Recommended Timeline |
|---|---|---|---|
| 4 | Uncontrolled building material loading on the roof | Building Engineer to assess building material loading on the Roof slab and advise on controls to limit loading to below slab capacity | 6-weeks |
| 5 | Uncontrolled building material loading on the roof | Monitor loading on top slab during construction of additional floors | 6-months |

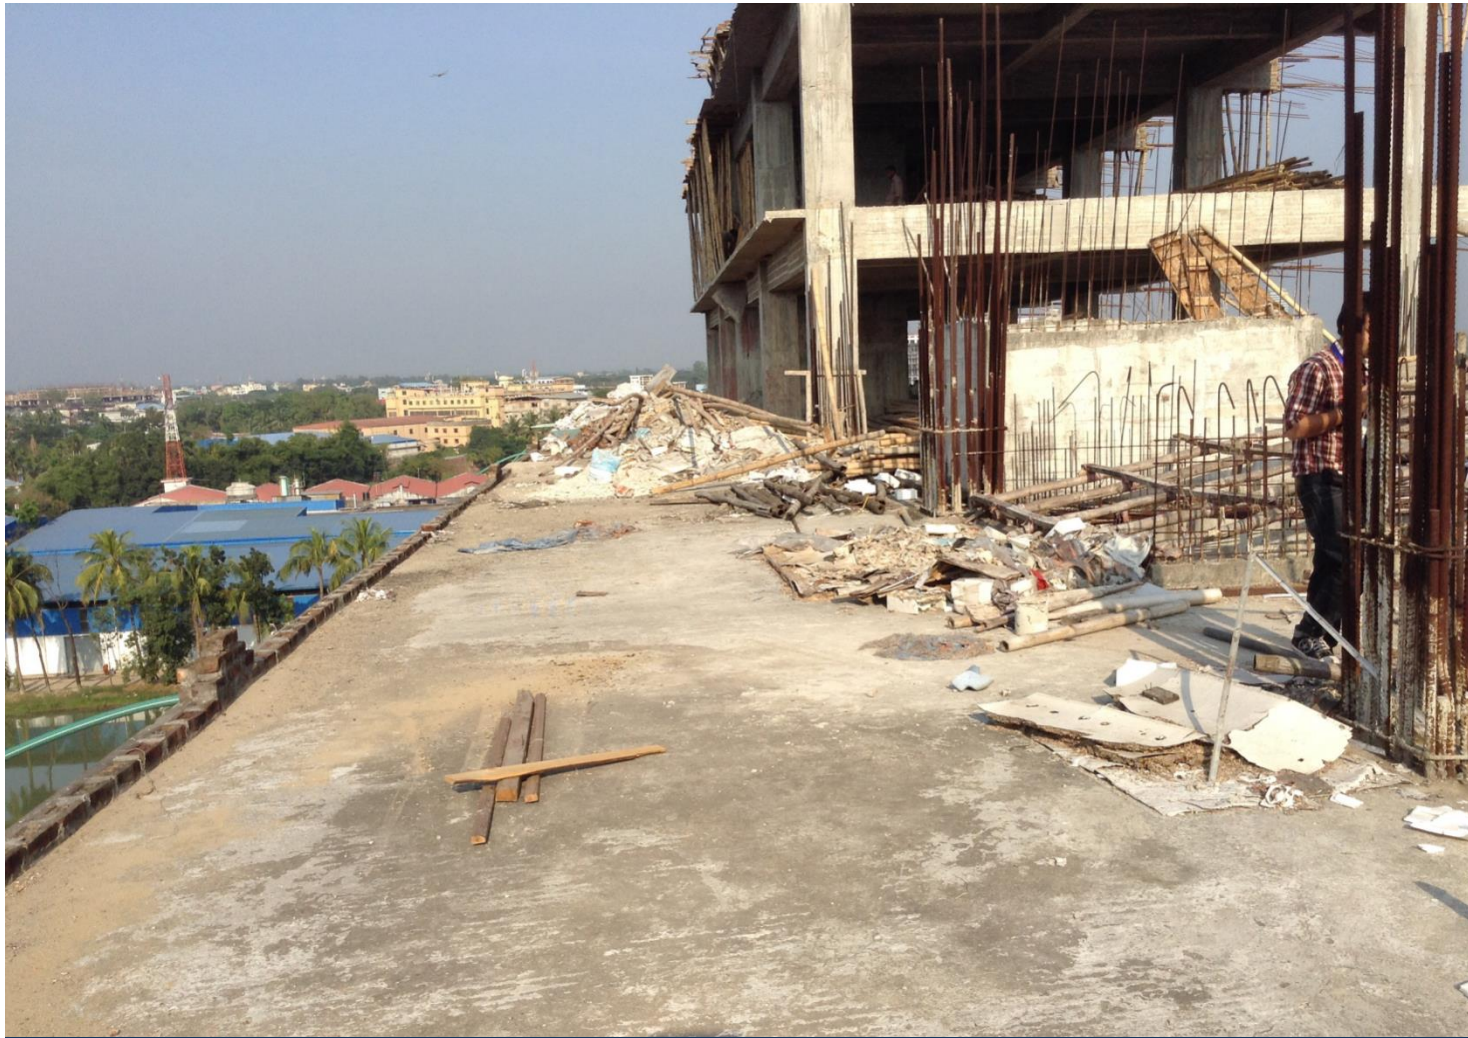
Non-structural observation - Absence of safety barrier at the roof perimeter

**No parapet wall or safety barrier observed at roof level (5<sup>th</sup> floor slab)**

**Observation: Lack of parapet wall or safety rails**

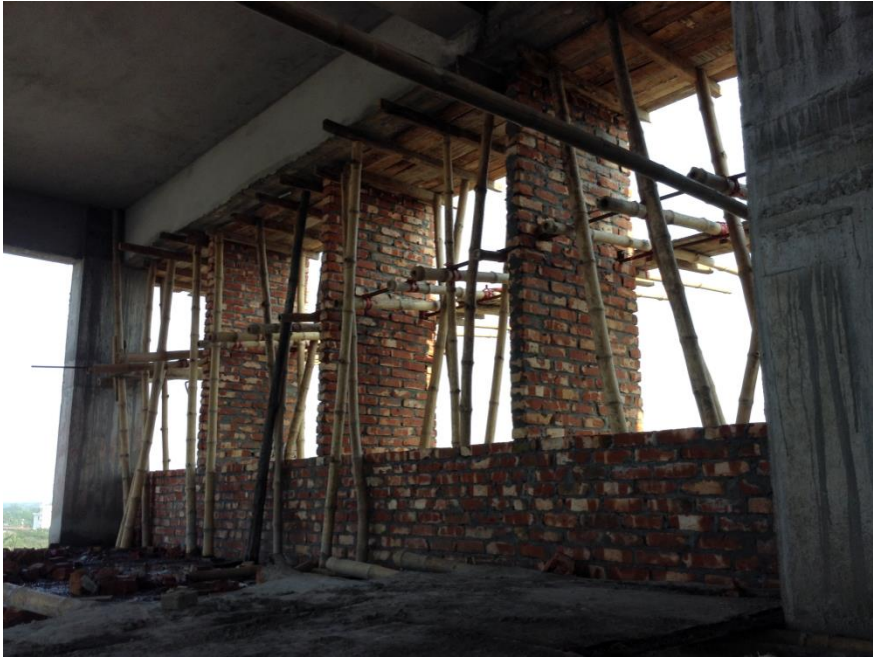
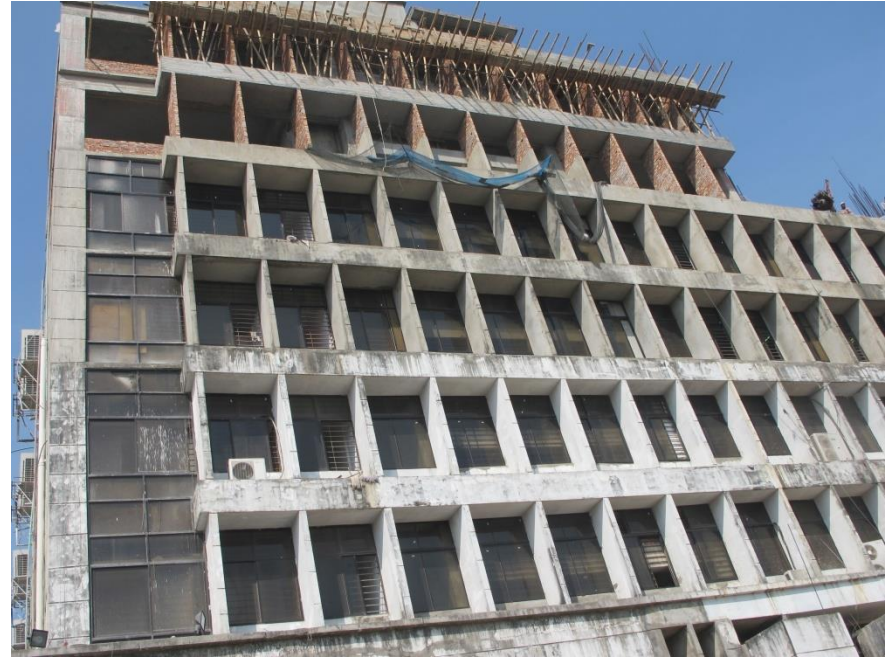
Lack of stability in façade wall brickwork features

**Façade wall with brickwork fins unrestrained over 3.67m floor-to-ceiling height force**

**Observation: Lateral instability of elements on façade wall**

| Item No. | Observation | Recommended Action Plan | Recommended Timeline |
|---|---|---|---|
| 6 | Lack of stability in façade wall brickwork features | Building Engineer to verify the stability of the brickwork 'fin' feature of the façade. | 6-weeks |
| 7 | Lack of stability in façade wall brickwork features | Provide adequate restraint to ensure stability of brick façade features | 6-months |

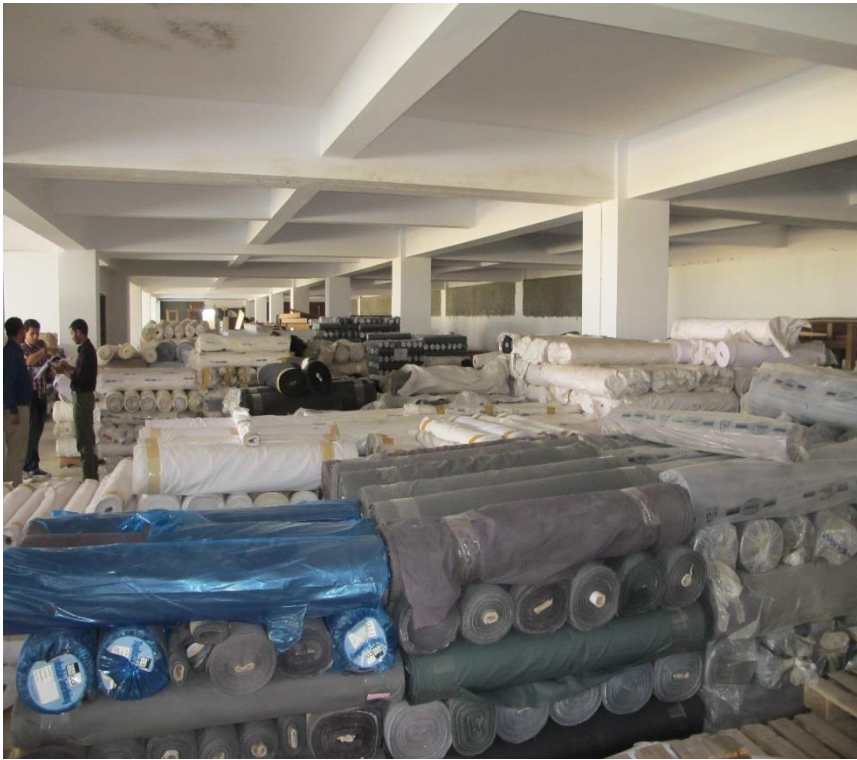
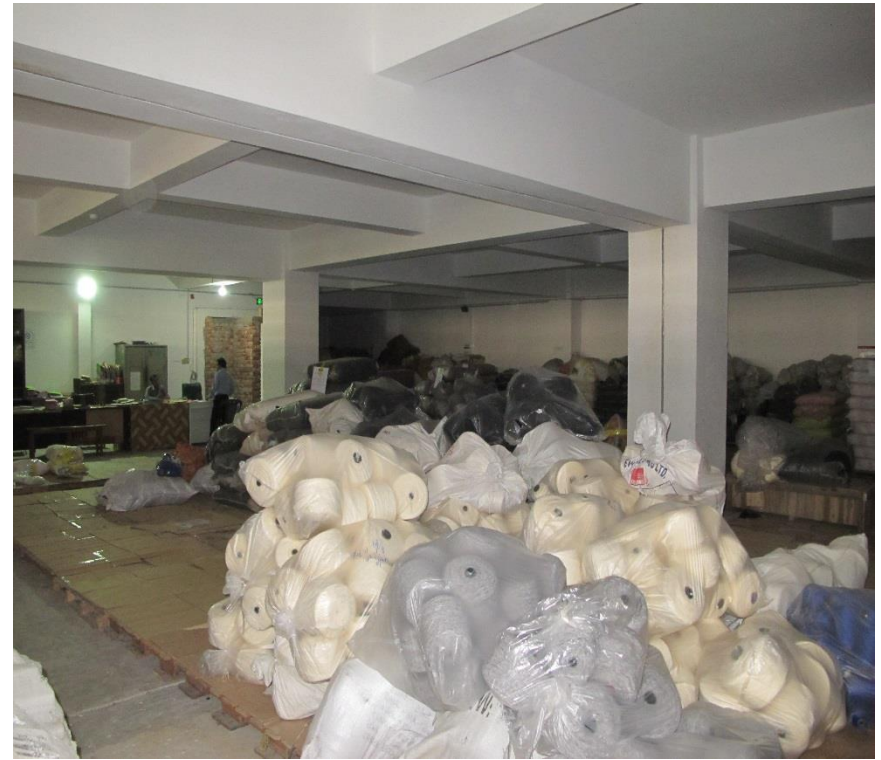
Loading control signage in Storage areas do not correspond to stated design load

**Signage at the entrance to a number of Storage areas indicated a maximum allowable storage load of 80psf for the area. Structural drawings indicate that all areas of all floors designed for 60 psf.**

**Loading control signage in Storage areas do not correspond to stated design load**

| Item No. | Observation | Recommended Action Plan | Recommended Timeline |
|---|---|---|---|
| 8 | Loading control signage in Storage areas do not correspond to stated design load | Building Engineer to assess loading in storage areas and the capacity of the floor structure to accommodate that loading | 6-weeks |
| 9 | Loading control signage in Storage areas do not correspond to stated design load | Provide Load Plan indicating the maximum storage load that can be accommodated by the slab structures | 6-months |
| 10 | Loading control signage in Storage areas do not correspond to stated design load | Post notices at all Storage areas indicating maximum storage loading for each area | 6-months |

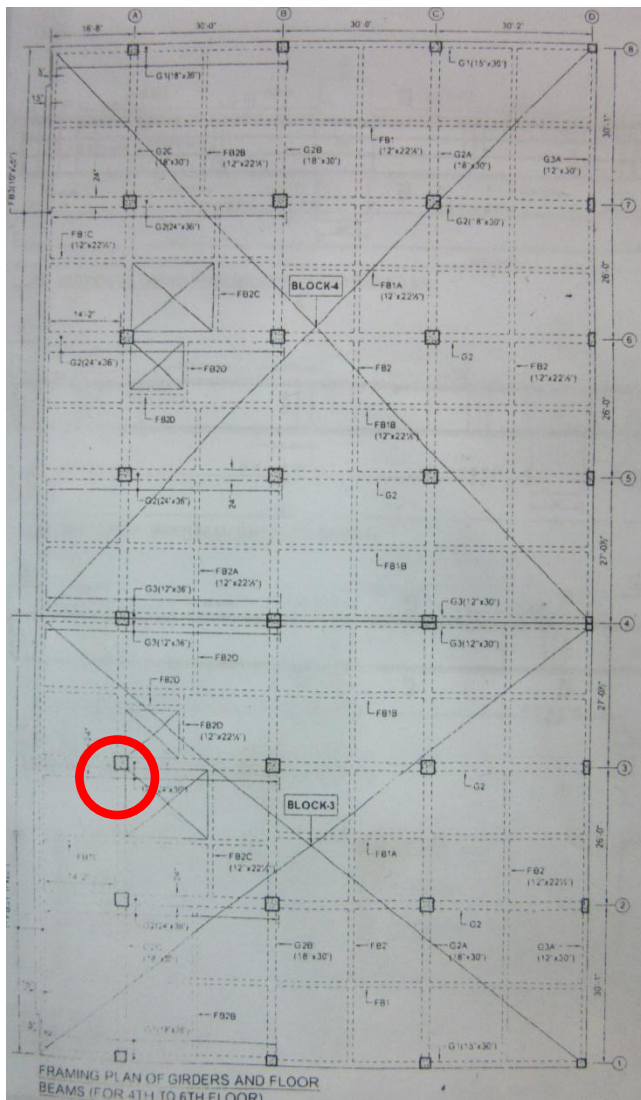
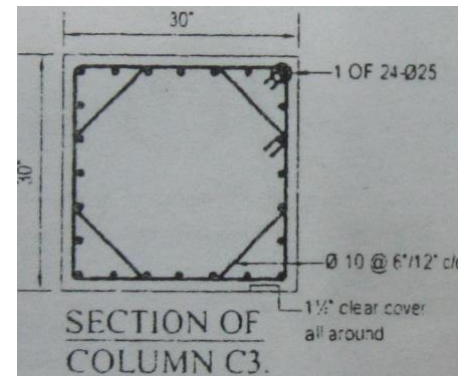
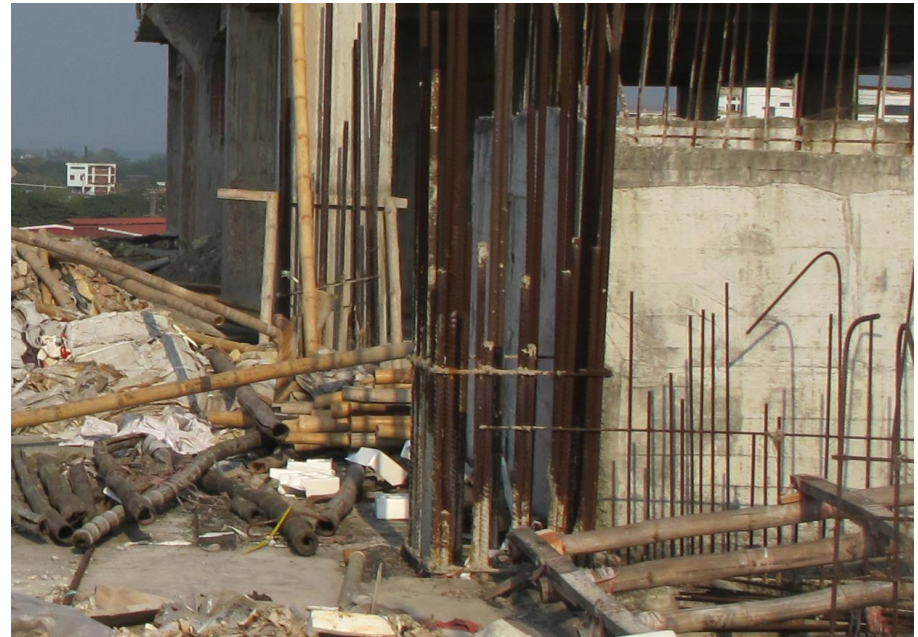
## Discrepancies in the column reinforcement

**For the columns on gridline A supporting cantilevera at blocks 3 and 4, drawing shows 24nos 25mm diam bars, instead 16nos 32mm diam bars observed.**

**Observation: Discrepancies in the drawing**

| Item No. | Observation | Recommended Action Plan | Recommended Timeline |
|---|---|---|---|
| 11 | Discrepancies between the column reinforcement | Update reinforcement drawings to show the correct number and diameter of reinforcement bars used in columns | 6-months |
