Pacific Attires Limited

Plot No. # 09-13 and Adjacent to Plot No. # 13, Sector # 05, Chattogram EPZ.
(22.29569012509762, 91.77564570719528)

18 May 2025

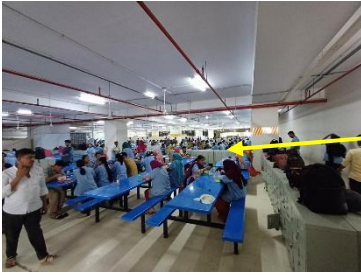
Dining area instead of Printing at 5th floor

Description: During the inspection, discrepancies were observed between the as-built drawing and the on-site condition. 10-inch brick partition wall on all floors except the ground floor, not shown in the as-built drawing. The void area (from the 1st to the 7th floor) is not shown in all the layout plans. The building engineer is required to survey the whole structure and update the as-built drawings reflecting the on-site conditions.

2.		Carry out suggested remedial works if required.	within 6 months
3.	Discrepancies and incomplete as-built drawings (Factory Building).	Building engineer is required to survey the whole structure and update the as-built drawings reflecting the on-site conditions.	within 6 weeks

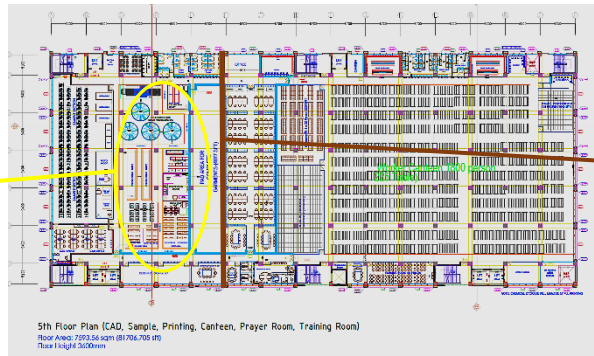
10-inch brick partition at all floor except GF.

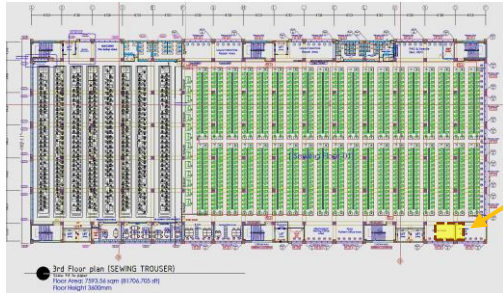
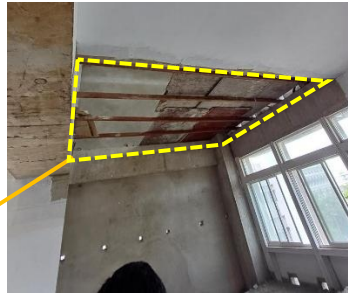
Void area at 1st to 7th floor.

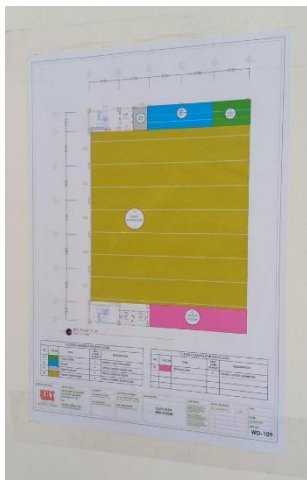
Partial load plan (about 30% of the floor area)

Description: During the inspection, a partial load plan (30% of the total floor area) was found. Dining is found on the 5th floor instead of the Printing section. Also, no load plan prepared or posted at the ground floor, suspended floor and ETP floors. In addition, the warehouse was proposed on the 6th floor, but 5 kPa live load was considered in the load plan, which does not comply with the minimum requirements of BNBC 2020.

The factory is required to revise the load plan as per BNBC 2020 and post it on every floor after getting accepted from RSC.

4.	Prepared load plan to be revised (Factory Building).	The factory is required to revise the load plan as per BNBC 2020 and post it on every floor after getting accepted from RSC.	within 6 weeks

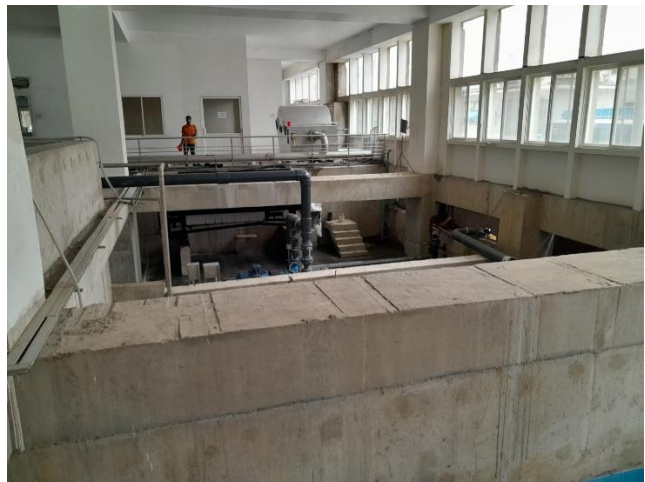
No Load plan for Ground floor and ETP floors

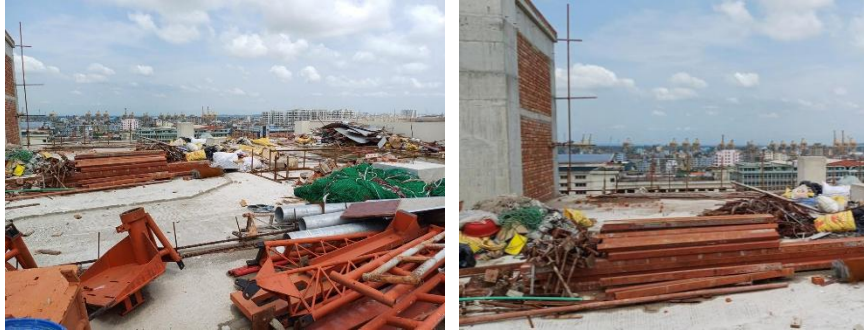
Observation-4: Construction debris on the roof (Factory Building).

Description: During the inspection, construction debris and stagnant water were found on the roof. The factory is required to remove all the construction debris and stagnant water.

5.		Building engineer is required to implement the accepted load plan.	within 6 weeks
6.	Construction debris on the roof (Factory Building).	The factory is required to remove all the construction debris and stagnant water.	within 6 weeks

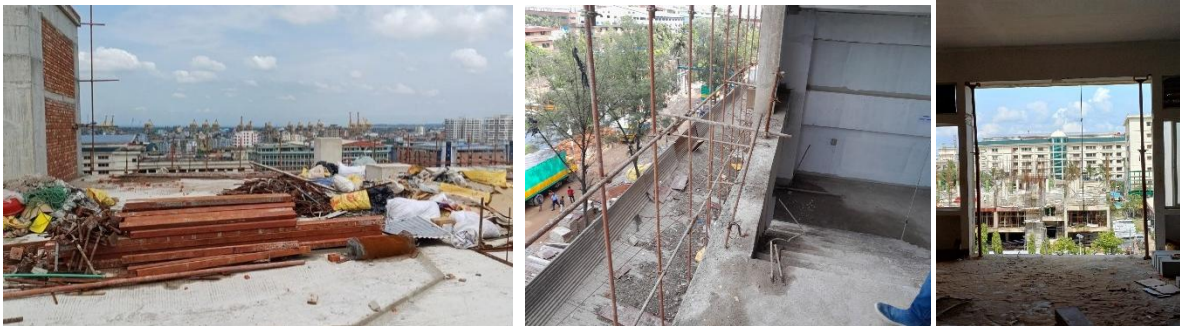
Observation-5: Falling hazard (Factory Building).

Description: During the inspection, the parapet or railing was missing at several locations and staircase. The factory is required to provide parapet/railing at all locations and a staircase to avoid the possible falling hazard.

7.	Falling hazard (Factory Building).	The factory is required to provide parapet/railing at all locations and a staircase to avoid the possible falling hazard.	within 6 weeks
Utility Building

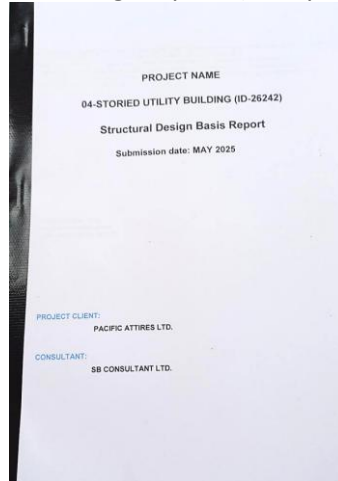
Observation-6: Inconsistencies & incomplete design report. (Utility Building).

Description: Calculation for average strength of materials and frequency of testing not incorporated in the design report. Also, serviceability check, justification for the considered framing system, site class calculations, foundation adequacy check in detail, beam and slab adequacy check in detail, etc., were not provided properly in the design report.

The building engineer is required to prepare a comprehensive design report per BNBC 2020 and submit the EA documents to RSC for detailed review.

8.	Inconsistencies and incomplete design report (Utility Building).	The building engineer is required to prepare a comprehensive design report per BNBC 2020 and submit the EA documents to RSC for detailed review.	within 6 weeks

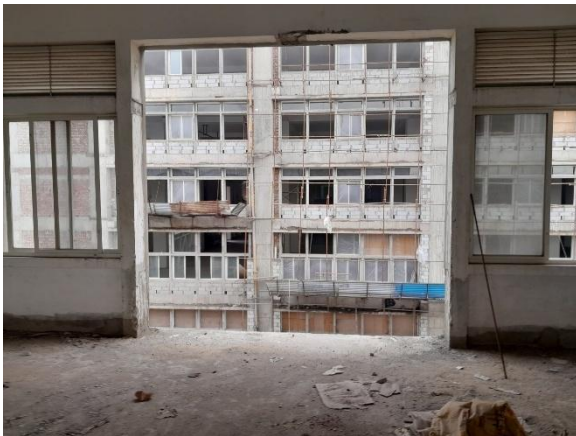
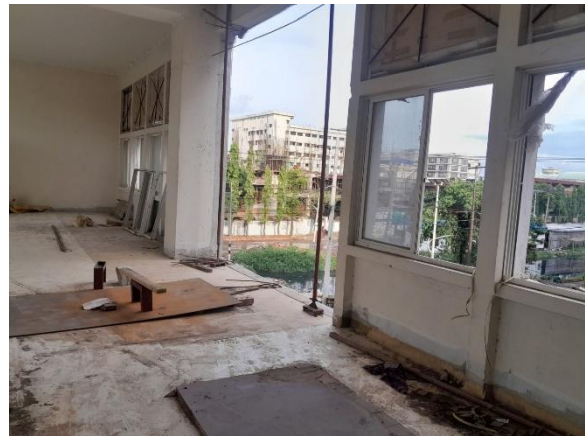
Observation-7: Falling hazard (Utility Building).

Description: During the inspection, the railing was missing at several locations. The factory is required to provide a parapet/railing at all locations to avoid the possible falling hazard.

9.		Carry out suggested remedial works if required.	within 6 months
10.	Falling hazard (Utility Building).	The factory is required to provide a parapet/railing at all locations to avoid the possible falling hazard.	within 6 weeks
Boiler Building

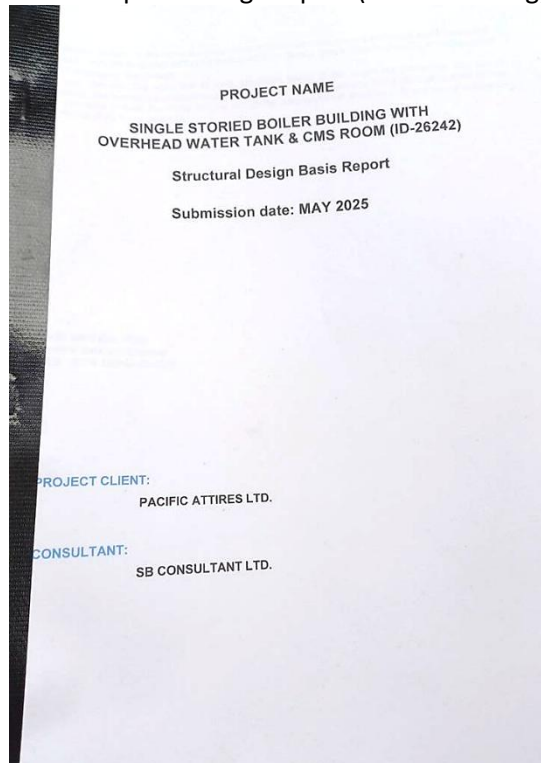
Observation-8: Inconsistencies and incomplete design report (Boiler Building).

Description: Calculation for average strength of materials and frequency of testing not incorporated in the design report. Also, serviceability check, justification for the considered framing system, foundation adequacy check in detail, beam and slab adequacy check in detail, etc., were not provided properly in the design report.

The building engineer is required to prepare a comprehensive design report in accordance with BNBC 2020 and submit the EA documents to RSC for detailed review.

11.	Inconsistencies and incomplete design report (Boiler Building).	The building engineer is required to prepare a comprehensive design report in accordance with BNBC 2020 and submit the EA documents to RSC for detailed review.	within 6 weeks

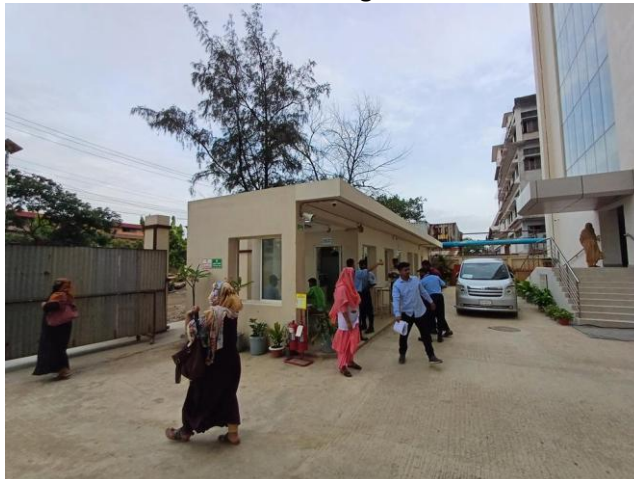
Observation-9: Heavy vehicle movement on slab of Underground Water Reservoir Tank. (Ancillary Blocks).

Description: During inspection, heavy vehicle movement was found on top slab of Underground Water Reservoir Tank. Building engineer is required to prepare slab adequacy check for heavy vehicle movement and submit it to RSC for review.

Ancillary Blocks			
13.	Heavy vehicle movement on slab of Underground Water Reservoir Tank. (Ancillary Blocks).	Building engineer is required to prepare slab adequacy check for heavy vehicle movement and submit it to RSC for review.	within 6 weeks
14.		Carry out suggested remedial works if required.	within 6 months
Connecting Bridge (for steam pipe)			
15.	Corrosion on the steel members.	Building engineer is required to apply anti-corrosive coating to protect the steel members from corrosion.	within 6 weeks

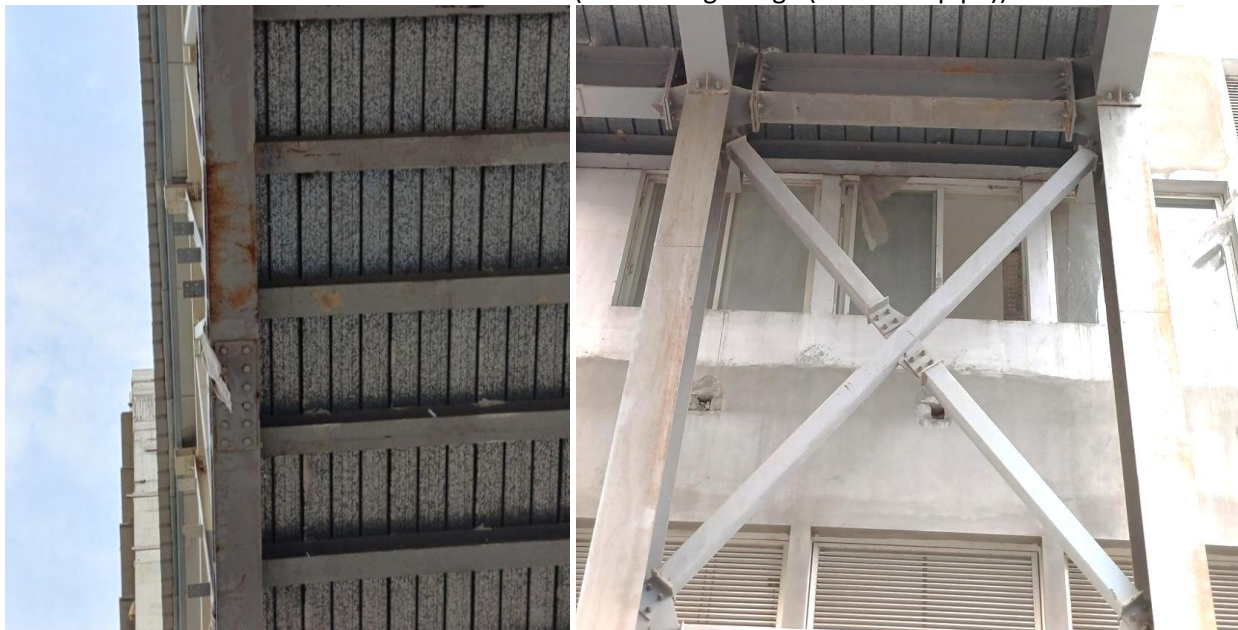
Observation-10: Corrosion on the steel members (Connecting Bridge (for steam pipe)).

Description: During inspection, corrosion was found on the steel members. Building engineer is required to apply anti-corrosive coating to protect the steel members from corrosion.
