# L'Usine Fashions Ltd. (Ref. 9258)

36, Gazipura, Sataish Road, Tongi, Gazipur-1712, Bangladesh

08.MARCH.2014

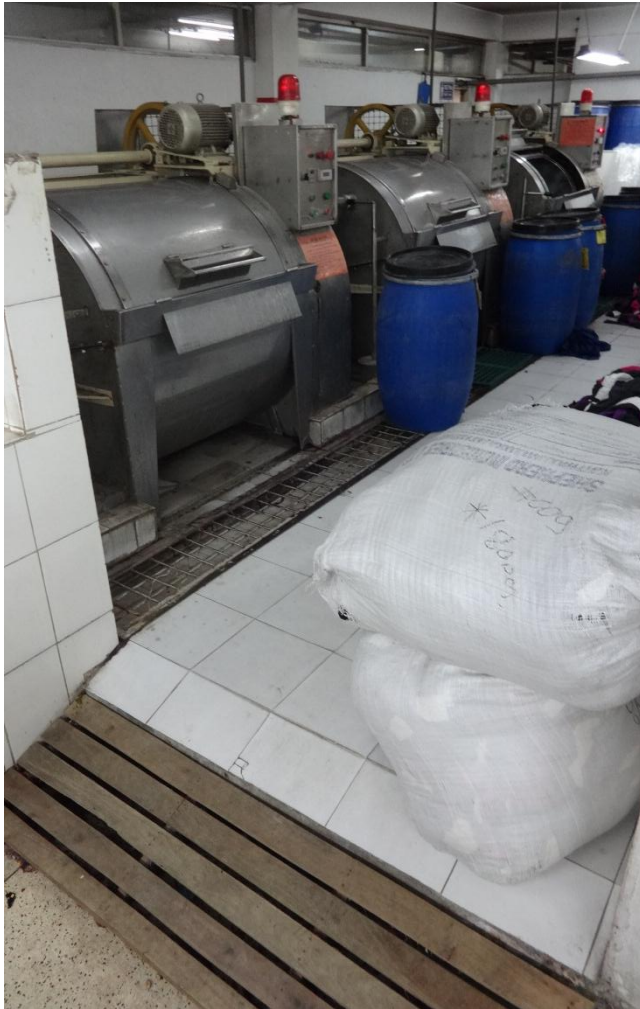
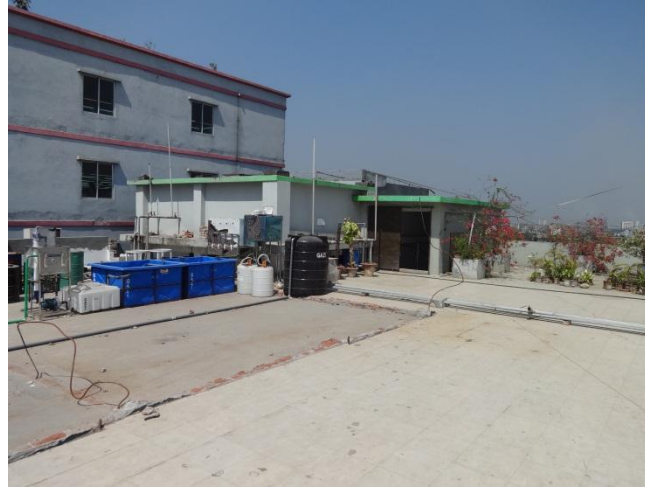
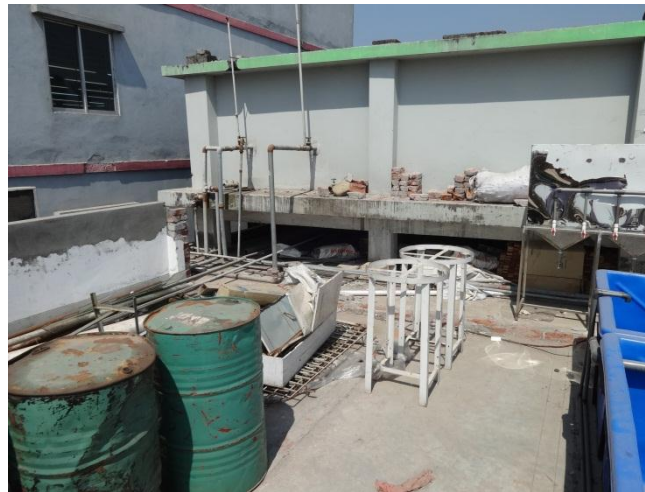
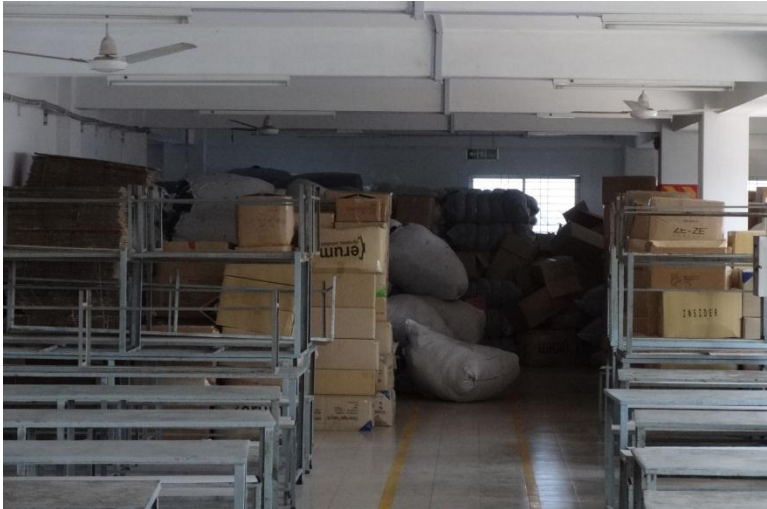
## 1<sup>st</sup> Priority 1 Concern

Heavy machinery at 1<sup>st</sup> floor level and large water reserve at roof level. Both have ancillary structural support systems which are not detailed in the structural drawings and should be checked through detailed design.

The large pieces of equipment shown at 1<sup>st</sup> floor level, and the water reserve at roof level, clearly exceed the design loading of  $3\text{kN/m}^2$ . This may not be a structural issue, as ancillary support systems have been constructed, however the capacity of these systems must be determined through detailed structural analysis.

**ITEM 1: (1<sup>st</sup> Priority 1) Heavy equipment at 1<sup>st</sup> floor level and water reserve at roof level exceed standard design loads. Ancillary support structures have been constructed but their capacity has not been checked in detail.**

Heavy equipment at 1<sup>st</sup> floor level and water reserve at roof level supported on structures which require further investigation.

- Carry out a detailed structural check of both the slab thickening at 1<sup>st</sup> floor level (and supporting columns) as well as the water reserve support structure at roof level.

- After determining the max. allowable loads in the stated areas, the equipment should be marked with its self-weight to ensure that the allowable load is not exceeded.

- Monitor the underside of the slab below (both the heavy equipment at 1<sup>st</sup> floor level and the water reserve at roof level) to ensure signs of distress do not develop.

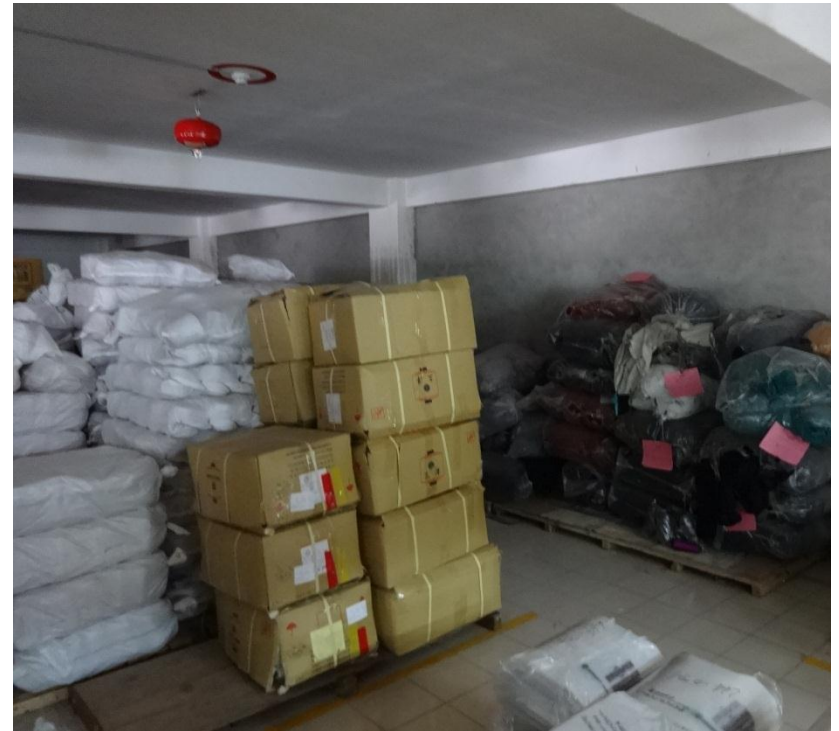
## 2<sup>nd</sup> Priority 1 Concern

Storage loading  
clearly exceeding  
3kN/m<sup>2</sup> design load.

The boxes shown in these photographs are labelled as 25.78kg each. They are stacked to a maximum of 6 boxes in height, with a plan area of approximately 700 x 450mm. The simple calculation below shows that the resultant area load comfortably exceeds the 3kN/m<sup>2</sup> maximum.

**ITEM 2: (2<sup>nd</sup> Priority 1) Storage of boxes and bags of material exceeds design loading by approximately 65%.**

Storage of boxes and bags of material/garments, which clearly exceed the 3kN/m<sup>2</sup> design loading.

- Remove all storage that exceeds the already marked lines of maximum storage height.

- Carry out detailed structural analysis to determine whether or not the existing limits are acceptable.
- If not, new storage height limits should be determined.

- Monitor the storage of goods to ensure maximum height are not exceeded.
- Erect clear signage to relay the meaning of the maximum height markers to the staff.

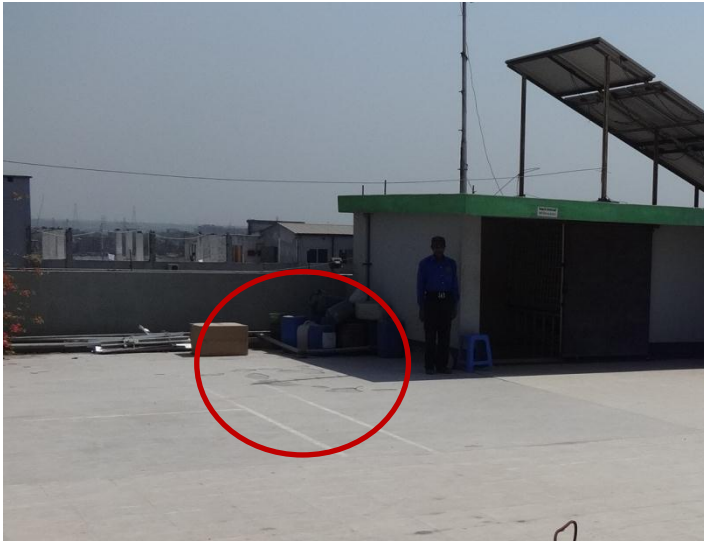
## 1<sup>st</sup> Priority 2 Concern

Small areas of damage to rooftop waterproofing layer should be repaired and monitored to ensure no signs of water ingress appear.

No signs of water ingress were observed, however the areas of damage should be repaired and internal soffits monitored to ensure that water ingress has not/does not occur.

**ITEM 3: (1<sup>st</sup> Priority 2) Waterproofing layer on the roof has some small areas of damage which should be repaired.**

Waterproofing layer at roof level shows some signs of damage, which could potentially lead to water ingress.

- Locally repair waterproofing in areas where it has been damaged.
- The missing areas should be covered with sufficient lap to ensure a continuous barrier.

- Continuing repairs should be carried out in future, where necessary.
- Monitor the underside of the slab below to ensure signs of water ingress do not develop.

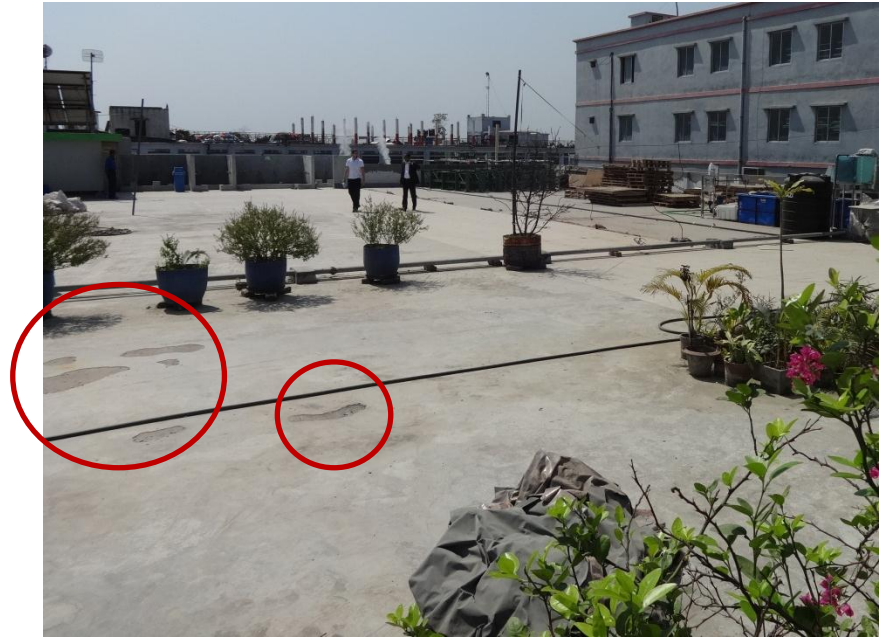
Missing areas of  
waterproofing layer on  
rooftop.
