# **FIRE SAFETY INSPECTION REPORT**

**MODISTE (CEPZ) LTD,  
PLOT NO # 33-36, SECTOR # 07, EXPORT  
PROCESSING ZONE**

**ACCORD**  
on Fire and Building Safety in Bangladesh

June 2, 2014

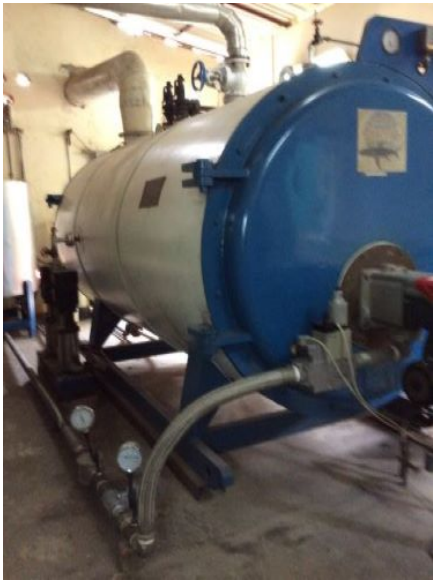
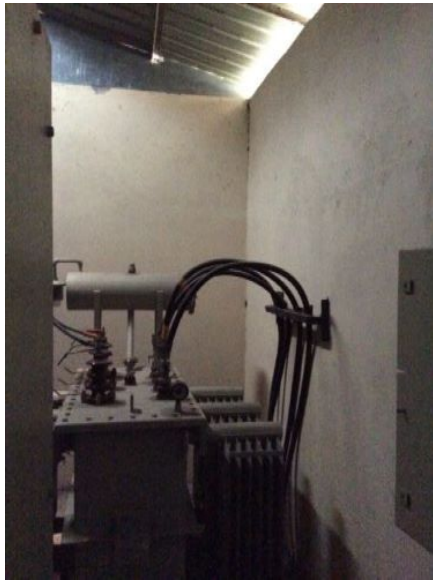
| No. | Category | Finding | Recommendation | Remediation Timeframe |
|---|---|---|---|---|
| F-1 | Fire Rated Construction | The boiler and transformer rooms are not separated by fire-rated construction that is openings, non-rated doors, penetrations on ground floor. | Separate the boiler and transformer rooms by a minimum 2-hr fire-rated construction. Seal and/or protected all openings to maintain the required fire separations | Within 3 months |

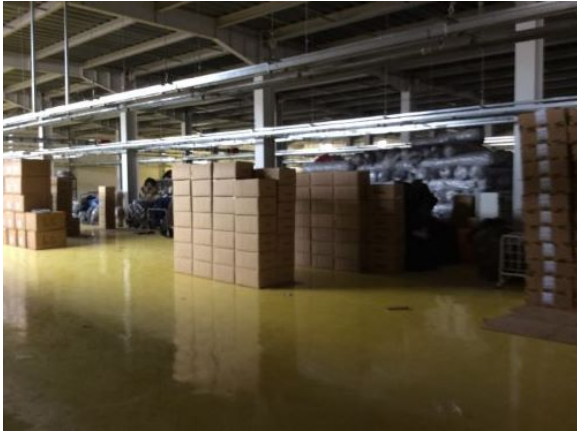
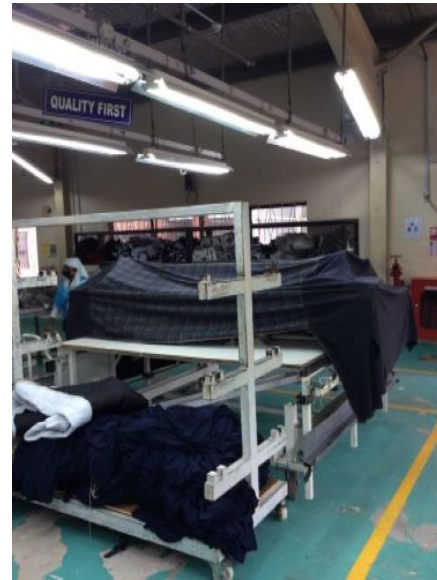
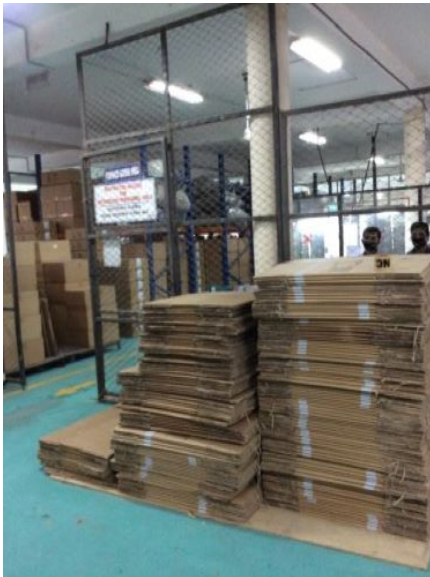
| No. | Category | Finding | Recommendation | Remediation Timeframe |
|---|---|---|---|---|
| F-2 | Fire Rated Construction | Areas used for combustible storage are not separated by fire-rated construction on all floors. | Provide dedicated storage rooms separated by minimum 1-hr fire-rated construction. | Within 3 months |

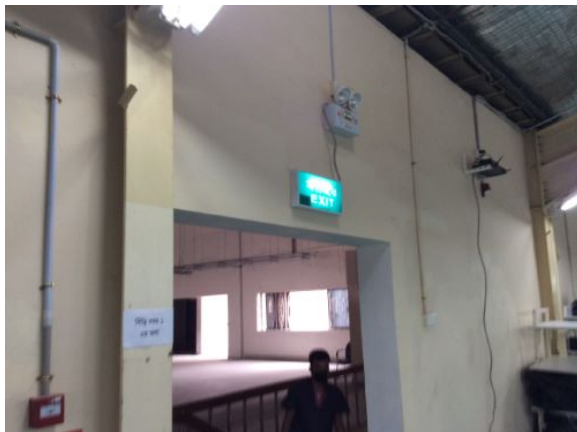
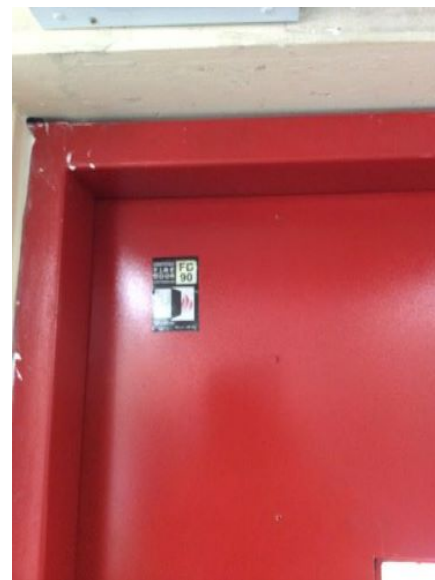
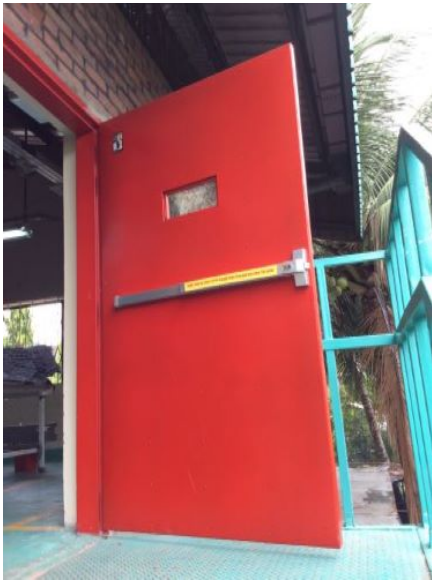
| F-3 | Fire Rated Construction | The exit stairs are not separated from work areas, and other spaces on each floor at south exit stair by fire-rated construction. However, the north and east exit stair are provided with 1.5-Hr. fire rated door | Provide minimum 1.5-hr fire rated doors and seal all unprotected openings to separate the exit stairs from work areas and other building spaces on all floor levels. Ensure that the fire doors are self-closing and positive latching and that they are provided with fire exit (panic) hardware where serving production floors. | Within 3 months |

If fire doors are required to be held open for functional reasons, provide automatic-closing devices tied to the fire alarm system.

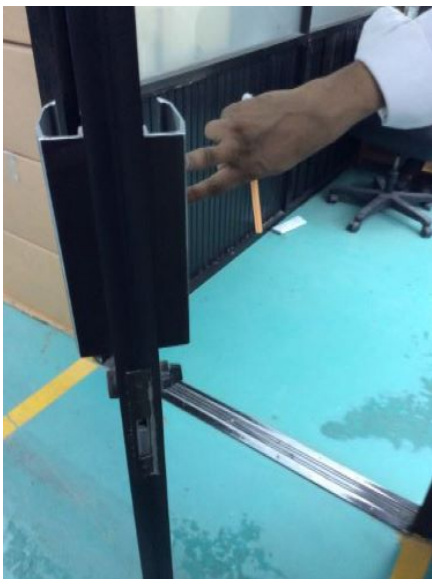
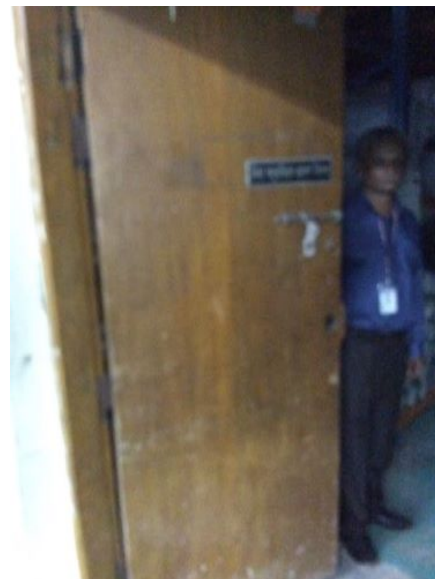
| F-4 | Egress | Egress doors / gates with locking features are provided at building exits, along egress routes, on ground and first floors. All doors are open and unlocked during inspection. | Remove locking features from all egress doors / gates.<br><br>If locks are required for security reasons, utilize special door locking features complying with NFPA 101. | Immediate |

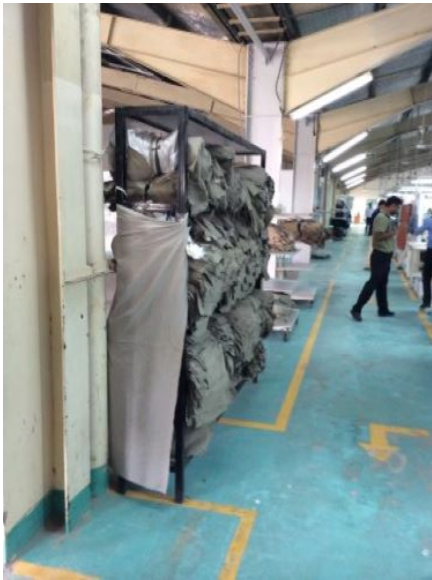
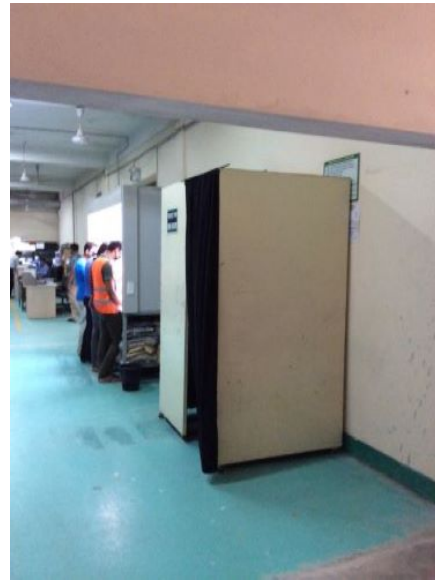
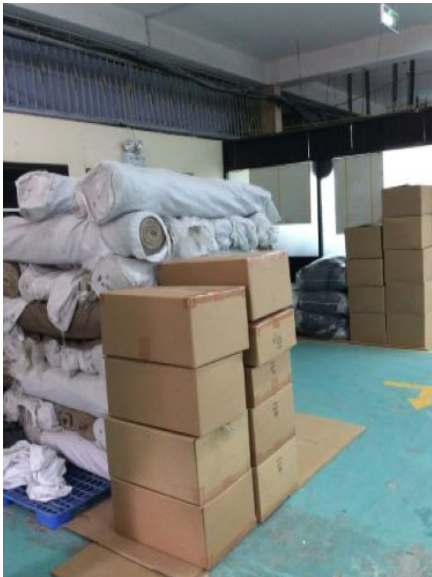
| F-5 | Egress | Storage was located in the egress path on ground and first floor. | Keep egress paths and stairs clear of storage. | Immediate |

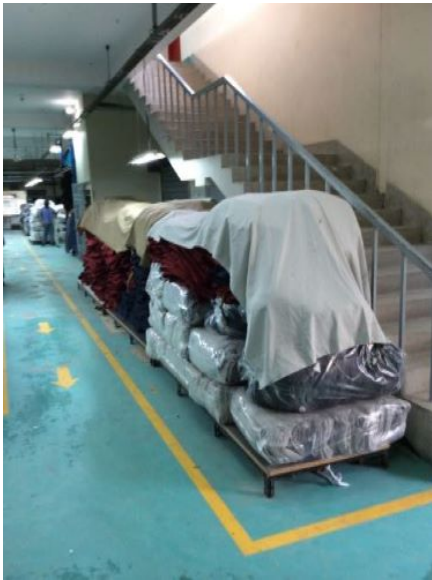
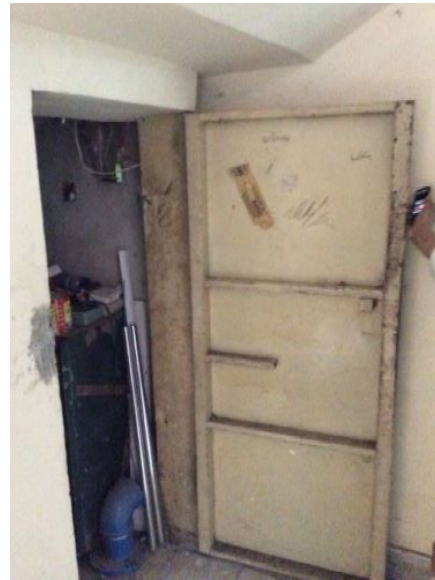
| F-6 | Egress | Storage was located in the exit stair on ground floor south exit stair . | Remove all storage from exit stairs and egress paths. | Immediate |

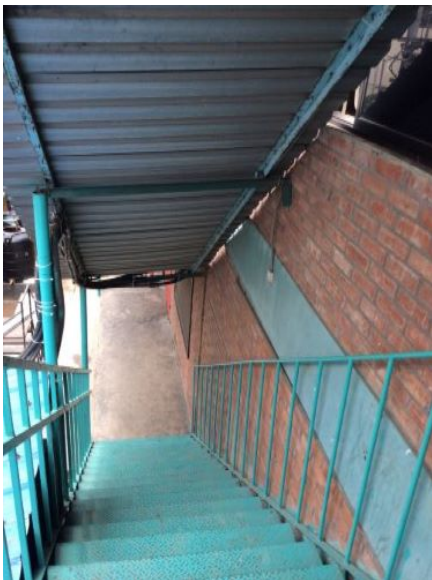
| F-7 | Egress | Unsealed penetrations and openings are located in exit stair enclosures. | Seal all penetrations and openings in exit stair enclosure walls to maintain the fire separation. | Within 3 months |

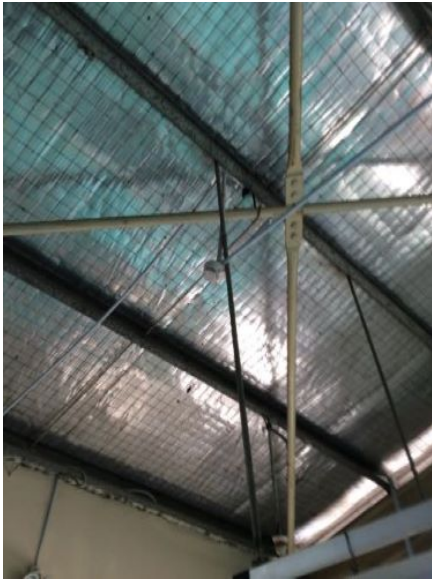
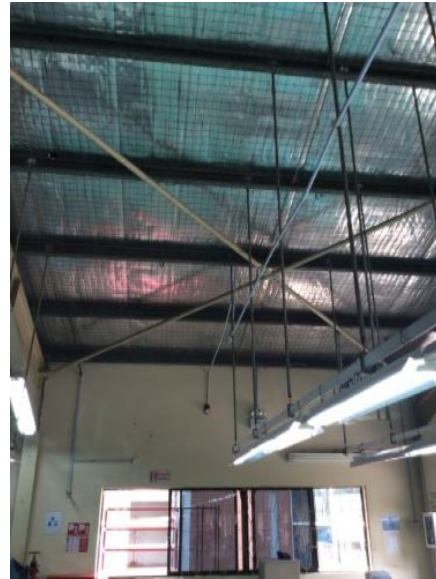
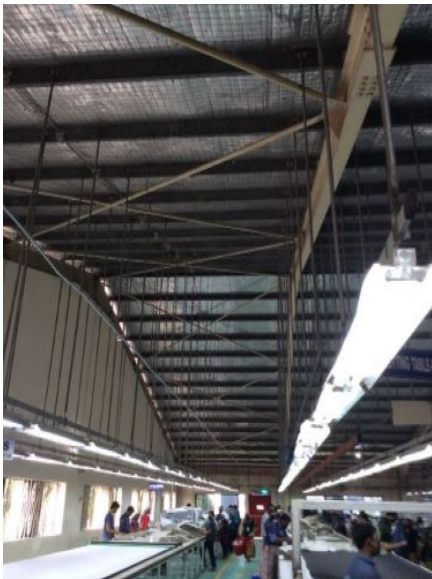
| F-9 | Fire Protection | The conduits, conduit supports, and smoke detector supports installed are not the correct type. | Provide RSC conduits or Raceway type system for wires and Hanger support system | Within 3 months |
