# ELECTRICAL SAFETY INSPECTION REPORT

## MULTIFABS LTD.

Inspected on April 9, 2014

**ACCORD**  
on Fire and Building Safety in Bangladesh

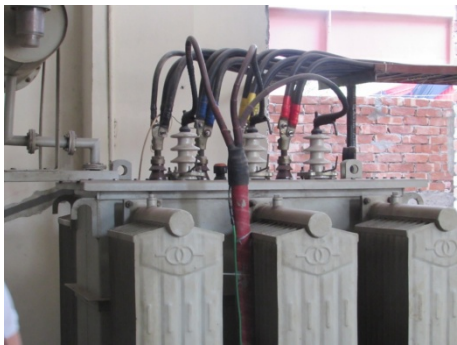
| <b>Finding #:</b> E- 1 | <p>HT cables are terminating at HT bushing.</p> |

| <b>Finding:</b><br><br>HT cable is not supported. | |

| <b>Recommendation:</b><br><br>HT Cable must be supported by cable riser or ladder with cover to ensure the mechanical protection of the cables from any physical damage or reduce the stress on termination point /bushing. | |

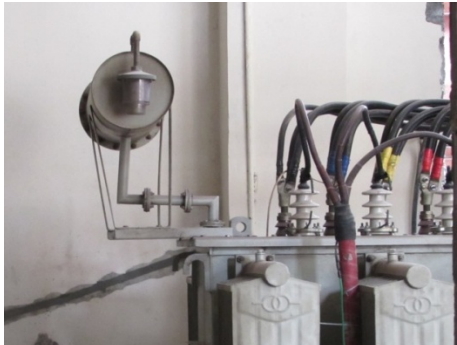
| <b>Finding:</b><br><br>Silica gel is discolored. | |

| <b>Recommendation:</b><br><br>Shut down the transformer and replace the silica gel or perform maintenance to remove moisture from it. Consult with transformer servicing company before performing the task. Establish a routine maintenance & inspection program for transformer to ensure any future repetition of the occurrence. | |

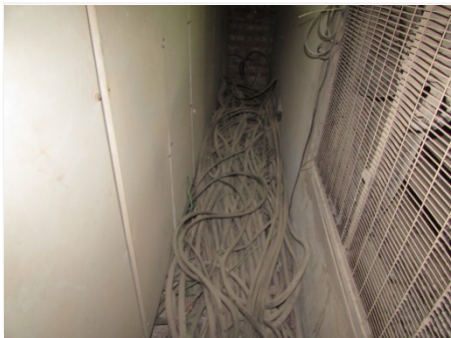
| <b>Finding #:</b> E- 3 | |

| <b>Finding:</b><br><br>Cables are not supported. | |
| <b>Remediation Timeframe:</b> 3 months | Cables are laid behind the panels. |

| <b>Recommendation:</b><br><br>Cable tray and riser with protective metal cover may be installed to support the cables laid haphazardly on floor behind the panel or cable trench may be constructed to arrange the cable inside the trench. | |

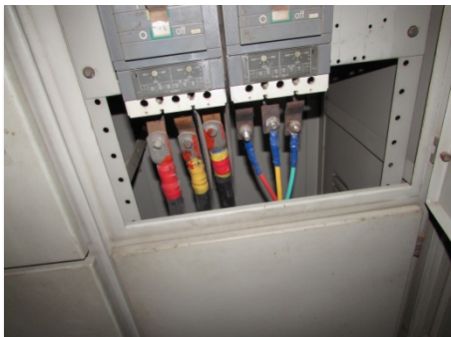
| <b>Finding #:</b> E- 4 | |

| <b>Finding:</b><br><br>Improper cable size terminating to the MCCB. | |
| <b>Remediation Timeframe:</b> 3 months | Small sized cable in MCCB. |

| <b>Recommendation:</b><br><br>Check the cables and circuit-breaker to find out the higher rated circuit-breakers. Choose the circuit-breaker according to the cable-size such as the rating of the device does not exceed the current carrying capacity of the cable. | |

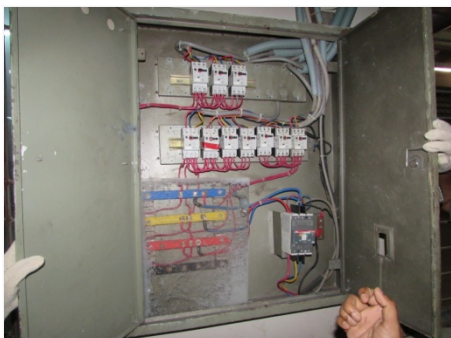
| <b>Finding #:</b> E- 5 | |

| <b>Finding:</b><br><br>Panel door is not connected to the earth bond. | |
| <b>Remediation Timeframe:</b> Within 1 month | Typical distribution panel. |

| <b>Recommendation:</b><br><br>Provide earth connection for body and doors of metallic distribution boards using green cables preferably braid so that the metallic door remains at zero potential all the time. | |

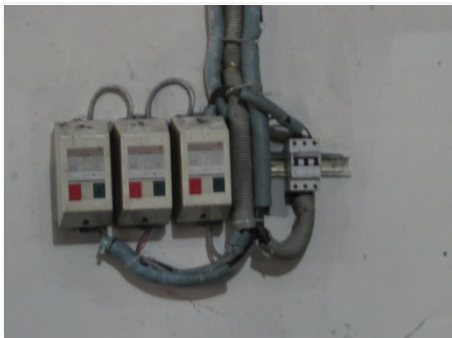
| <b>Finding #:</b> E- 6 | <p>MCB is mounted on the wall without any enclosure.</p> |

| <b>Finding:</b><br><br>Control device is installed without enclosure. | |

| <b>Recommendation:</b><br><br>Place the protection devices inside an enclosed panel made of metallic sheet of minimum 20 SWG thickness. | |

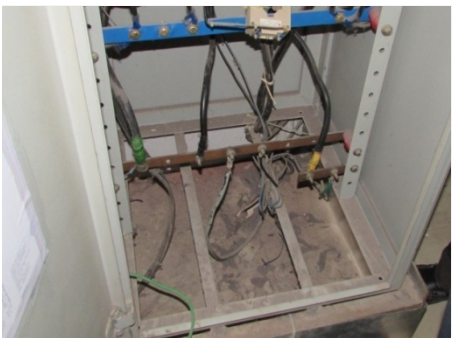
| <b>Finding:</b><br><br>Excessive dust found inside the panel. | |

| <b>Recommendation:</b><br><br>Disconnect the power source of the panel and clean dust and debris of all interior components. Establish a periodic cleaning program and maintain records of the activities. Provide cover made of noncombustible material on the unused opening for preventing ingress of dust and debris in future. | |

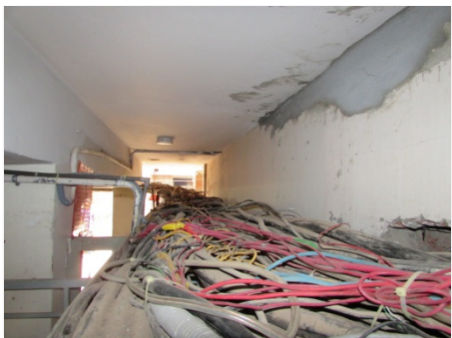
| <b>Finding:</b><br><br>Cables are kept hazardous in the cable tray. | |

| <b>Recommendation:</b><br><br>Additional cable tray may be installed to arrange the noted cables laid haphazardly on tray. Keep 30% free inside cable tray/channels/ducts for proper heat dissipation. Provide cover made of noncombustible material on the channel for preventing ingress of dust and debris in future | |

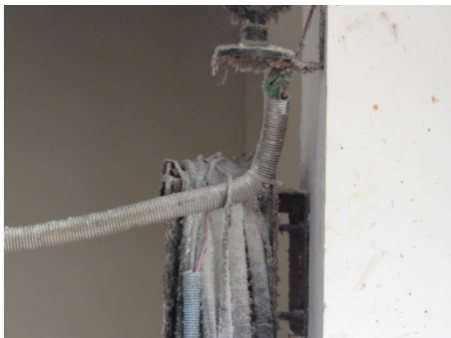
| <b>Finding #:</b> E- 9 | <p>Excessive dust on cables.</p> |

| <b>Finding:</b><br><br>Flexible conduit containing power cable is covered by dust. | |

| <b>Recommendation:</b><br><br>Establish a periodic cleaning program and maintain records of the activities. | |
