# Pioneer Knitwears (BD) Ltd. (Extension 2)

Jamirdia, Habirbari, Valuka, Mymensingh-2240

17 June 2025

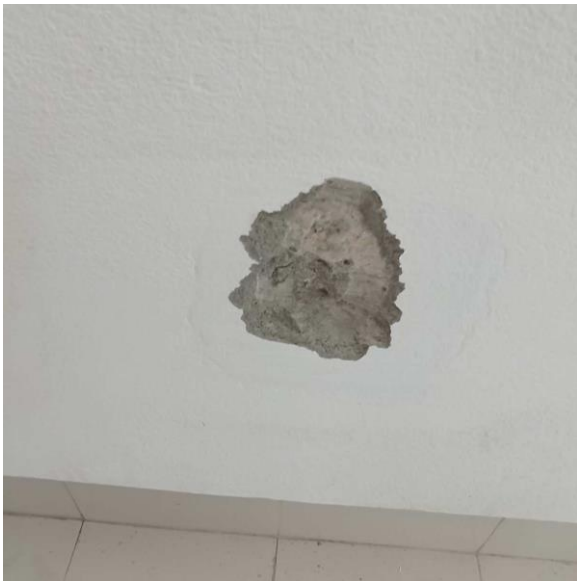
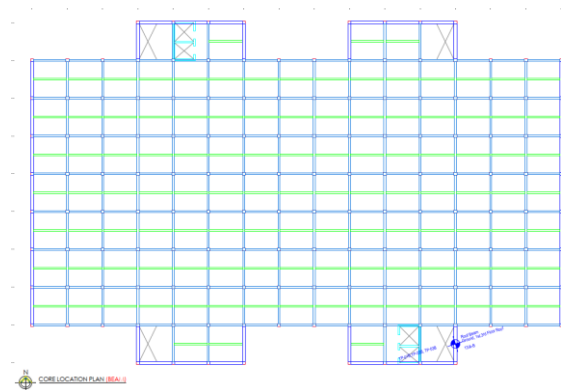
**Observation-01:** Core layout doesn't match with onsite conditions. (R & D Building).

**Description:** At the time of inspection, accepted core layout from RSC was available on site. However, the location of the core of the slab was not found. Also, the location of the core of the beams didn't match with onsite condition. The building engineer is required to identify the location of the core from slab and update core layout as per the onsite condition. Keep the updated layout onsite for further verification.

| Item No | Observation | Action Plan | Timeline |
|---|---|---|---|
| 1. | Core layout doesn't match with onsite conditions. (R & D Building). | The building engineer is required to identify the location of the core from slab and update core layout as per the onsite condition. Keep the updated layout onsite for further verification. | within 6 weeks |

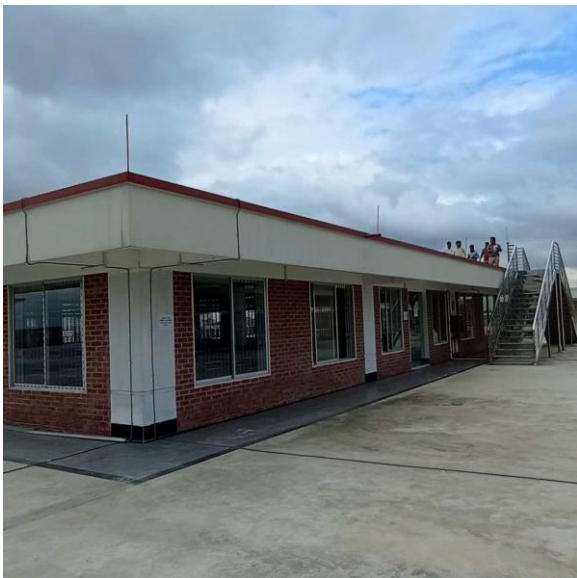
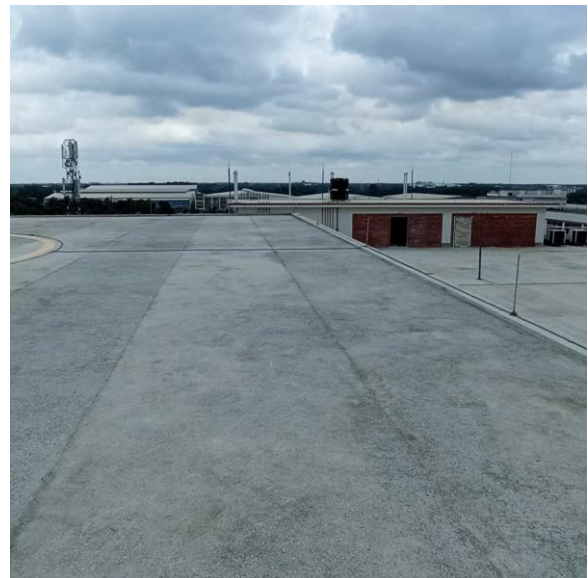
**Observation-02:** Falling hazard at helipad area (R & D Building).

**Description:** Falling hazard was observed at the helipad area as no parapet/railing is provided. Provide edge protection to avoid a falling hazard.

| Item No | Observation | Action Plan | Timeline |
|---|---|---|---|
| 2. | Falling hazard at helipad area (R & D Building). | Provide edge protection to avoid a falling hazard. | within 6 weeks |

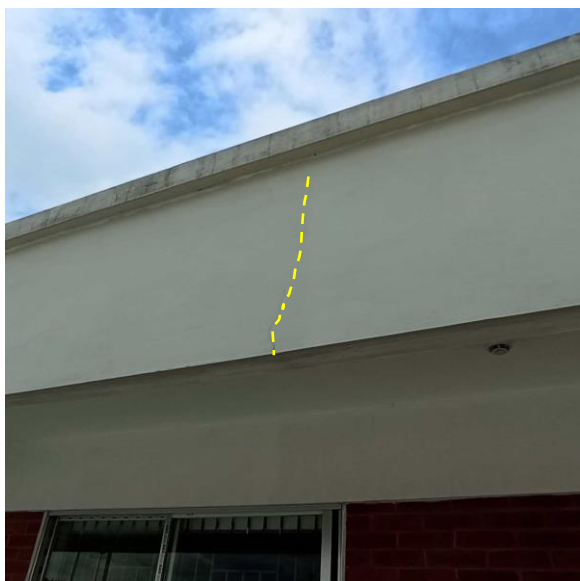
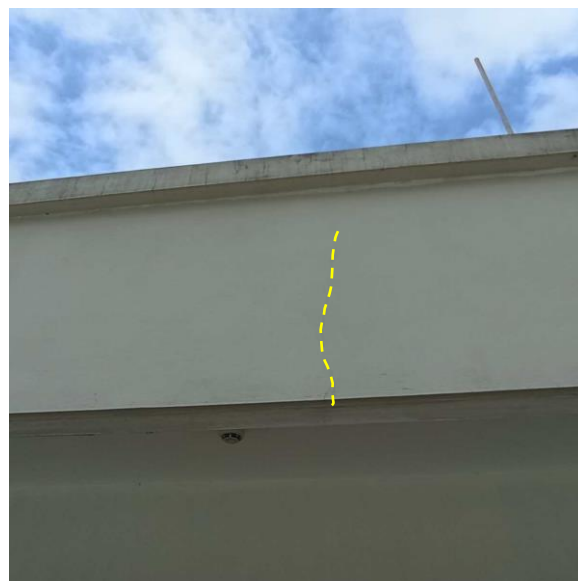
**Observation-03:** Appearance of crack on drop wall at roof level canteen area (R & D Building).

**Description:** Hairline cracks were observed on the drop wall at the roof level canteen area. The building engineer is required to repair the crack with a suitable method.

| Item No | Observation | Action Plan | Timeline |
|---|---|---|---|
| 3. | Appearance of crack on drop wall at roof level canteen area (R & D Building). | The building engineer is required to repair the crack with a suitable method. | within 6 weeks |

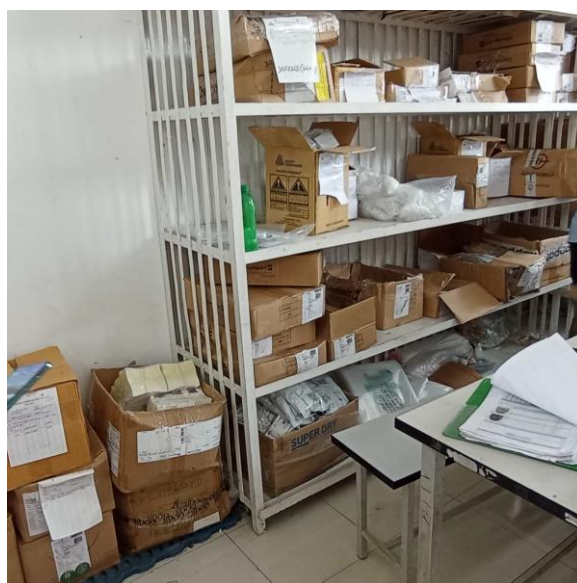
**Observation-04:** Nonstructural elements (storage racks) were found as not anchored/braced at some places (R & D Building).

**Description:** Storage racks were found as not anchored/braced at some places (R & D Building). The building engineer is required to anchor/brace all non-structural elements.

| Item No | Observation | Action Plan | Timeline |
|---|---|---|---|
| 4. | Nonstructural elements (storage racks) were found as not anchored/braced at some places (R & D Building) | The building engineer is required to anchor/brace all non-structural elements. | within 6 months |
