Oxford Knit Composite Ltd. (Extension)

260, Ariab, Rupshi, Tarabo Pourosova, Rugganj, Narayanganj

24 June 2025

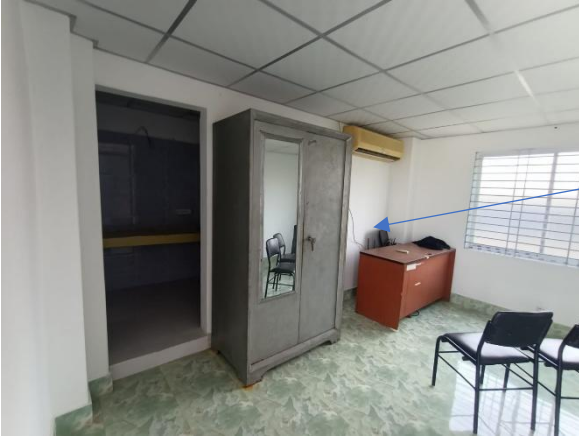
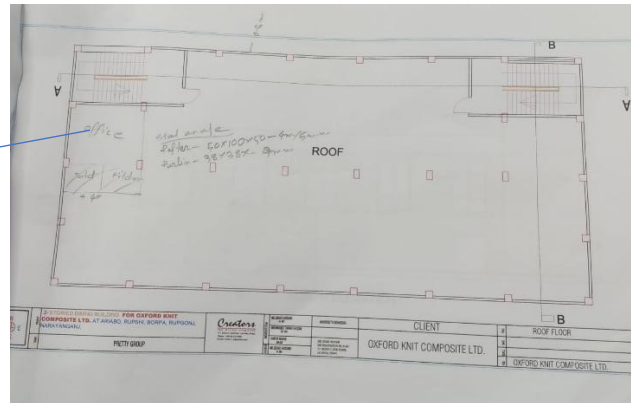
Observation-1: Mismatches in as-built drawings (Building-5).

Description: Structural and architectural details were not available for rooftop office shed. The building engineer is required to survey the whole structure and prepare accurate as-built drawings.

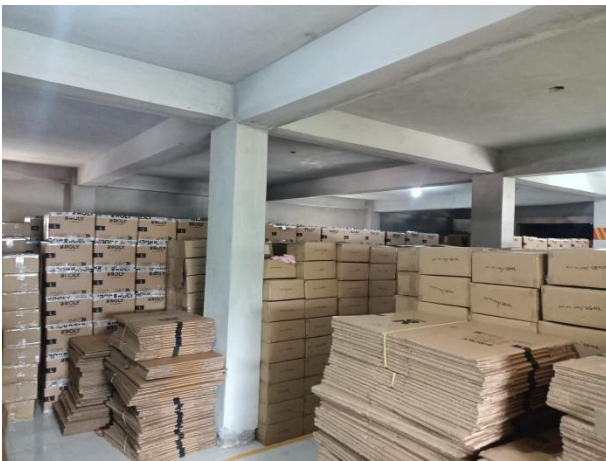
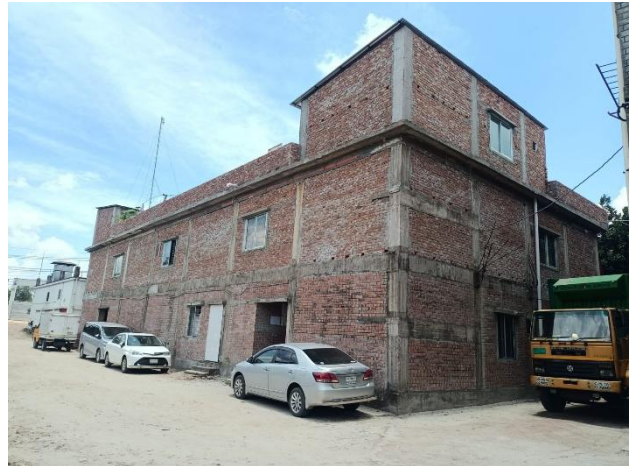
Observation 2: Absence of design report (Building-5).

Description: As per BNBC, every building or structure designed shall have its design documents prepared following the provision of Section 1.9.1. The design document shall include a design report and a structural drawing. At the time of inspection, no design report was available which is required to be prepared (including roof shed) in compliance with section 1.9.1.1 and section 1.9.1.2 (part 6, BNBC).

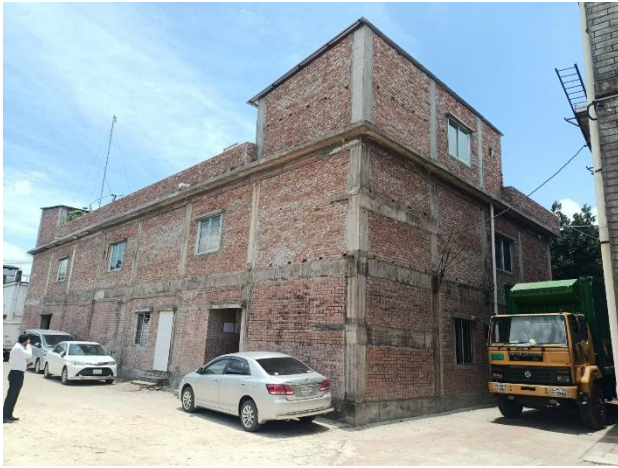
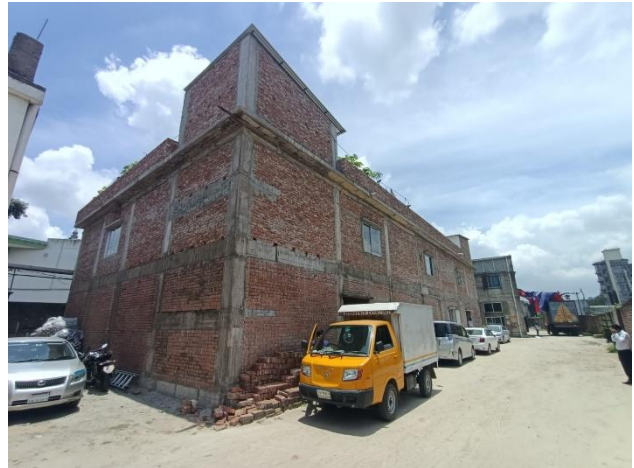
Observation-3: Vehicle impact risk on column (Building-5).

Description: Columns in the south are susceptible to vehicle impact. The factory is required to provide separate column guards to avoid vehicle impact.

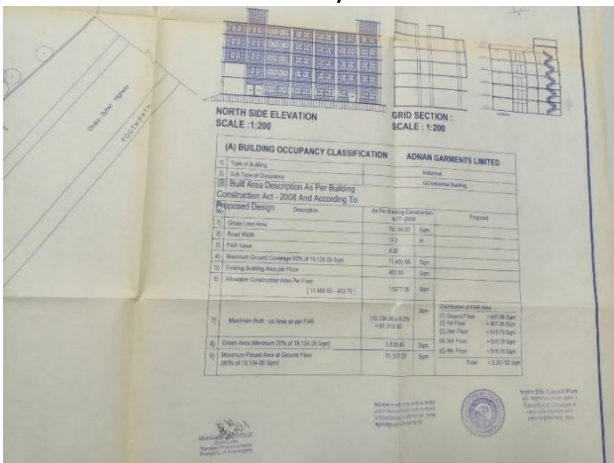
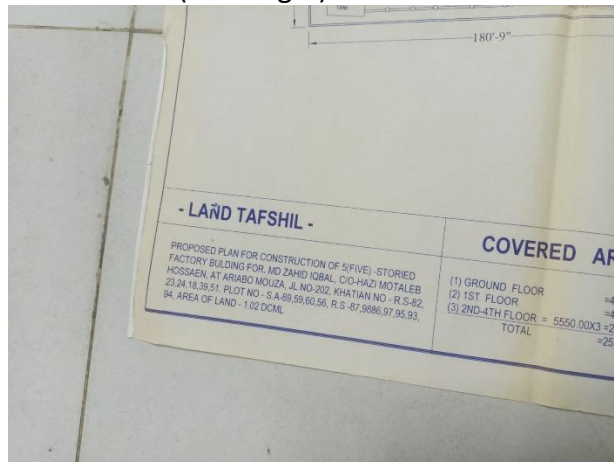
Observation 4: Probability of vertical and horizontal extension (Building-5).

Description: The building is permitted for 5 stories. So, there is a possibility of horizontal & vertical extension of the building according to the approved layout. Prior to any extension, a Detailed Engineering Assessment (DEA) is required to be carried out and submit to RSC for review.

06	Probability of vertical and horizontal extension (Building-5).	In case of any extension, the building engineer is required to conduct a Detail Engineering Assessment (DEA) prior commencement of construction work. Submit DEA documents to the RSC for review.	within 6 months
