# **FIRE SAFETY INSPECTION REPORT**

**SAMS ATTIRE LTD.**

**BHUIYAN TOWER, PLOT NO. 10, ASHULIA JAMGORA,  
SAVAR**

March 23, 2014

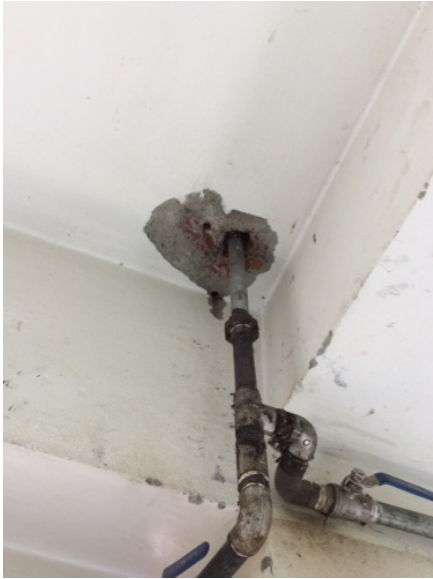
| No. | Category | Finding | Recommendation | Remediation Timeframe |
|---|---|---|---|---|
| F-1 | Fire Rated Construction | An unsealed penetration and opening is located in the fire-rated ceiling assembly on the fifth floor. | Seal all penetrations and openings in floor and ceiling assemblies to maintain the fire separation. | Within 3 months |

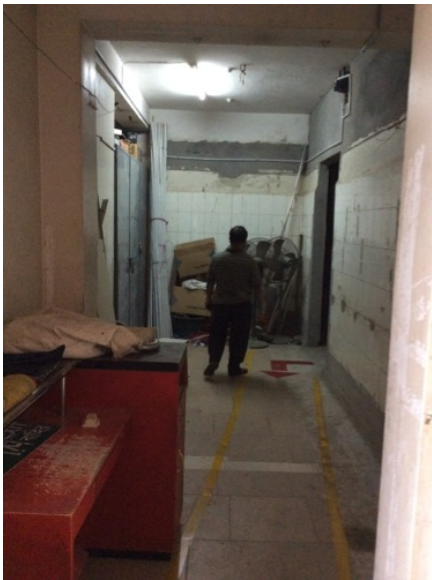
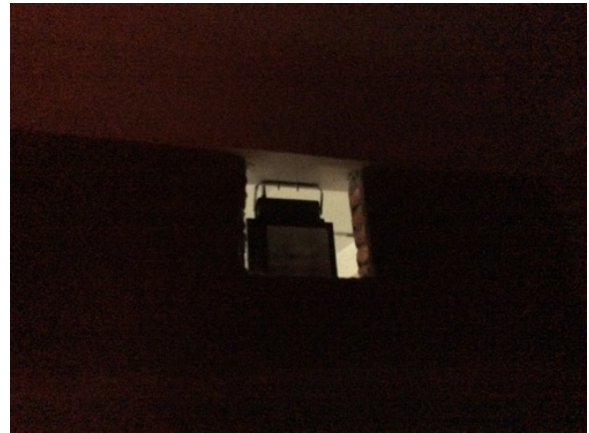
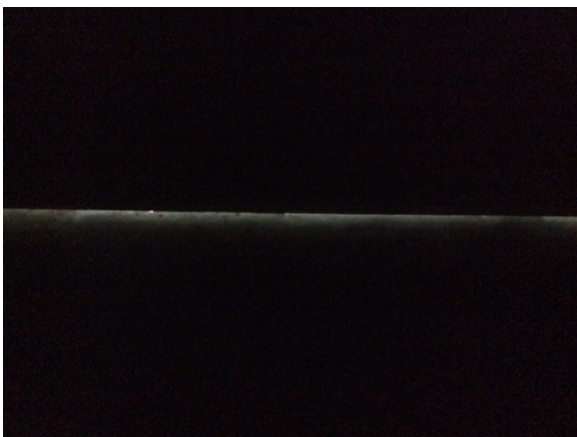
| F-3 | Fire Rated Construction | The ground floor bonded warehouse is not separated by fire-rated construction due to non-rated doors and unprotected openings. The storage room currently discharges to the southwest stairwell through an unprotected vestibule. | Provide the bonded warehouse separation by minimum 1-hr fire-rated construction. Provide the vestibule with a 1-hr fire-rated door to the warehouse and a 1.5-hr fire-rated door to the stairwell. | Within 3 months |

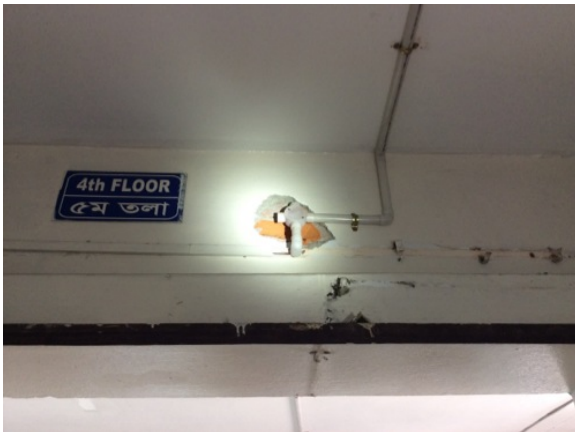
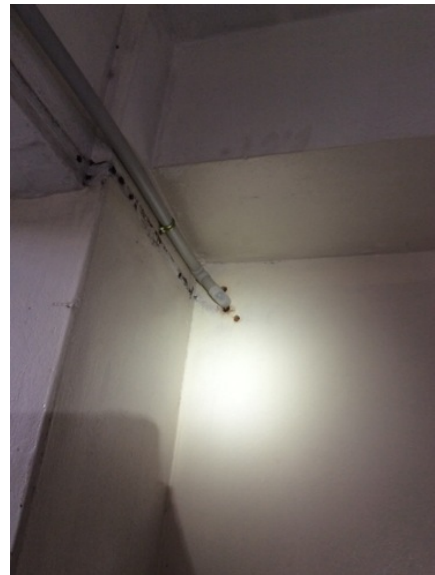
| F-5 | Fire Rated Construction | Unsealed penetrations and openings are located in exit stair enclosures. | Seal all penetrations and openings in exit stair enclosure walls to maintain the fire separation. | Within 3 months |

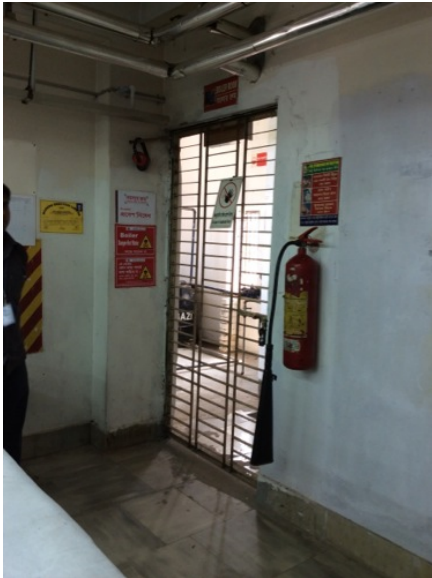
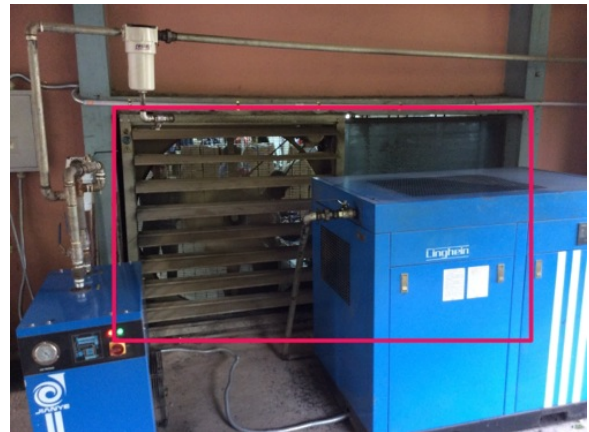
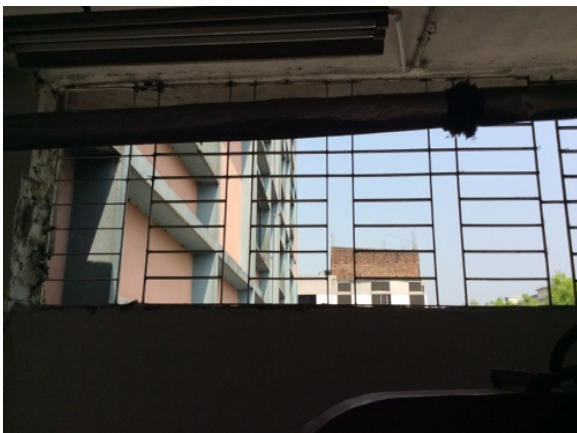
| F-6 | Fire Rated Construction | The boiler rooms on the first and second floors are not separated by fire-rated construction due to openings (to factory floor and the exterior of the building), non-rated doors, and penetrations. | Separate the boiler rooms by a minimum 2-hr fire-rated construction. Seal and/or protected all openings to maintain the required fire separations | Within 3 months |

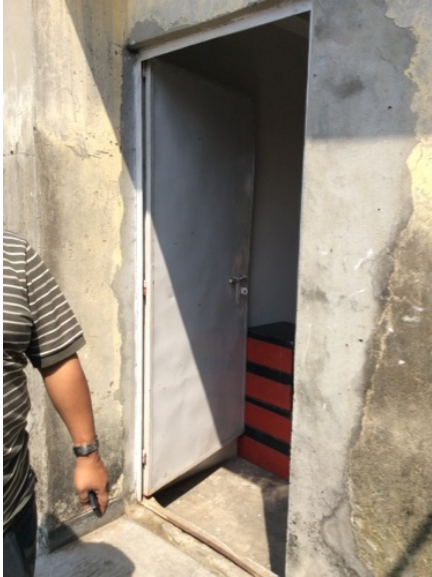
| F-7 | Fire Rated Construction | The second entrance to the southwest stairwell on the sixth floor is not necessary for egress. | Seal the opening with fire-rated construction. | Within 3 months |

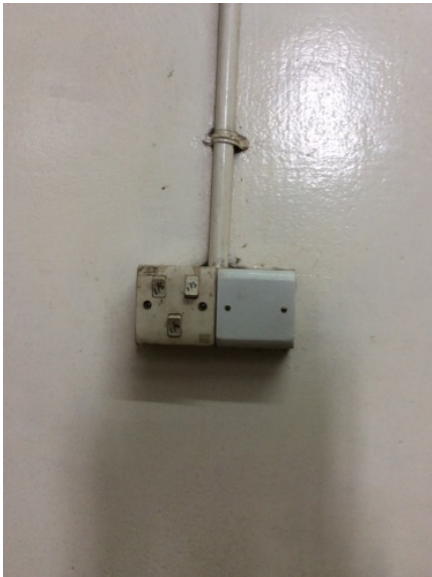
| F-8 | Fire Rated Construction | Non serving electric appliances are located in each stairwell. | Remove and relocate non serving electric appliances to the exterior of the stairwells. | Within 3 months |

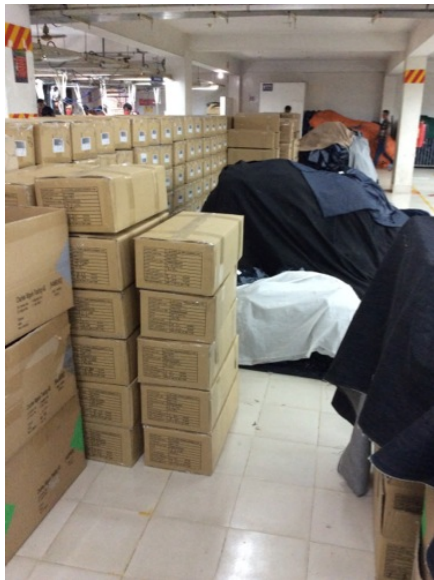
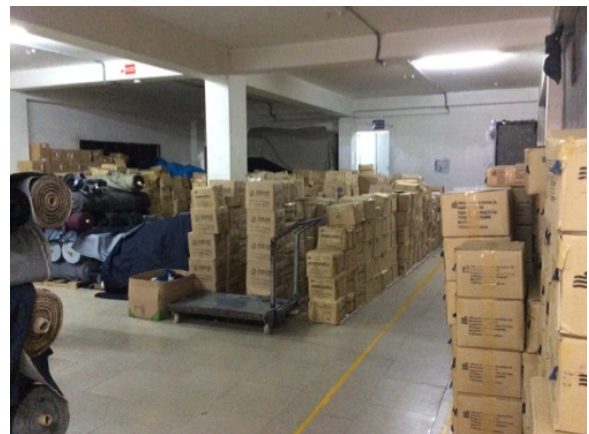
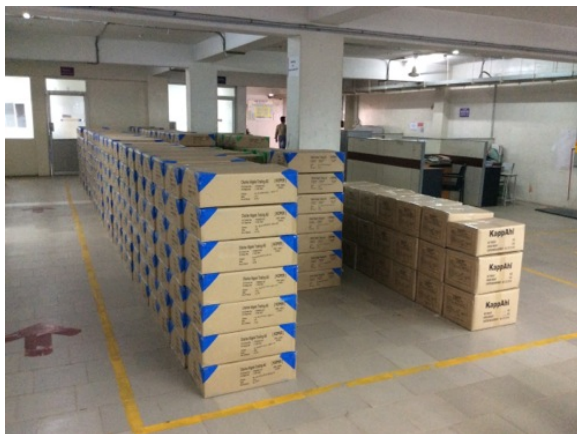
| F-9 | Fire Rated Construction | Storage open to factory floors is not separated by fire-rated construction in various locations throughout the factory. | Provide defined storage areas and limit the storage arrangement as follows: <ul style="list-style-type: none"><li>- Maximum height of 2.4m and maximum area of 23m<sup>2</sup></li><li>- If sprinkler protected: maximum height of 3.66m and maximum area of 93m<sup>2</sup></li></ul><br>Separate areas of unenclosed combustible storage by a minimum clear distance of 3m. | Within 3 months |

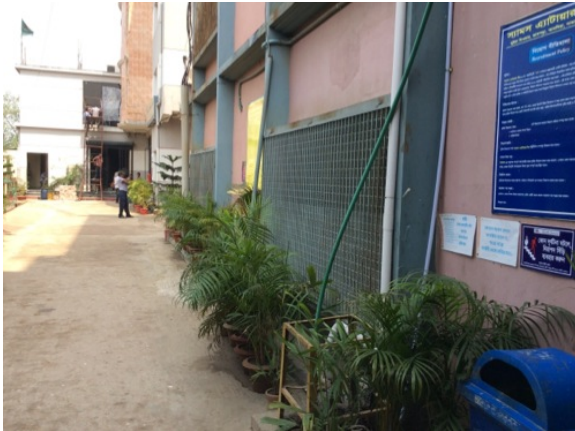
| F-10 | Fire Rated Construction | Southwest stairwell discharge path to assembly point, with less than 30 ft. building separation, has unprotected openings at a height of less than 15 ft. | Seal all penetrations and openings to the interior of the building, up to a height of 15 ft., to maintain the fire separation.<br><br>Alternately, provide fire-rated windows. | Within 3 months |

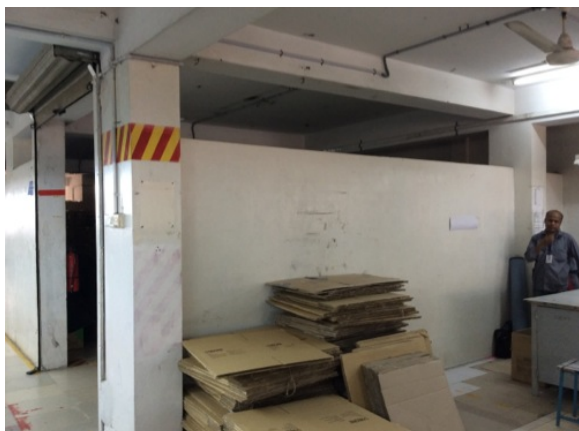
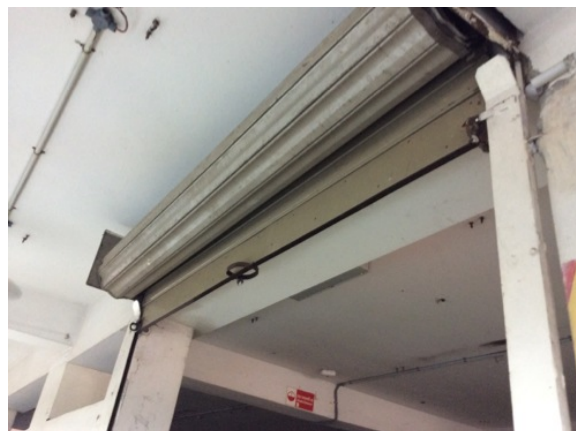
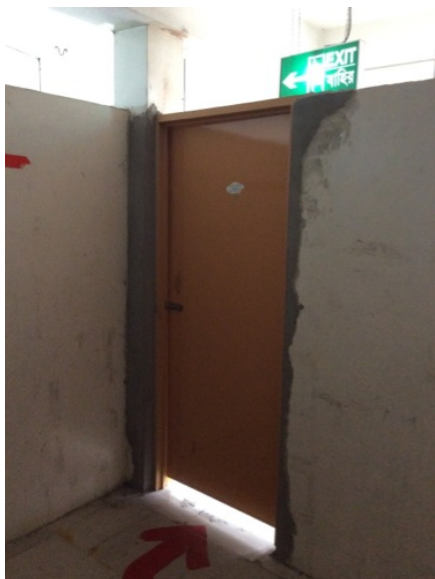
| F-11 | Fire Rated Construction | The second floor transient storage room is not separated by fire-rated construction due to a non-rated door and unprotected openings. The room is also provided with an unnecessary exit. | Provide the transient storage room separation by minimum 1-hr fire-rated construction and seal the unnecessary exit. | Within 3 months |

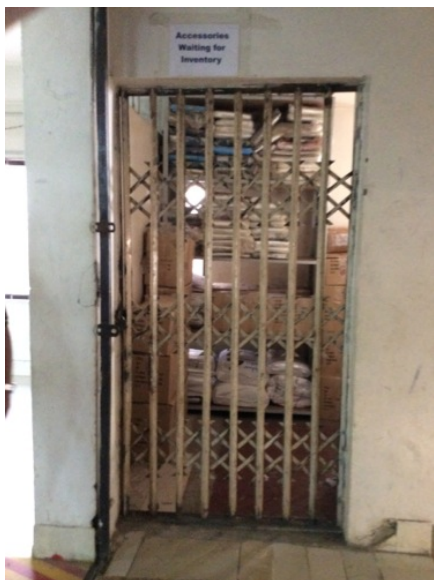
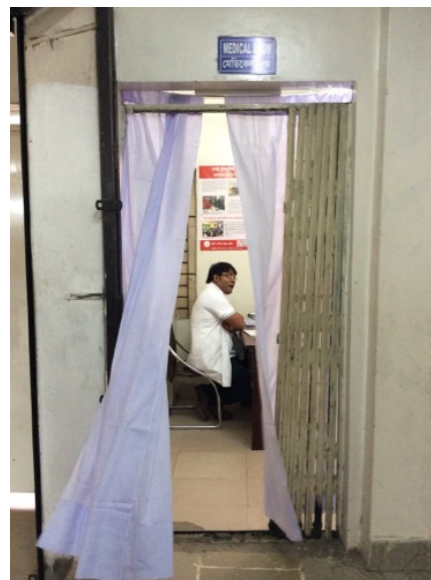
| F-12 | Fire Rated Construction | The Medical Room and Accessories Waiting for Inventory rooms discharge to the northeast stairwell. | Seal the doors with 2-hr fire-rated construction and reposition doors to egress to factory floor. | Within 3 months |

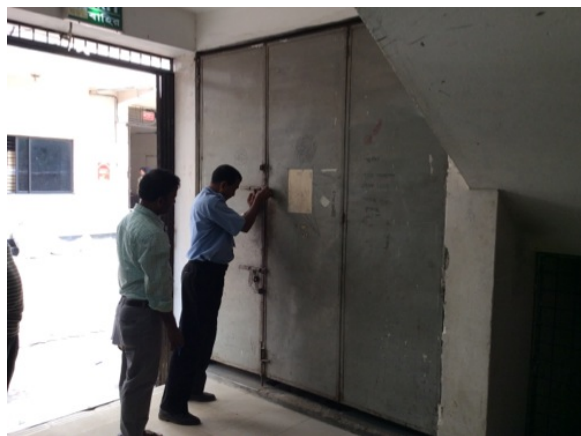
| F-13 | Fire Rated Construction | The elevator shaft is open to the northeast stairwell on the ground floor. | Seal the shaft on the ground floor with fire-rated construction. | Within 3 months |

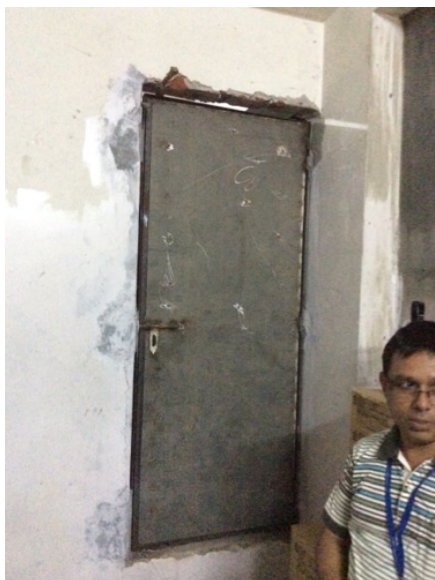
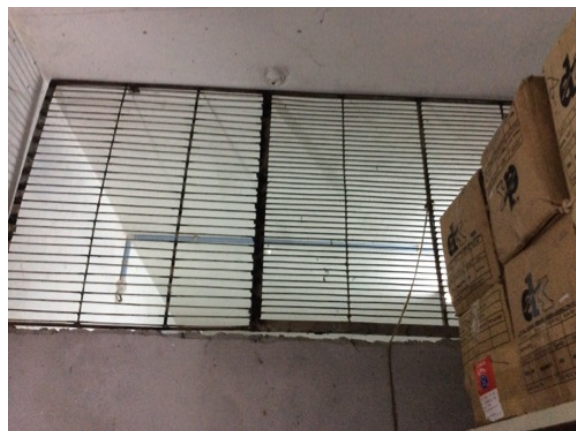
| F-14 | Fire Rated Construction | The ground floor storage room adjacent to the wash room is not separated by fire-rated construction due to a non-rated door and unprotected openings. | <p>Provide the storage room separation by minimum 1-hr fire-rated construction.</p> <p>Alternately, relocate the storage to a dedicated storage room and utilize the room for something other than storage.</p> | Within 3 months |

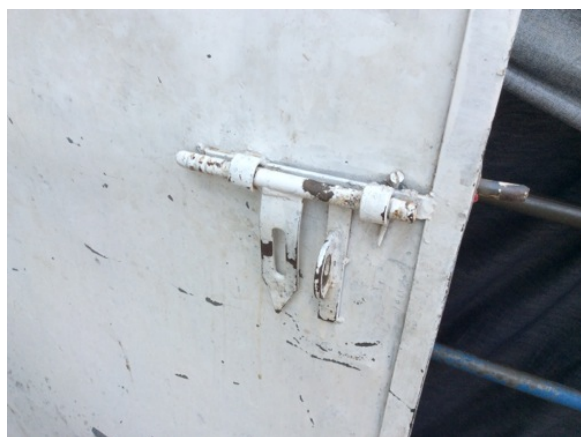
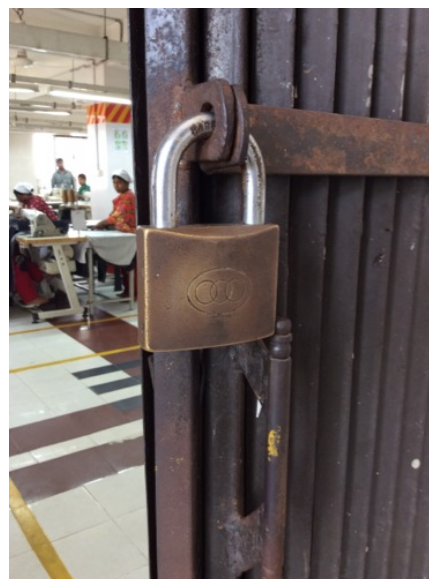
**F-15 Egress**

Egress doors and gates with locking features are provided at building exits, exit stairs, and along egress routes in various locations throughout the factory. All gates and doors were open and unlocked during the inspection.

Remove locking features from all egress doors and gates.

If locks are required for security reasons, utilize special door locking features complying with NFPA 101.

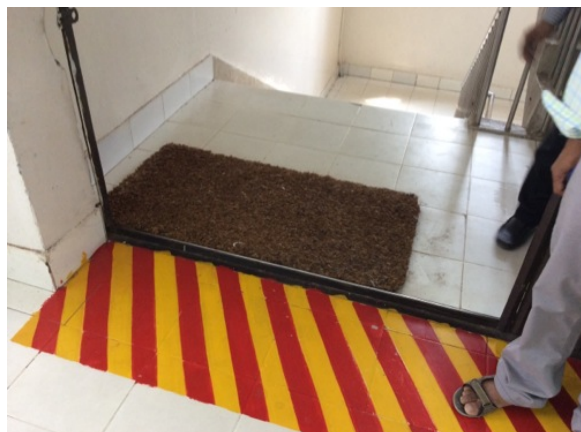
| F-16 | Egress | The floor matts at the entrance to the stairwells pose a tripping/slipping hazard to occupants. | Remove the floor matts. | Immediate |

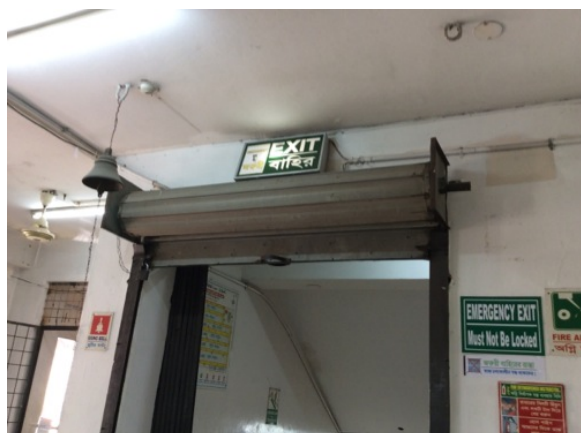
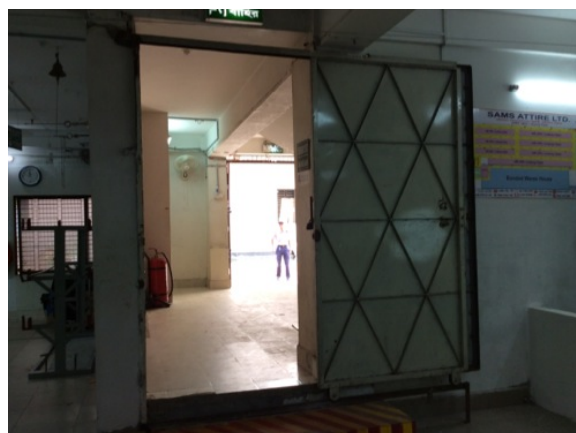
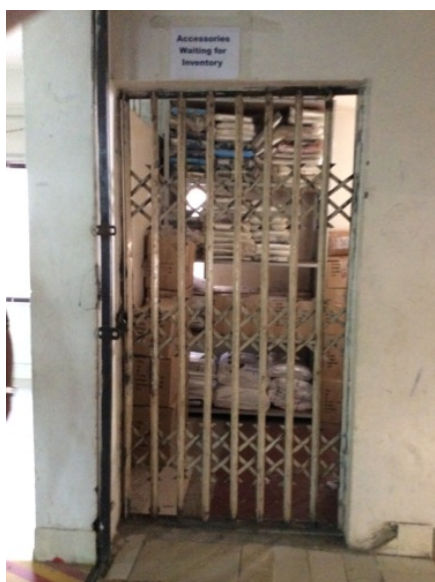
| F-17 | Egress | Collapsible gates and sliding doors are provided at building exits, exit stairs, and along egress routes in various locations throughout the factory. | <p>Replace all gates and sliding doors along the means of egress with side-hinged, swinging egress doors.</p> <p>If locks are required for security reasons, utilize special door locking features complying with NFPA 101.</p> | Within 1 month |

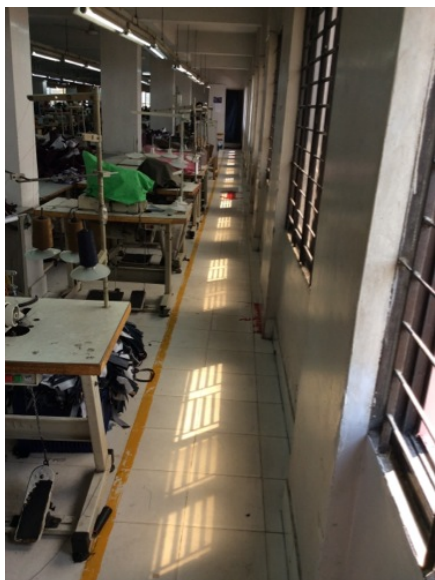
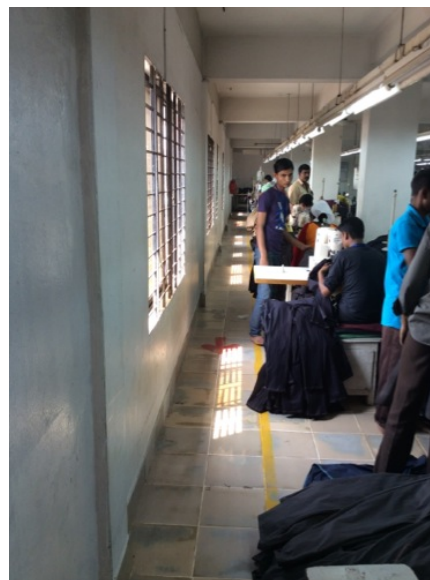
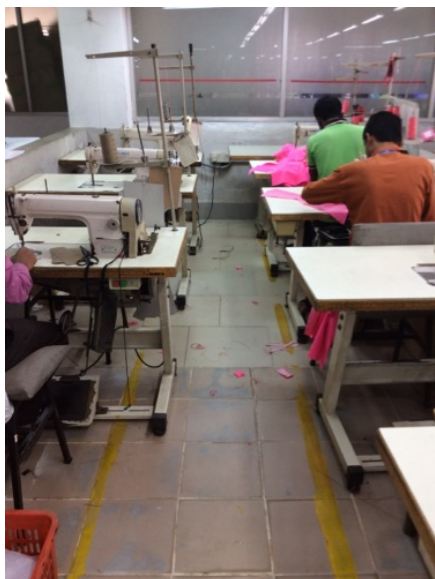
| F-18 | Egress | The width of egress aisles is less than 36-in. in various locations throughout the factory. | Provide minimum aisle widths of 36-in. | Within 3 months |

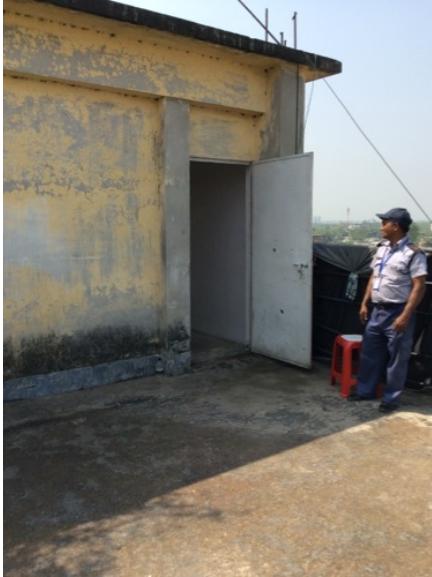
| F-19 | Egress | Exit stair door to the sixth floor southwest stairwell does not swing in the direction of egress travel. | Modify the egress door to swing in the direction of egress travel. | Within 3 months |

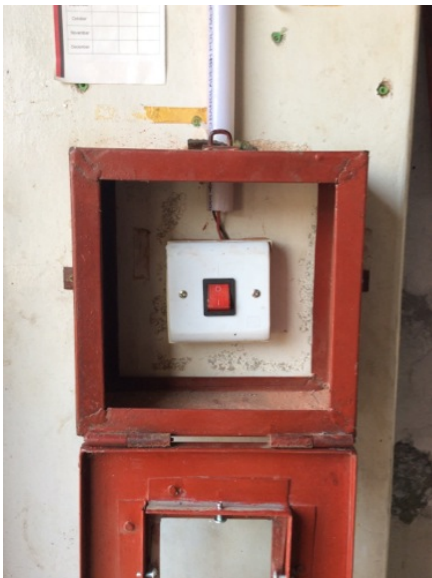
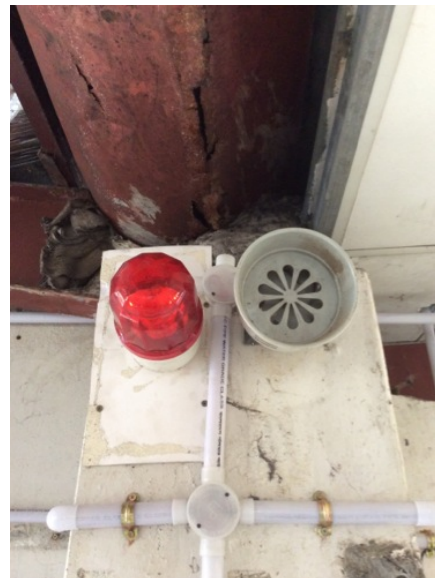
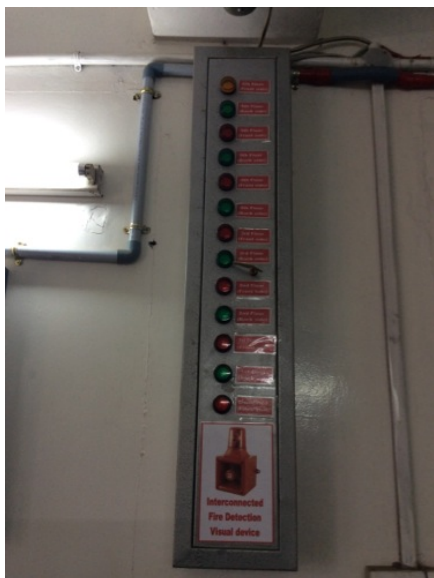
| F-20 | Fire Protection | The fire alarm system is antiquated, not a listed system, and does not provide alarm and notification features consistent with acceptable standards. | Replace the fire alarm system with a new, listed addressable fire alarm system in accordance with NFPA 72. | Design within 4 months, install within 9 months |

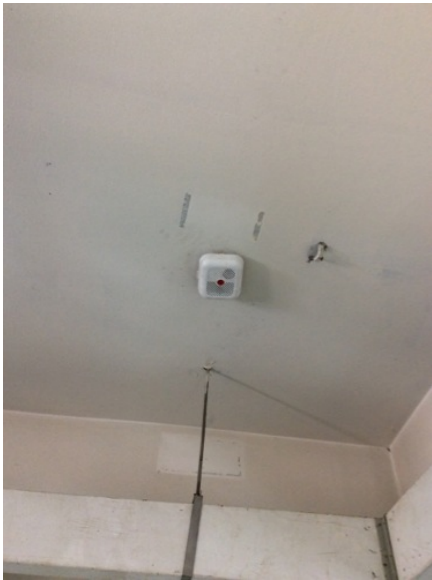
| F-23 | Fire Protection | The building is equipped with single-station smoke alarms. Smoke alarm activation sounds only a local alarm and does not provide automatic fire alarm notification of occupants. | Replace the single-station smoke alarms with automatic smoke detectors tied into the fire alarm system. Configure the fire alarm system to initiate occupant notification upon activation of any two smoke detectors in addition to the manual fire alarm stations. | Within 6 months |
