# Humana Apparels Pvt. Ltd

Gorai, Mirzapur, Tangail-1941, Bangladesh

25 June 2025

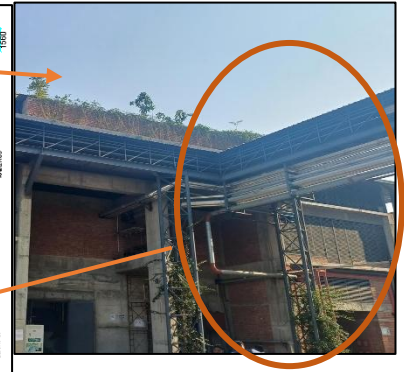
A steel pipe tray connected to the steel part which is absent in as-built drawings.

**Description:** During the inspection, mismatches were found between the onsite condition and the as-built drawing. Water tank and roof top gardening was not shown in the drawing. Also, steel pipe tray is connected to the steel portion which has not shown in drawings. The building engineer is required to survey the full structure and produce accurate as-built drawings.

| Item No. | Observation | Action Plan | Timeline |
|---|---|---|---|
| 5. | Mismatch in as-built drawings (Utility Building). | The building engineer is required to survey the full structure and produce accurate as-built drawings. | within 6 weeks |

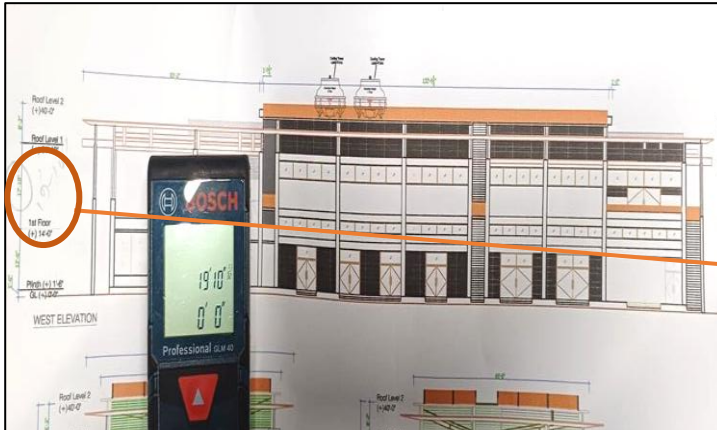
Floor to ceiling height was observed 6.04 m instead of 5.44 m.

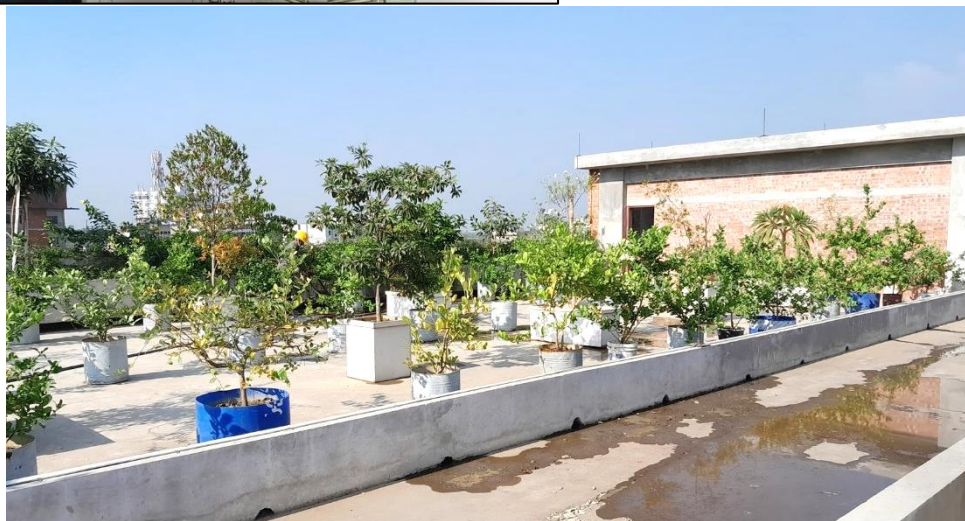
Gardening at the roof – not shown in the drawing

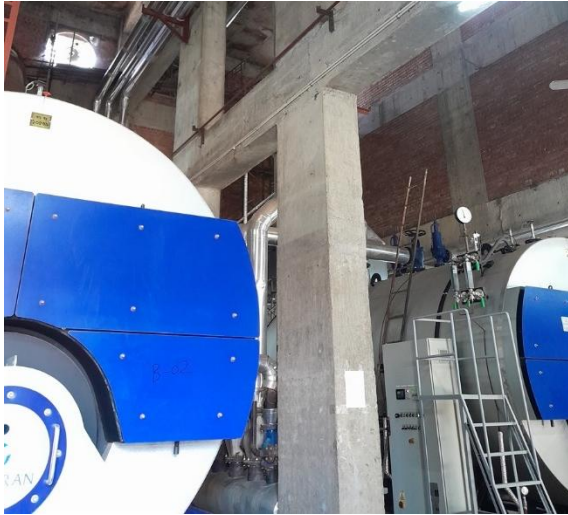
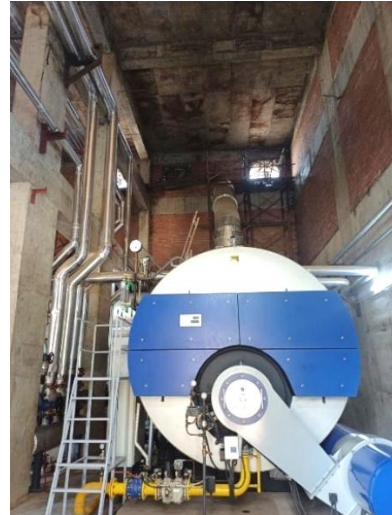
**Observation-4:** Load plan needs to be implemented at the ground floor (Utility Building)

**Description:** A boiler was found at the top slab of the underground water reservoir. Building engineer is required to produce and implement a load plan as per slab capacity.

| Item No. | Observation | Action Plan | Timeline |
|---|---|---|---|
| 6. | Load plan needs to be implemented at ground floor (Utility Building) | Produce and actively manage a loading plan for all floor plates within the factory considering slab capacity. | within 6 weeks |

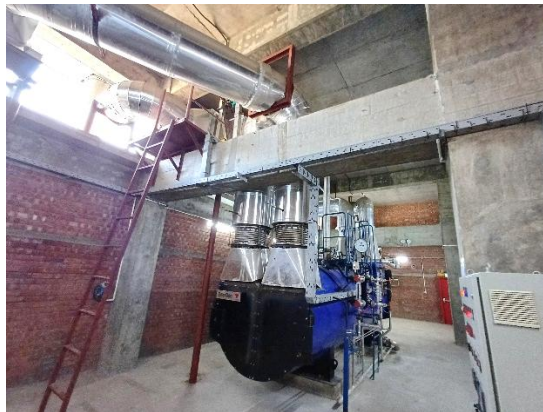
**Observation-5:** Vibration on 1<sup>st</sup> floor (Utility Building)

**Description:** Vibration was felt on the 1st floor. The building engineer is required to check the reason for the vibration, check the slab adequacy subject to imposed loading & vibration and suggest proper remedial/damping methodology.

| Item No. | Observation | Action Plan | Timeline |
|---|---|---|---|
| 7. | Vibration on 1 <sup>st</sup> floor (Utility Building) | The building engineer is required to check the reason for the vibration, check the slab adequacy subject to imposed loading & vibration and suggest proper remedial/damping methodology. | within 6 weeks |
| 8. | | Carry out remedial work if required. | within 6 months |

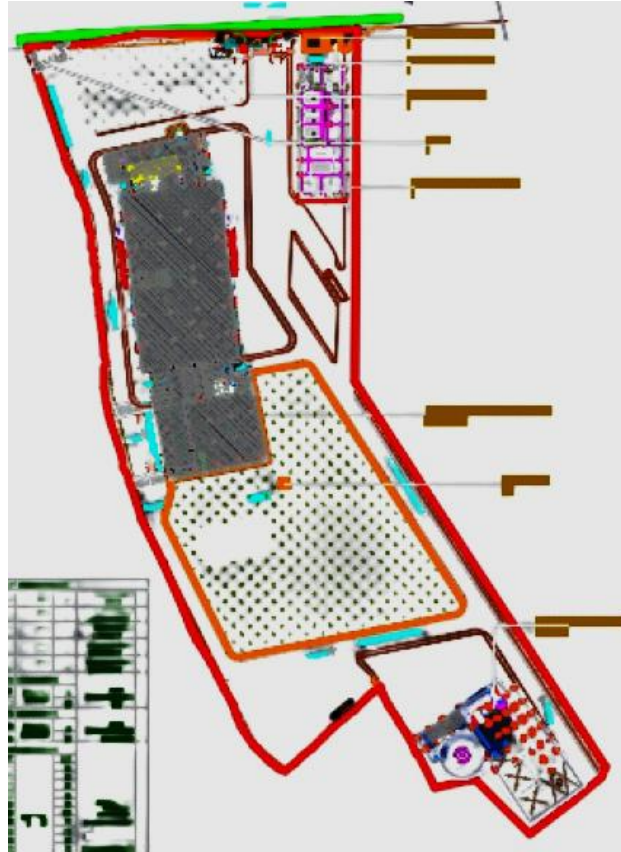
**Observation-6:** Building Permit from local authority not available (All Structures)

**Description:** During the inspection, the building permit from the local authority was not available for all buildings. The factory authority is required to collect building permits from the local government authority for all buildings.

| Item No. | Observation | Action Plan | Timeline |
|---|---|---|---|
| 9. | Building Permit from local authority not available (All Structures) | The factory authority is required to collect building permits from the local government authority for all buildings. | within 6 months |
