# Rizvi Fashions Ltd. (Extension)

18 June 2025

## Structural Inspection Report

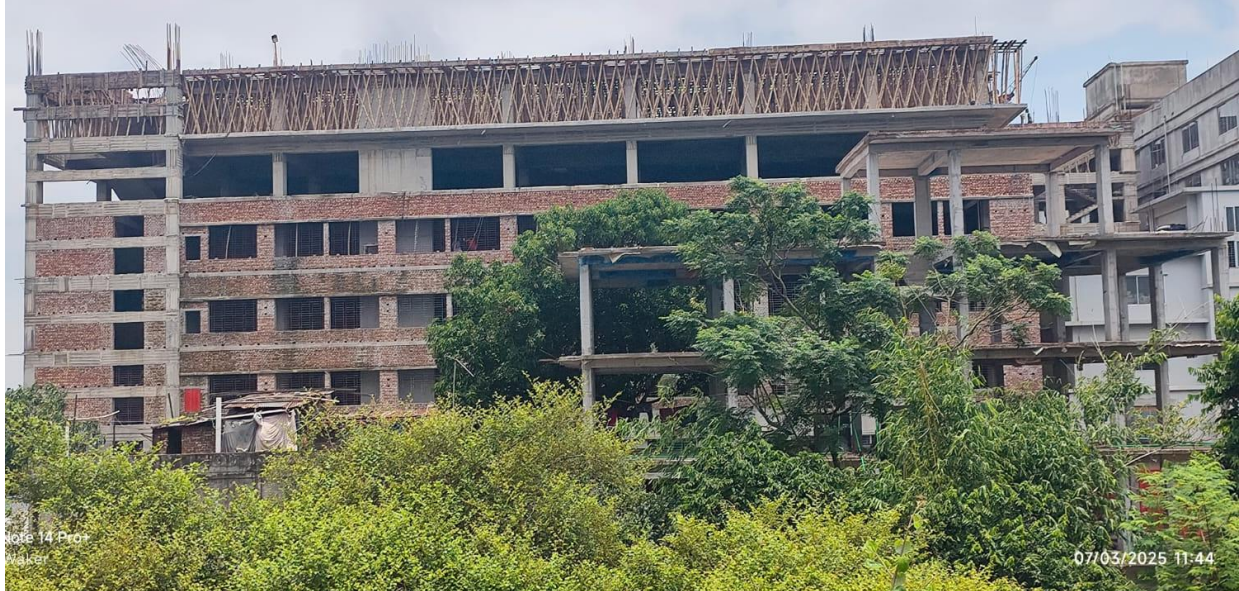
**Observation 1:** Lack of design report, in situ material test report (Building -2, Stair and Lift Building).

**Description:** As per BNBC, every building or structure designed shall have its design documents prepared in accordance with the provision of Section 1.9.1. The design document shall include a design report, and a set of structural drawings, which shall be prepared in compliance with section 1.9.1.1 and section 1.9.1.2 as per BNBC. At the time of inspection, a set of construction drawings were available for proposed 7 storied structure. However, any design report was not available. Also, no in situ material test report (cylinder test report, rebar test report) was available.

The building engineer is required to verify in situ material test for concrete and steel and prepare an Engineering Assessment (EA) report with proper remediation plan (if required) and submit to RSC for review.

| Item No | Observation | Action Plan | Timeline |
|---|---|---|---|
| 1. | Lack of design report, in situ material test report (Building - 2). | Verify in-situ concrete material strength by taking concrete cores (minimum 4 nos and 100 mm diameter) from lower tier building columns and prepare steel rebar test report. | within 6 weeks |
| 2. | | Building engineer is required to review, design of foundation stress and prepare a Engineering Assessment (EA) report with proper remediation plan and submit to RSC for review. | within 6 weeks |
| 3. | | Carry out remedial work if required. | within 6 months |
| 6. | Lack of design report, in situ material test report (Stair and Lift Building). | Verify in-situ concrete material strength by taking concrete cores (minimum 4 nos and 100 mm diameter) from lower tier building columns and prepare steel rebar test report. | within 6 weeks |
| 7. | | Building engineer is required to review, design of foundation stress and prepare a Engineering Assessment (EA) report with proper remediation plan and submit to RSC for review. | within 6 weeks |
| 8. | | Carry out remedial work if required. | within 6 months |

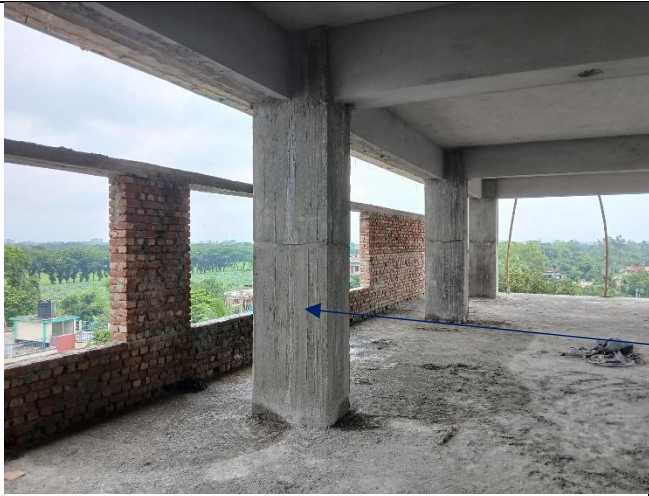
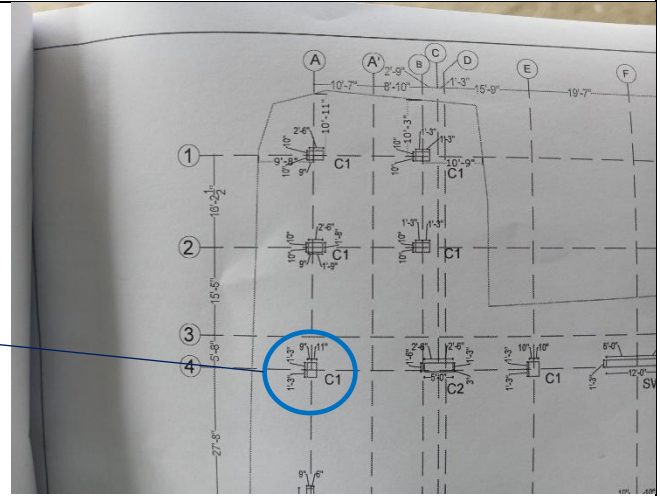
**Observation-2:** Mismatch in as-built drawing (Building-2).

**Description:** During Inspection, Column orientation of C1 column didn't match between drawing and onsite condition. In addition, rebar  
The building engineer is required to survey the structures and prepare a comprehensive as built Drawings.

| Item No | Observation | Action Plan | Timeline |
|---|---|---|---|
| 4. | Mismatch in as-built drawing (Building-2). | The building engineer is required to survey the structures and prepare comprehensive as built drawings. | within 6 weeks |

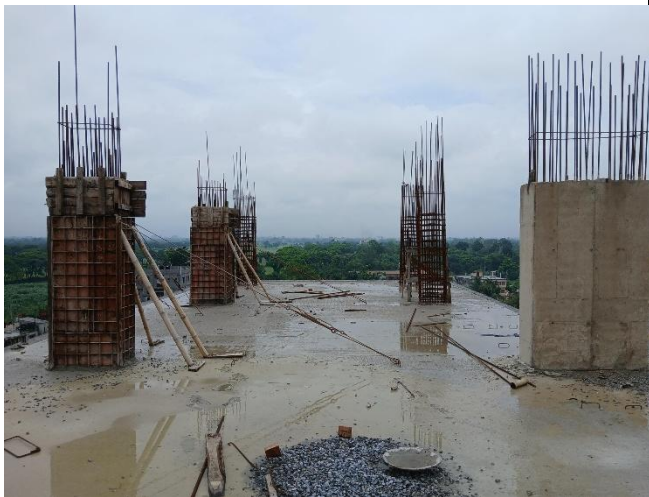
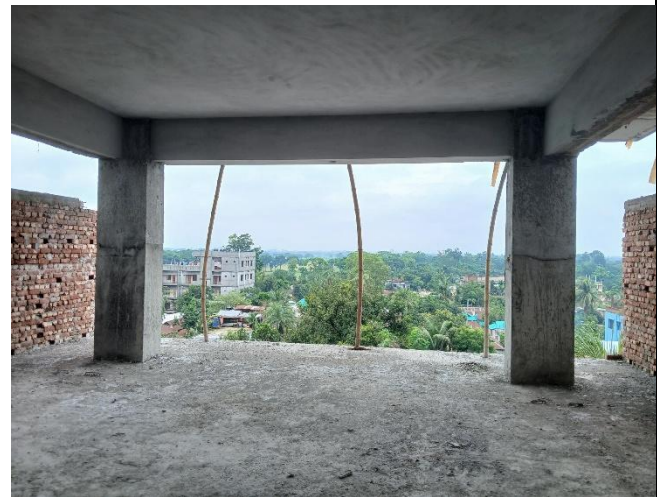
**Observation 03:** Falling hazard on 4th floor and Roof (Building -2, Stair and Lift Building).

**Description:** During inspection, no railing/parapet wall was observed on the 4th floor and Roof.  
The building engineer is required to provide railing/parapet walls to avoid falling hazard.

| Item No | Observation | Action Plan | Timeline |
|---|---|---|---|
| 5. | Falling hazard on 4th floor and Roof (Building-2). | The building engineer is required to provide railing/parapet wall to avoid Falling hazard. | Immediate |
| 9. | Falling hazard on 4th floor and Roof (Stair and Lift Building). | The building engineer is required to provide railing/parapet wall to avoid Falling hazard. | Immediate |

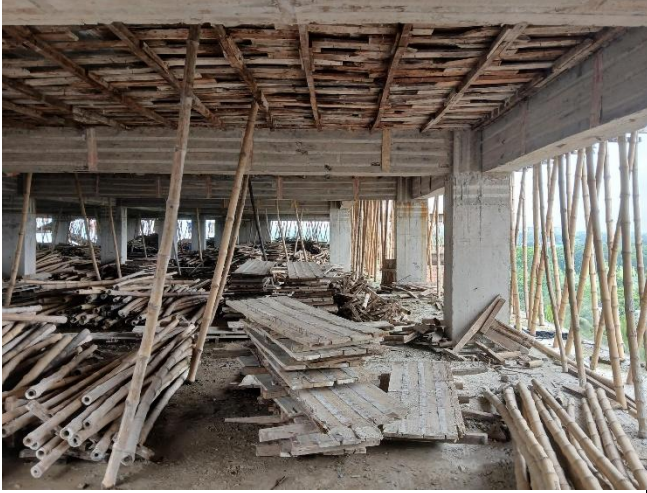
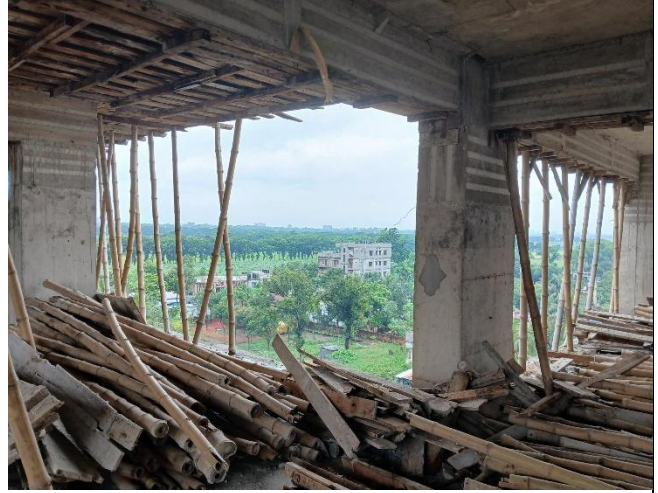
**Observation-4:** Lack of Construction safety practice (Building -2, Stair and Lift Building).

**Description:** During Inspection, construction safety practice was not observed during construction work such as using fall protection system (entry restriction, barriers, platform, walkway), personal protection equipment (helmet, boot, harness), caution signages, trainings, electrical & fire safety and so on.

The building engineer is required to ensure construction safety practice following BNBC (part-7, chapter 3&4) guideline till the completion of all construction work.

| Item No | Observation | Action Plan | Timeline |
|---|---|---|---|
| 10. | Lack of Construction safety practice (Building -2, Stair and Lift Building). | The building engineer is required to ensure construction safety practice following BNBC (part-7, chapter 3&4) guideline till the completion of all construction work. | Immediate |
