Saad Saan Apparels Ltd.

Jamirdia, Valuka, Mymensing, Bangladesh.
(24.291828 N, 90.405102E)

28th November 2015

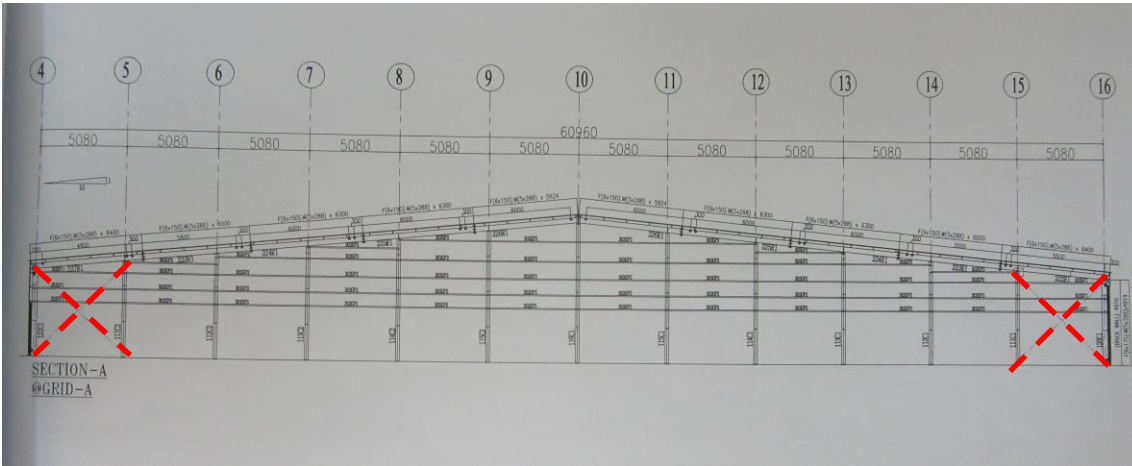
Section of Sewing Shed

Missing Vertical Bracing in Sewing Shed

Missing vertical bracing in Sewing Shed on both ends of the shed.

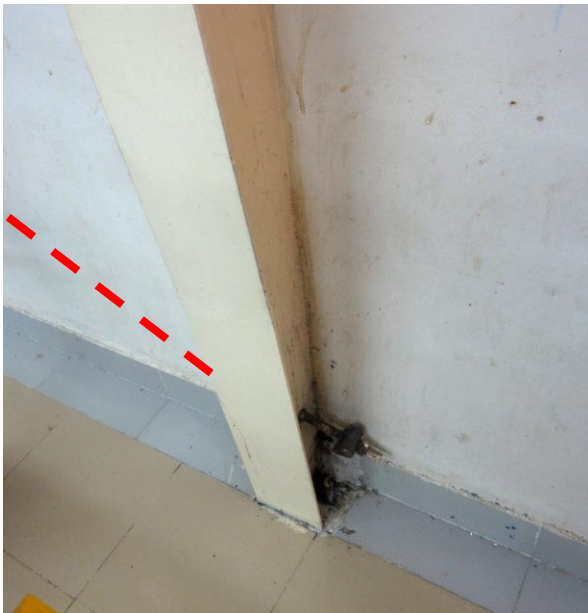
Missing Vertical Bracing

ITEM 1: Missing Vertical Bracing Members (Sewing Shed)

Item No.	Observation	Recommended Action Plan	Recommended Timeline
1	Missing Vertical Bracing Members (Sewing Shed)	No vertical bracing observed at the locations where design drawings shows such. Missing members to be provided.	6-weeks
2	Horizontal Bracing Members Sagged (Sewing Shed)	Most of the horizontal bracing cables are sagged. Necessary actions to be taken to provide proper tension on cables.	6-weeks
3	Corroded Structural Members (Warehouse – Sewing Shed)	Connection parts of the bracing cables and main structural members at several locations are corroded. Necessary corrective and protective measures to be taken.	6-weeks
4	Several Connections to be Checked (Sewing Shed)	There is a gap between end plates of frame beam splice connection at some locations.	6-months
5	Several Connections to be Checked (Sewing Shed)	Nuts of the base plate anchors are not visible.	6-months
6	Several Connections to be Checked (Sewing Shed)	Building Engineer to check and take necessary actions.	6-months

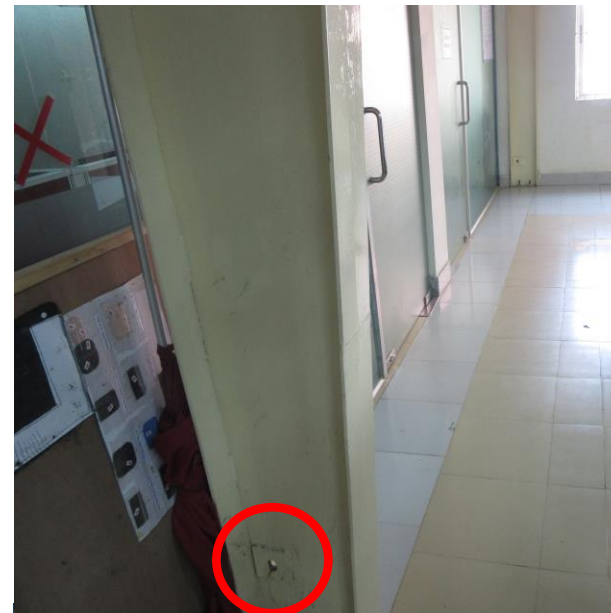
Missing Vertical Bracing

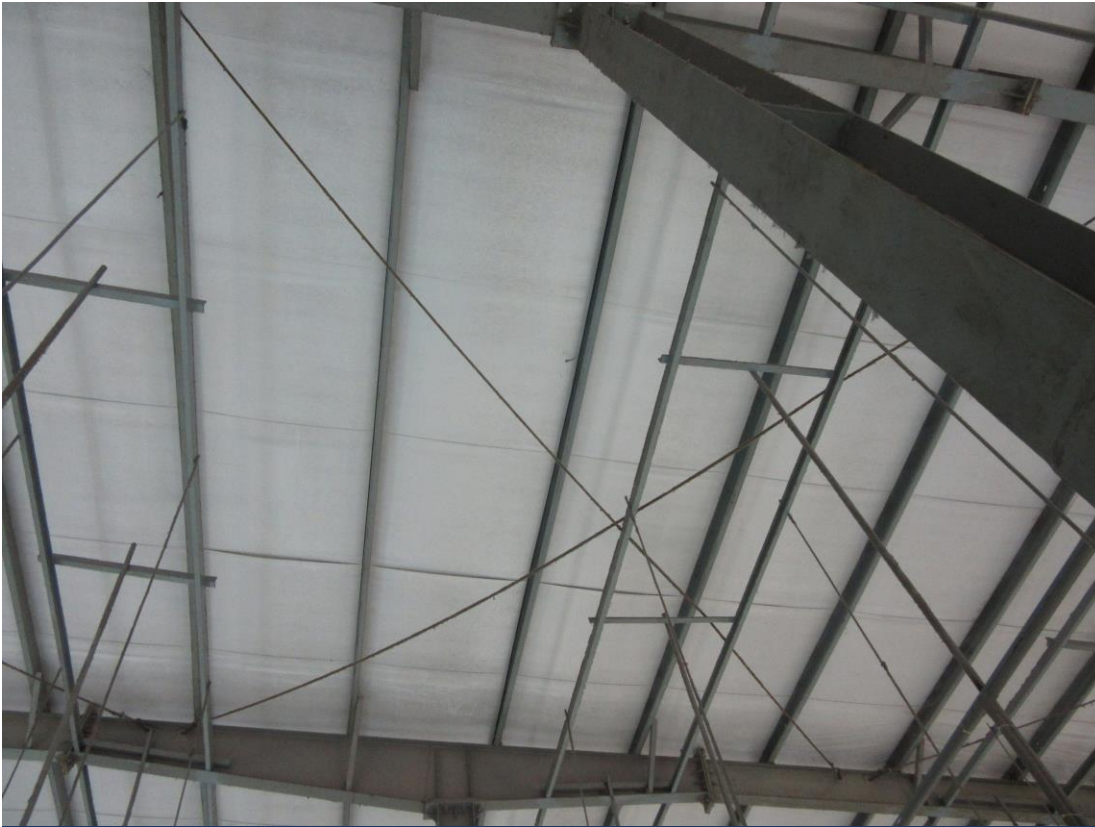
Sagged Horizontal Bracing Cables Sewing Shed

Sagged Horizontal Bracing Cables

Horizontal bracing cables observed to be sagged.

ITEM 2: Horizontal Bracing Members Sagged (Sewing Shed)

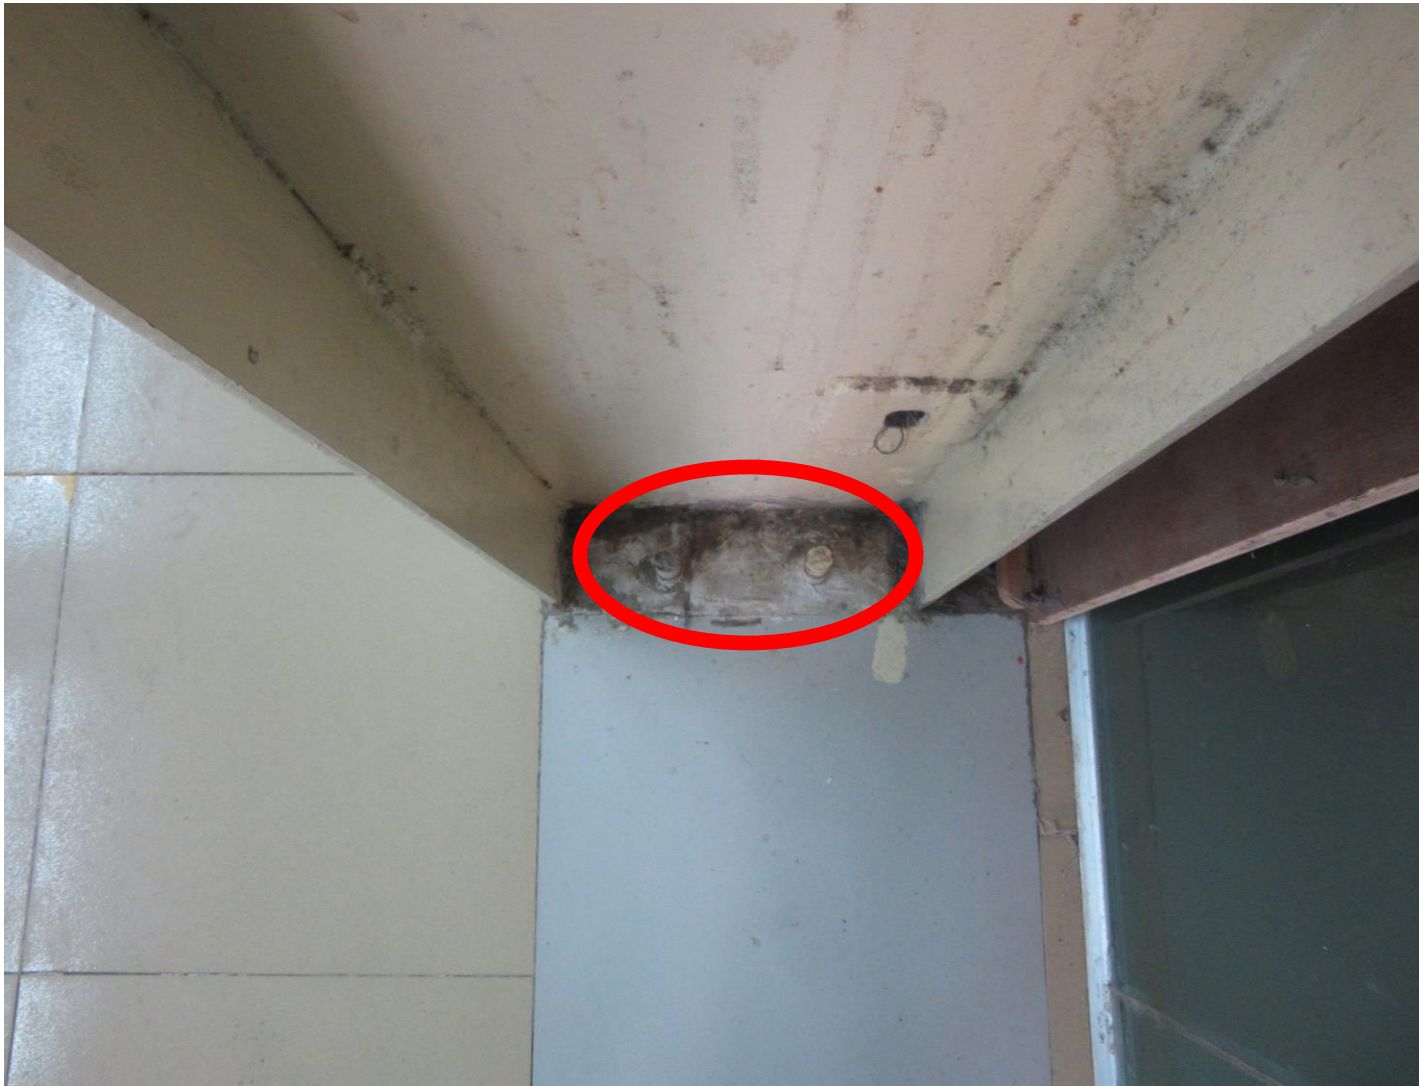
Nuts not Visible on Column-Base Plate Joints Due to Concrete Cover in Sewing Shed

Nuts could not be seen at the base plate connection.

ITEM 4: Several Connections to be Checked (Sewing Shed)

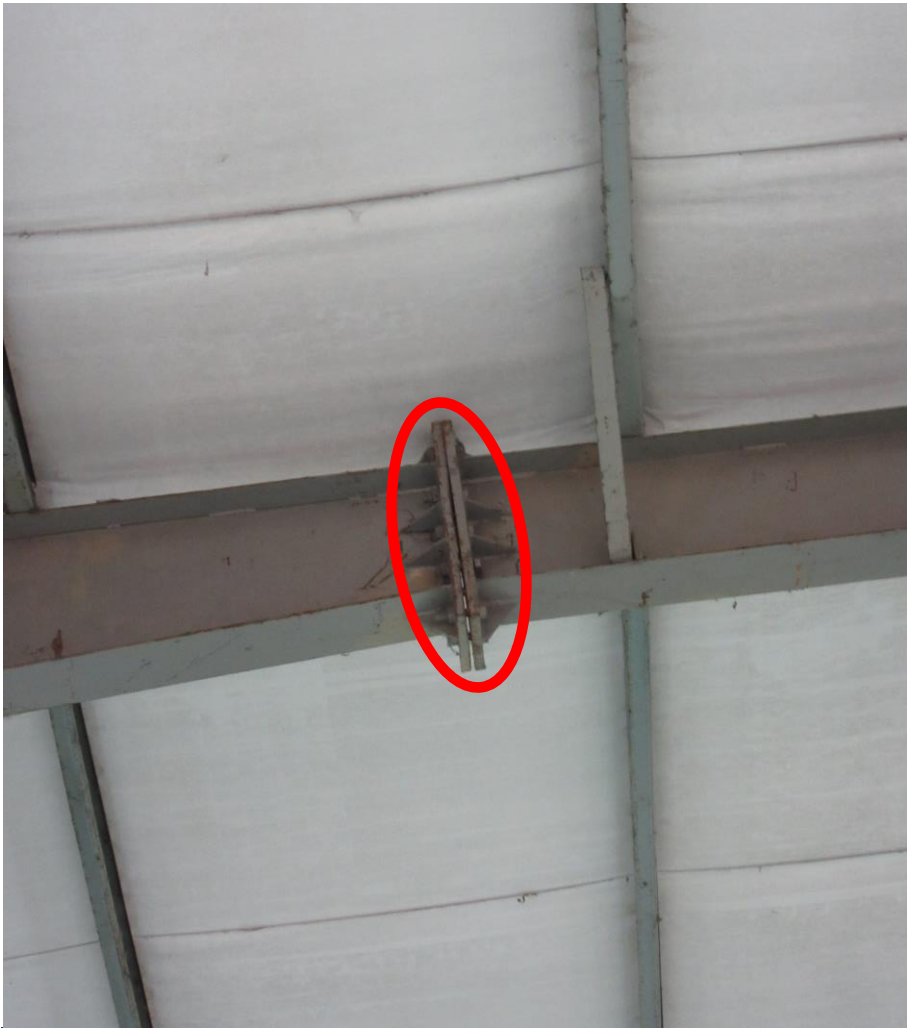
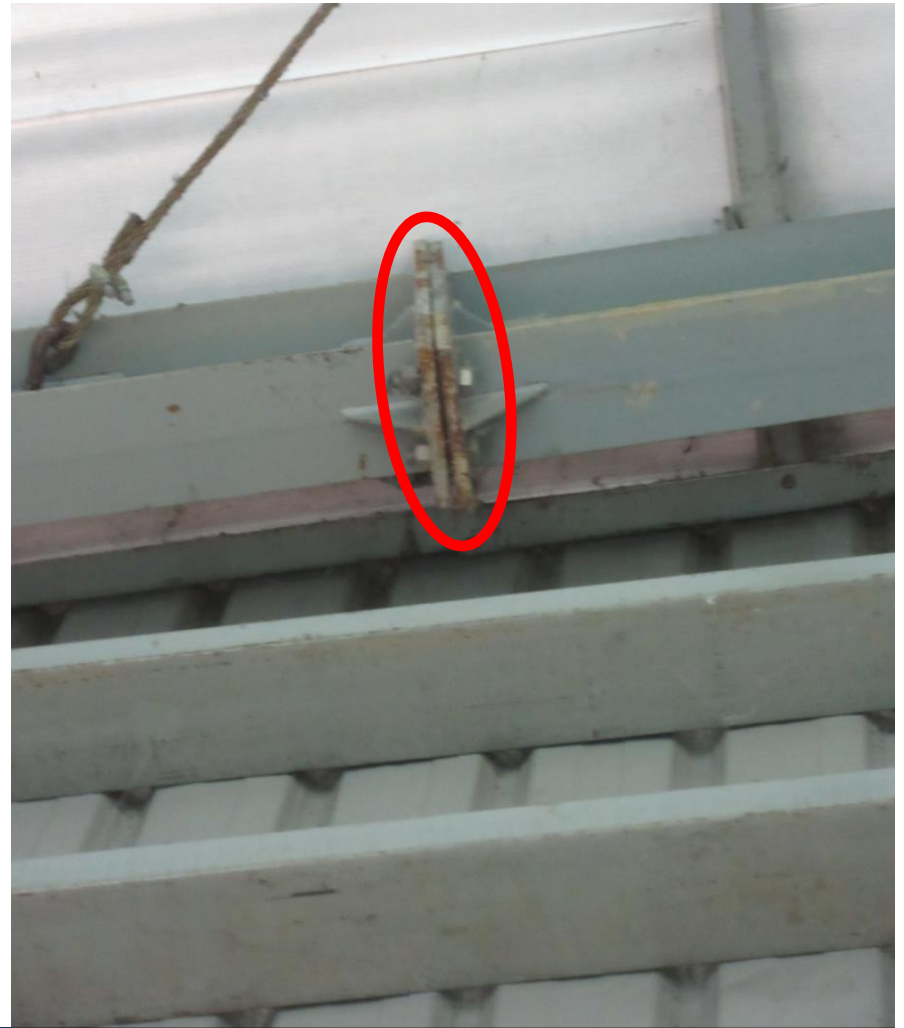
Gap between End Plates At Frame Beams Sewing Shed

Gaps between End Plates of Frame Beam Splice Connections

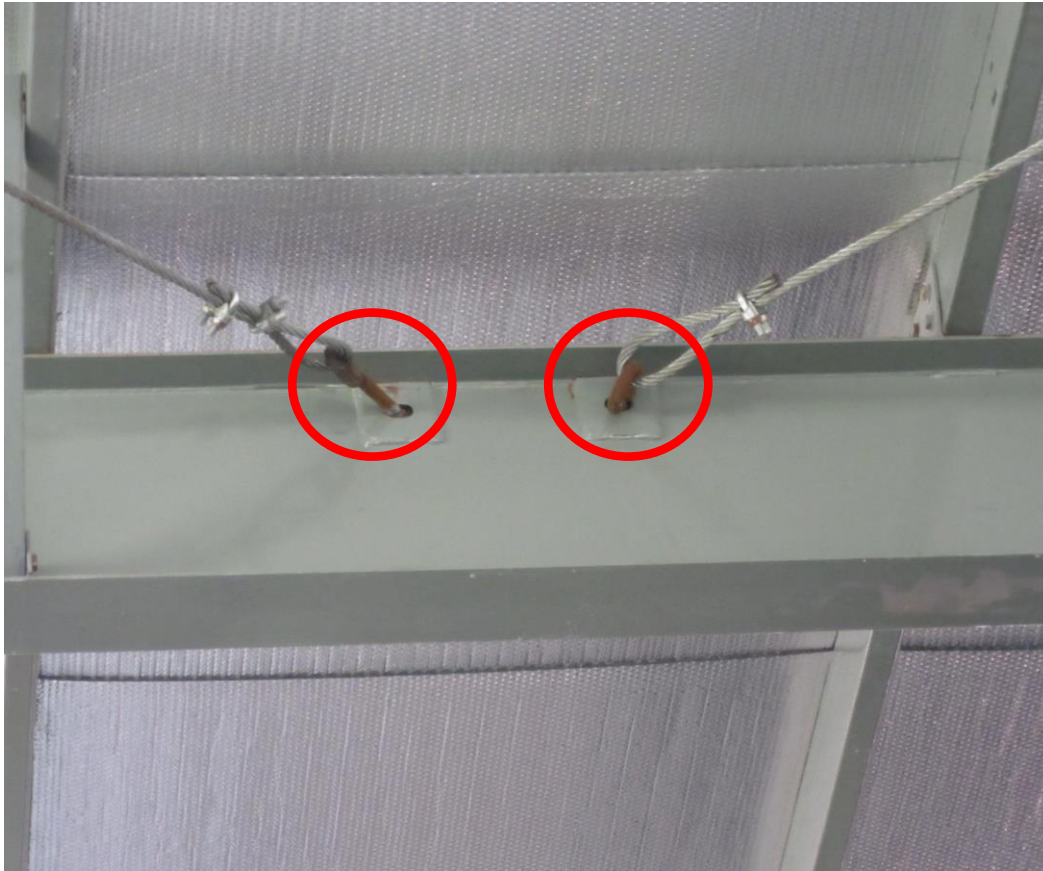
Corroded Cables of Horizontal Bracing Warehouse

Corroded Parts of Bracing Cables

Corroded parts observed at horizontal bracing cables at roof level.

ITEM 3: Corroded Structural Members (Warehouse – Sewing Shed)
