INITIAL FIRE SAFETY INSPECTION REPORT

GENESIS FASHIONS LTD. (Extension - 2)

RSC ID: 26201

Date: 21 April, 2025

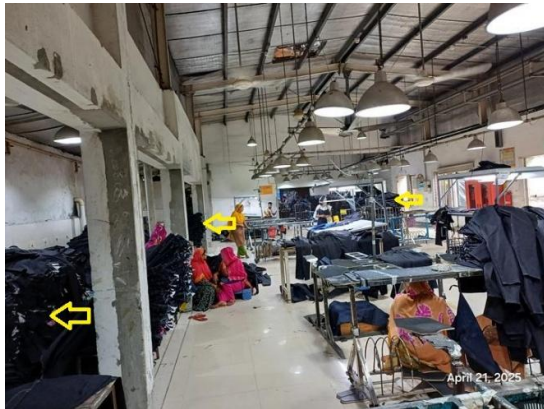
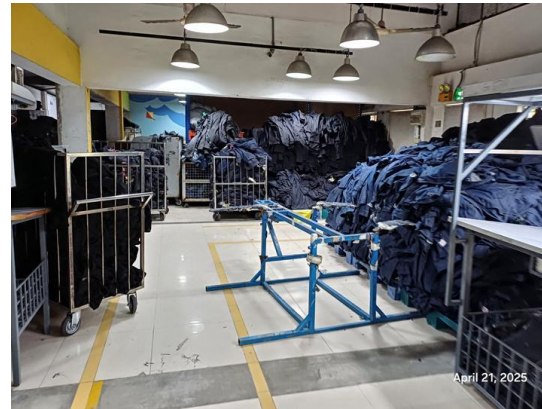
SI No.	Category	Findings	Required Action	Remediation Time Frame
F3	Fire Rated Construction	<p>Areas used for in-process storage of combustible materials are open to the surrounding occupancy.</p> <p>Location: Ground floor of Whisker Shed</p>	<p>Provide defined storage areas and limit the storage arrangement as follows:</p> <p>Maximum height of 2.45 m and maximum area of 23 m² and is separated by a minimum 3.0 m (10ft) from other storage areas and they do not exceed 10 percent of the building area of the story in which they occur.</p> <p>or,</p> <p>If sprinkler protected, Maximum height 12 ft (3.66 m) and maximum area of 1000 ft² (93 m²) and separated by a at least 25 ft (7.62 m) and does not constitute more than 10 percent of the building area or 4000 ft² (372 m²) of the sprinklered area, whichever is greater.</p> <p>or,</p> <p>Enclose the storage area from the surrounding occupancy with a minimum 1 hour construction.</p>	Within 3 Months

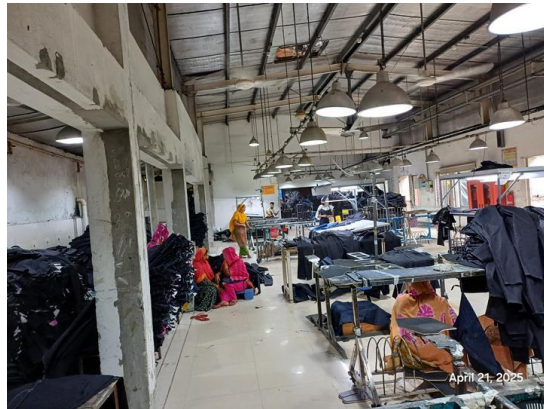
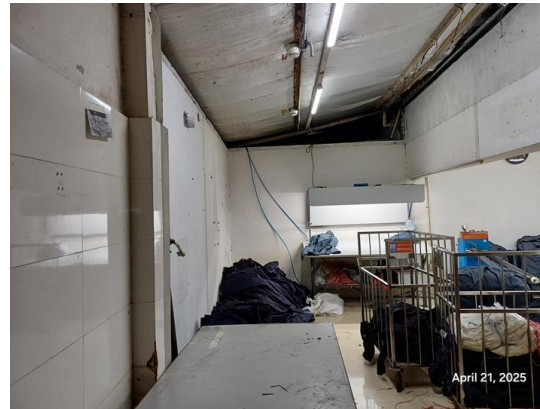
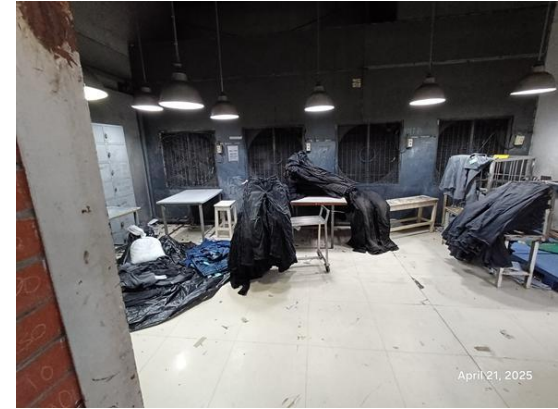
SI No.	Category	Findings	Required Action	Remediation Time Frame
F5	Fire Alarm & Detection system (ITM of FADS)	Inspection, testing and maintenance for the fire alarm system is not in accordance with NFPA 72 and The RSC Technical Guidelines (Standard). Location: Building-1 Whisker Shed	Inspect, test and maintain the fire alarm system and keep written records on-site, in accordance with NFPA 72 and The RSC Technical Guidelines (Standard) and keep written records on-site	Within 1 Month (after installation)
F6	Means of Egress	Aisles are found missing on several locations throughout the Whisker Shed. Location: Whisker Section, Rubbing Section on Ground floor of whisker shed	Provide minimum aisle widths of 36-in. Aisles mark shall be clearly visible.	Within 1 Month

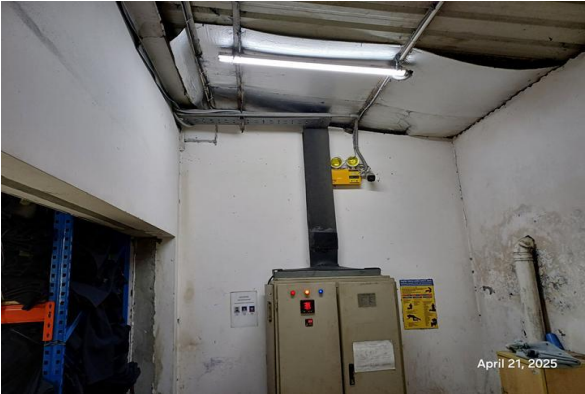
SI No.	Category	Findings	Required Action	Remediation Time Frame
F7	Fire Suppression System (SUPS)	<p>Portable fire extinguishers are not installed throughout all facilities.</p> <p>Location: Near Distribution Board of Whisker Shed</p>	<p>Portable fire extinguishers shall be installed throughout the facilities in accordance with BNBC 2006 and NFPA 10. Extinguishers shall be placed so that maximum travel distance to the nearest unit shall not exceed 30 m (100 ft).</p>	Within 3 Months

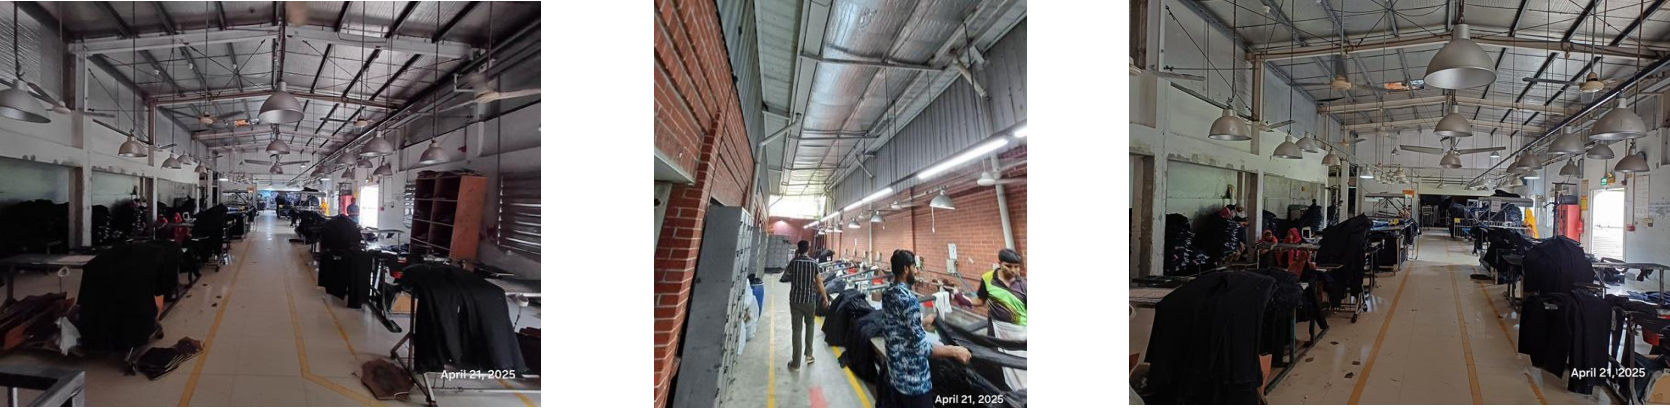
SI No.	Category	Findings	Required Action	Remediation Time Frame
F9	Means of Egress	<p>Based on the number and location of emergency lights observed, adequate illumination levels are not anticipated along egress routes.</p> <p>Location: Whisker Section & Rubbing Section of Whisker Shed.</p>	<p>Test the emergency lighting system on each floor and provide additional emergency fixtures to provide adequate illumination along the means of egress. Provide a minimum illumination of 10 lux at the floor level within exit stairs and exit discharge paths and minimum 2.5 lux along exit access aisles. Illumination on means of egress shall meet in accordance with RSC Technical Guidelines (Standard)¹ V1.0 Section 10.12.2.</p>	Within 3 Months

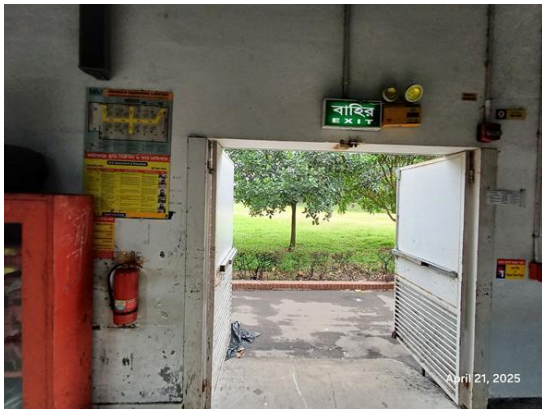
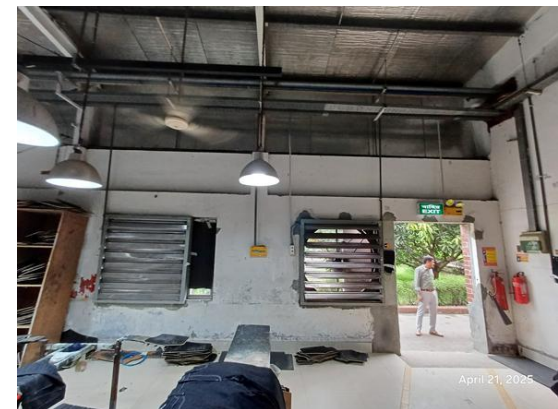
SI No.	Category	Findings	Required Action	Remediation Time Frame
F11	Means of Egress	<p>Building does not have occupant load signs at required locations on all floors.</p> <p>Location: All Exits in Whisker Shed</p>	<p>Post the occupant load for every assembly and production floor in a facility in a conspicuous space near the main exit or exit access doorway for the space in accordance with RSC Technical Guidelines (Standard)¹ V1.0 Section 6.4.4 .</p>	<p>Within 1 Month</p>

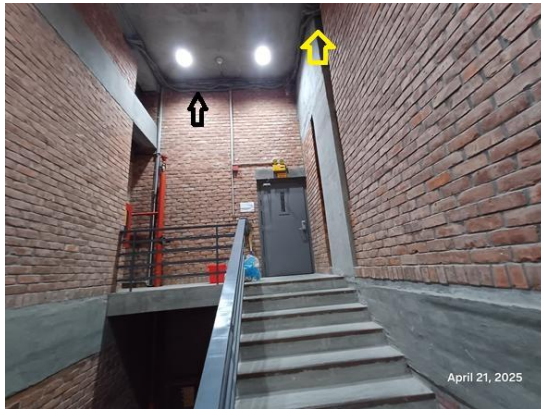
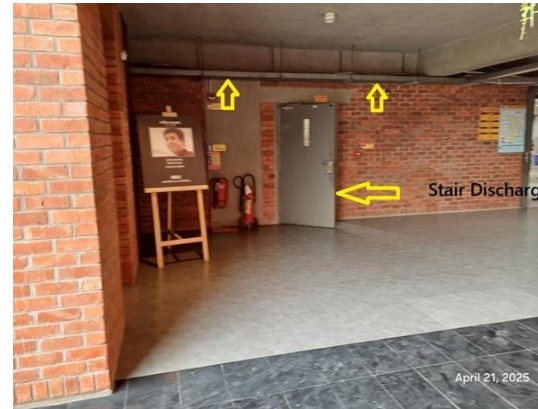
SI No.	Category	Findings	Required Action	Remediation Time Frame
F13	Means of Egress	<p>Unsealed penetrations and openings are located in exit stair enclosures. Electrical cable/ BBT raceway passing through the exit enclosure.</p> <p>Location(s): south-east stair-1 on ground and 2nd floor of Annex Building</p>	<p>No other penetration into and through the exit enclosure except for fire alarm equipment electrical raceway, required exit doors, sprinkler piping, standpipes, and electrical conduit serving the exit enclosure is permitted in accordance with section 6.14.4 of RSC Technical Guidelines (Standard)¹ V1.0. So, relocate the electrical wires/raceways to somewhere else avoiding the exit enclosure, and seal the created unprotected openings with a minimum of 1.5 hours listed/certified fire-rated materials. Installation shall be as per manufacturer published installation guideline and the certification authority guideline to ensure the fire-rating. Or seal the penetration by 2-hr masonry construction.</p>	Within 3 Months

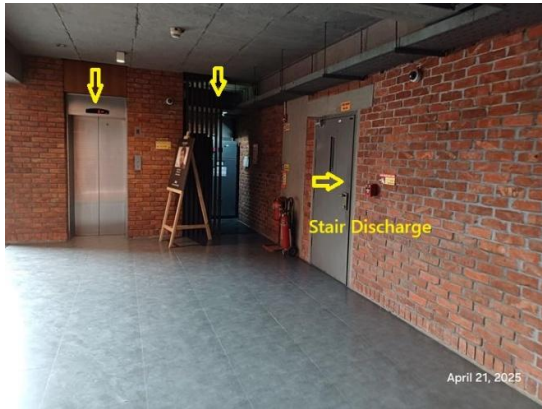
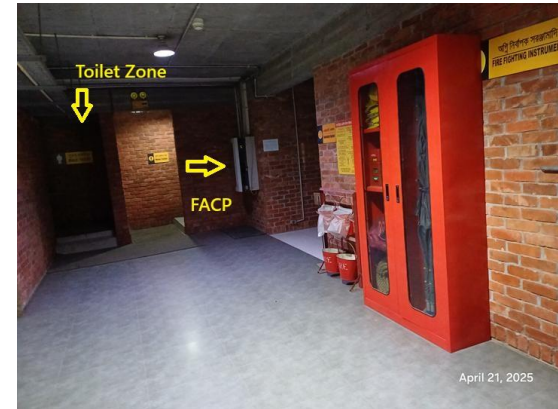
SI No.	Category	Findings	Required Action	Remediation Time Frame
F14	Means of Egress	<p>Exit stair-1 (South-East) terminates the occupants inside the building which does not comply with section 6.17 of RSC Technical Guidelines (Standard)¹ V1.0.</p> <p>Location: South-East Exit Stair-1 Discharge on ground floor of Annex Building.</p> <p>Non-compliance reason: Unsealed openings are found (i) From production area on ground, 1st and 2nd floor; (ii) From Lift Shaft, FACP room and Toilet zones on ground floor</p>	<p>Exits shall discharge directly to the exterior of the building unless meeting the requirements of 6.17.2 or 6.17.3 as per RSC Technical Guidelines (Standard)¹ V1.0.</p>	<p>Within 3 Months</p>

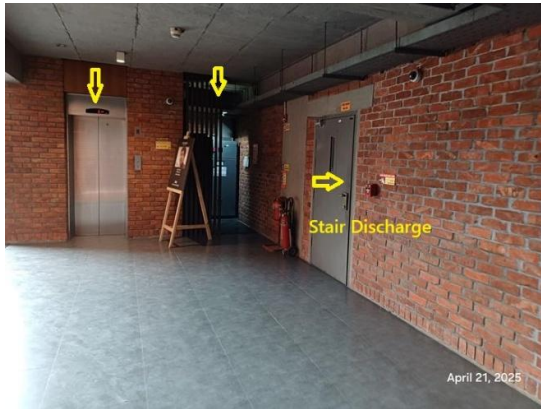
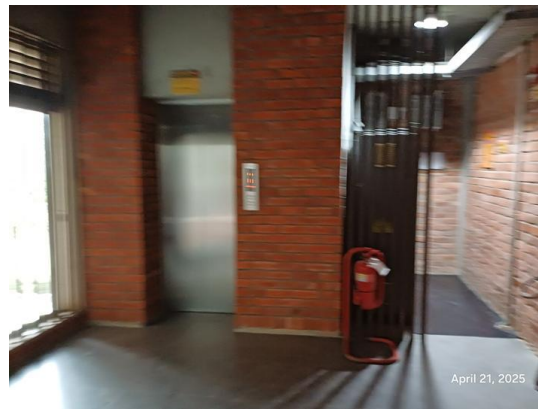
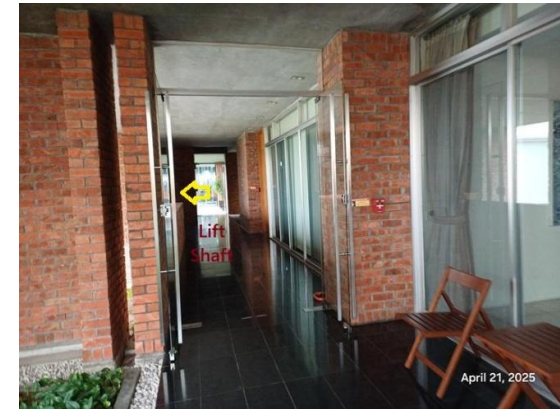
SI No.	Category	Findings	Required Action	Remediation Time Frame
F16	Fire Rated Construction	<p>Elevator shafts open directly into the production or office floor without proper fire separation due to unprotected opening.</p> <p>Location: Production area on all floors of Annex Building</p>	<p>Elevator shaft shall be separated from production area by 2 hours fire rated construction. 2-hr fire barriers shall be protected with minimum 1.5-hr fire protective opening assemblies.</p>	<p>Within 3 Months</p>

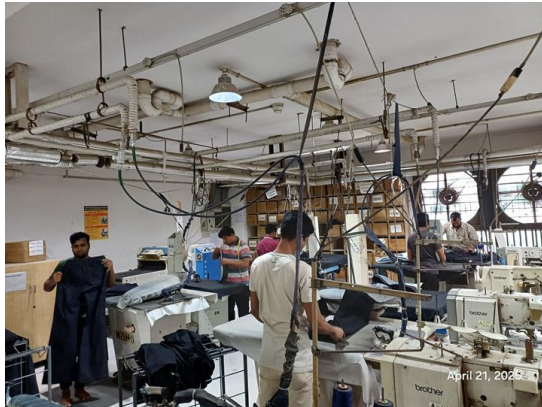
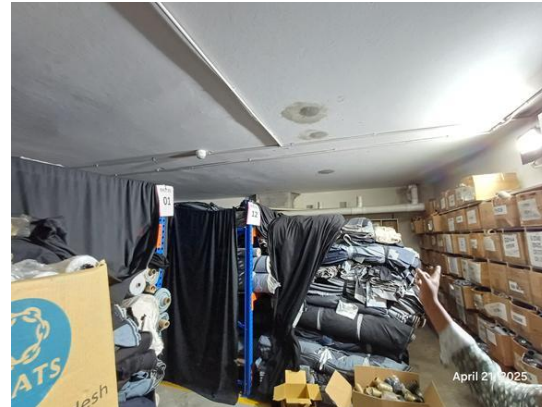
SI No.	Category	Findings	Required Action	Remediation Time Frame
F17	Fire Rated Construction	<p>Penetrations through floor/ceiling assemblies are found unsealed due to electrical cable riser and plumbing PVC Pipes.</p> <p>Location: DB room in all floors, Toilet zones in all floor and production & Storage area on 1st floor of Annex building</p>	<p>Seal all penetrations and openings in floor/ceiling assemblies by a listed through-penetration fire stop system tested in accordance with ASTM E814 or approved alternative standard to maintain minimum 2-hr. fire resistance rating. Installation shall be as per manufacturer published installation guideline and the certification authority guideline to ensure the fire-rating in accordance with section 4.7 of RSC Technical Guideline (Standard)</p> <p>Or,</p> <p>Provide a minimum 2-hr fire rated shaft to separate the penetration from each floor if required.</p>	Within 3 Months

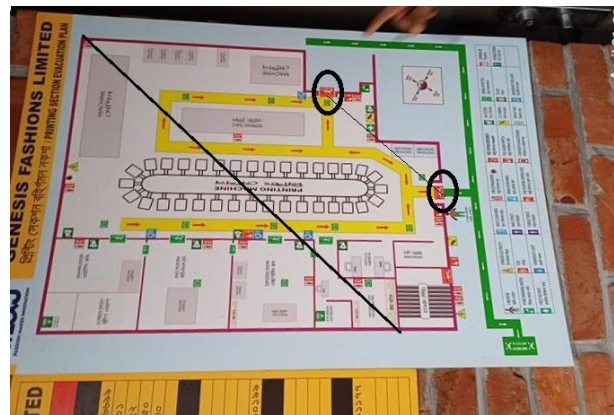
SI No.	Category	Findings	Required Action	Remediation Time Frame
F21	Means of Egress	<p>The exits are not remotely located from each other such that a single fire event could compromise both exits of the Printing section located on ground floor.</p> <p>Location: Annex Building</p>	<p>Provide additional exit or reconfigure the exit arrangement to ensure that the exit doors or means of egress openings are located a distance apart as per RSC Technical Guideline (Standard) section of 6.6.6.</p>	<p>Within 3 Months</p>

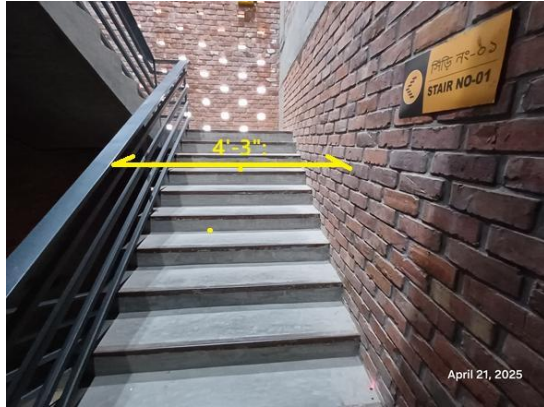
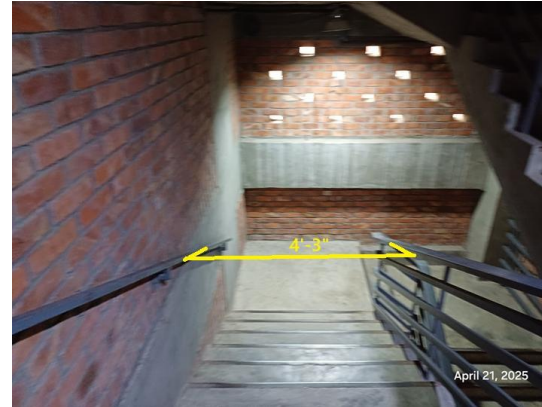
SI No.	Category	Findings	Required Action	Remediation Time Frame
F22	Means of Egress	<p>Each of the Stair clear width is found less than 60 in.</p> <p>Location: South-East Stair-1 and North-West Stair-2 in Annex Building</p>	<p>Stairs shall have a minimum clear width of 60 in. for all industrial occupancies as per RSC Technical Guideline (Standard) section of 6.5.6</p>	<p>Within 3 Months</p>

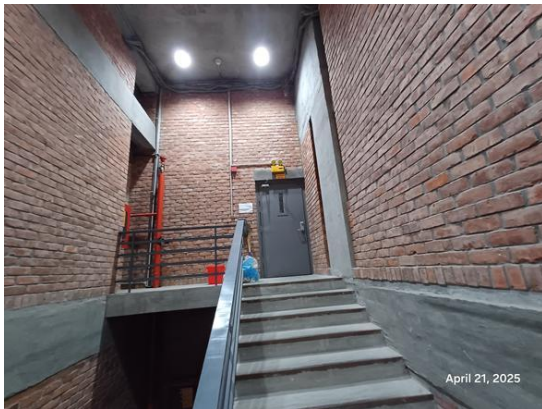
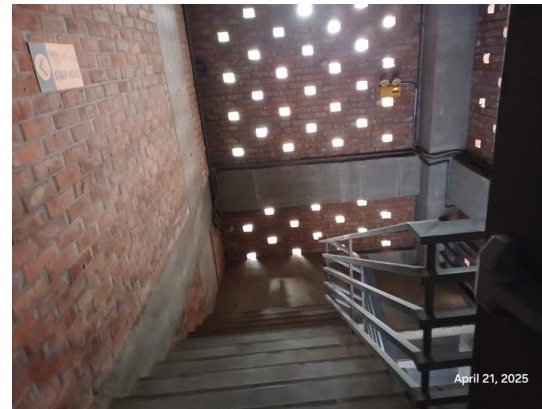
SI No.	Category	Findings	Required Action	Remediation Time Frame
F23	Means of Egress	<p>Handrails are not provided on both sides of each exit stairs on all floors. Having handrails on one side of said staircase, may pose as a falling hazard during evacuation. Height of handrails are below standard.</p> <p>Location: South-East Stair-1 and North-West Stair-2 in Annex Building</p>	<p>Provide handrails on both sides of the exit stair. New handrails shall have a minimum height of 865 mm (34 in.) and a maximum height of 965 mm (38 in.) as measured from the leading edge of the tread. Intermediate handrails shall be provided when the stair width exceeds 2.2 m (87 in.).</p> <p>Open guards shall have intermediate rails or pattern such that a sphere 200 mm (8 in.) in diameter cannot pass through any opening up to a height of 865 mm (34 in.). Handrail shall construct in accordance with RSC Technical Guidelines (Standard)¹ V1.0 Section 6.12.</p>	Within 3 Months

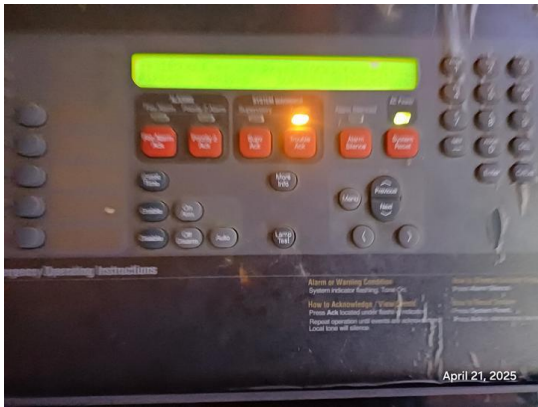
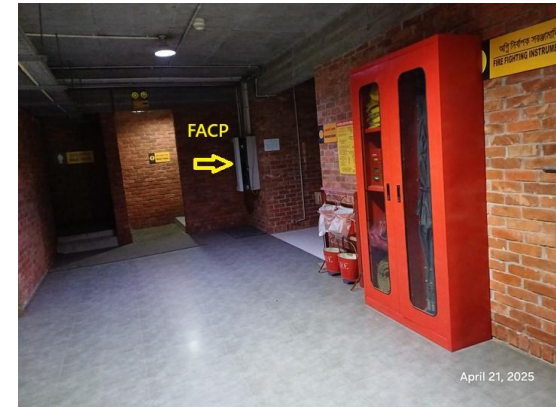
SI No.	Category	Findings	Required Action	Remediation Time Frame
F24	Fire Alarm & Detection System (FADS)	<p>The factory has installed a fire alarm and detection system that requires a detailed review to confirm compliance with NFPA 72 and RSC Technical Guidelines (Standard).</p> <p>Location: Annex Building</p> <p>Note- FACP is located at common area on ground floor of Annex Building. FACP serves 3 Storied Annex building, Single Storied Store Building-02 and 3 storied child care, medical and dining building.</p>	<p>Submit the fire alarm and detection system design to RSC for review.</p> <p>Once the design is reviewed, install and modify the fire detection and alarm system throughout the building in accordance with review comment, RSC Technical Guidelines (Standard) and NFPA 72.</p> <p>After installation/modification the owner shall conduct internal testing and commissioning and then contact the RSC for witness of final acceptance testing.</p>	<p>Design within 2 month and modification/ installation with 4 months</p>

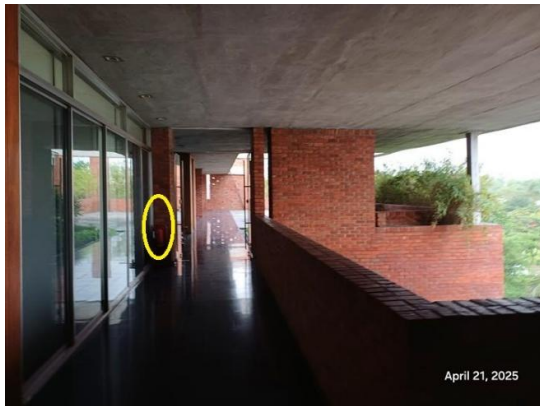
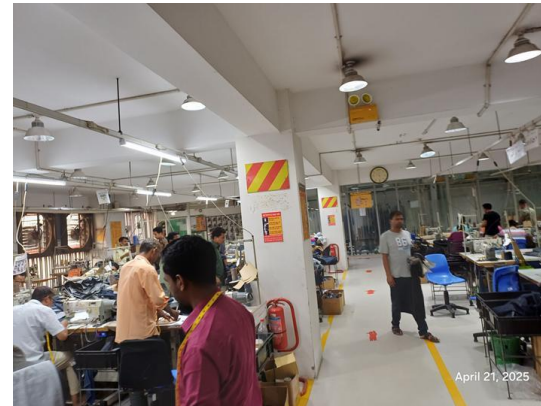
SI No.	Category	Findings	Required Action	Remediation Time Frame
F-25	Inspection, Testing & Maintenance (Fire detection system)	Inspection, testing and maintenance for the fire alarm system is not in accordance with NFPA 72.	Inspect, test and maintain the fire alarm system and keep written records on-site, in accordance with NFPA 72 and RSC Technical Guidelines (Standard) ¹ V1.0.s.	Within 1 Month after installation.
F-26	Fire Suppression System (SUPS)	The travel distance between portable fire extinguishers were found to be more than 30 m (100 ft). Location: 2nd Floor Few fire extinguishers are found obstructed on 1st floor.	Portable fire extinguishers shall be installed throughout all new, interim, and existing facilities in accordance with BNBC 2020 and NFPA 10. Extinguishers shall be placed so that maximum travel distance to the nearest unit shall not exceed 30 m (100 ft). Keep all fire extinguishers accessible.	Within 1 Month

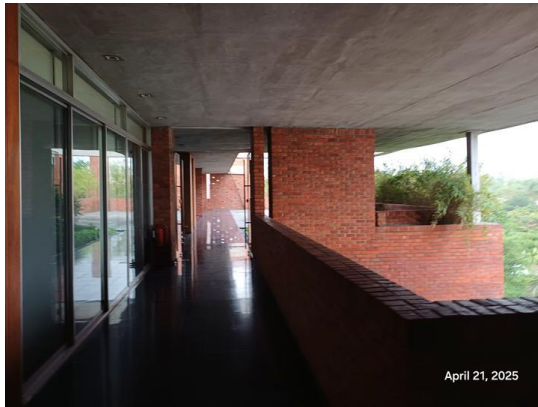
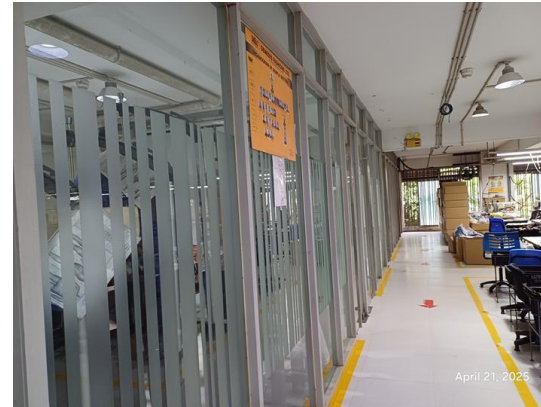
SI No.	Category	Findings	Required Action	Remediation Time Frame
F-27	Inspection, Testing & Maintenance (Portable fire extinguishers)	Inspection, testing and maintenance of portable fire extinguishers is not in accordance with NFPA 10.	Inspect, test and maintain the portable fire extinguishers and keep written records on- site, in accordance with NFPA 10 and RSC Technical Guidelines (Standard) ¹ V1.0.s.	Within 1 Month
F-28	Means of Egress (Egress Lighting)	Based on the number and location of emergency lights observed, adequate illumination levels are not anticipated along egress routes. Location: All Floors	Test the emergency lighting system on each floor and provide additional emergency fixtures to provide adequate illumination along the means of egress. Provide a minimum illumination of 10 lux at the floor level within exit stairs and exit discharge paths and minimum 2.5 lux along exit access aisles. Illumination on means of egress shall meet in accordance with RSC Technical Guidelines (Standard) ¹ V1.0 Section 10.12.2.	Within 3 Months

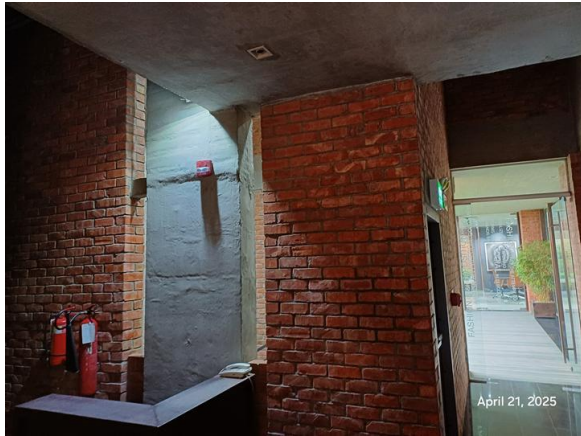
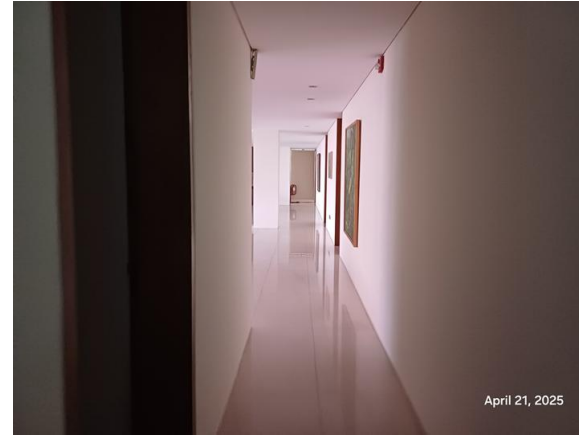
SI No.	Category	Findings	Required Action	Remediation Time Frame
F-34	Means of Egress (Evacuation plan)	<p>Fire evacuation maps is not posted at the entrance of all exit stair.</p> <p>Location: 2nd Floor of Annex Building</p>	<p>Fire evacuation maps shall be posted at the entrance to each exit stair in accordance with RSC Technical Guidelines (Standard)¹ V1.0 Section 13.3.</p>	<p>Within 1 Month</p>

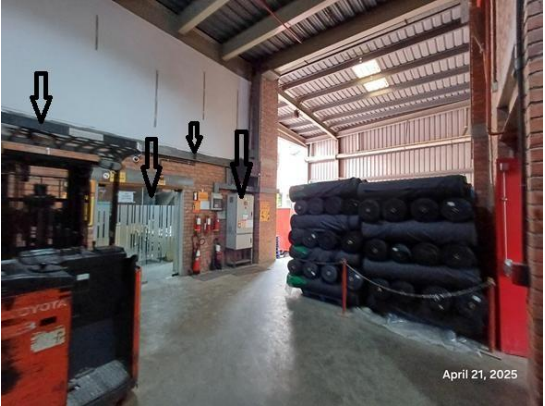
SI No.	Category	Findings	Required Action	Remediation Time Frame
F-35	Means of Egress	<p>The exit stair enclosures are not separated from work areas and other spaces on each floor by fire-rated construction.</p> <p>Location: Building-3: Store Building-01</p> <p>Non-compliance reason: (i) Unsealed openings are found fire rated barrier construction; (ii) Proper certification is not available for fire rated doors and door accessories installed in the factory. 19mm gaps at bottom of fire door, clarification of listing mark on one leaf, broken panic bar & (iii) Steel Beam and Columns in fire barrier which does not provide required fire rating.</p>	<p>The exit stair enclosure shall be provided with a minimum 1-hr fire resistance rating for buildings with 3 or fewer stories and a minimum of 2- hr. fire resistance rating for buildings 4 or more stories. Provide 1-hr. fire rated door and seal all penetrations and openings by 1 hr. fire rated fire rated barrier construction for building with 3 or fewer stories. Provide 1.5 hr. fire rated door and seal all penetrations and openings by 2 hr. fire rated fire rated barrier construction for building with 4 or more stories in accordance with section 6.3.1.2 of RSC Technical Guidelines (Standard)¹ V1.0.</p> <p>Ensure that the fire doors are self-closing and positive latching and that they are provided with fire exit (panic) hardware where serving production floors. If fire doors are required to be held open for functional reasons, provide automatic closing devices tied to the fire alarm system.</p> <p>Keep proper datasheet & certifications for installed fire doors & accessories on-site for verification. The clearance under the bottom of a door shall be a maximum of 3/4 in. (19 mm).</p>	Within 3 Months

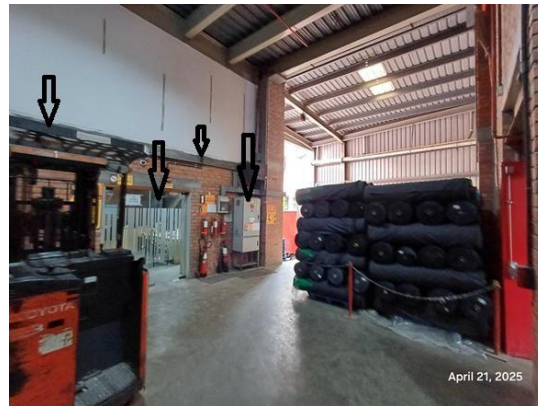
SI No.	Category	Findings	Required Action	Remediation Time Frame
F-36	Means of Egress	<p>Electrical DB and Electrical cable/ BBT raceway located on ground floor the exit stair discharge.</p> <p>Location(s): south-west stair-1 on ground floor of Store Building-01</p>	<p>Remove and re-locate all Electrical panels/Toilet from exit stair enclosures.</p> <p>Or,</p> <p>Provide fire separation with stair enclosure in accordance with section 6.3.1 of RSC Technical Guidelines (Standard)¹ V1.0.</p>	Within 3 Months

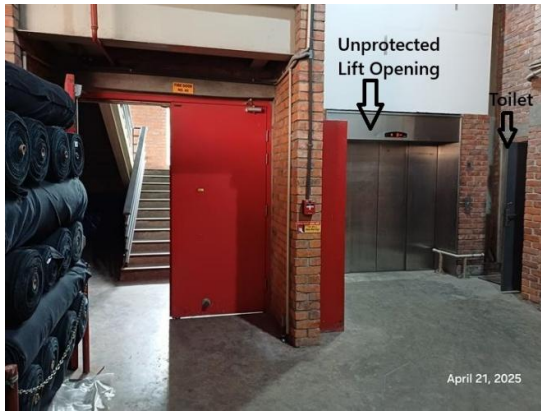
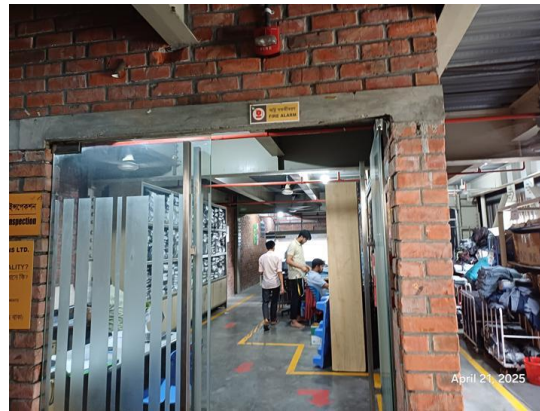
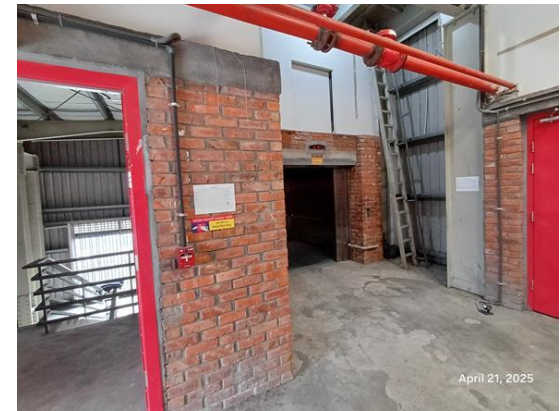
SI No.	Category	Findings	Required Action	Remediation Time Frame
F-38	Fire Rated Construction	<p>Elevator shafts open directly into the Store, production or office floor without proper fire separation due to unprotected opening.</p> <p>Location: Storage and production area on ground, 1st and 4th floor of Store Building-01</p>	<p>Elevator shaft shall be separated from production area by 2 hours fire rated construction. 2-hr fire barriers shall be protected with minimum 1.5-hr fire protective opening assemblies.</p>	<p>Within 3 Months</p>

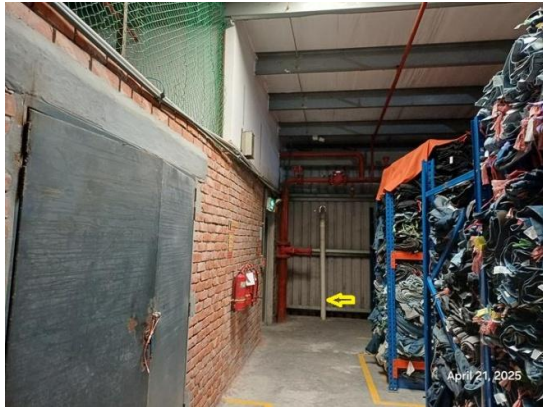
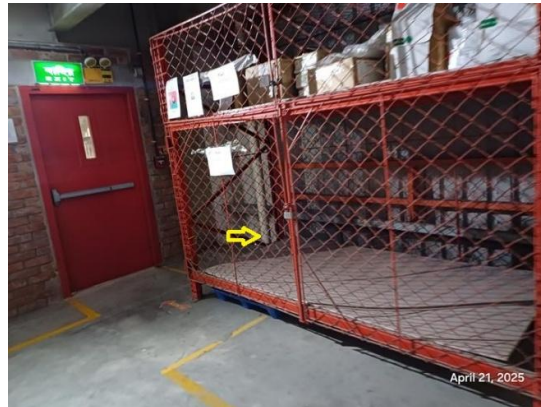
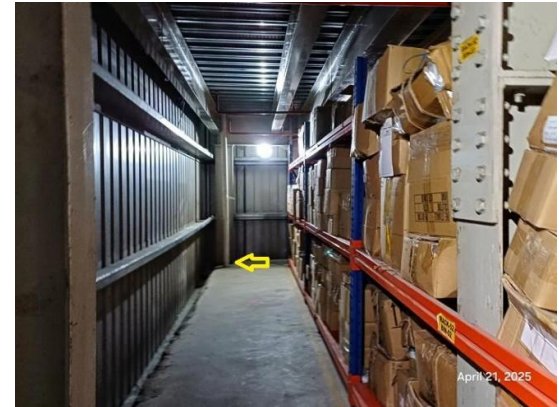
SI No.	Category	Findings	Required Action	Remediation Time Frame
F-39	Fire Rated Construction	<p>Penetrations through floor/ceiling assemblies are found unsealed due to plumbing PVC Pipes.</p> <p>Location: All Floor of Store Building</p>	<p>Seal all penetrations and openings in floor/ceiling assemblies by a listed through-penetration fire stop system tested in accordance with ASTM E814 or approved alternative standard to maintain minimum 2-hr. fire resistance rating. Installation shall be as per manufacturer published installation guideline and the certification authority guideline to ensure the fire-rating in accordance with section 4.7 of RSC Technical Guideline (Standard)</p> <p>Or,</p> <p>Provide a minimum 2-hr fire rated shaft to separate the penetration from each floor if required.</p>	Within 3 Months

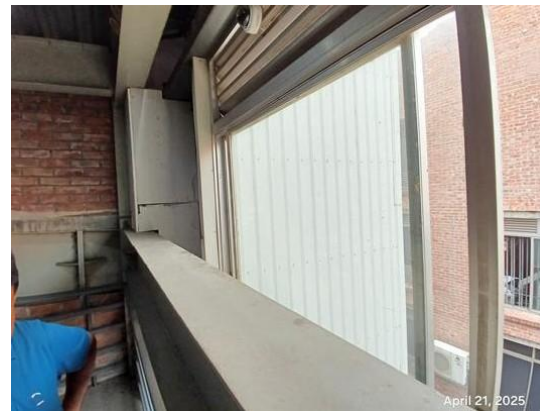
SI No.	Category	Findings	Required Action	Remediation Time Frame
F-42	Means of Egress	<p>The exterior of the south-east stair-2 is enclosed by nonrated walls or unprotected openings, which are exposed to other parts of the building at an angle of less than 180 degrees (3.14 rad).</p> <p>Location: Store Building-01</p>	<p>Nonrated walls or unprotected openings enclose the exterior of the stairway and the walls or openings are exposed by other parts of the building at an angle of less than 180 degrees (3.14 rad), the building exterior walls within 3050 mm (10 ft) horizontally of a nonrated wall or unprotected opening shall have a fire-resistance rating of not less than 1 hr. in accordance with section 6.14.7 of RSC Technical Guidelines (Standard)¹ V1.0. Openings within such exterior walls shall be protected by opening protectives having a fire protection rating of not less than ¾ hr.</p>	Within 3 Months

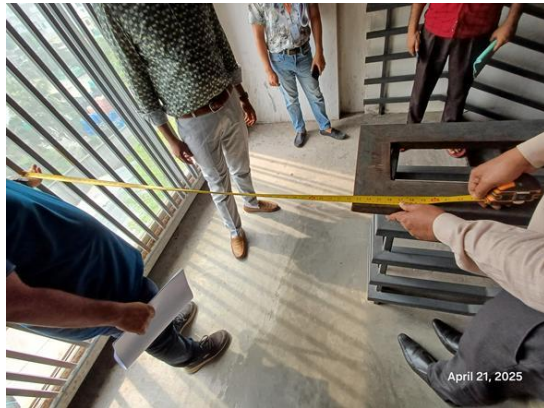
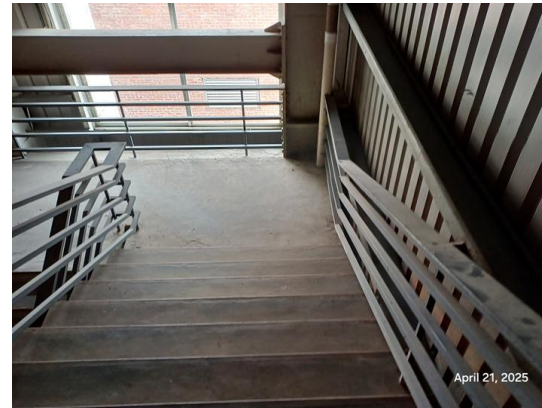
SI No.	Category	Findings	Required Action	Remediation Time Frame
F-43	Means of Egress	<p>Each of the Stair clear width is found greater than 60 in. But, width of intermediate landings in Stair-1 and Stair-2 is found 52 in. and 44 in. respectively.</p> <p>Location: South-West Stair-1 and South-East Stair-2 in Store Building-01</p>	<p>Stairs shall have a minimum clear width of 60 in. for all industrial and storage occupancies as per RSC Technical Guideline (Standard) section of 6.5.6</p> <p>Landings with same width as the stair clear width shall be provided at each level and at intermediate landings as per RSC Technical Guideline (Standard) section of 6.9.2.2.</p>	Within 3 Months

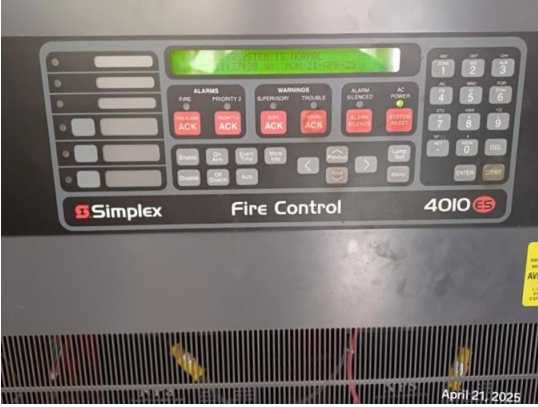
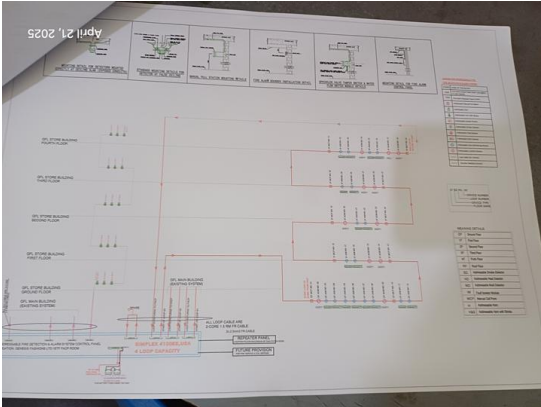
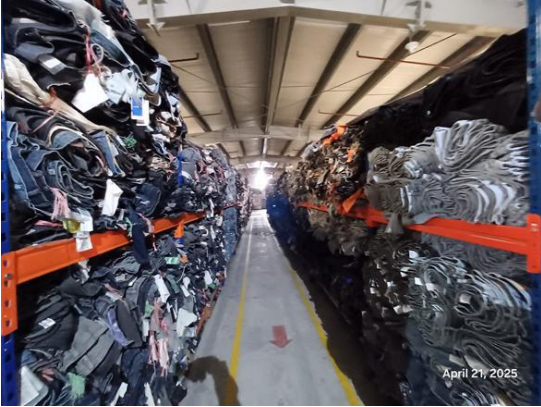
SI No.	Category	Findings	Required Action	Remediation Time Frame
F-44	Fire Alarm & Detection System (FADS)	<p>The factory has installed a fire alarm and detection system that requires a detailed review to confirm compliance with NFPA 72 and RSC Technical Guidelines (Standard).</p> <p>Location: Store Building-01</p> <p>Note- An automatic fire alarm and detection system (Brand-SIMPLEX, Model: 4010ES) has been found installed. FACP is located at FACP room on 1st floor of Security Building. During the visit, FACP is active and in normal condition. All floors of 5 storied storage building are not covered by detectors as floors are covered by sprinkler system.</p>	<p>Submit the fire alarm and detection system design to RSC for review.</p> <p>Once the design is reviewed, install and modify the fire detection and alarm system throughout the building in accordance with review comment, RSC Technical Guidelines (Standard) and NFPA 72.</p> <p>After installation/modification the owner shall conduct internal testing and commissioning and then contact the RSC for witness of final acceptance testing.</p>	Design within 2 month and modification/ installation with 4 months

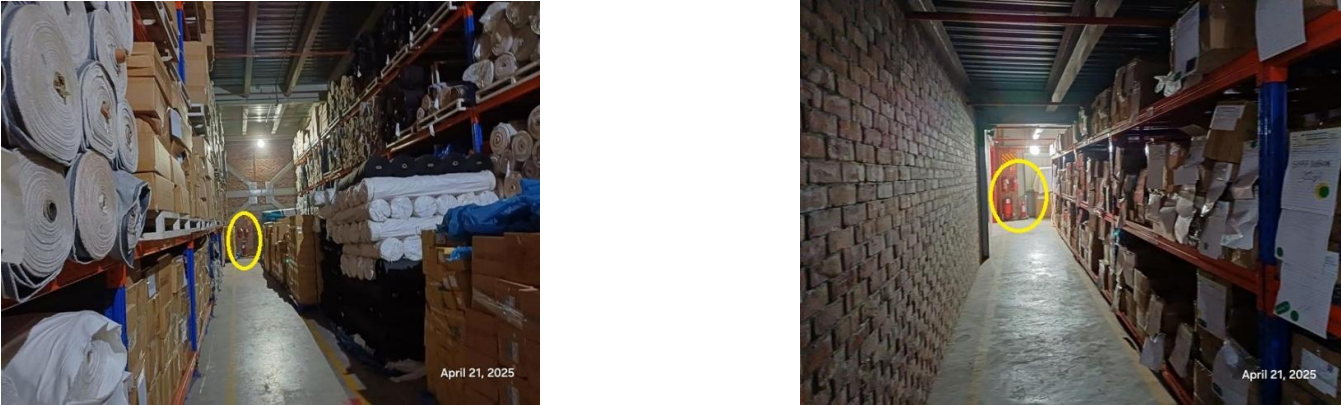
SI No.	Category	Findings	Required Action	Remediation Time Frame
F-46	Fire Suppression System (SUFS)	<p>Fire extinguishers are found at several areas but placed on floors.</p> <p>Location: Ground, 3rd & 4th floor of Store Building-01</p>	<p>The bottom of the fire extinguisher and the floor be less than 4 in.(102 mm).As per NFPA 10 section 6.1.3.8.3</p> <p>Fire extinguishers having a gross weight not exceeding 18.14 kg (40 lb.) shall be installed so that the top of the fire extinguisher is not more than 1.53 m (5 ft) above the floor (NFPA 10 6.1.3.8) to meet section 5.6 of RSC Technical Guideline (Standard)</p>	Within 1 Month

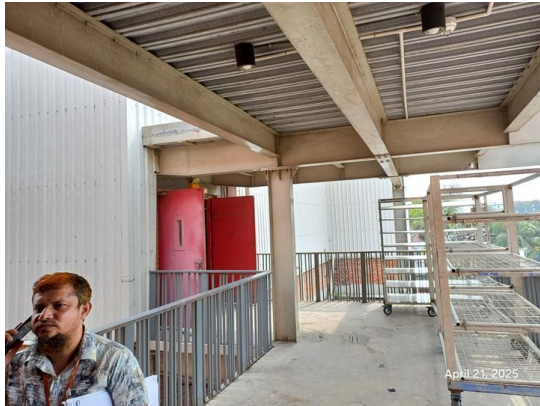
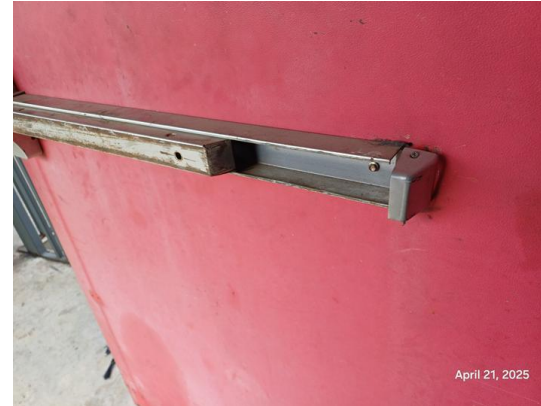
SI No.	Category	Findings	Required Action	Remediation Time Frame
F-54	Fire Rated Construction (Fire Separation)	<p>A non-rated connecting corridor has been constructed between two buildings which is not fire separated from the adjacent building due to damaged fire door.</p> <p>Location: 1st Floor of Storage Building-01</p>	<p>Separate the buildings with a minimum 2-hour fire-rated construction on both sides of the connecting corridor. Opening protection extending up to 10 feet beyond the connecting corridor shall meet section 4.6 of RSC Technical Guidelines (Standard)¹ V1.0 .</p>	Within 3 Months

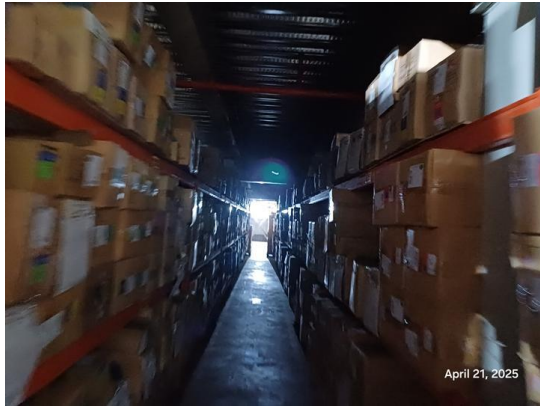
SI No.	Category	Findings	Required Action	Remediation Time Frame
F-55	Means of Egress (Egress Lighting)	<p>Based on the number and location of emergency lights observed, adequate illumination levels are not anticipated along egress routes.</p> <p>Location: 2nd, 3rd & 4th Floor of store Building 01</p>	<p>Test the emergency lighting system on each floor and provide additional emergency fixtures to provide adequate illumination along the means of egress. Provide a minimum illumination of 10 lux at the floor level within exit stairs and exit discharge paths and minimum 2.5 lux along exit access aisles. Illumination on means of egress shall meet in accordance with RSC Technical Guidelines (Standard)¹ V1.0 Section 10.12.2.</p>	Within 3 Months

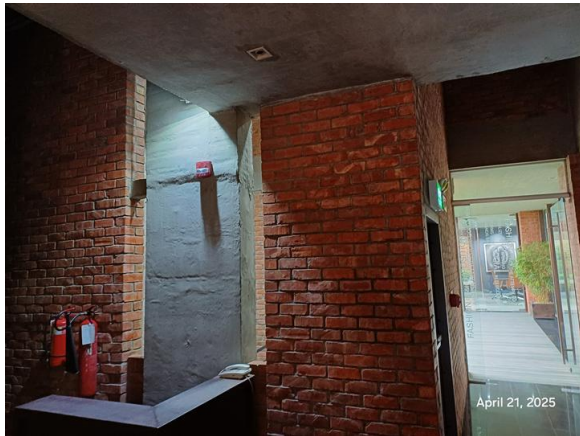
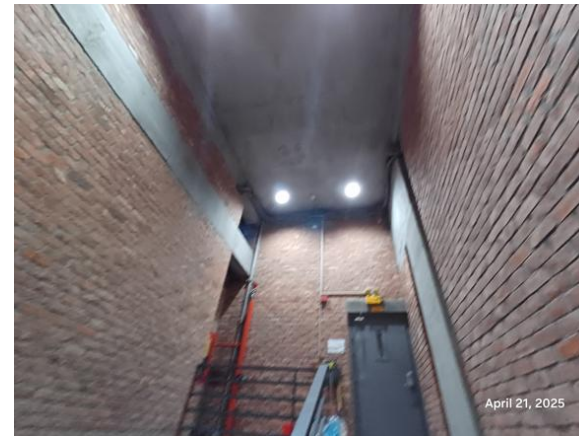
SI No.	Category	Findings	Required Action	Remediation Time Frame
F-58	Means of Egress (Exit Sign, Stair sign & occupant load sign)	<p>Building does not have occupant load signs at required locations on all floors.</p> <p>Location: All Floor of Store Building-01</p>	<p>Post the occupant load for every assembly and production floor in a facility in a conspicuous space near the main exit or exit access doorway for the space in accordance with RSC Technical Guidelines (Standard)¹ V1.0 Section 6.4.4 .</p>	<p>Within 1 Month</p>

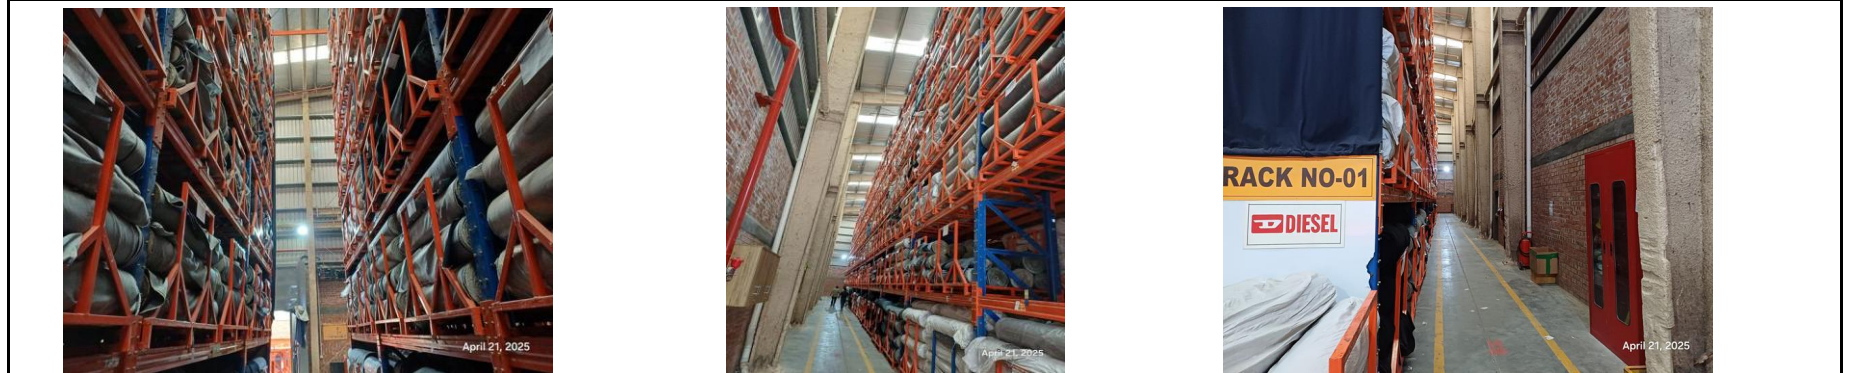
SI No.	Category	Findings	Required Action	Remediation Time Frame
F-59	Fire Rated Construction (Passive Fire Protection of Steel Structure)	<p>The main structural element of the new building is constructed by steel which is non-rated and were found in exposed condition without any fire protection.</p> <p>Location: Single Storied Storage Building-02</p> <p>Note- Peak Height- 47'-2"; Eave Height-41'-2" and Avg Height- 44.17 ft/ 13.46m, factory has provided cementitious spray to steel columns of shed but credible documents are not found during the visit.</p>	<p>The construction type shall confirm to be in accordance with BNBC 2020 Part-3, Table 3.1.7. Ensure fire resistive rated construction following Table 3.3.1 (a) Part 3 Section-3, Table 3.2.2 and Table 3.2.3 Part 3 Section 2 and Table 4.1.1 from BNBC 2020 Part 4 Section 1. Provide design philosophy to determine the construction type as per BNBC 2020. If any construction rating requires, Consult a qualified fire protection engineer to achieve the require fire rating.</p> <p>Submit the design philosophy along with the required documents to RSC for review the required construction type.</p> <p>Once the design philosophy is reviewed, provide fire ratings of structural members.</p>	Within 6 Months

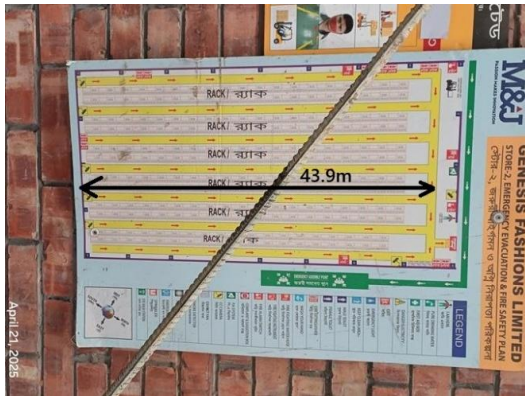
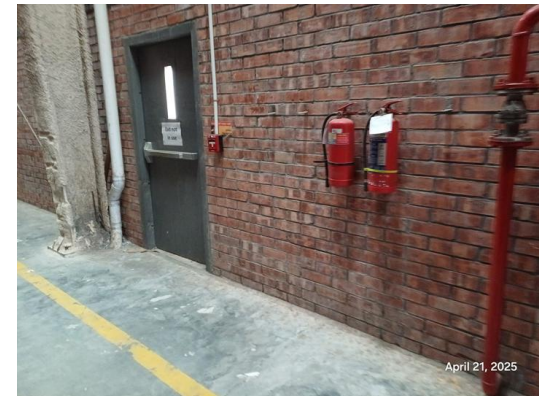
SI No.	Category	Findings	Required Action	Remediation Time Frame
F-60	Means of Egress (Exit Adequacy)	<p>Common path of egress travel exceeds 30.0m.</p> <p>Location: Single Storied Store Building-02</p> <p>Occupancy/Process: H2</p> <p>Available Common Path: 43.90m</p>	<p>Reconfigure the egress arrangement to reduce the maximum common path of travel to not more than 30.0 m.</p> <p>The common path of egress travel shall not exceed 23 m (75 ft). Where the building is provided with a complete automatic sprinkler system, the common path of egress travel shall not exceed 30 m (100 ft). The common path of egress travel for Group H (storage) occupancies with not more than 30 occupants shall not exceed 30 m (100 ft). The common path of egress travel for Group J (high hazard) occupancies shall not exceed 8 m (25 ft).</p> <p>Section 6.13.2 of RSC Technical Guidelines (Standard) shall meet.</p>	Within 3 Months

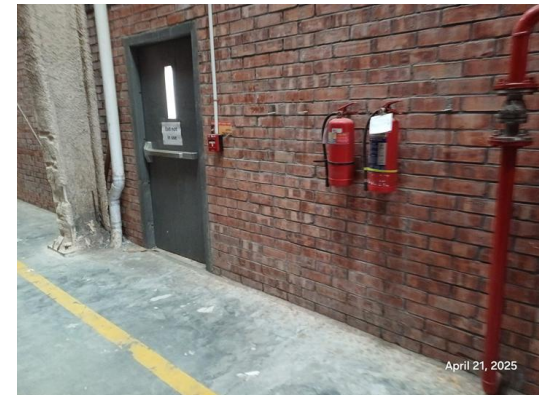
SI No.	Category	Findings	Required Action	Remediation Time Frame
F-61	Means of Egress (Exit Adequacy)	<p>A single means of exit has been provided on ground floor of store building-02. Another door is found which declared as not an exit.</p> <p>Location: Single Storied Store Building-02</p> <p>Occupant Load: 30 Travel distance: 70.0m</p>	<p>The number of means of egress from any floor, story or portion thereof shall not be less than 2 except where a single exit is permitted by RSC Technical Guideline (Standard), section 6.6.2.</p> <p>Provide additional exit and ensure that the exit doors or means of egress openings are located a distance apart as per RSC Technical Guideline (Standard) section of 6.6.6. Ensure that travel distance does not exceed 38.0m or for fully sprinklered building travel distance does not exceed 45.0m.</p>	Within 3 Months

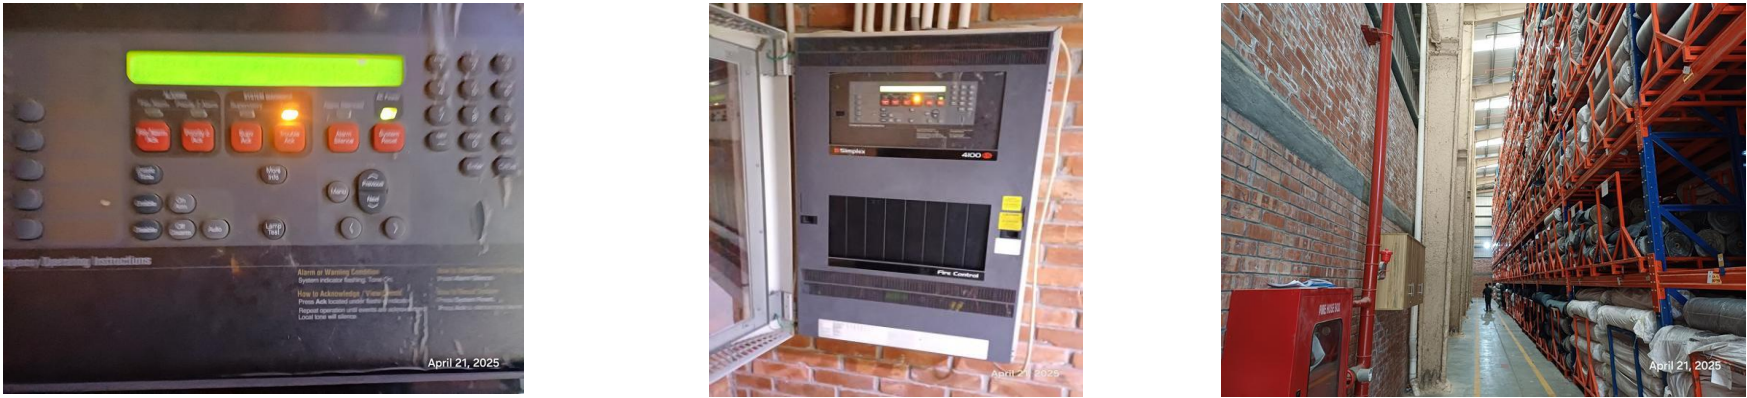
SI No.	Category	Findings	Required Action	Remediation Time Frame
F-62	Fire Alarm & Detection system	<p>The factory has installed a fire alarm and detection system that requires a detailed review to confirm compliance with NFPA 72 and RSC Technical Guidelines (Standard).</p> <p>Location: Single Storied Store Building-02</p> <p>Note- An automatic fire alarm and detection system (Brand-SIMPLEX, Model: 4100ES) has been found installed in building -4, Single Storied Store Building-02. FACP is located at common area on ground floor of Annex Building. FACP serves 3 Storied Annex building, Single Storied Store Building-02 and 3 storied child care, medical and dining building. During the visit, FACP is in active condition. Ground floor of single storied storage building-02 is not covered by detectors as floor is covered by sprinkler system.</p>	<p>Submit the fire alarm and detection system design to RSC for review.</p> <p>Once the design is reviewed, install and modify the fire detection and alarm system throughout the building in accordance with review comment, RSC Technical Guidelines (Standard) and NFPA 72.</p> <p>After installation/modification the owner shall conduct internal testing and commissioning and then contact the RSC for witness of final acceptance testing.</p>	<p>Design within 2 Months and modification/ installation with 4 Months</p>

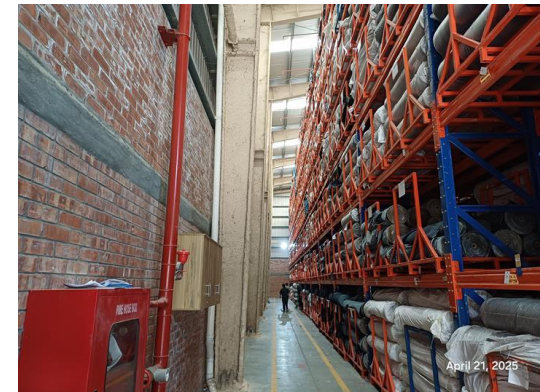
SI No.	Category	Findings	Required Action	Remediation Time Frame
F-64	Sprinkler system Design & Installation	<p>Sprinkler system is not mandatory for the building based on height and type of construction but the system installed for the building along with standpipe system in lieu of automatic detection system. Both the system requires detailed review to confirm compliance with NFPA 13, 14, 20, 22, 24 and RSC Technical Guidelines (Standard).</p> <p>Location: Single Storied Store Building-02</p>	<p>Submit the sprinkler system drawing to RSC for review. Once the design is reviewed, install and modify the sprinkler/standpipe system throughout the building in accordance with review comment, RSC Technical guideline (Standard) and NFPA 13,14,20,22 and 24. After installation the owner shall conduct internal testing and commissioning and then contact the RSC for witness of final acceptance testing.</p> <p>(Provide automatic sprinkler protection along with class-I standpipe system throughout the building in accordance with NFPA 13, 14, 20 and 22. Submit design to RSC for review prior installation.)</p>	Design within 2 month and modification/ installation with 4 months

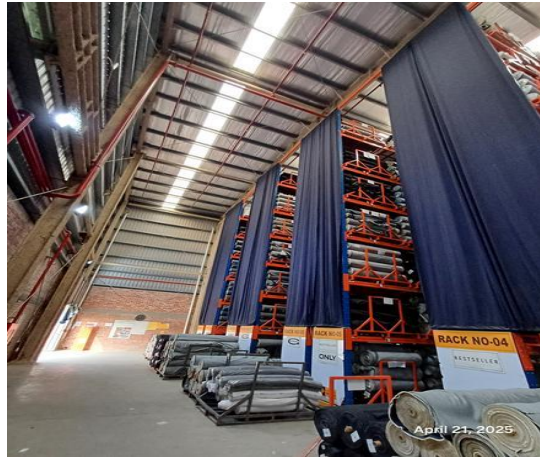
SI No.	Category	Findings	Required Action	Remediation Time Frame
F-67	Means of Egress	<p>Aisles is found missing on several locations throughout the single storied storage shed.</p> <p>Location: Ground floor of single storied storage building-02</p>	<p>Provide minimum aisle widths of 36-in. Aisles mark shall be clearly visible.</p>	<p>Within 1 Month</p>
