INITIAL FIRE SAFETY INSPECTION REPORT

GENESIS FASHIONS LTD. (Extension - 2)

RSC ID: 26201

Date: 21 April, 2025

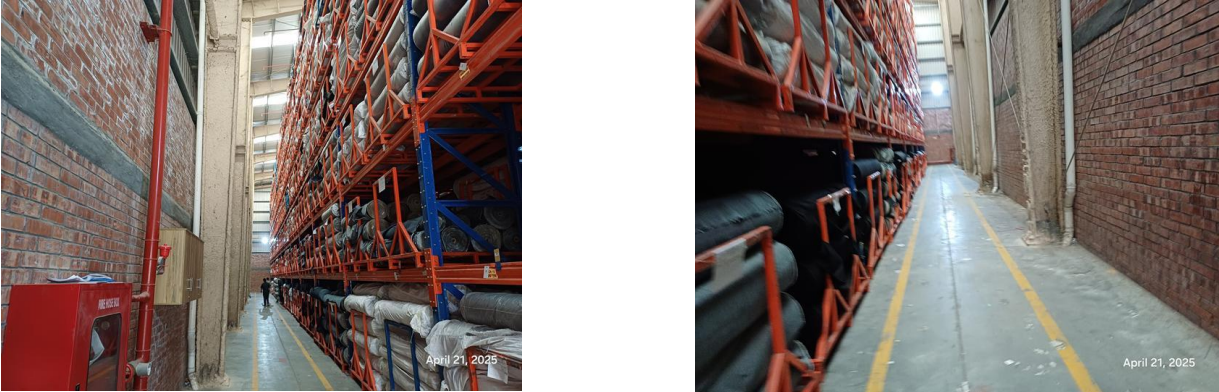
SI No.	Category	Findings	Required Action	Remediation Time Frame
F-68	Fire Suppression System (SUFS)	<p>Portable fire extinguishers are not placed maintaining maximum travel distance for the occupant on ground floor.</p> <p>Location: Single storied Storage Building-02</p>	<p>Portable fire extinguishers shall be installed throughout all new, interim, and existing facilities in accordance with BNBC 2020 and NFPA 10. Extinguishers shall be placed so that maximum travel distance to the nearest unit shall not exceed 30 m (100 ft).</p>	Within 3 Months

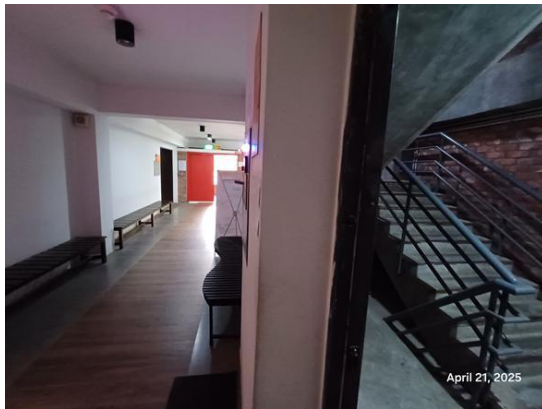
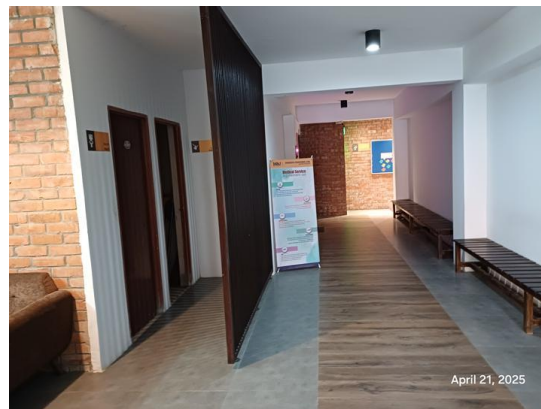
SI No.	Category	Findings	Required Action	Remediation Time Frame
F-77	Means of Egress	<p>Exit stair-1 (Mid-East) terminates the occupants inside the building which does not comply with section 6.17 of RSC Technical Guidelines (Standard)¹ V1.0.</p> <p>Location: Mid-East stair-1 discharge on ground floor of 3 Storied Daycare, Medical & Dining Building</p> <p>Non-compliance reason: On ground floor, Unsealed openings are found from medical, daycare and toilet zone.</p>	<p>Exits shall discharge directly to the exterior of the building unless meeting the requirements of 6.17.2 or 6.17.3 as per RSC Technical Guidelines (Standard)¹ V1.0.</p>	Within 3 Months

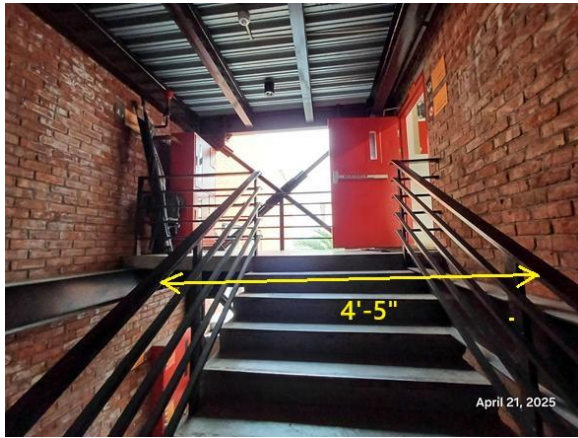
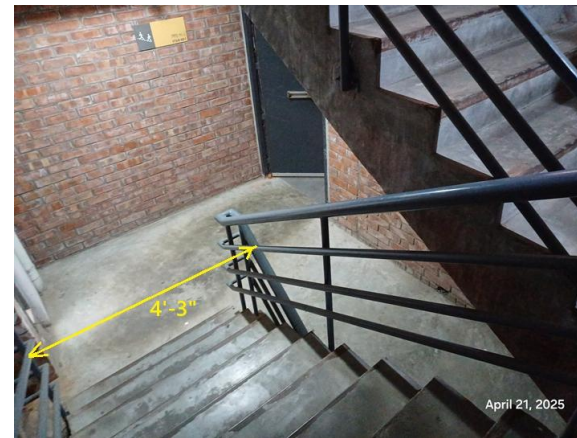
SI No.	Category	Findings	Required Action	Remediation Time Frame
F-80	Means of Egress (Exit Adequacy)	<p>Each of the two Stairs clear width is found less than 79 in. (Width of Stair-1 and stair-2 is 4'-3" and 4'-5" respectively.</p> <p>Location: Mid-South Stair-1 and North-West Stair-2 in 3 Storied Daycare, Medical & Dining Building</p>	<p>Stairs shall have a minimum clear width of 79 in. for all assembly occupancies as per RSC Technical Guideline (Standard) section of 6.5.6</p> <p>Landings with same width as the stair clear width shall be provided at each level and at intermediate landings as per RSC Technical Guideline (Standard) section of 6.9.2.2.</p>	Within 3 Months

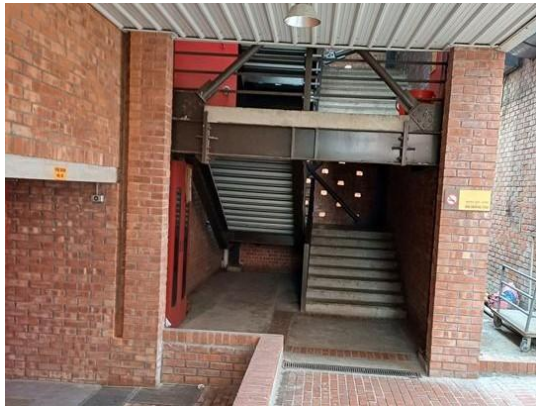
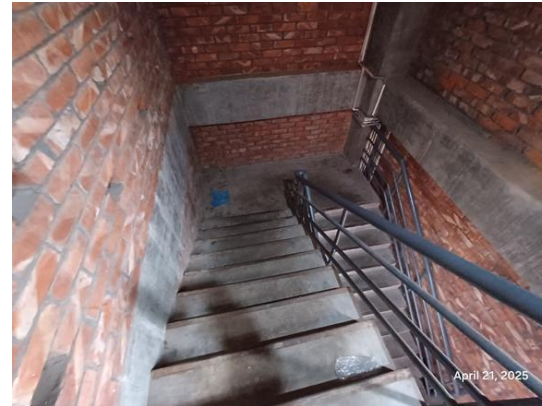
SI No.	Category	Findings	Required Action	Remediation Time Frame
F-84	Means of Egress	<p>Handrails are not provided on both sides of each exit stairs on all floors. Having handrails on one side of said staircase, may pose as a falling hazard during evacuation.</p> <p>Location: Mid-South Stair-1 and North-West Stair-2 in 3 Storied Daycare, Medical & Dining Building</p>	<p>Provide handrails on both sides of the exit stair. New handrails shall have a minimum height of 865 mm (34 in.) and a maximum height of 965 mm (38 in.) as measured from the leading edge of the tread. Intermediate handrails shall be provided when the stair width exceeds 2.2 m (87 in.).</p> <p>Open guards shall have intermediate rails or pattern such that a sphere 200 mm (8 in.) in diameter cannot pass through any opening up to a height of 865 mm (34 in.). Handrail shall construct in accordance with RSC Technical Guidelines (Standard)¹ V1.0 Section 6.12.</p>	Within 3 Months

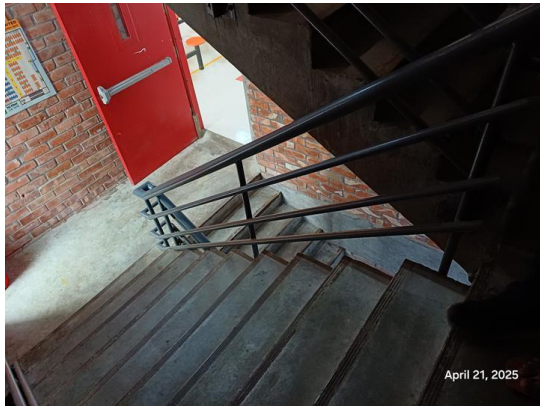
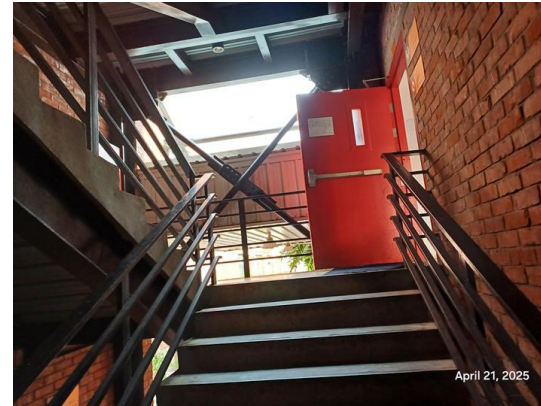
SI No.	Category	Findings	Required Action	Remediation Time Frame
F-85	Means of Egress	<p>Doors are swing out over stairs landing.</p> <p>Location: Mid-South Stair-1 and North-West Stair-2 in 3 Storied Daycare, Medical & Dining Building</p>	<p>A landing shall be provided on both sides of doors used in the means of egress to facilitate uninterrupted egress of occupants. Door shall not swing out over stairs. Landings with same width as the stair clear width shall be provided at each level and at intermediate landings.</p>	Within 3 Months

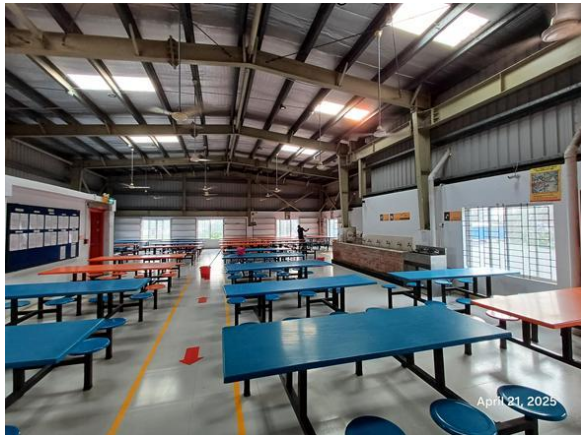
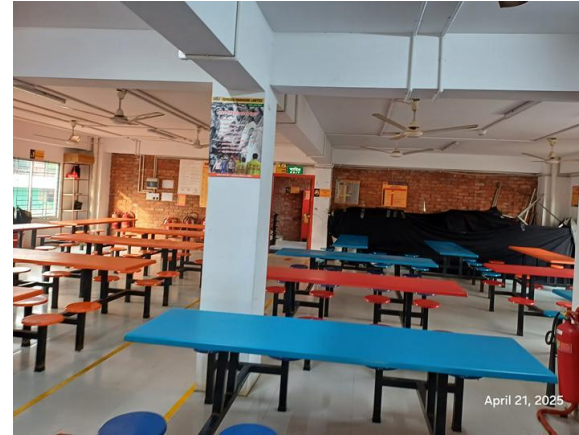
SI No.	Category	Findings	Required Action	Remediation Time Frame
F-86	Means of Egress (Egress Lighting)	<p>Based on the number and location of emergency lights observed, adequate illumination levels are not anticipated along egress routes.</p> <p>Location: All Floors of 3 Storied Daycare, Medical & Dining Building</p>	<p>Test the emergency lighting system on each floor and provide additional emergency fixtures to provide adequate illumination along the means of egress. Provide a minimum illumination of 10 lux at the floor level within exit stairs and exit discharge paths and minimum 2.5 lux along exit access aisles. Illumination on means of egress shall meet in accordance with RSC Technical Guidelines (Standard)¹ V1.0 Section 10.12.2.</p>	Within 3 Months
