# ELECTRICAL SAFETY INSPECTION REPORT

**INTERLOOP BD LTD.**

**86, Soydana, P.O. National University, Gazipur, Bangladesh.**

**Inspected on March 9, 2014**

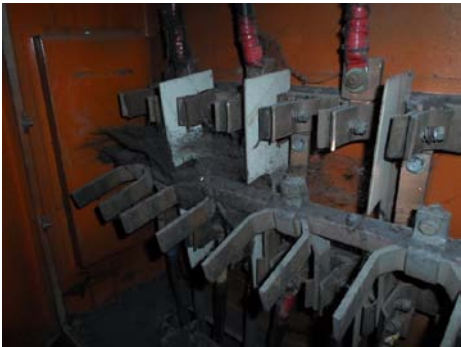
| <b>Finding #:</b> E- 1 | <p>Inside of the changeover switch panel.</p> |
| <b>Finding:</b><br>Excessive dust was found inside of the changeover switch panel. | |

| <b>Recommendation:</b><br>Disconnect the panel from the electrical service (switch off the power) and clean interior components of the panel to remove all dust and debris. Seal/block all openings (kept unused at cable entry point or other) within the enclosure to prevent dust and debris from entering inside. | |

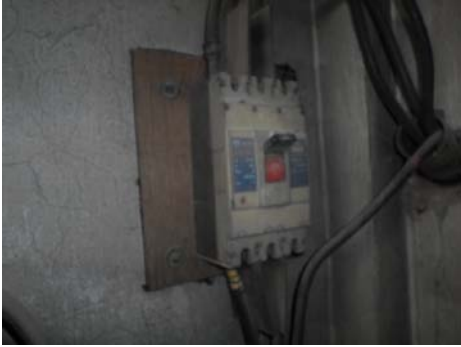
| <b>Finding #:</b> E- 2 | <p>MCCB mounted on wooden board.</p> |
| <b>Finding:</b><br>MCCB mounted on wooden board without enclosure. | |

| <b>Recommendation:</b><br>Remove the wooden board and install the MCCB into an enclosure made of galvanized plain sheet (metallic) of minimum thickness 20 SWG in order to reduce the risk of spreading fire due to short circuit. | |

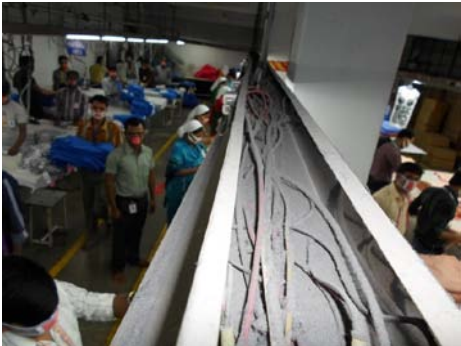
| <b>Finding:</b><br>Lint/ dust was found inside the cable duct. | |
| <b>Remediation Timeframe:</b> Within 3 month | Dusty Cable duct in the production floor |

| <b>Recommendation:</b><br>Clean the dust inside the cable-duct and provide cover (made of non-combustible material) for the cable-duct to prevent the further accumulation of dust inside the duct. | |

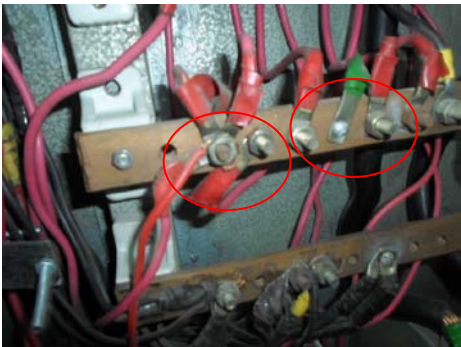
| <b>Finding:</b><br>1) Multiple cables connected at a point on the bus-bar.<br>2) Lug was found punched improperly during termination. | |
| <b>Remediation Timeframe:</b> Within 1 month | Improper termination inside the SDB. |

| <b>Recommendation:</b><br>1) Connect all the cable individually on bus-bar(multiple cable shall not be terminated at a same point keeping other area of the bus bar unused).<br>2) Use proper crimping tool or hydraulic puncher to punch the cable-socket/lug during termination (hammer shall not be used to punch lugs). After punching the lug, PIB tape and then PVC cable-sleeve (heat-shrinkable type preferably) shall be used instead of using only PVC/electric- tape. | |

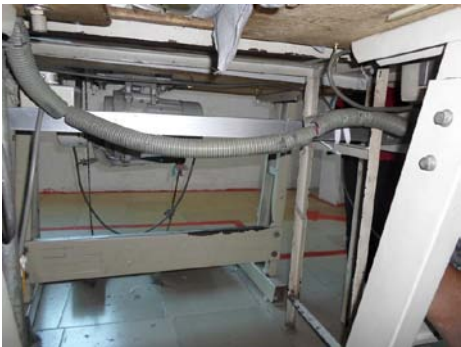
| <b>Finding:</b><br>Damaged flexible conduit goes under the table without proper support. | |
| <b>Remediation Timeframe:</b> Within 3 month | Flexible conduit under the sewing machine table |

| <b>Recommendation:</b><br>Wiring for connections to machines shall be carried in steel pipes or cable tray(with metal cover) running in concrete or over the floor(clamped properly on floor).Where steel pipe/tray cannot be used, industrial graded flexible pipes shall be used with proper support( instead of using normal PVC flexible pipes).<br>See standard details in Accord Standard 10.3.2.4 | |

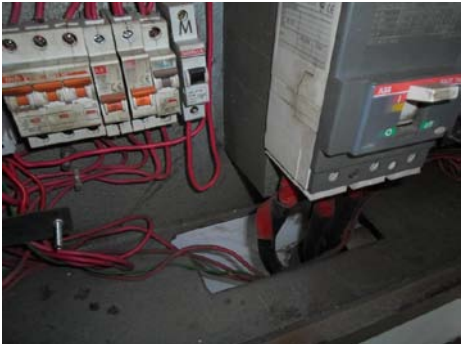
| <b>Finding:</b><br>Cables are connected to the panel without providing any support(without gland fixation). | |
| <b>Remediation Timeframe:</b> Within 3 month | Cable connected to panel without proper material |

| <b>Recommendation:</b><br>Block the opening in base plate or cable-entry-openings & keep the provision for gland fixation for incoming and outgoing cables.Cables shall be connected in the panel through the glands. | |

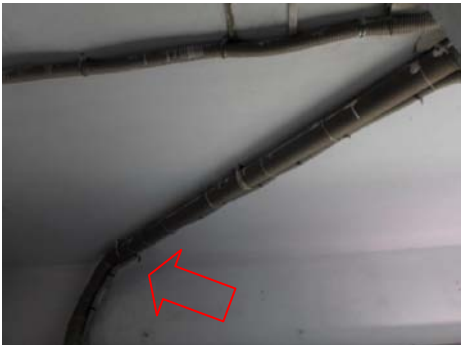
| <b>Finding:</b><br>Cable is run in the ceiling at an angle. | |
| <b>Remediation Timeframe:</b> Within 3 month | Cable run on the ceiling |

| <b>Recommendation:</b><br>Cables shall be run either horizontally or vertically(not at an angle). | |

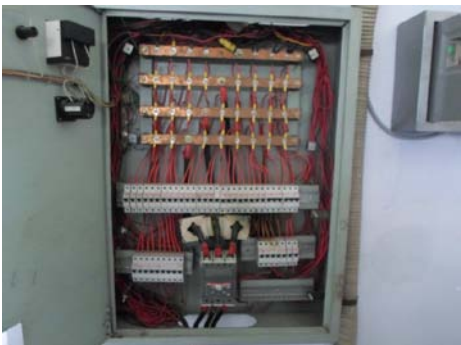
| <b>Finding:</b><br>Earth wire of SDB door is not installed. | |
| <b>Remediation Timeframe:</b> Within 1 month | Opened SDB door |

| <b>Recommendation:</b><br>Provide earthing connections for all panels' door in the factory (with flexible copper braids preferably). | |

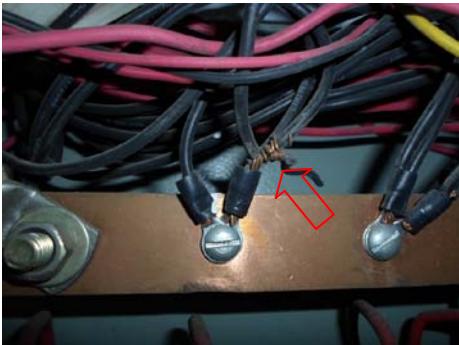
| <b>Finding:</b><br>Wire is jointed inside panel and the wire is terminated without providing any cable-socket. | |
| <b>Remediation Timeframe:</b> Within 1 month | Strip connection inside the panel |

| <b>Recommendation:</b><br>Terminate all the cable providing copper cable socket/lug (size according to the respective cable size) on bus-bar individually. Use proper crimping tools for punching the lug/connector. | |

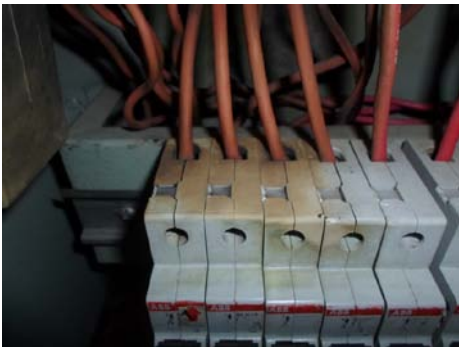
| <b>Finding:</b><br>Burning sign was observed at the termination point of MCB, which might be induced from the loose connection. | |
| <b>Remediation Timeframe:</b> Within 1 month | Burnt MCCB inside the panel. |

| <b>Recommendation:</b><br>Replace the burnt MCBs and make sure all the termination are tight. Arrange a periodic inspection and thermal scan for identifying the loose connection and overloading which may induce unexpected heat-rise. | |
