Mawna Fashions Ltd

Tepirbari, Sreepur, Gazipur
(24.248209N, 90.42759E)

10th February 2015

Observations

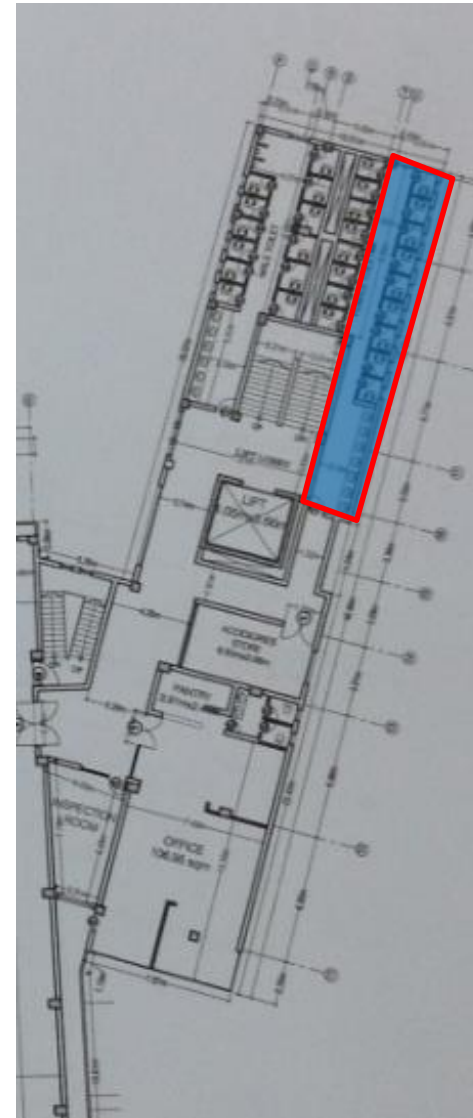
An additional space for functions mentioned in the subject is being constructed on the roof top with additional columns and slabs. On the North-East portion of the new construction Building, a cantilever slab of 8'-4" span was planned. The detailed design drawings supplied to us during the factory visit, showed that the reinforcement details were deficient. Also, an additional problem arose, which is that some of the extended columns has already been cast and hence the beams in the North-South direction of the Easternmost portion of the Building supporting this cantilever slab could not be continued through to the edge.

Calculation of the additional or revised reinforcements was done at site and on-site remedy including limiting the cantilever to 7'-3" has been provided and explained orally.

Letter on file outlining a noted rebar deficiency onsite and an verbal remedial action agreed.

Item No.	Observation	Recommended Action Plan	Recommended Timeline
1	Building 1 Large cantilever in North East corner under toilet (structural details queried in a letter following a site inspection)	Letter on file relating to large cantilever where there was a deficiency in rebar noted. It suggested a reduction in the cantilever. Factory engineer to carry out a review of the as-built structure including the columns and cantilever beams in this area.	6-weeks
2	Building 1 Large cantilever in North East corner under toilet (structural details queried in a letter following a site inspection)	The current documentation is to be brought up to date with the agreed remedial action.	6-weeks
3	Building 1 Large cantilever in North East corner under toilet (structural details queried in a letter following a site inspection)	Carry out any remedial actions from the review	6-months
4	Building 1 Minor differences between layout drawings and as-built	Factory Engineer to update drawings to reflect as-built structure.	6-weeks

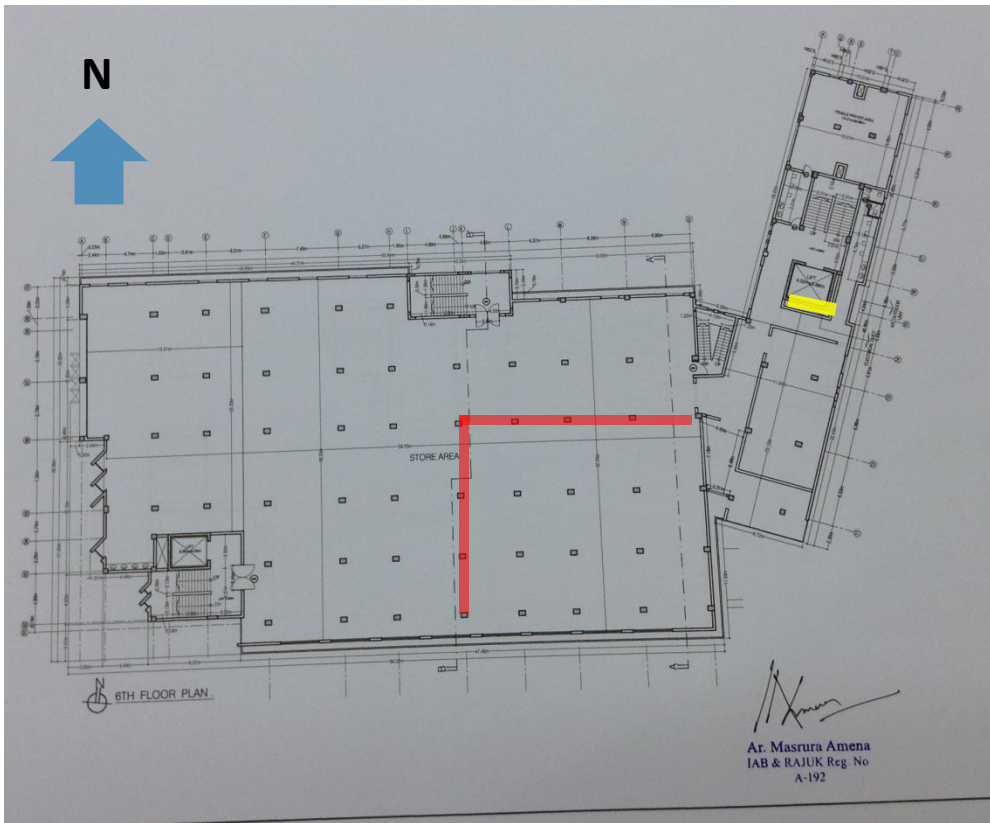
6th floor plan

Minor differences between layout drawings and as-built

Walls are not shown in the architectural drawing

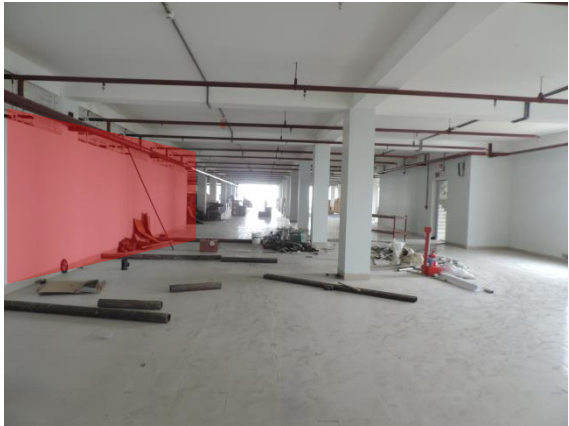
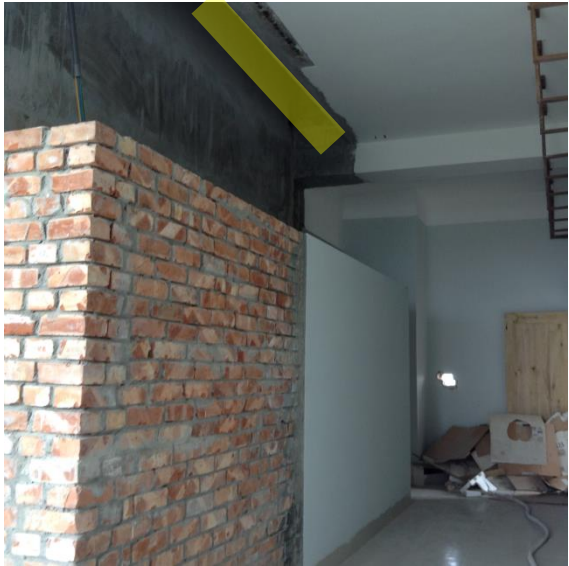
Full opening is only on 6th floor and half opening on all other floors

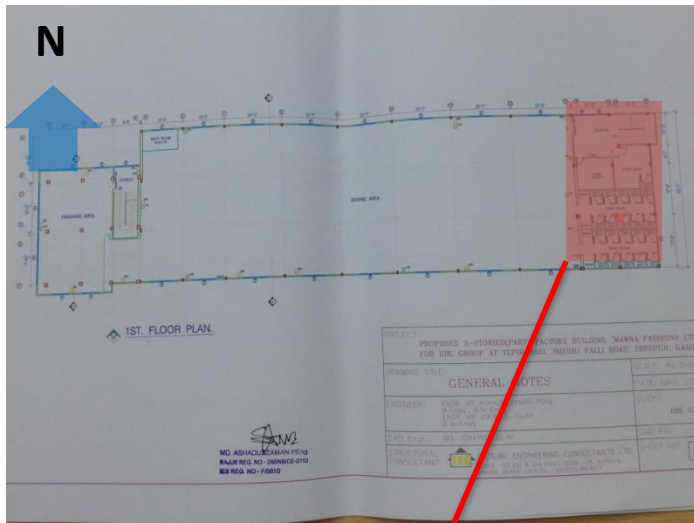
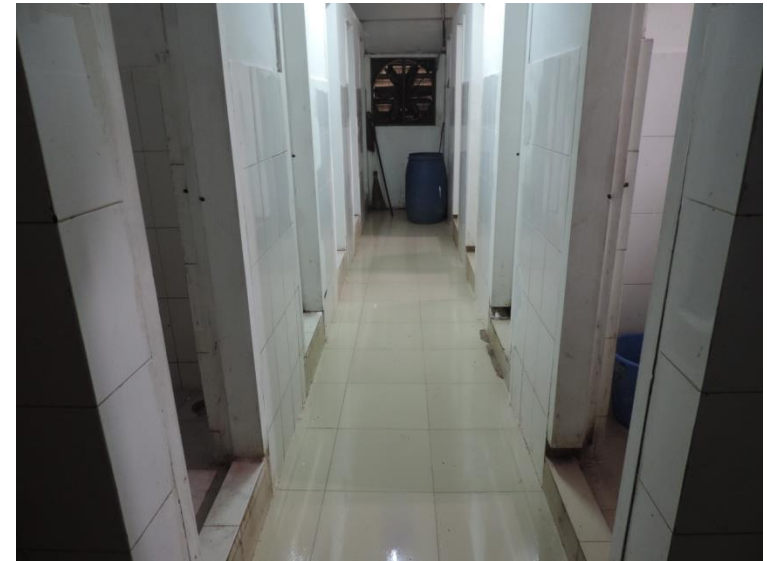
Heavily loaded columns

Toilet built up in the marked area

Item No.	Observation	Recommended Action Plan	Recommended Timeline
5	Building 2 Heavy loaded column in toilet area	Factory Engineer to investigate the floor loading, and advise on any necessary alterations taking account of floor capacity and column capacity.	6-weeks
6	Building 2 Heavy loaded column in toilet area	Make any structural alterations as advised by Factory Engineer.	6-months
7	Building 2 Lack of Roof and longitudinal bracing on the upper floor	Factory Engineer to review the steel portal structure and its ability to resist lateral load. In particular the lack of effective roof bracing	6-weeks
8	Building 2 Lack of Roof and longitudinal bracing on the upper floor	Make any structural alterations as advised by the Engineer.	6-months
9	Building 2 Water tanks on the roof	Factory Engineer to investigate the roof capacity to carry the Gazi water tanks, and advise on any necessary alterations taking account of slab capacity	6-weeks

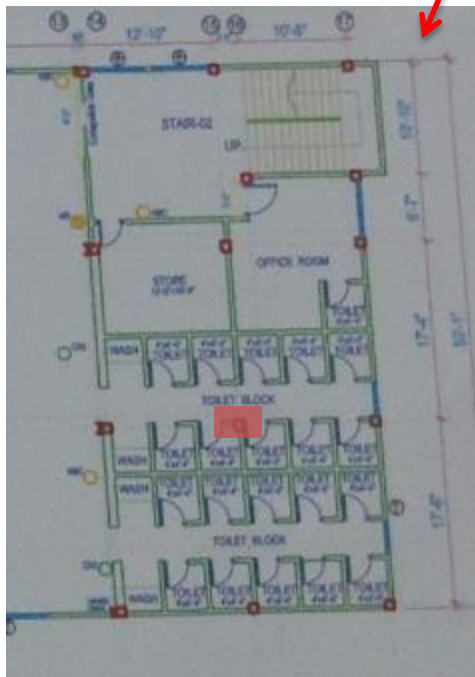
Heavily loaded column

Non-Engineered Roof structure lack of longitudinal bracing on the upper floor

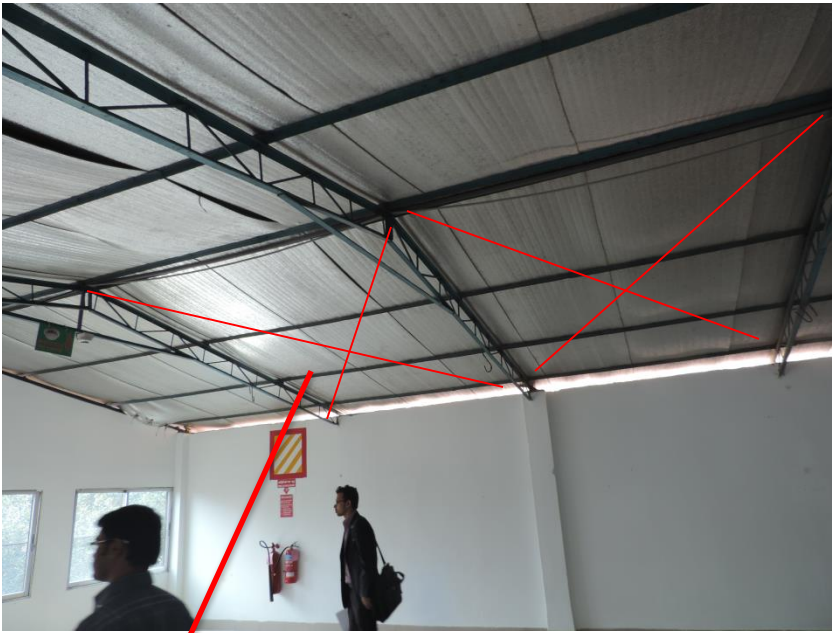
Missing roof bracings

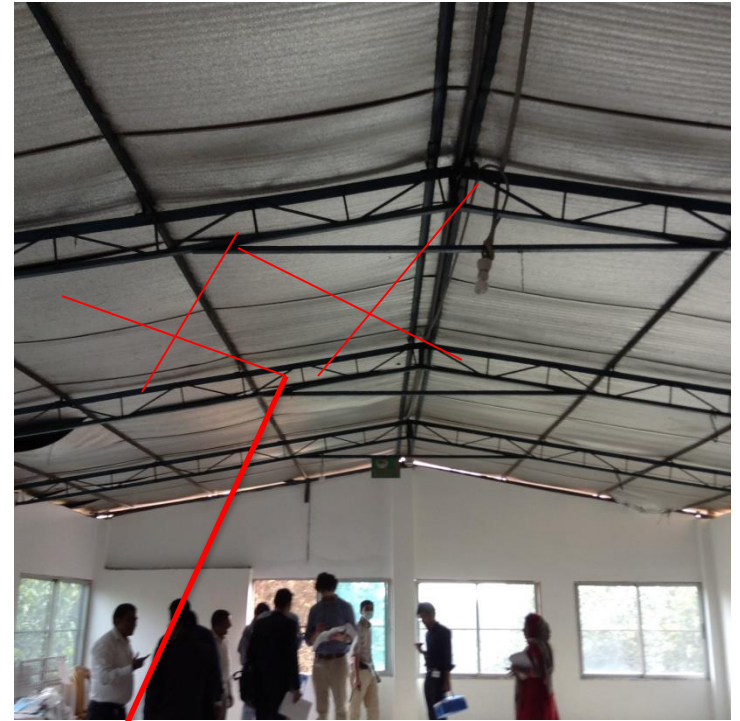
Lack of bracings on the metal roof

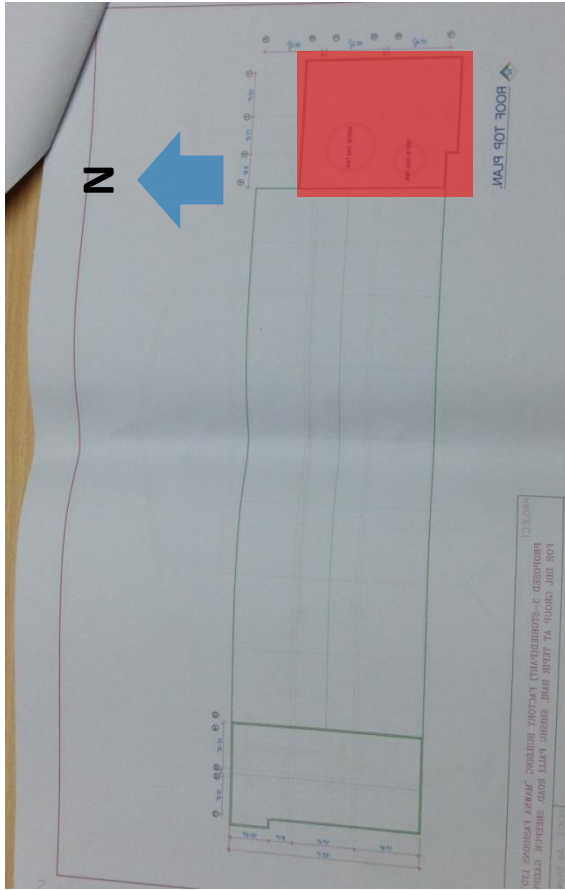
Roof Layout

Water tanks on the roof

Position of the water tanks

10	Building 2 Water tanks on the roof	Make any structural alterations as advised by the Engineer.	6-months

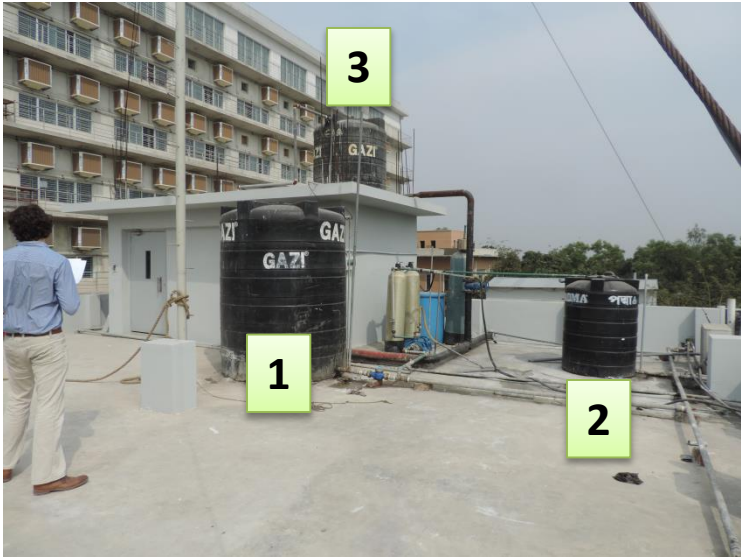
Water Tanks on the roof

1 5000 litre

2 1000 litre

3 1500 litre

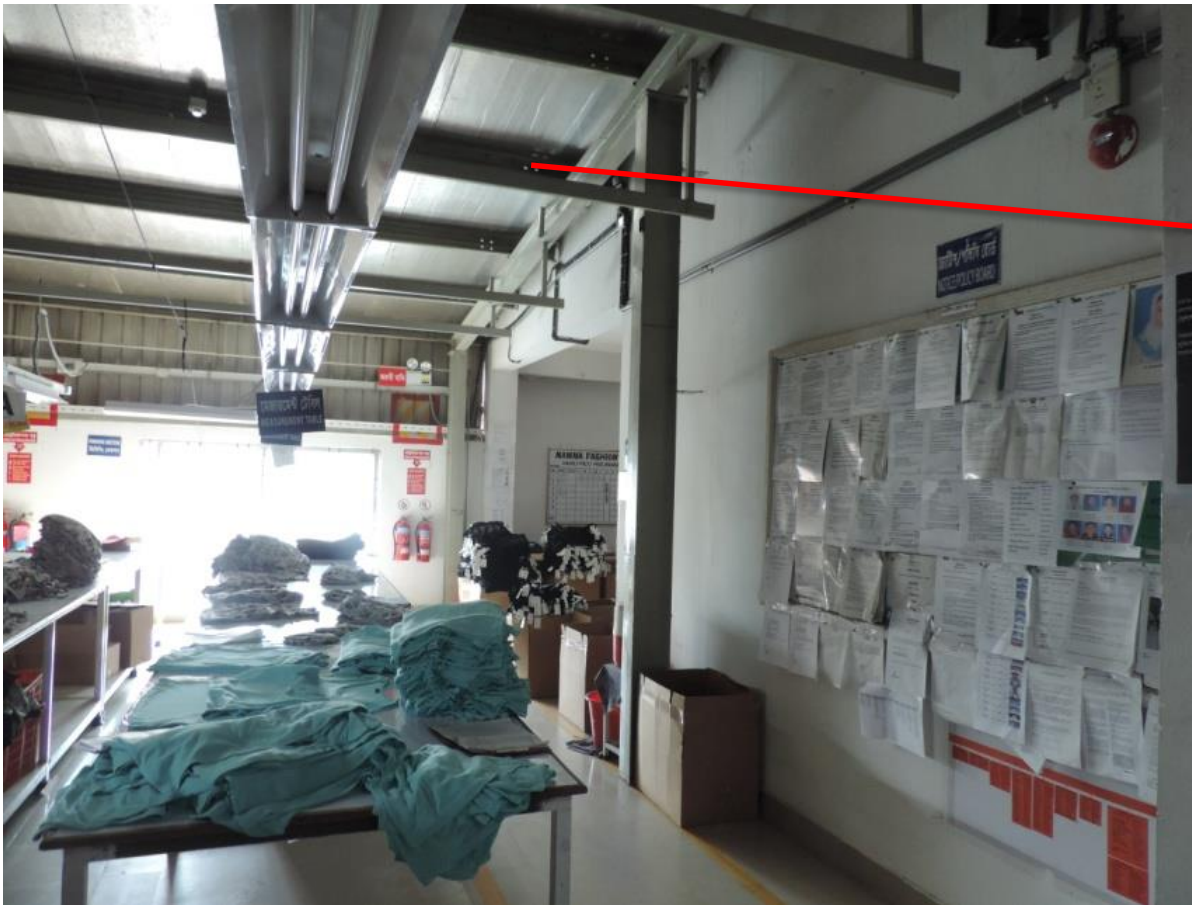
1st floor slab

No fire proofing noted on the steel

**Lack of fire
proofing on
the steel**

No fire proofing on the steel sections during the inspection
