# Haesong Corporation Limited

## Haesong Sweater Ltd.

Hizalhati (Baroipara), Kaliakair, Gazipur, Bangladesh  
(24.027194N, 90.23911123E)

30 October 2013

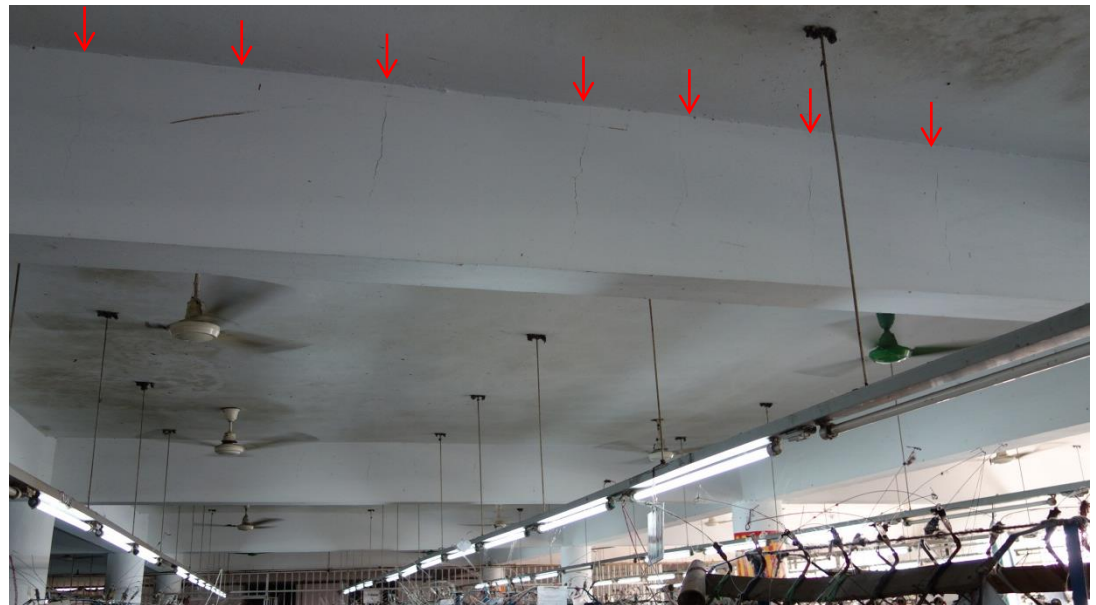
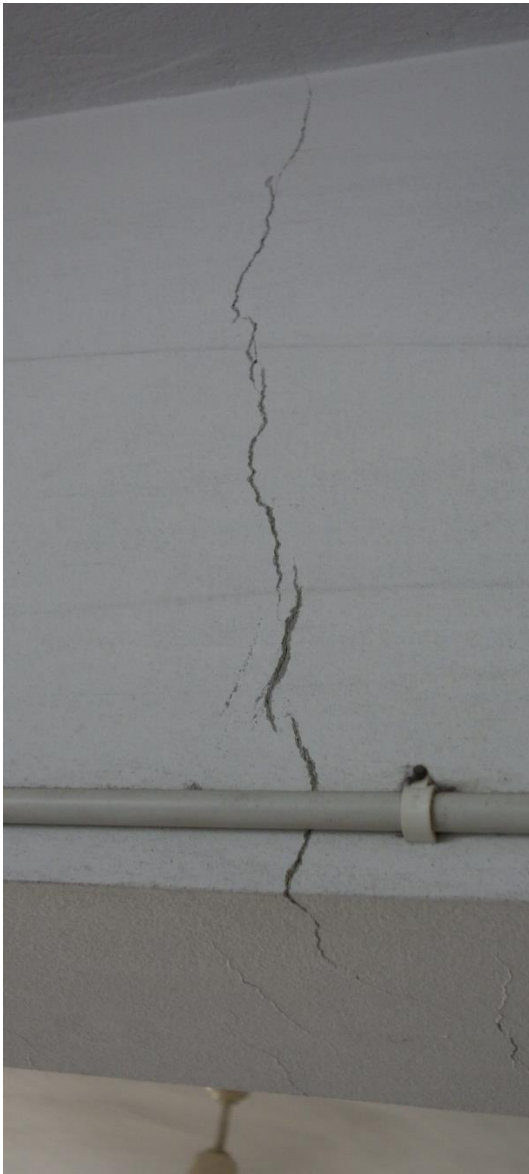
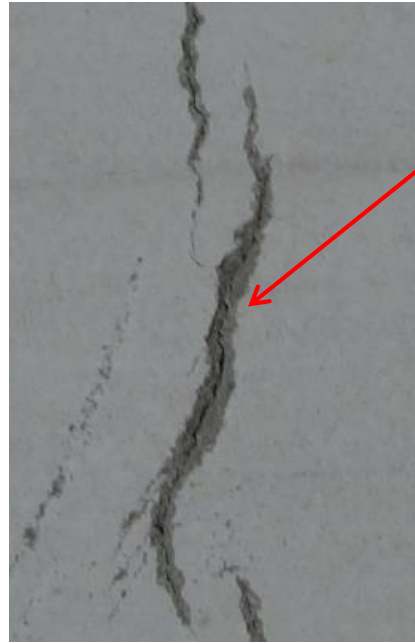
### Cracking on beams:

Numerous beams in the building have shrinkage cracks, Upper floors beams are more cracked. Cause to be investigated.

Appears that lack of side reinforcement bar on deep beams missing(700x280)

Cracks appear be bigger that they are due to paint is lost both sides of crack.

1-After cracking plastic paint swells and produce a bubble.

2-Paint peels off and ends falling down around crack.

| Item No. | Observation | Recommended Action Plan | Recommended Timeline |
|---|---|---|---|
| 11 | Shrinkage cracking on all beams | Shrinkage cracks need to be sealed against water entry and moisture to prevent corrosion. Building's Engineer must specify a sealant system. Common repair methods include chipping out the crack and applying a mortar patching compound to the surface, use of epoxies, or other sealants. | 6-months |

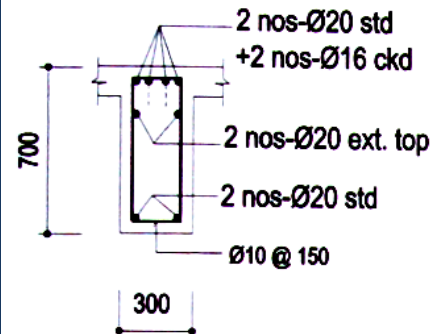
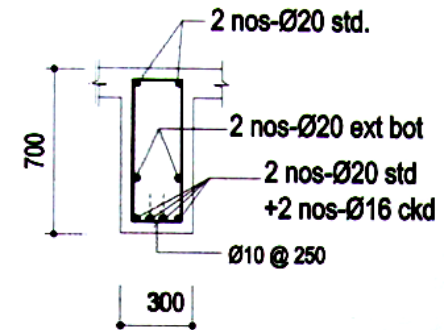
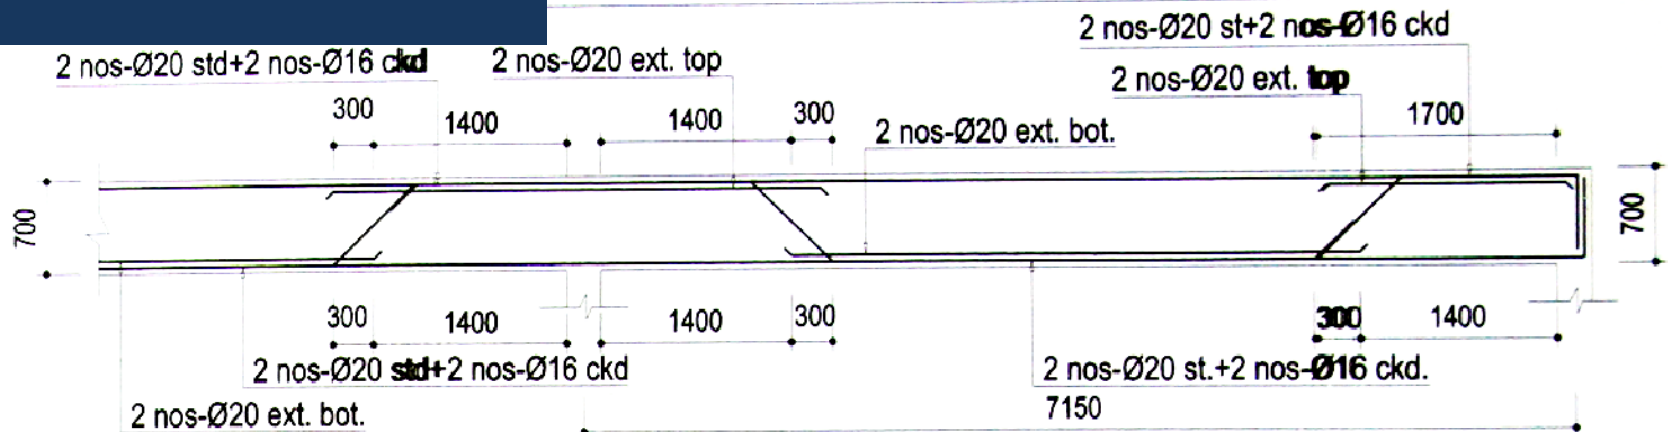
## Cracking on beams

### Possible cause:

Lack of side reinforcement  
on deep beams  
(700x280)

To be investigated

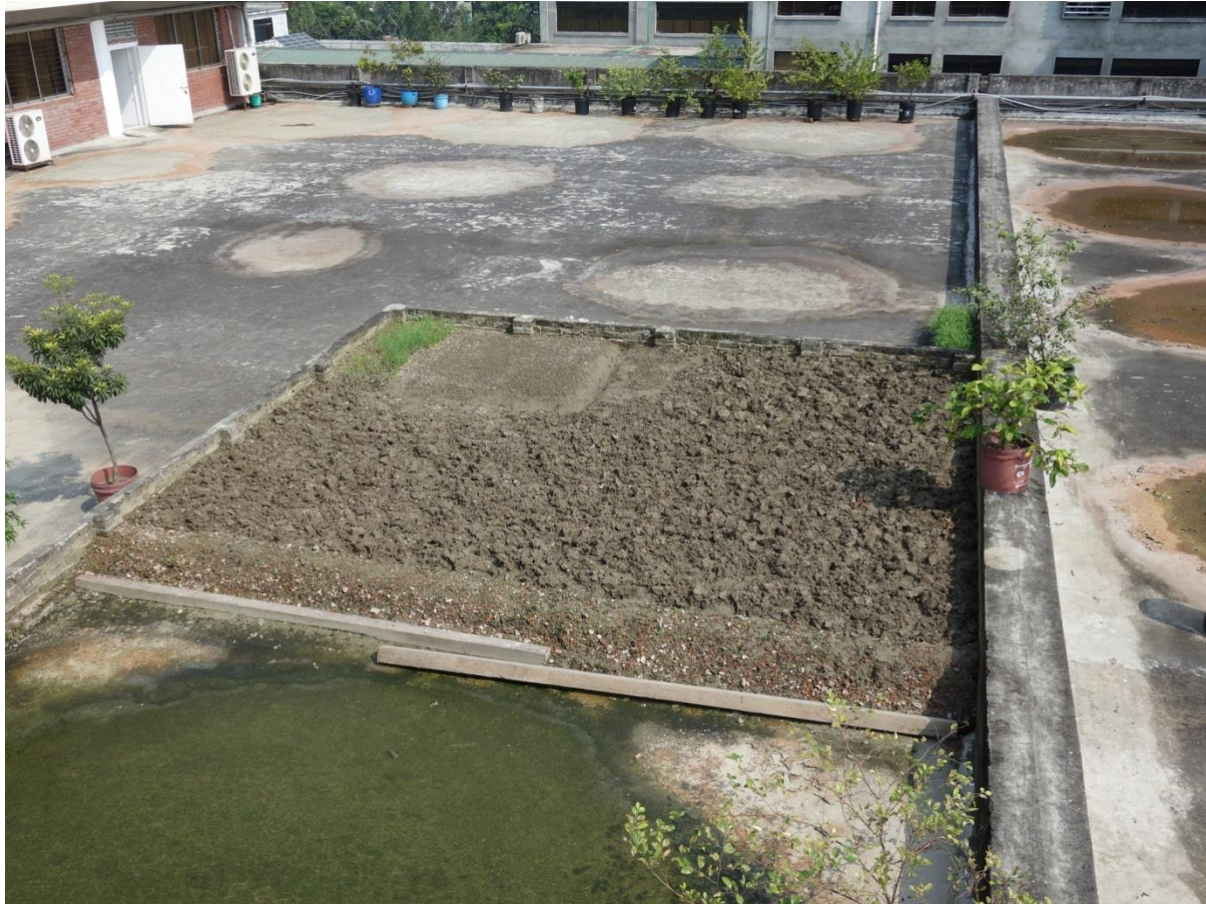
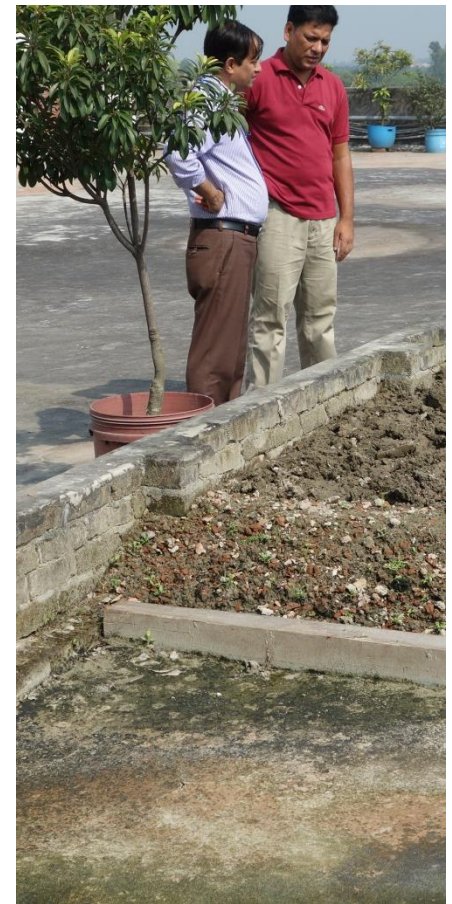
### Broken parapet

Masonry parapet laying on a cantilever slab. Crack produced by slab deflection.

Currently the cantilever slab is overloaded by a mound of earth. It must be removed

| Item No. | Observation | Recommended Action Plan | Recommended Timeline |
|---|---|---|---|
| 12 | Broken parapet on roof top corner | Remove mound of earth from roof corner which is overloading the cantilever. | 6-weeks |

| Item No. | Observation | Recommended Action Plan | Recommended Timeline |
|---|---|---|---|
| 13 | Broken parapet on roof top corner | Cracks have been produced by deflection of the cantilever slab . Building's Engineer must specify a masonry repair system to fix parapet pieces currently separated by cracks. | 6-months |

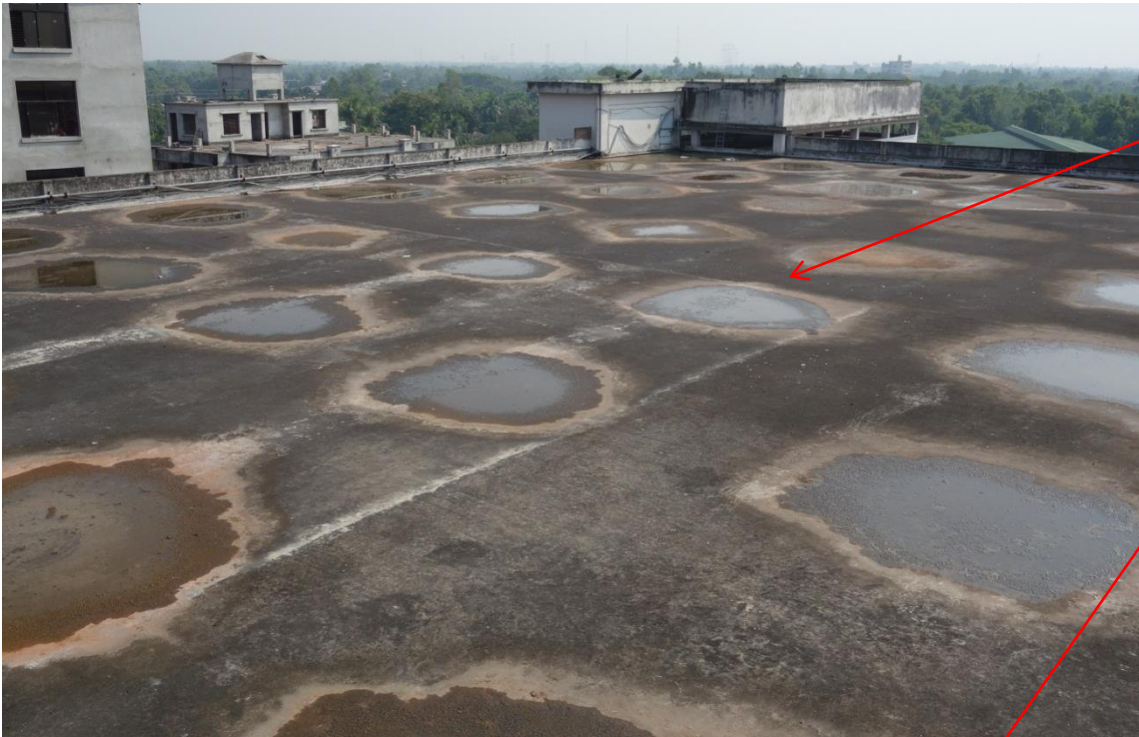
### **Soil overloading roof slab**

Currently there are 22 cm of non compact soil . possible overload of 3.5 kPa  
Limit the soil layer to 18 cm. Better if it is removed.

| Item No. | Observation | Recommended Action Plan | Recommended Timeline |
|---|---|---|---|
| 14 | Roof Top Garden overloading of roof slab | Limit earth layer thickness to 18 cm. Building's Engineer to ensure adequate water proofing system has been located under the orchard | 6-months |

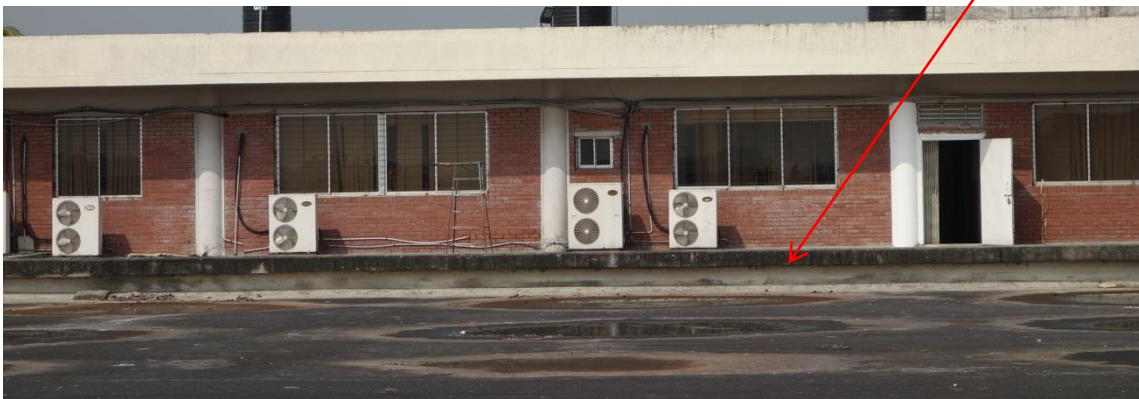
**No drainage flat roof**  
Rain water accumulation on deflected slabs between beams may produce damage and corrosion.

Inadequate sloped layer on top of the structural slab or non sloped slab.

Down pipes are on long facades, then drainage slope might be in that direction (transversal slope)

| Item No. | Observation | Recommended Action Plan | Recommended Timeline |
|---|---|---|---|
| 15 | Deflections on slabs produce rain water accumulation on a non well sloped roof | Manage drainage from roof level and downpipes to avoid structural corrosion due to continuous moisture. Avoid overloading from casting heavy sloped layer on top of the structural slab. Lightweight system required. | 6-months |

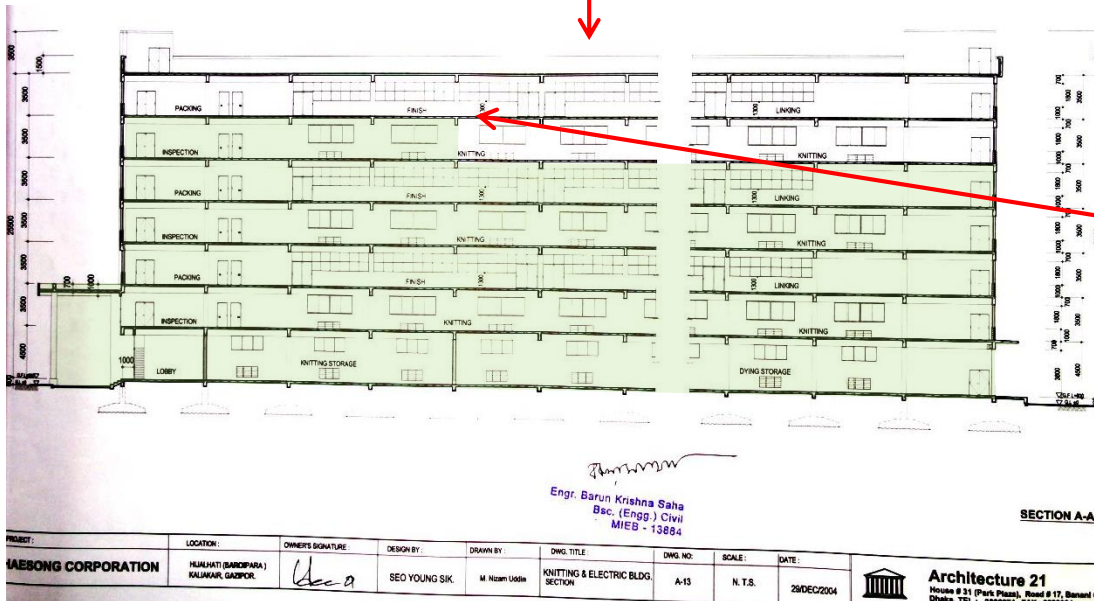
## Structure drawings

Structure drawings do not agree with actual arrangement of the building.

Structure drawings do not agree with the permit drawings. They show a 7 storied building (only 6 have been built).

Roof top has been partially built according approved lay out drawings

| Item No. | Observation | Recommended Action Plan | Recommended Timeline |
|---|---|---|---|
| 17 | Structural drawings do not agree with current arrangement of the building at roof top | The structural drawings showed inconsistencies compared to the current structure observed on site at roof. We suggest a professional structural engineer verifies the current design and corrects these drawings. | 6-months |
