# Graphics Textiles Ltd. (Extension 2)

Sreerampur, Kalampur, Dhamrai, Dhaka.

01 July 2025

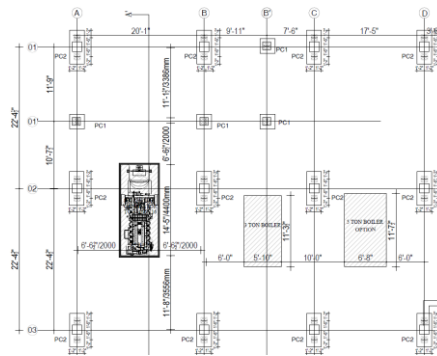
### Observation-1: Incomplete as-built drawing. [Building- 6 (Generator Building)]

**Description:** During the inspection, a set of architectural and structural drawings was found. But column layout was found missing in the structural drawing. The building engineer is required to survey the full structure and update the as-built drawings to accurately reflect the current site conditions.

| SL | Observation | Action Plan | Timeline |
|---|---|---|---|
| 1. | Incomplete as-built drawing. [Building- 6 (Generator Building)] | The building engineer is required to survey the full structure and update the as-built drawings to accurately reflect the current site conditions. | within 6 weeks |

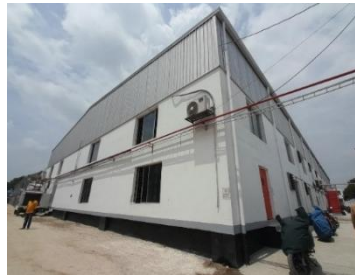
### Observation-2: Lack of design report. [Building- 8 (Printing Building)]

**Description:** As per BNBC, every building or structure designed shall have its design documents prepared following the provision of Section 1.9.1. The design document shall include a design report, and a set of structural drawings, which shall be prepared in compliance with section 1.9.1.1 and section 1.9.1.2, part 6 of BNBC.

| SL | Observation | Action Plan | Timeline |
|---|---|---|---|
| 2. | Lack of design report. [Building- 8 (Printing Building)] | The design document shall include a design report, and a set of structural drawings, which shall be prepared in compliance with section 1.9.1.1 and section 1.9.1.2, part 6 of BNBC. | within 6 weeks |

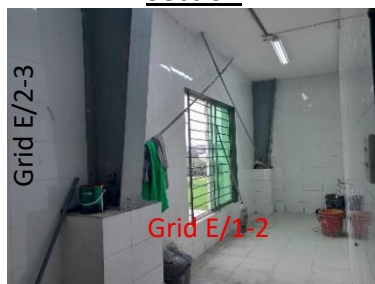
Onsite condition

Build up not shown in drawing

**Description:** Vertical bracing was found missing at grid location E/2-3. Additionally, the floor buildup on the 1st floor was not reflected in the as-built drawings. Also details of cable bracing (25 mm dia) were not mentioned in drawing. The building engineer is required to survey the full structure and update the as-built drawings to accurately reflect the current site conditions.

| SL | Observation | Action Plan | Timeline |
|---|---|---|---|
| 4. | Discrepancies in as-built drawings. [Building- 8 (Printing Building)] | The building engineer is required to survey the full structure and update the as-built drawings to accurately reflect the current site conditions. | within 6 weeks |

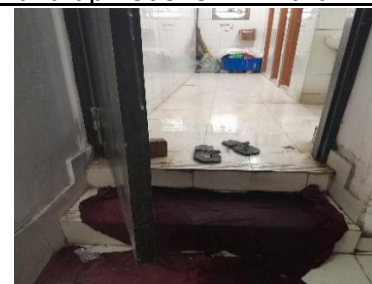
On site condition (15 inch build up)

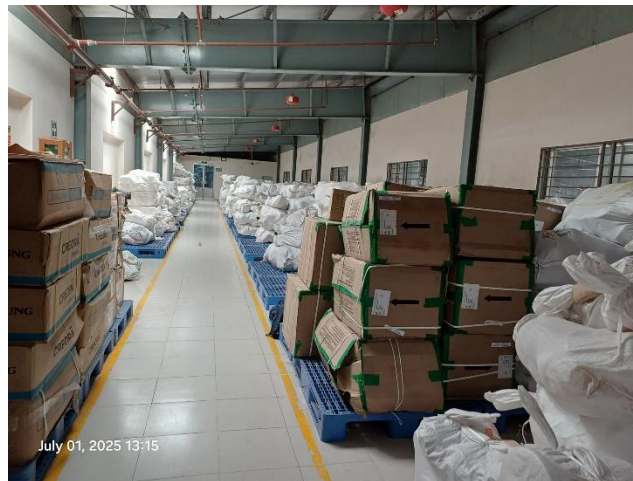
Observed floor loading at mezzanine

**Description:** The factory has produced EA report following BNBC 2020. In EA report, compressive strength of concrete has been considered as 3000 psi for beam, column, foundation, but the available test results are insufficient to meet the evaluation and acceptance criteria of Art 5.12, Part VI, BNBC 2020.

Storage was found at mezzanine, but 3 kPa was mentioned at load plan.

The building engineer is required to evaluate concrete strength as per BNBC, revise load plan & design report accordingly and submit to RSC for review.

| SL | Observation | Action Plan | Timeline |
|---|---|---|---|
| 6. | Inconsistencies in the EA report (Building- 9 Knitting Building) | Verify in-situ concrete strength either by 100 mm diameter cores or existing credible cylinder test reports. | within 6 weeks |
| 7. | | Update floor live load plan for mezzanines following BNBC requirements | within 6 weeks |

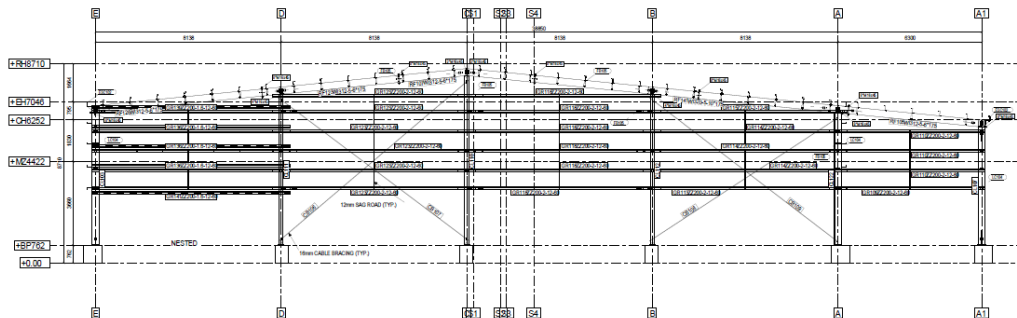
## Observation 06: Inconsistencies in as-built drawing. (Building-10 New Dyeing Shed)

**Description:** Sufficient sectional drawing was not found. No column schedule and rafter schedule were provided in the drawing. As a result, all member's sizes were not verified due to lack of information.

The building engineer is required to conduct a full survey of the structure and revise the as-built drawings to reflect the actual site conditions.

| 15. | Inconsistencies in as-built drawing. (Building-10 New Dyeing Shed) | The building engineer is required to conduct a full survey of the structure and revise the as-built drawings to reflect the actual site conditions. | within 6 weeks |

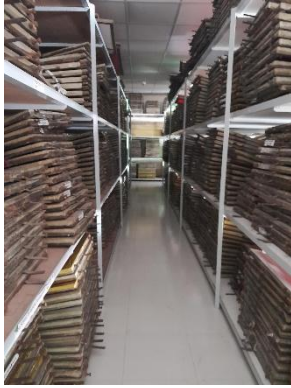
Building 8

**Description:** Some racks on floors are not anchored or braced to resist lateral (earthquake) forces. The factory is required to anchor/brace all non-structural elements adequately to resist earthquake forces.

| SL | Observation | Action Plan | Timeline |
|---|---|---|---|
| 5. | Non-structural elements are not anchored or braced. [Building- 8 (Printing Building)] | The factory is required to anchor/brace all non-structural elements adequately to resist earthquake forces. | within 6 months |

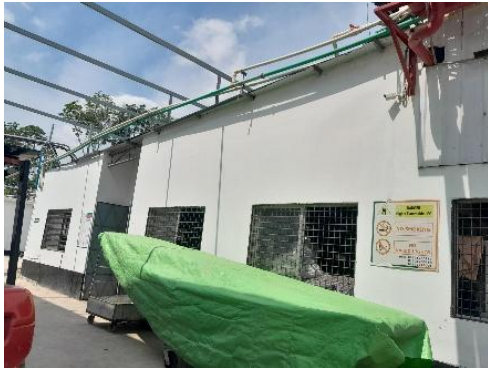
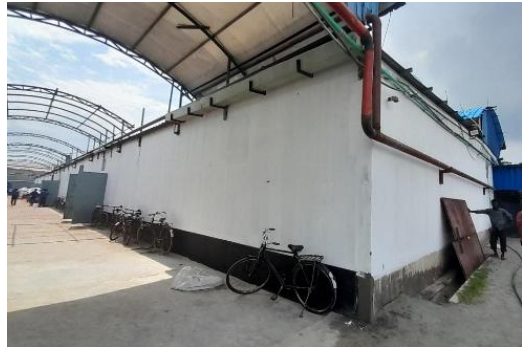
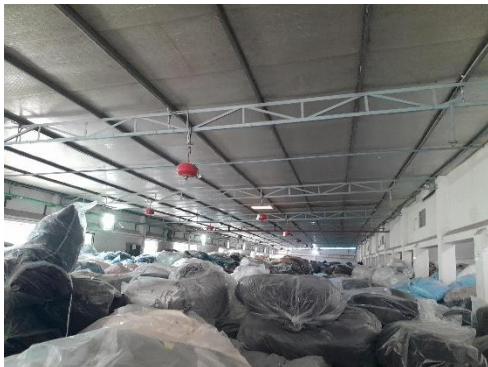
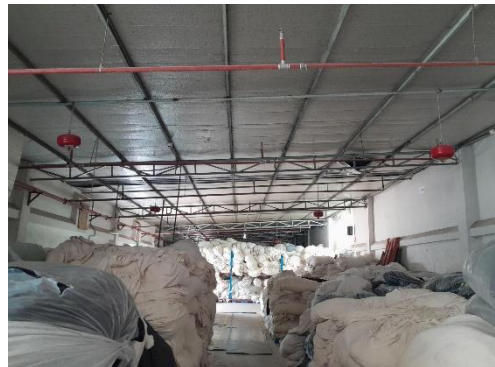
Building- 11 Fabric Store Shed A

**Observation-8:** Lack of design report. [Building- 11 Fabric Store Shed A]

**Description:** As per BNBC, every building or structure designed shall have its design documents prepared following the provision of Section 1.9.1. The design document shall include a design report, and a set of structural drawings, which shall be prepared in compliance with section 1.9.1.1 and section 1.9.1.2, part 6 of BNBC.

| 16. | Lack of design report. (Building- 11 Fabric Store Shed A) | The design document shall include a design report, and a set of structural drawings, which shall be prepared in compliance with section 1.9.1.1 and section 1.9.1.2, part 6 of BNBC. | within 6 weeks |

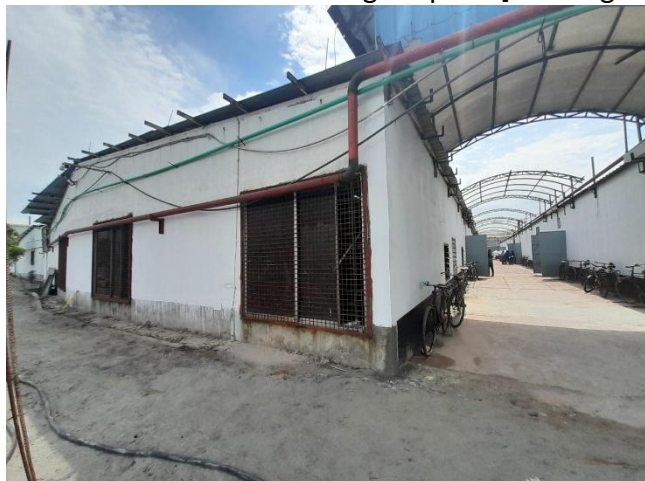
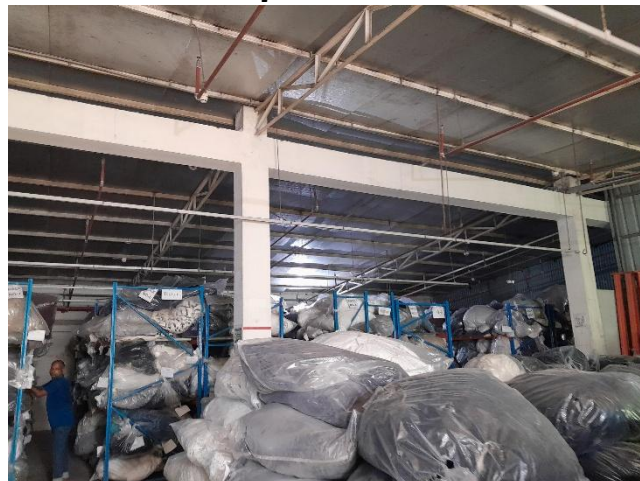
Building- 12 Fabric Store Shed B

**Observation-9:** Lack of design report. [Building- 12 Fabric Store Shed B]

**Description:** As per BNBC, every building or structure designed shall have its design documents prepared following the provision of Section 1.9.1. The design document shall include a design report, and a set of structural drawings, which shall be prepared in compliance with section 1.9.1.1 and section 1.9.1.2, part 6 of BNBC.

| 20. | Lack of design report. (Building- 12 Fabric Store Shed B) | The design document shall include a design report, and a set of structural drawings, which shall be prepared in compliance with section 1.9.1.1 and section 1.9.1.2, part 6 of BNBC. | within 6 weeks |

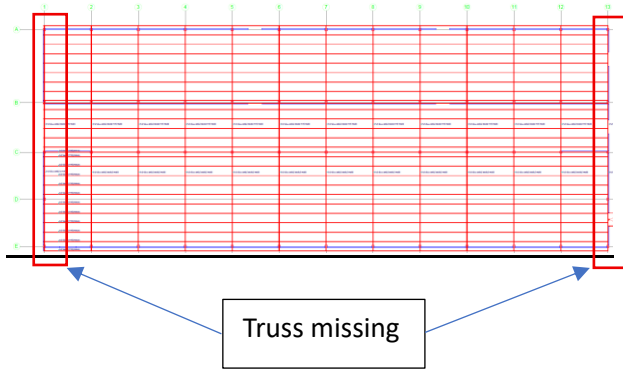
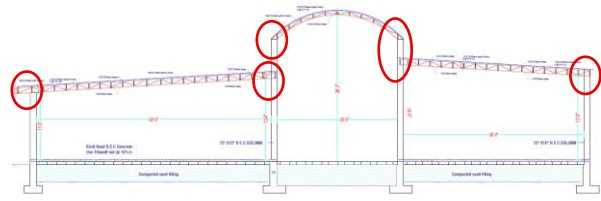
**Building- 11 Fabric Store Shed A**

Missing connection details in drawing

**Description:** Truss was found missing at marked area of Building- 11 Fabric Store Shed A and Building- 12 Fabric Store Shed B. Also, grid dimensions and connection details are missing in the as-built drawings of Building 11 Fabric Store Shed A and 12 Fabric Store Shed B. A typical section detail is included in the as-built drawings, but truss is not typical at all grids particularly along the edge grids.

The building engineer is required to conduct a full survey of the structure and revise the as-built drawings to reflect the actual site conditions.

| 18. | Mismatches in the as-built drawing. (Building- 11 Fabric Store Shed A) | The building engineer is required to conduct a full survey of the structure and revise the as-built drawings to reflect the actual site conditions. | within 6 weeks |

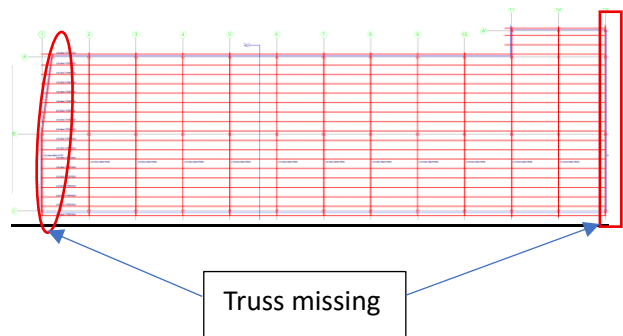
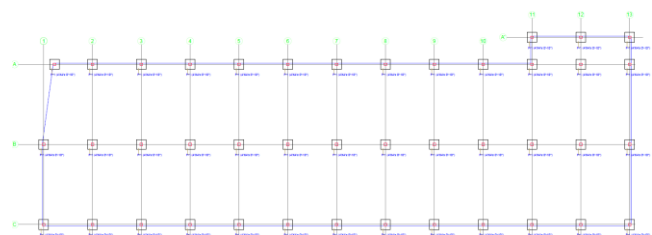
**Building- 12 Fabric Store Shed B**

Missing connection details in drawing

| 22. | Mismatches in the as-built drawing. (Building-12 Fabric Store Shed B) | The building engineer is required to conduct a full survey of the structure and revise the as-built drawings to reflect the actual site conditions. | within 6 weeks |

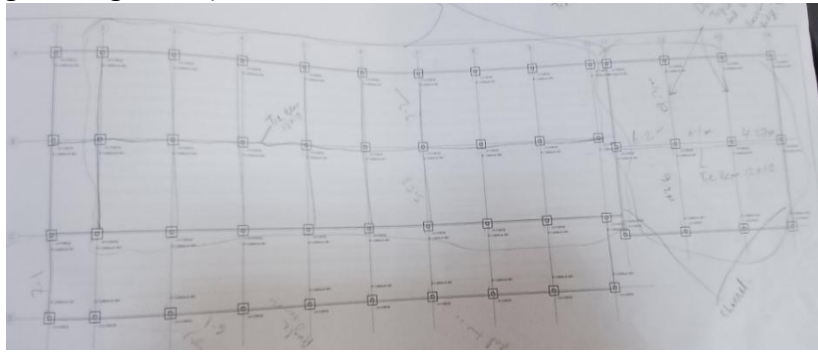
Building-13, 14, 15 [Gray Fabric Store Shed A, B, C]

**Description:** Grid dimensions and connection details are missing in the as-built drawings of Building 13, 14, 15, 16, 17, 18, 19. A typical section detail is included in the as-built drawings, but truss is not typical at all grids particularly along the edge grids.

The building engineer is required to conduct a full survey of the structure and revise the as-built drawings to reflect the actual site conditions.

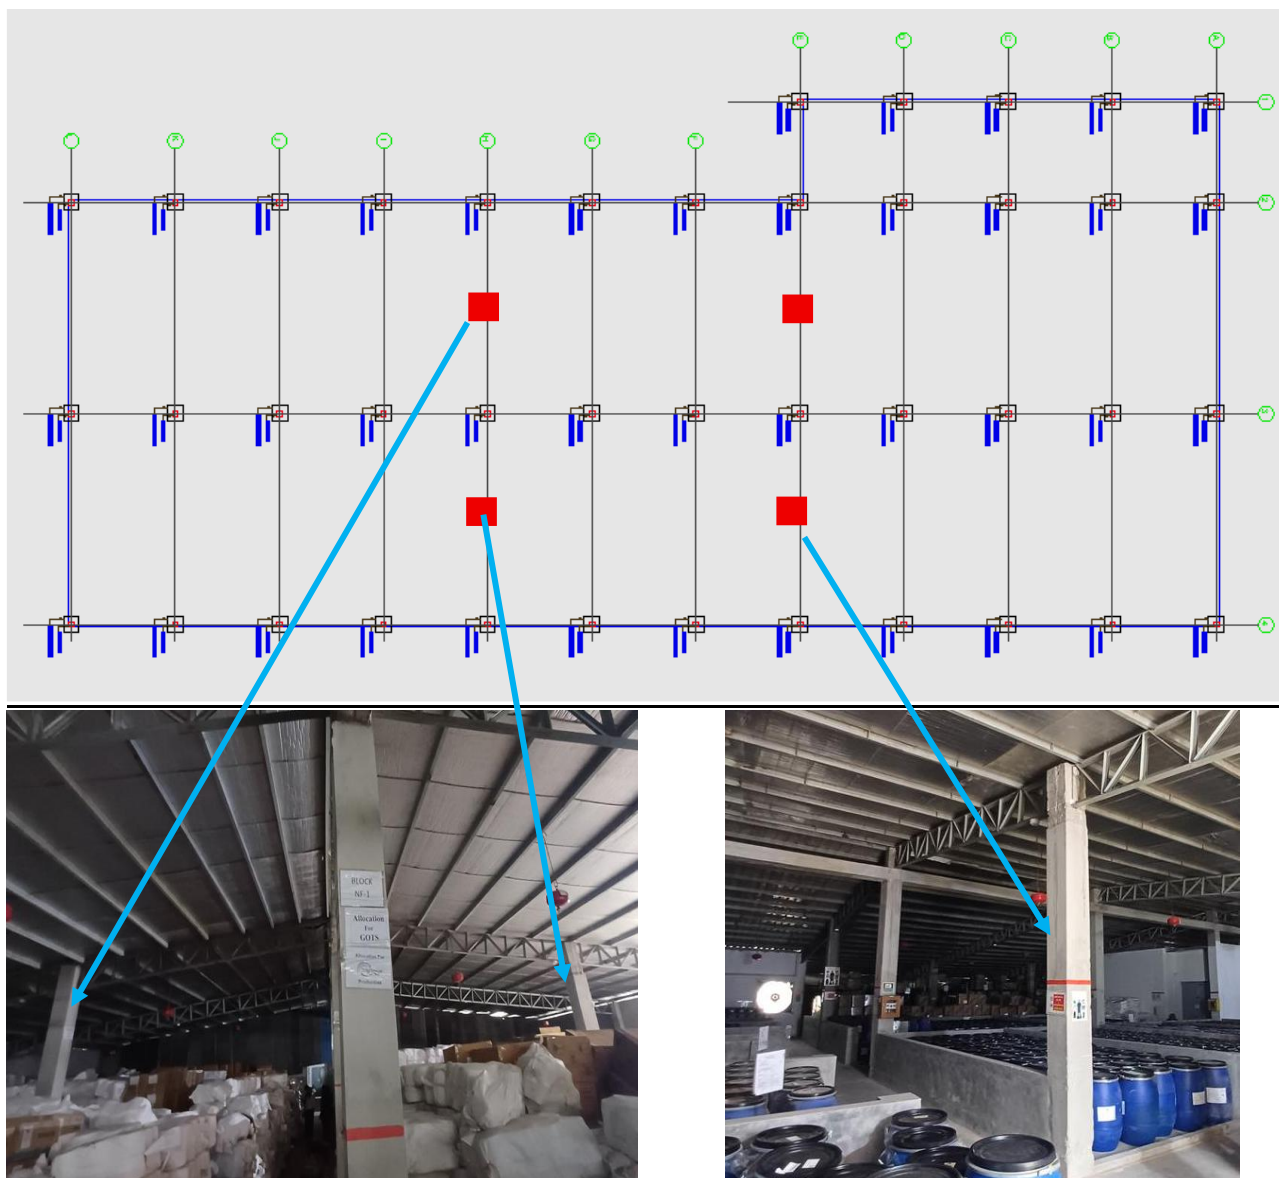
**Observation 12:** Mismatches in as-built drawing (Building 17 Yarn & Chemical Store)

**Description:** Red marked columns were found onsite but not shown in drawing.

| 39. | Mismatches in as-built drawing (Building- 17 Yarn & Chemical Store) | The building engineer is required to survey the whole structure and prepare accurate as-built drawings as per onsite conditions. | within 6 weeks |

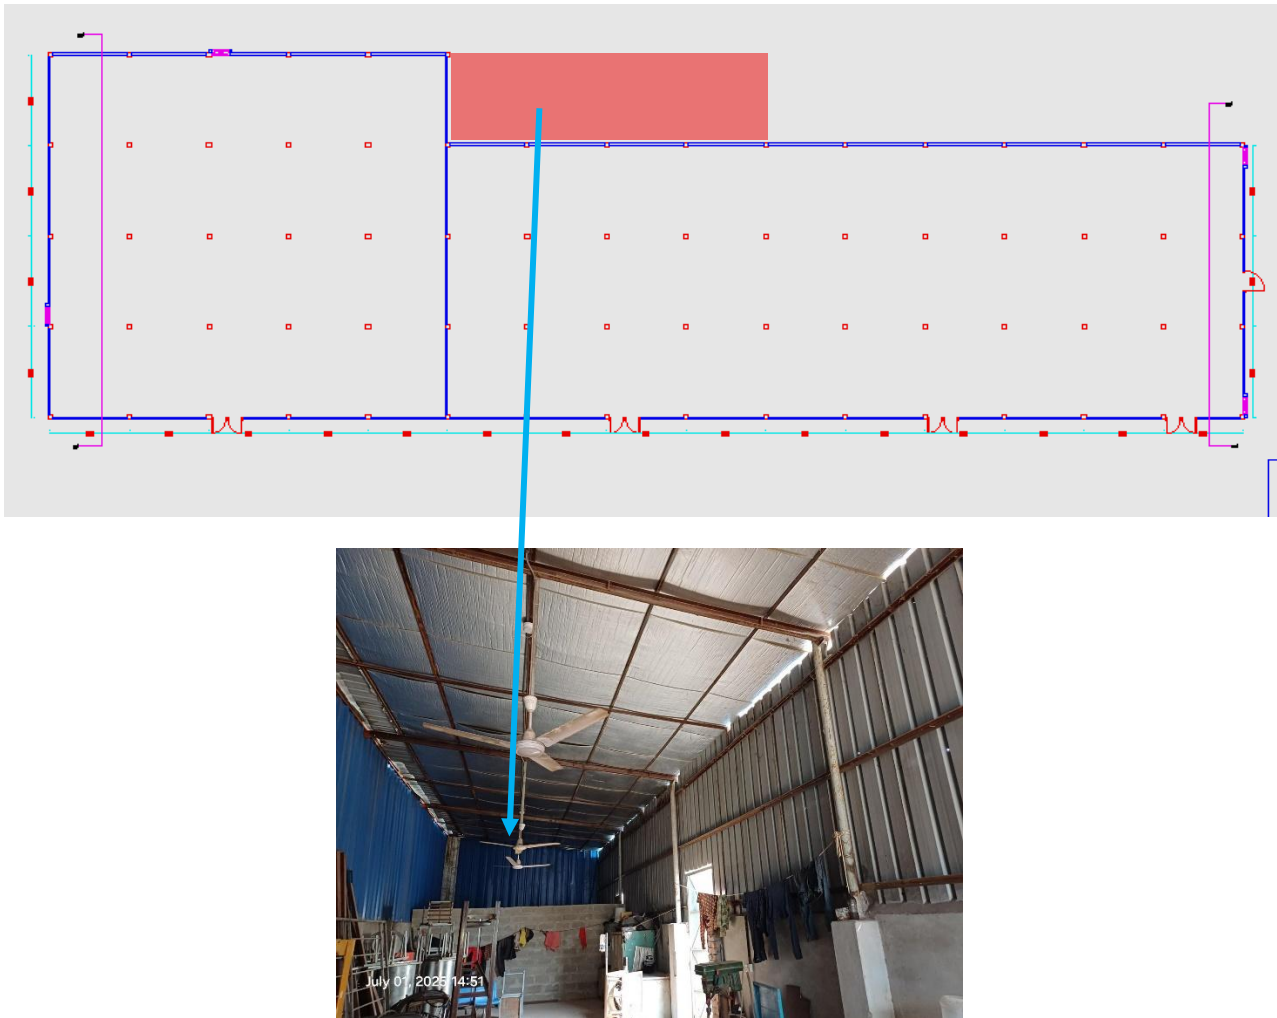
**Observation 13:** Mismatches in as-built drawing (Building 18 Cartoon Store & Workshop)

**Description:** Red marked areas were not shown in drawing.

| 43. | Mismatches in as-built drawing (Building- 18 Cartoon Store & Workshop) | The building engineer is required to survey the whole structure and prepare accurate as-built drawings as per onsite conditions. | within 6 weeks |

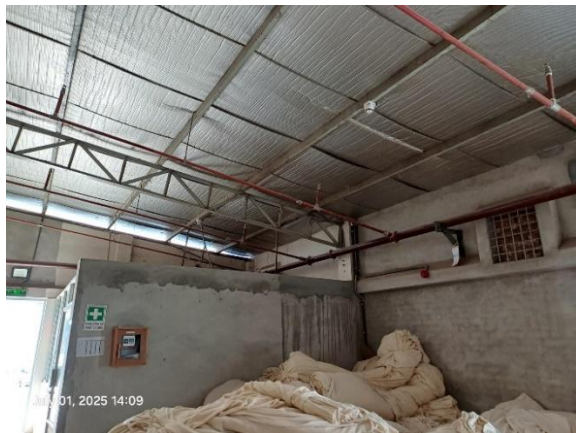
Building 13

**Description:** As per BNBC, every building or structure designed shall have its design documents prepared under the provisions of Section 1.9. The design document shall include a design report and a set of structural drawings, which shall be prepared in compliance with section 1.9.2 and section 1.9.3 as per BNBC 2020.

| 24. | Lack of design documents (Building- 13 Gray Fabric Store Shed A) | The building engineer is required to prepare a set of design documents in compliance with BNBC 2020 and submit the documents to RSC for review | within 6 weeks |

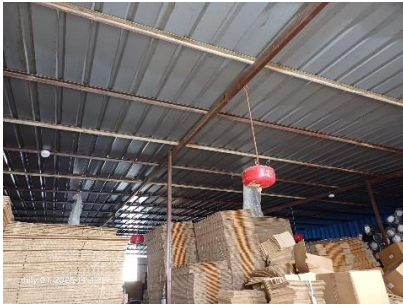
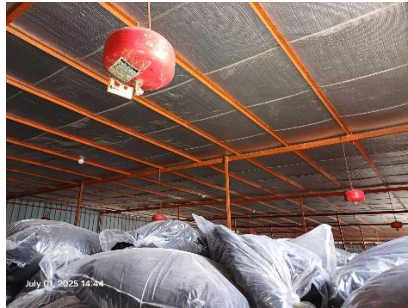
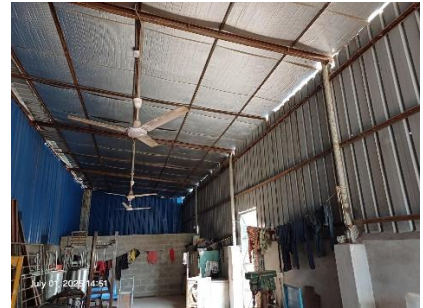
Building 18

**Description:** Non-engineered framing and connection was observed. The building engineer is required to produce EA following BNBC 2020 or provide the necessary alternatives to make the structure stable. Otherwise, replace it with an engineered one.

| 44. | Non-engineered shed (Building- 18 Cartoon Store & Workshop) | The building engineer is required to produce EA following BNBC 2020 or provide the necessary alternatives to make the structure stable. Otherwise, replace it with an engineered one. | within 6 weeks |

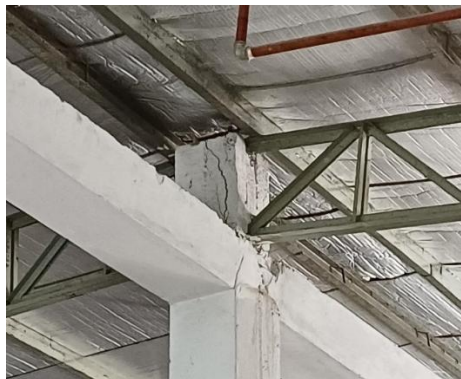
**Observation 16:** Crack in joint between RC column top (truss joint) (Building-16 Yarn Store Shed)

**Description:** Crack was found at joint between RC column and truss. The building engineer is required to repair the cracks with suitable methods.

| 38. | Crack in joint between RC column top (truss joint) (Building- 16 Yarn Store) | The building engineer is required to repair the cracks with suitable methods. | within 6 weeks |

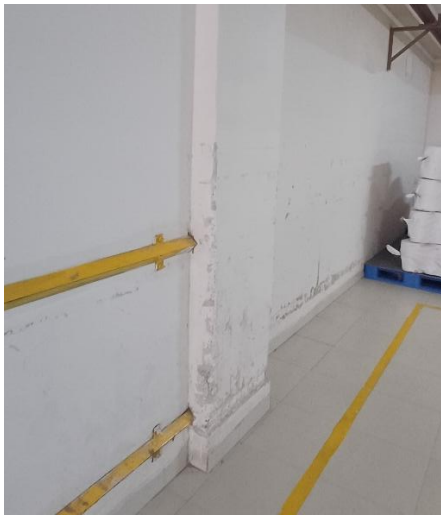
Building 9

**Description:** Edges of columns were found damaged due to trolley impact.

| SL | Observation | Action Plan | Timeline |
|---|---|---|---|
| 11. | Column surface damage due to trolley impact (Building- 9 Knitting Building) | The building engineer is required to repair the damaged portion and provide barriers around the column to prevent trolley impact. | within 6 weeks |

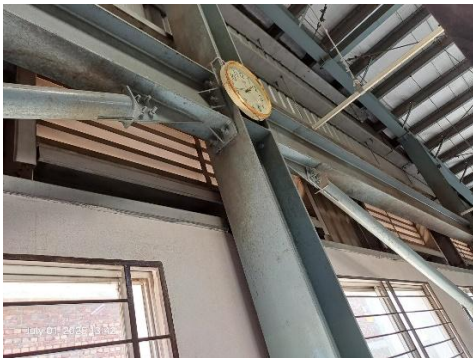
Building 9

**Description:** During the inspection, corrosion was observed on several steel members.

| SL | Observation | Action Plan | Timeline |
|---|---|---|---|
| 12. | Corrosion on steel members (Building- 9 Knitting Building) | The factory is required to remove the rust and apply anti-corrosive paint to the steel member | within 6 months |

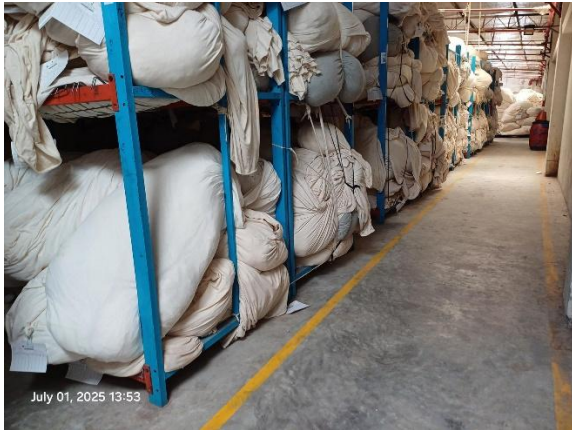
Building 14

**Description:** Unbraced and unanchored steel storage racks were found at several locations. The factory is required to brace/anchor all non-structural elements (storage racks) to resist falling during earthquake.

| 29. | Non-structural elements found unbraced/not anchored (Building- 14 Gray Fabric Store Shed B) | The factory is required to brace/anchor all non-structural elements (storage racks) to prevent falling during an earthquake. | within 6 months |

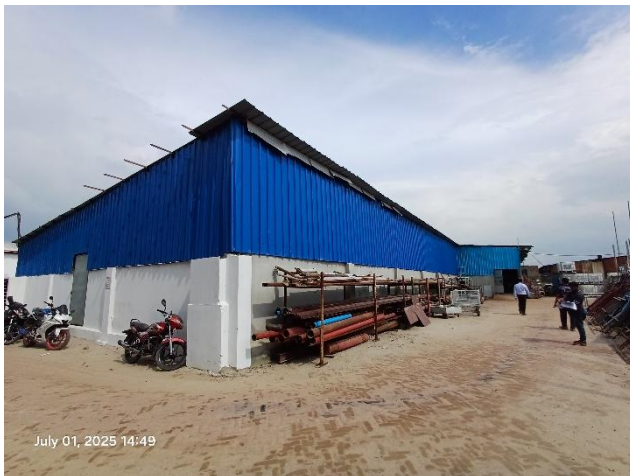
Building 18

**Description:** During the inspection, building permits from the local authority was not available for Building 18, 19, 20, 21, 22. The factory authority is required to collect building permits from the local authority for the buildings.

| 52. | Building Permit from the local authority - not available (Buildings 18, 19, 20, 21, 22) | The factory authority is required to collect building permits from the local authority for the buildings. | within 6 months |
