# **FIRE SAFETY INSPECTION REPORT**

**SOFTEX SWEATERS INDUSTRIES LTD**  
**165-166, DHAKA EPZ, GANAKBARI, SAVAR, DHAKA**

May 29, 2014

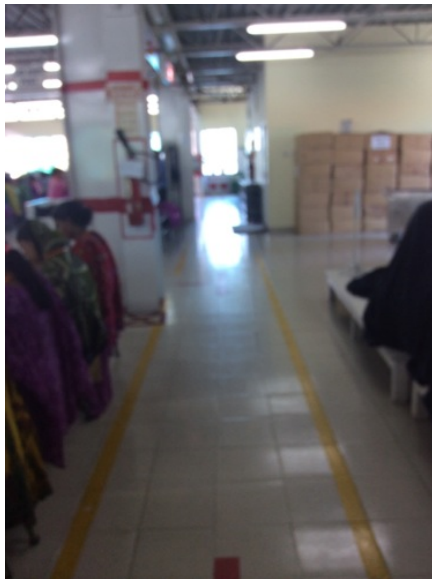
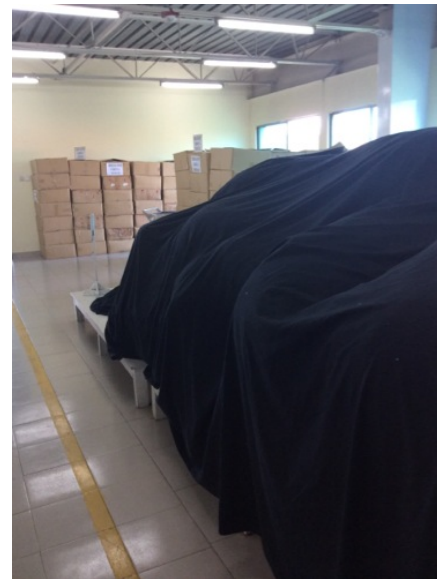
| No. | Category | Finding | Recommendation | Remediation Timeframe |
|---|---|---|---|---|
| F-1 | Fire Rated Construction | Areas used for combustible storage are not separated by fire-rated construction on the 3rd floor. | <p>Where separate storage rooms are not feasible, provide defined storage areas and limit the storage arrangement as follows:</p> <ul style="list-style-type: none"> <li>- Maximum height of 2.4m and maximum area of 23m<sup>2</sup></li> <li>- If sprinkler protected: maximum height of 3.66m and maximum area of 93m<sup>2</sup></li> </ul> <p>Separate areas of unenclosed combustible storage by a minimum clear distance of 3m.</p> | Within 3 months |

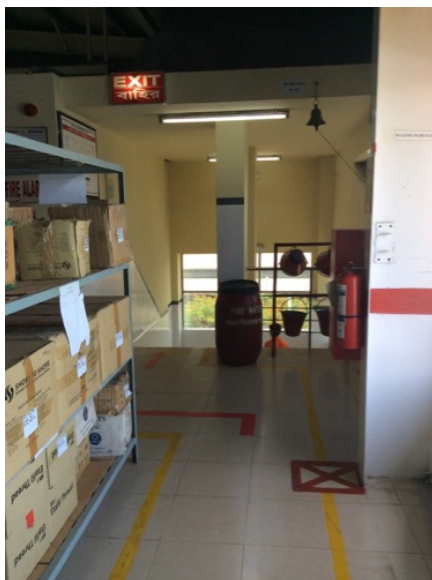
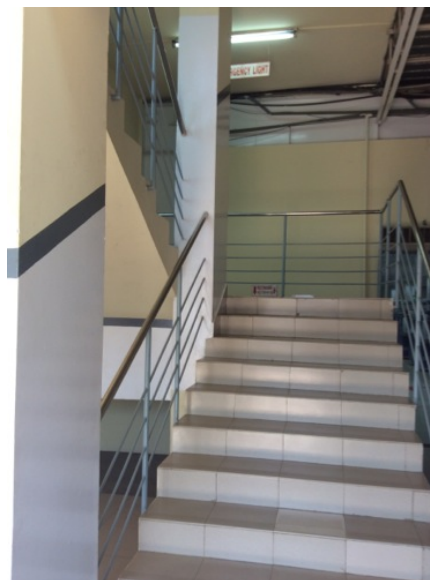
| F-2 | Fire Rated Construction | The exit stairs are not separated from work areas on each floor by fire-rated construction. | Provide minimum 1.5-hr fire rated doors and seal all unprotected openings to separate the exit stairs from work areas and other building spaces on all floor levels. Ensure that the fire doors are self-closing and positive latching and that they are provided with fire exit (panic) hardware where serving production floors. | Within 3 months |

If fire doors are required to be held open for functional reasons, provide automatic-closing devices tied to the fire alarm system.

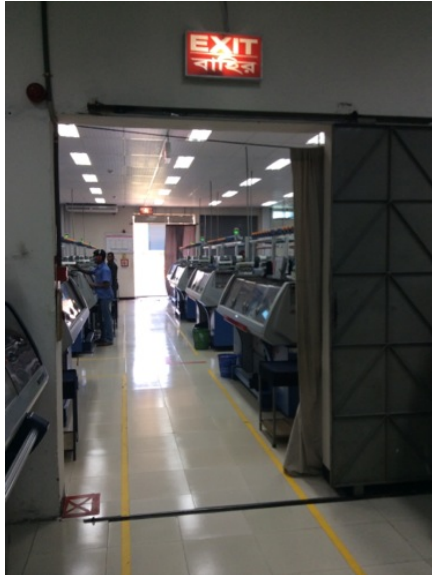
| F-4 | Egress | Sliding doors are provided along egress routes on the ground floor. | Sliding doors along the means of egress with side-hinged, swinging egress doors.<br><br>If locks are required for security reasons, utilize special door locking features complying with NFPA 101. | Within 1 month |
