# **FIRE SAFETY INSPECTION REPORT**

**SQ CELSIUS LTD**

**BERAIDECHALA, KEOA, MAONA, SREEPUR, GAZIPUR**

June 5, 2014

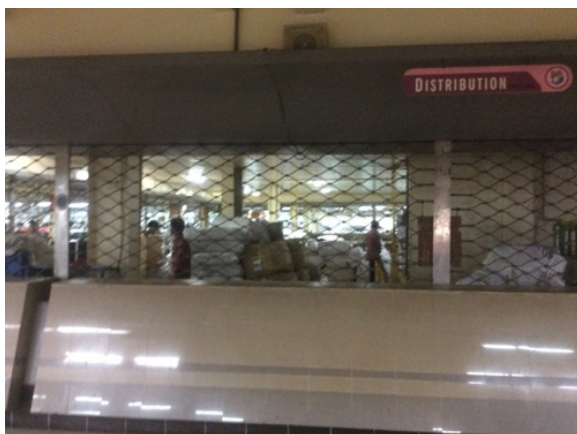
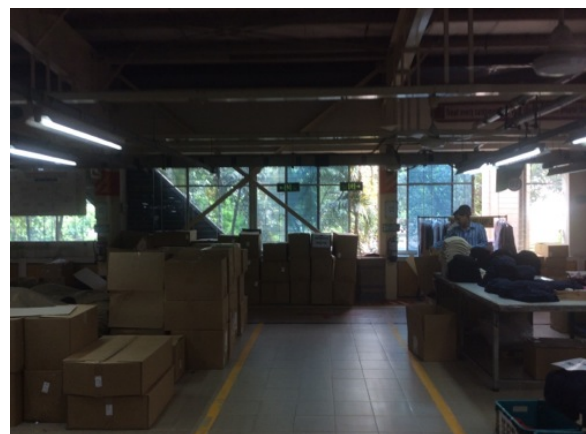
| No. | Category | Finding | Recommendation | Remediation Timeframe |
|---|---|---|---|---|
| F-1 | Fire Rated Construction | The finished goods store on the 1st floor and the accessory store on the ground floor are separated by non-fire-rated construction from the adjacent work areas and exit stairs. | Provide dedicated storage rooms separated by minimum 1-hr fire-rated construction. | Within 3 months |

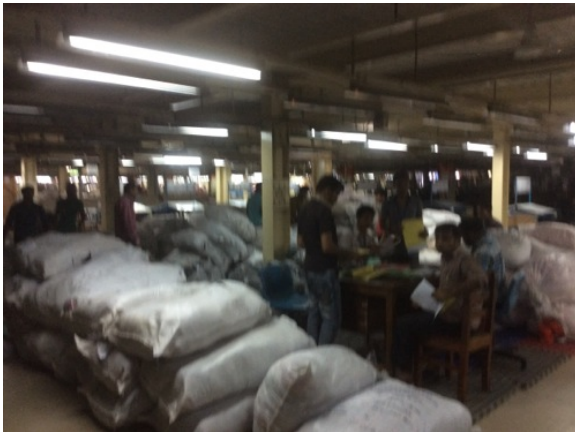
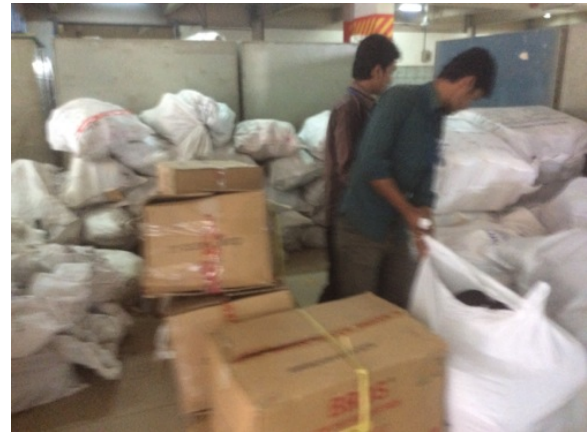
| F-2 | Fire Rated Construction | A significant amount of storage was observed to be open to the factory floor and dining area, particularly on the ground floor. | <p>Provide dedicated storage rooms separated by minimum 1-hr fire-rated construction.</p> <p>Where separate storage rooms are not feasible, provide defined storage areas and limit the storage arrangement as follows:</p> <ul style="list-style-type: none"> <li>- Maximum height of 2.4m and maximum area of 23m<sup>2</sup></li> <li>- If sprinkler protected: maximum height of 3.66m and maximum area of 93m<sup>2</sup></li> </ul> <p>Separate areas of unenclosed combustible storage by a minimum clear distance of 3m.</p> | Within 3 months |

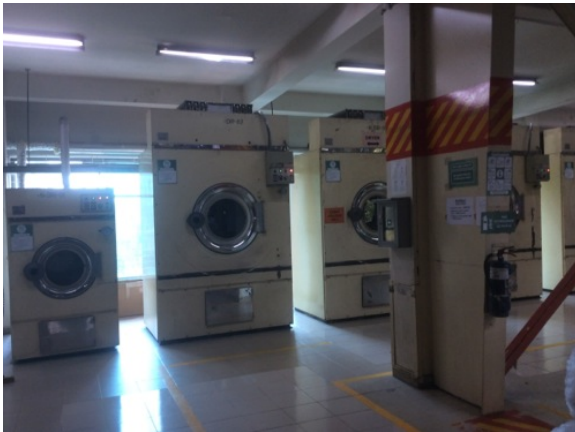
| F-3 | Fire Rated Construction | The industrial gas dryers in the washing area are not separated by any fire-rated construction. | Separate the gas dryers in a room with a minimum 2-hr fire-rated construction. Seal and/or protected all openings to maintain the required fire separations | Within 3 months |

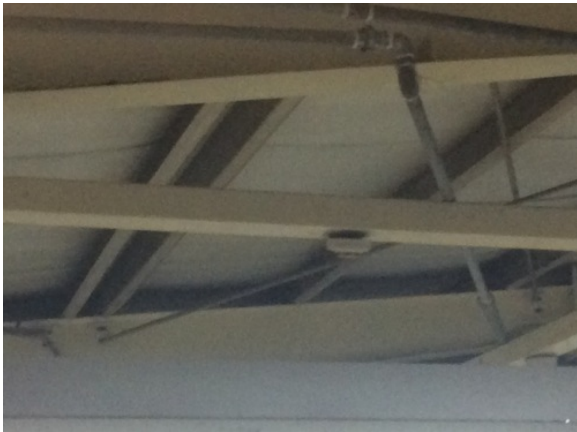
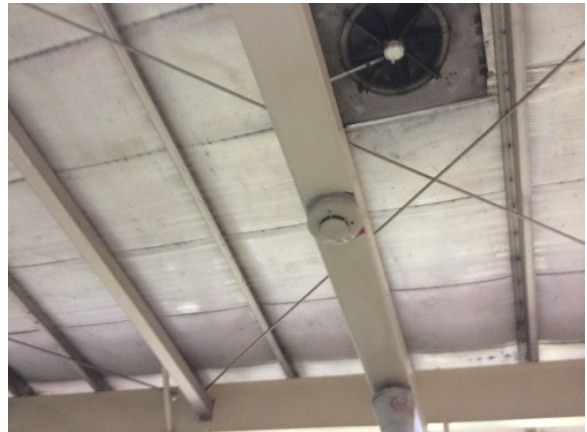
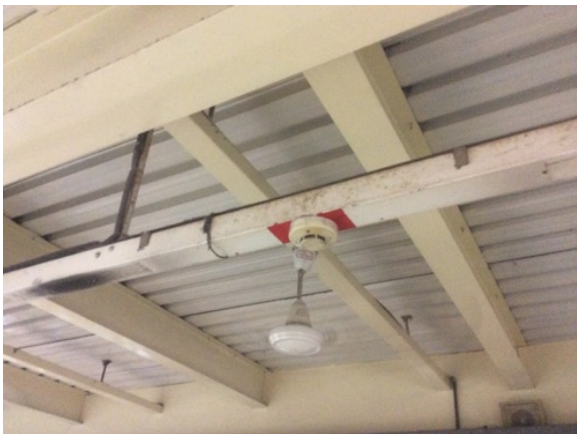
| F-6 | Fire Protection | Based on observations, the smoke detectors were not installed in accordance with NFPA 72. | Provide automatic smoke detection throughout the building, tied into the fire alarm system, in accordance with NFPA 72. | Within 6 months |

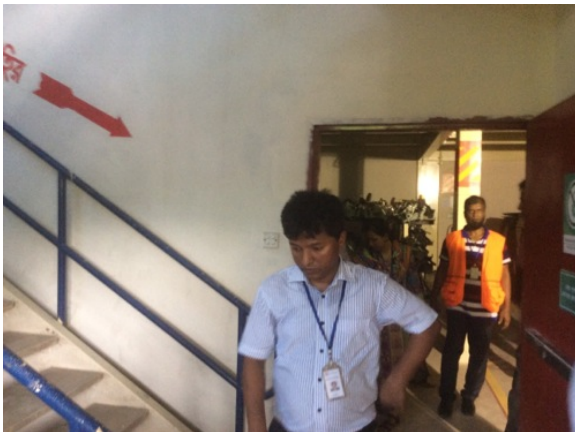
| No. | Category | Finding | Recommendation | Remediation Timeframe |
|---|---|---|---|---|
| F-1 | Fire Rated Construction | The bonded warehouse on the ground floor exits directly into the Southeast stair enclosure. | Change exit arrangement so that the bonded warehouse exits directly to the exterior. | Within 3 months |

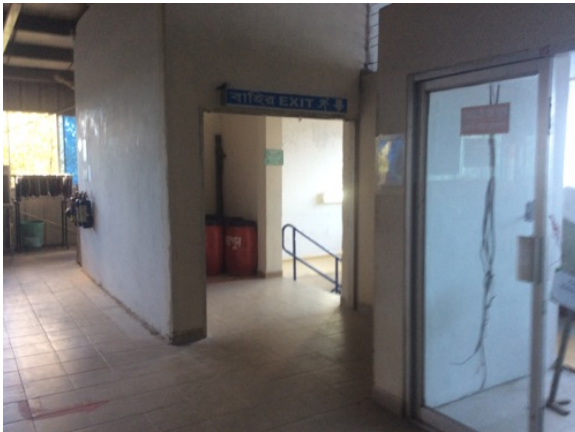
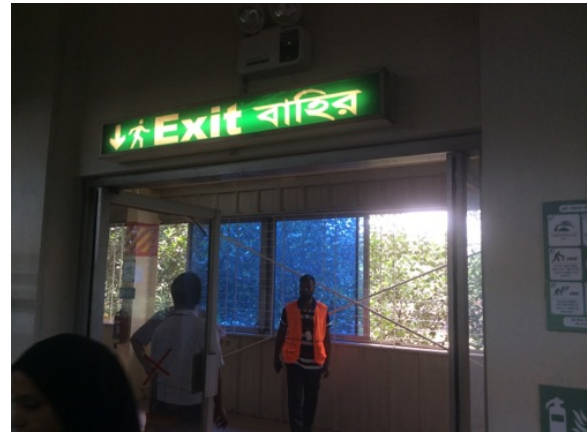
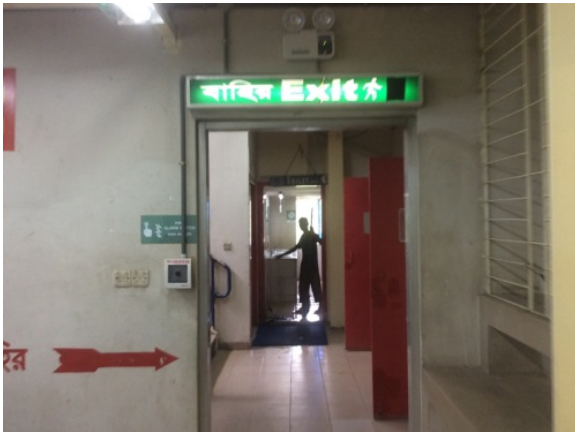
| F-2 | Fire Rated Construction | The automatic knitting section on the 1st floor had a glass door to the Northwest stair, and no door in the opening to the Northeast stair. On the 2nd floor, which was under construction, no doors were yet installed at the exit enclosures. | Provide minimum 1.5-hr fire rated doors and seal all unprotected openings to separate the exit stairs from work areas and other building spaces on all floor levels. Ensure that the fire doors are self-closing and positive latching and that they are provided with fire exit (panic) hardware where serving production floors.<br><br>If fire doors are required to be held open for functional reasons, provide automatic-closing devices tied to the fire alarm system. | Within 3 months |

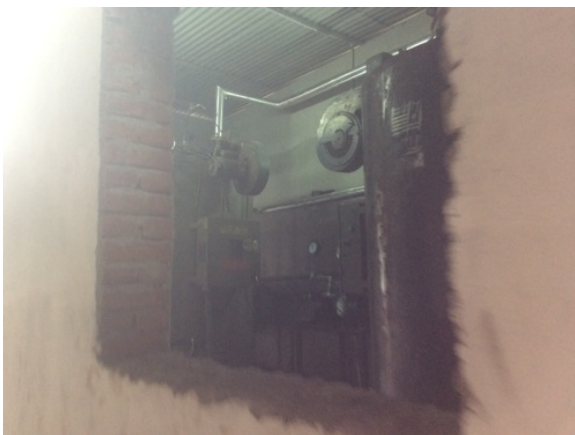
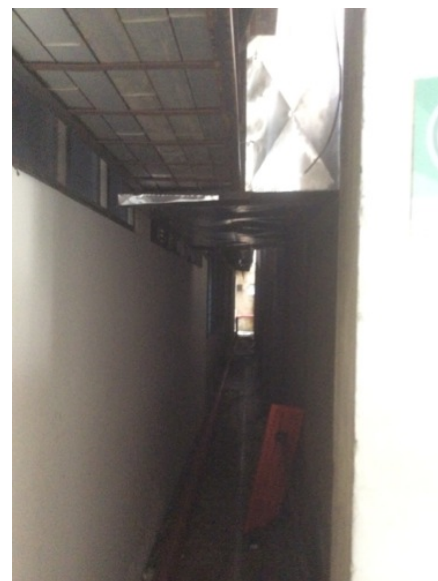
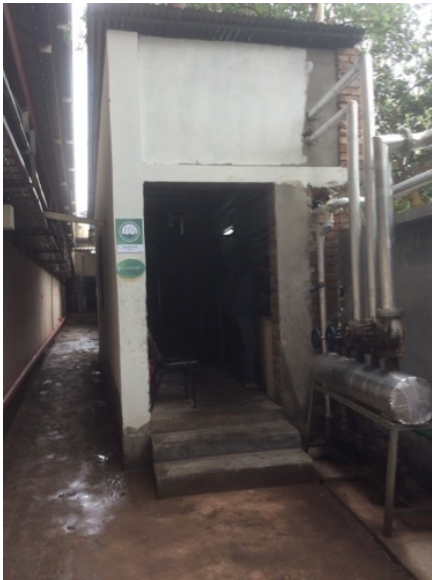
| F-3 | Fire Rated Construction | The boiler and generator rooms are not separated by fire-rated construction due to unprotected openings and non-rated doors. These rooms are arranged so that windows on Building 2 are exposed to the unprotected openings. | Separate the boiler and generator rooms by a minimum 2-hr fire-rated construction. Seal and/or protected all openings to maintain the required fire separations | Within 3 months |
