# AB Mart Fashion Wear Ltd (Extension)

786, Kakil Sataish, 13/3, Mudafa Purbopara, Tongi, Gazipur.

16 July 2025

1. Extension Building (Building C).

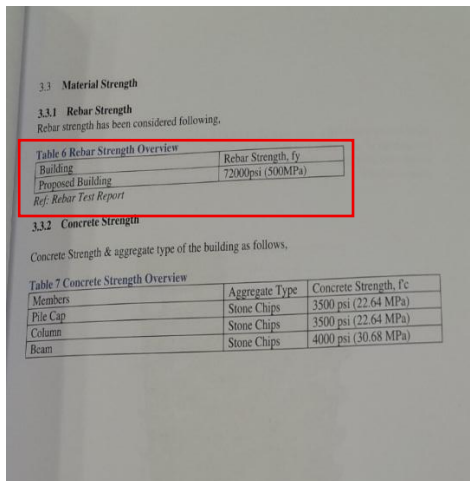
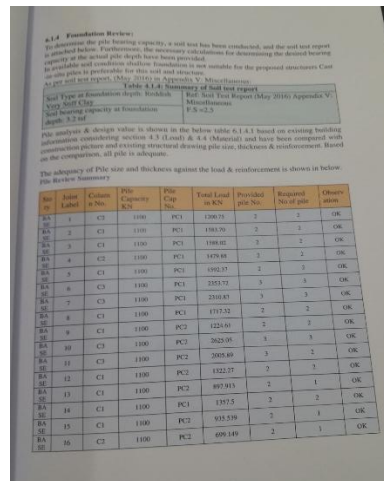
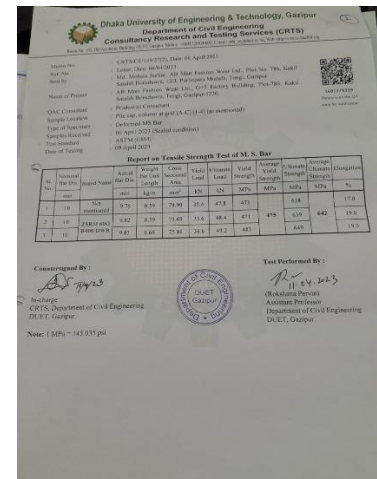
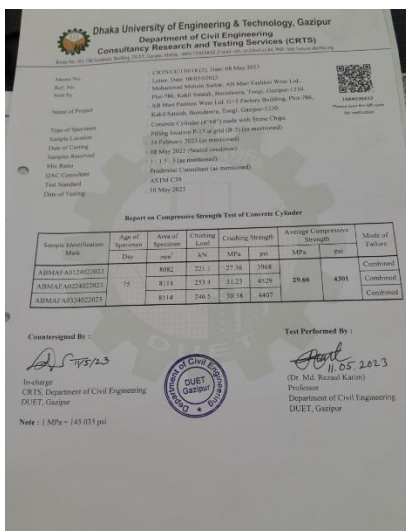
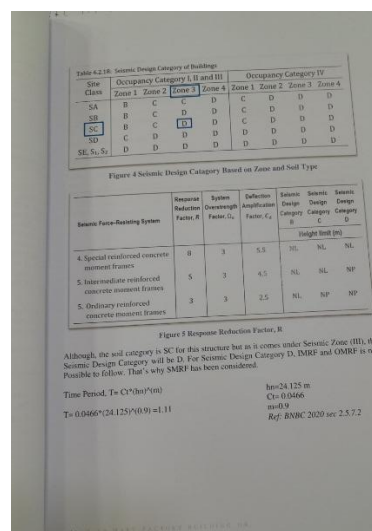
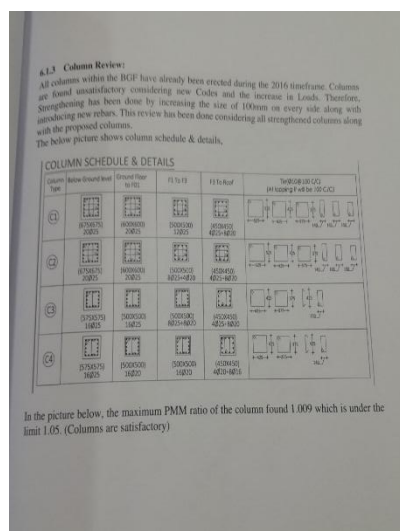
### Observation-01: Inconsistencies in the design report & material strength. (Extension Building)

### Description: Inconsistencies were found in the design report.

1. Design rebar strength is considered 500 MPa, but 420 MPa grade is used in construction.
2. The number of concrete cylinder tests does not meet the frequency of testing requirements of the BNBC 5.12.1
3. Framing system considered SMRF, but no detailed calculation was provided.
4. In the column review chapter, it is mentioned that columns are strengthened 100 mm on four sides with additional rebar. But no remedial drawing was found on-site.
5. The number pile provided in the pile adequacy check is not match the drawing.

The building engineer is required to assess the design and prepare the design report as per BNBC 1.9 and material strength from the in-situ testing.

| Item No | Observation | Action Plan | Timeline |
|---|---|---|---|
| 1. | Inconsistencies in the design report & material strength. (Extension Building) | Building engineer is required to review the design report and prepare the design report as per BNBC 1.9 | within 6 weeks |
| 2. | | Verify in-situ concrete strength by taking min four cores from the lower-tier columns & four cores from the beam-slab (100 diameter core). | within 6 weeks |
| 3. | | Verify the rebar grade. | within 6 weeks |
| 4. | | Carry out the suggested remedial work if required. | within 6 months |

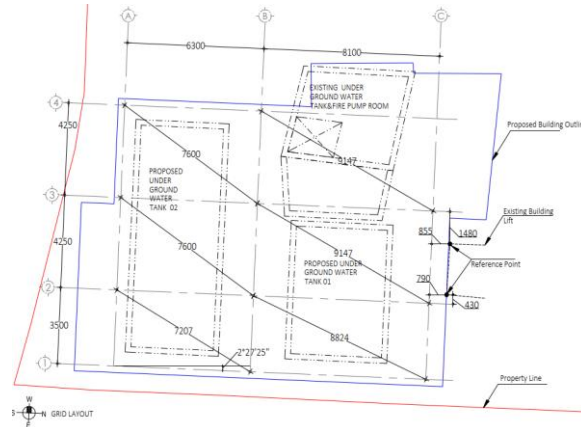
**Observation-02:** Lack of details in the as-built drawing. (Extension Building)

**Description:** Structural Details of the UGWR are not provided in the drawing. The building engineer is required to prepare a detailed as-built drawing.

| Item No | Observation | Action Plan | Timeline |
|---|---|---|---|
| 5. | Lack of details in the as-built drawing. (Extension Building) | Building engineer is required to prepare detailed and accurate as-built drawings. | within 6 weeks |

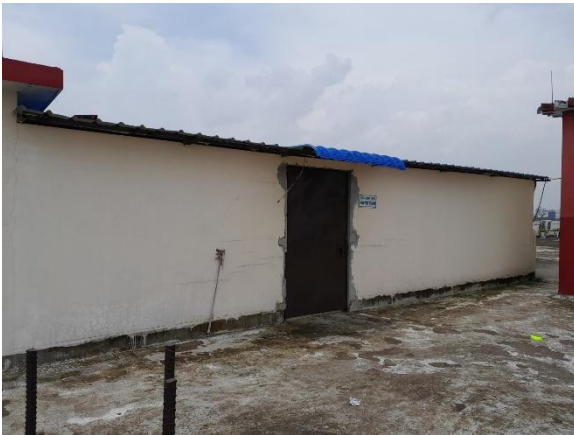
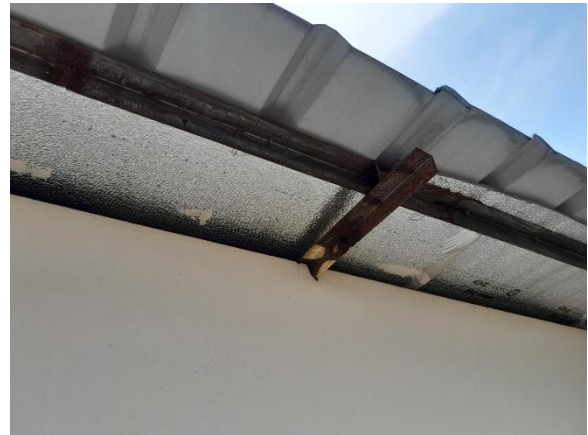
**Observation-03:** Undocumented non-engineered shed on the roof. (Extension Building)

**Description:** Undocumented non-engineered shed observed on the roof of the extension building. Poor connection details, inadequate member size, lack of an as-built drawing found on the shed. The building engineer is required to carry out an Engineering Assessment on the roof prayer shed, including it in the permit drawing otherwise demolish the shed.

| Item No | Observation | Action Plan | Timeline |
|---|---|---|---|
| 6. | Undocumented non-engineered shed on the roof. (Extension Building) | Building engineer is required to carry out an Engineering Assessment on the roof prayer shed, including it in the permit drawing otherwise demolish the shed. | within 6 weeks |
| 7. | | Carry out the suggested remedial work if required. | within 6 months |

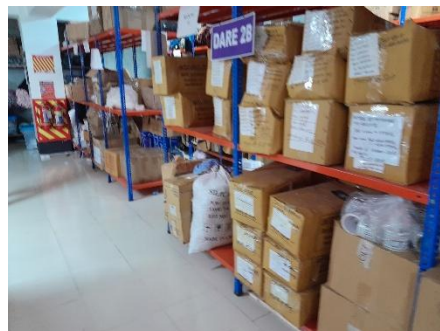
**Observation-04:** Anchorage of non-structural elements (Extension Building)

**Description:** Lack of anchorage was found on the storage racks. Provide anchorage on the non-structural elements.

| Item No | Observation | Action Plan | Timeline |
|---|---|---|---|
| 8. | Anchorage of non-structural elements (Extension Building) | Provide anchorage on the non-structural elements. | within 6 months |

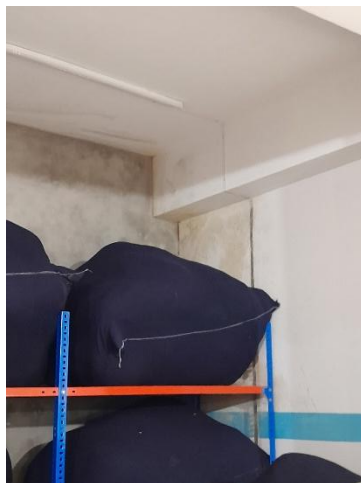
**Observation-05:** Dampness on the brick wall (Extension Building)

**Description:** Dampness was found on the brick wall. The building engineer is required to remove the dampness and repair it with a suitable method.

| Item No | Observation | Action Plan | Timeline |
|---|---|---|---|
| 9. | Dampness on the brick wall (Extension Building) | Building engineer is required to remove the dampness and repair with a suitable method. | within 6 weeks |

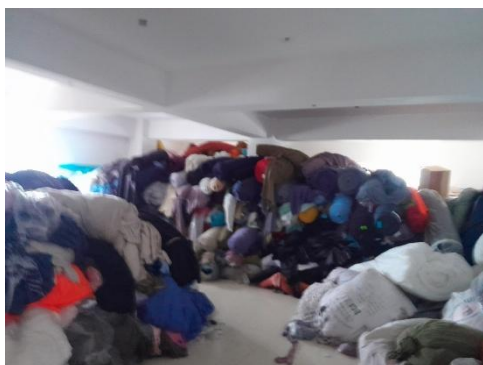
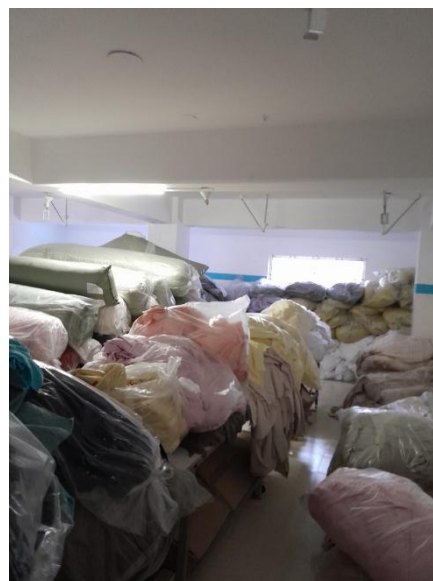
**Observation-06:** Uncontrolled loading in all floors (Extension Building)

**Description:** Uncontrolled loading observed on the floors. The building engineer is required to implement the load management program and maintain the floor loading accordingly.

| Item No | Observation | Action Plan | Timeline |
|---|---|---|---|
| 10. | Uncontrolled loading on all floors (Extension Building) | The building engineer is required to implement the load management program (posting load plan, marking storage area & height and maintaining loading within limit) | within 6 weeks |

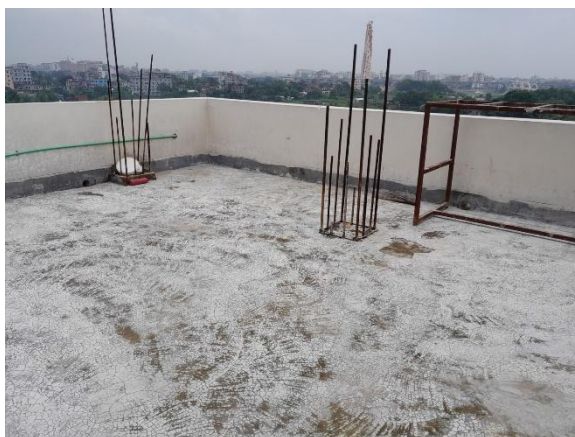
**Observation-07:** Exposed rebar on the roof. (Extension Building)

**Description:** Exposed rebar observed on the roof is prone to corrosion. The building engineer is required to remove the rust and provide anti-corrosive paint.

| Item No | Observation | Action Plan | Timeline |
|---|---|---|---|
| 11. | Exposed rebar on the roof. (Extension Building) | Building engineer is required to remove the rust and provide anti-corrosive coating. | within 6 weeks |
