# Searock Apparels Ltd

Plot No. 98, National University, Choydana, Gazipur  
(WGS 1984: 23.957122N, 90.381394E)

## Structural Inspection Report

### Observations & Actions

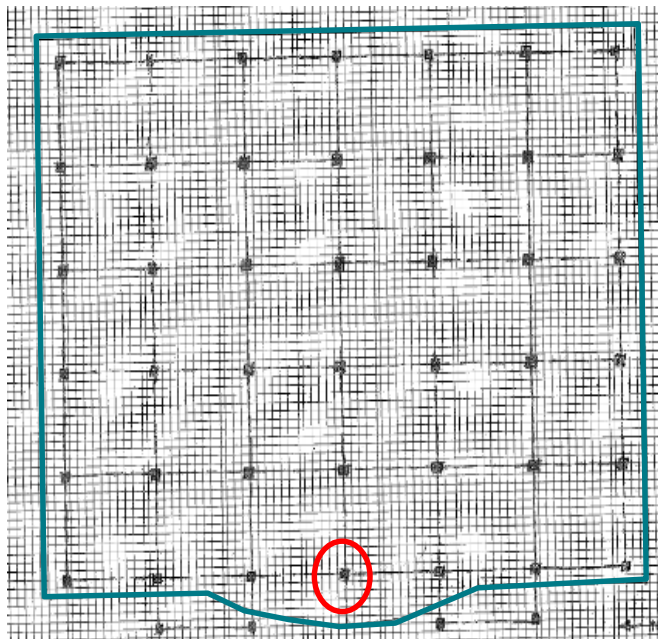
**Column suspected to be stressed**

| Item No. | Observation | Recommended Action Plan | Recommended Timeline |
|---|---|---|---|
| 1 | <b>Columns appear to be stressed</b> | Factory Engineer to review design, loads and columns stresses in all columns. | 6 – weeks |
| 2 | <b>Columns appear to be stressed</b> | Verify in situ concrete strength by 100mm diameter cores. | 6 – weeks |
| 3 | <b>Columns appear to be stressed</b> | Produce and actively manage a loading plan for all floor plates within the factory giving consideration to floor capacity and column capacity. | 6 – weeks |
| 4 | <b>Columns appear to be stressed</b> | Implement actions arising from Engineering Assessment. | 6 – Month |

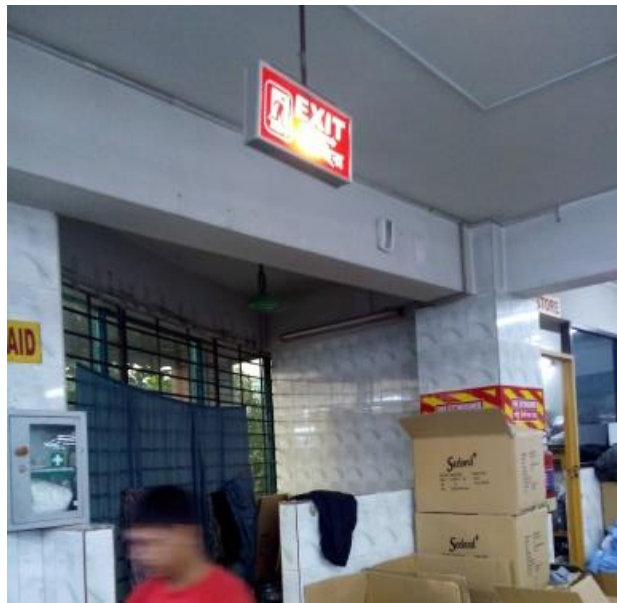
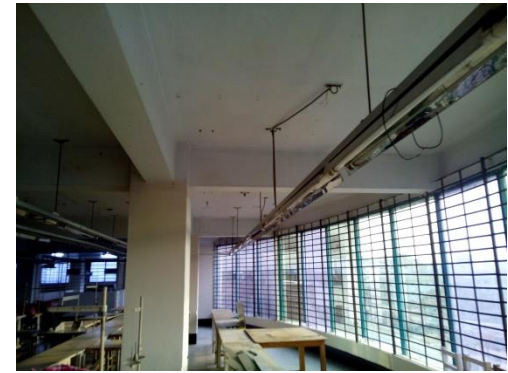
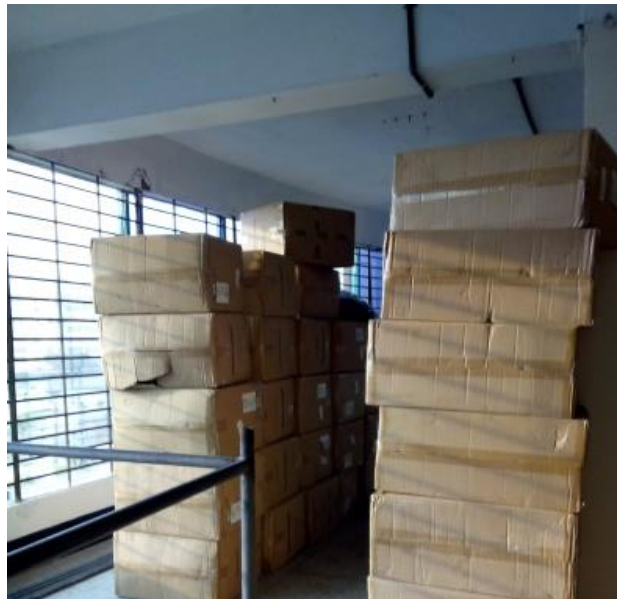
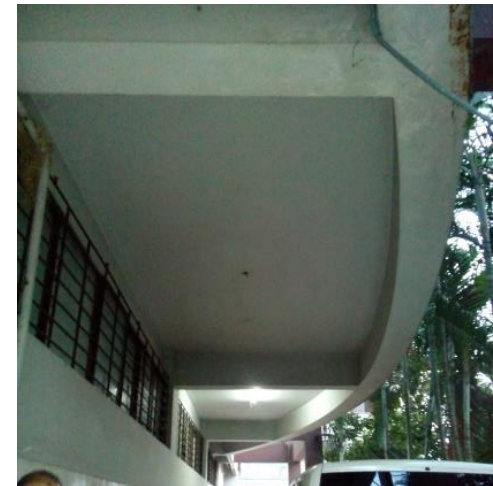
**Large 3.1 m cantilever is constructed on west side of the building from 1<sup>st</sup> to 5<sup>th</sup> floor, which is supported by beams and it's used for temporary store, office and prayer hall etc.**

**Columns appears to be stressed**

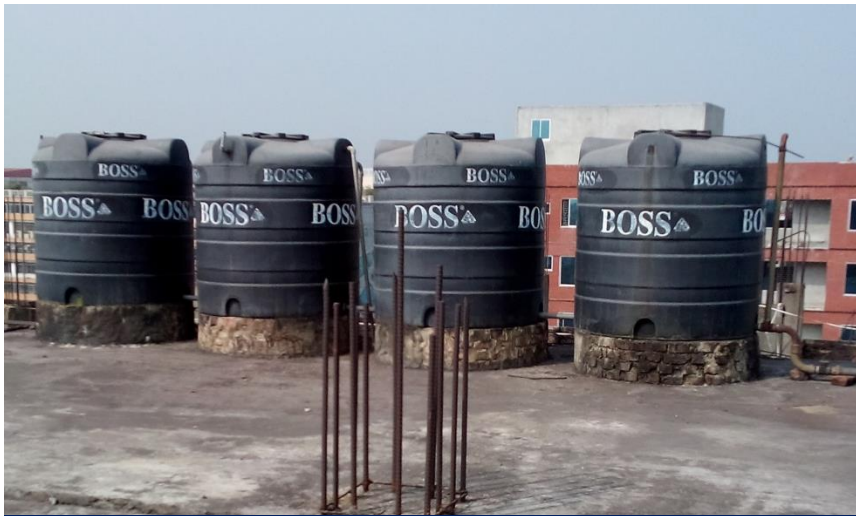
4, 2000 lt water tank on roof

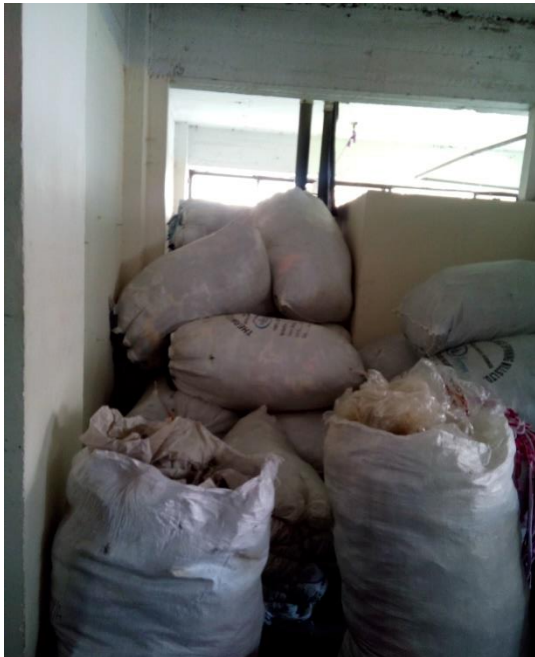
Uncontrolled storage

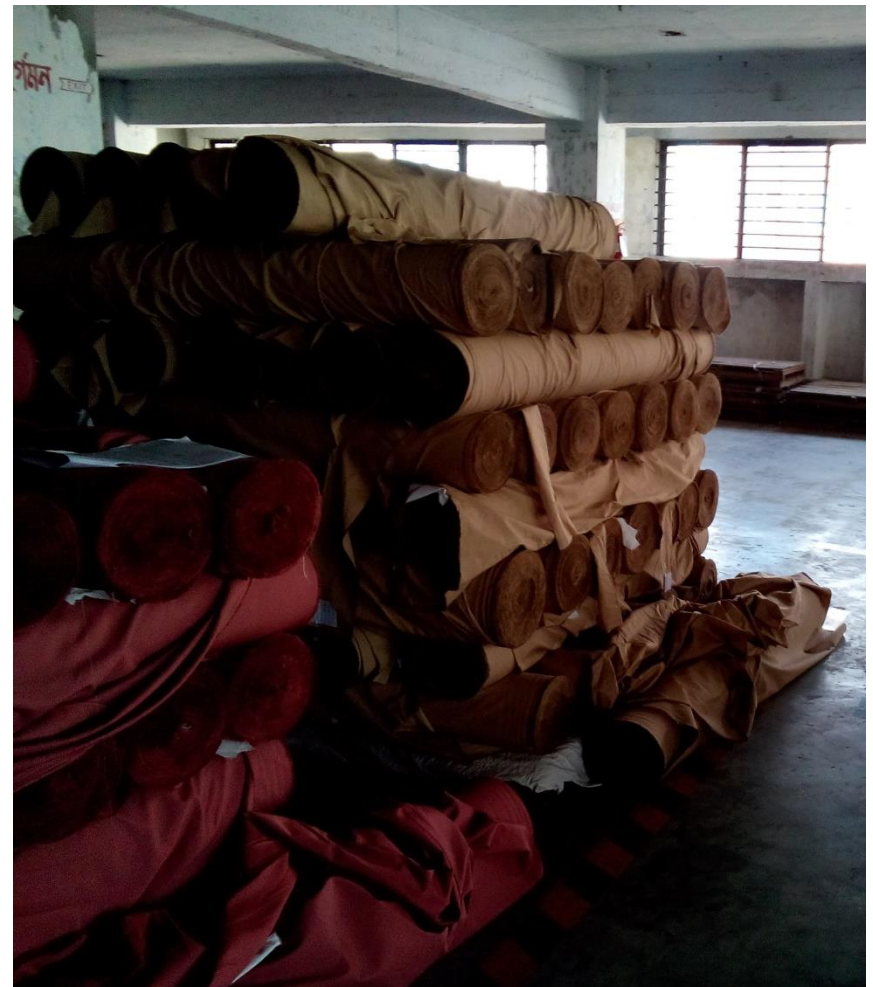
Uncontrolled stacking of fabric roll

Columns appears to be stressed

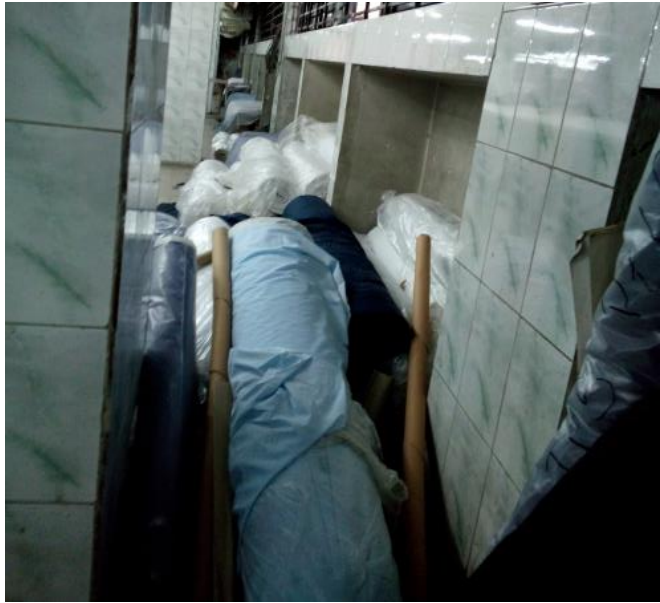
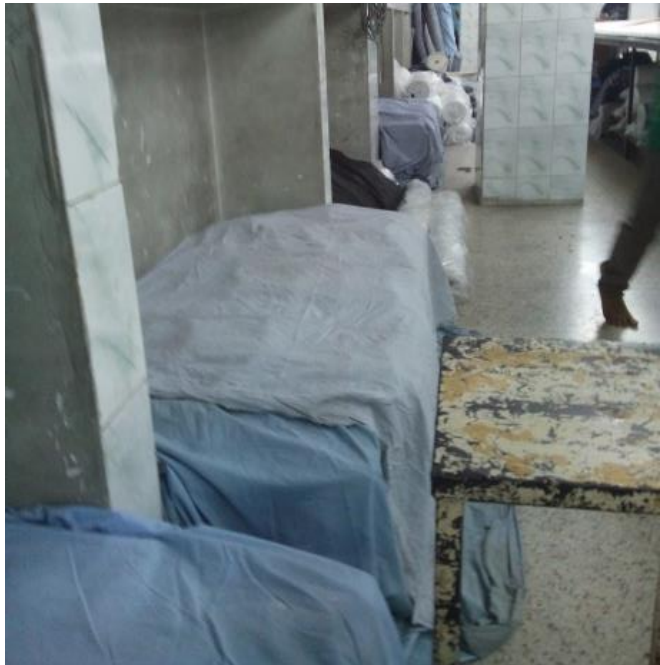
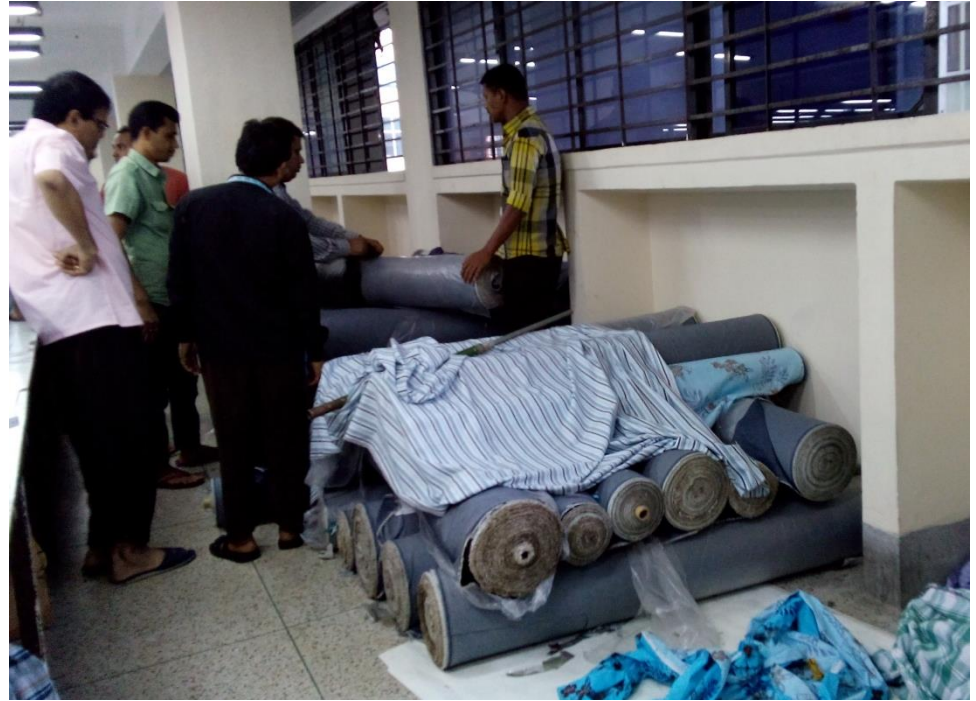
**1.25 m long cantilevers on east are loaded with heavy denim and fabric rolls. Those cantilevers are used as temporary storage for cutting section.**

| Item No. | Observation | Recommended Action Plan | Recommended Timeline |
|---|---|---|---|
| 5 | <b>Loaded cantilever slab</b> | Building Engineer to Assess or check the structural design of cantilever slab and supporting columns of factory building. | 6 – weeks |
| 6 | <b>Loaded cantilever slab</b> | Implement actions arising from Engineering Assessment. | 6 – Month |

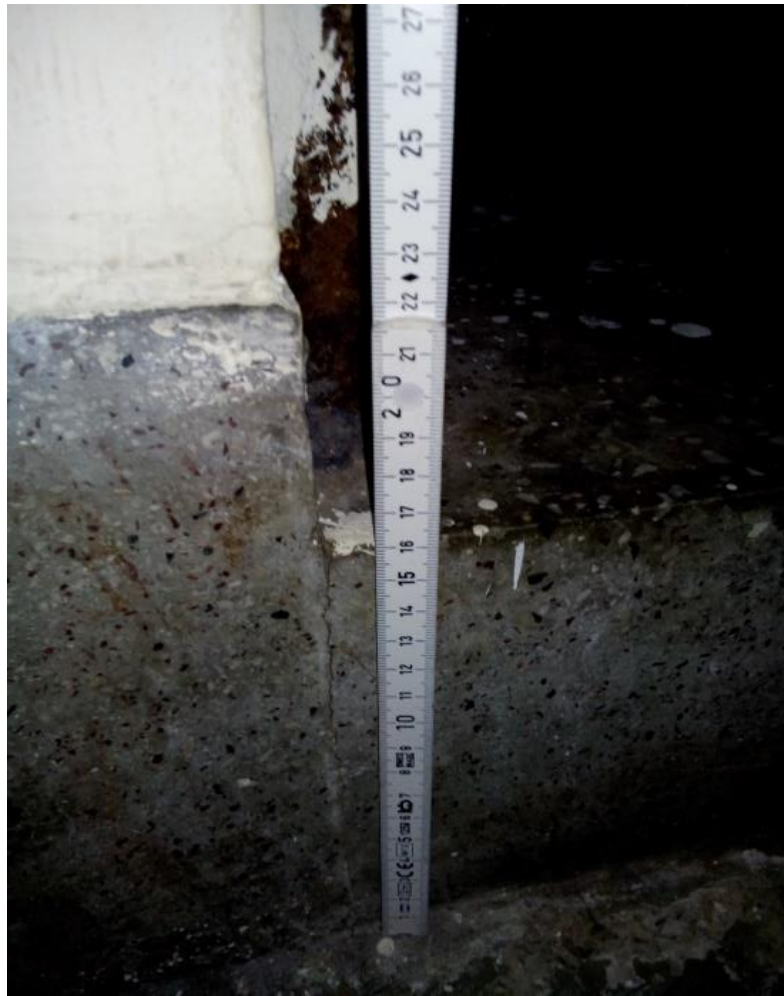
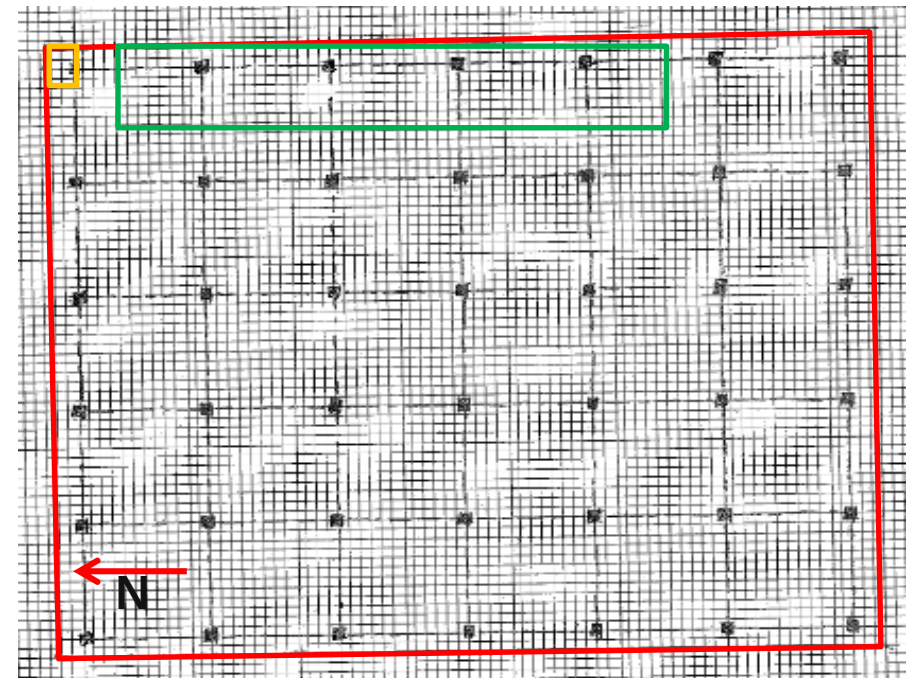
**Build up on 4<sup>th</sup> floor**

- 16 cm build up on floor slab
- 10 cm build up on floor slab

16 cm Build up on north east corner and 10 cm build up on east side are observed on 4<sup>th</sup> floor cantilevers and main slab. Which increase the stress on edge and corner columns.

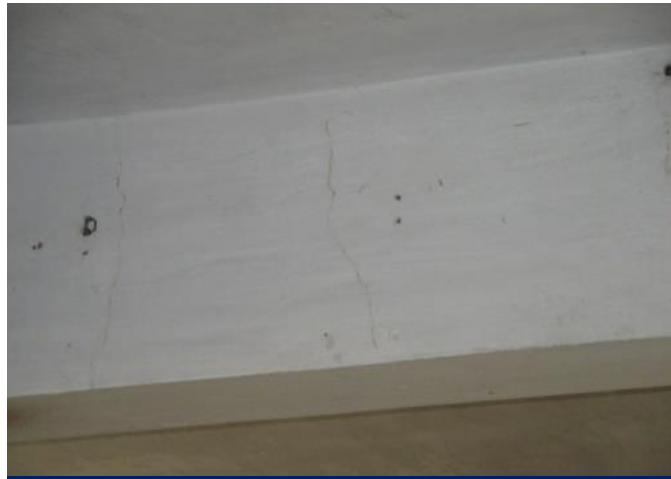
**Cracks on Beams of 5<sup>th</sup> floor roof slab**

**Several Cracks are observed on various slabs and beams of 5<sup>th</sup> and 6<sup>th</sup> floor. Which is Suspected as flexural cracks.**

| Item No. | Observation | Recommended Action Plan | Recommended Timeline |
|---|---|---|---|
| 7 | <b>Cracks in several Beams and Slabs</b> | Building engineer to check all cracks either their structural or not. If it is structural then repair all cracks. Only plaster is not acceptable. | 6 – weeks |

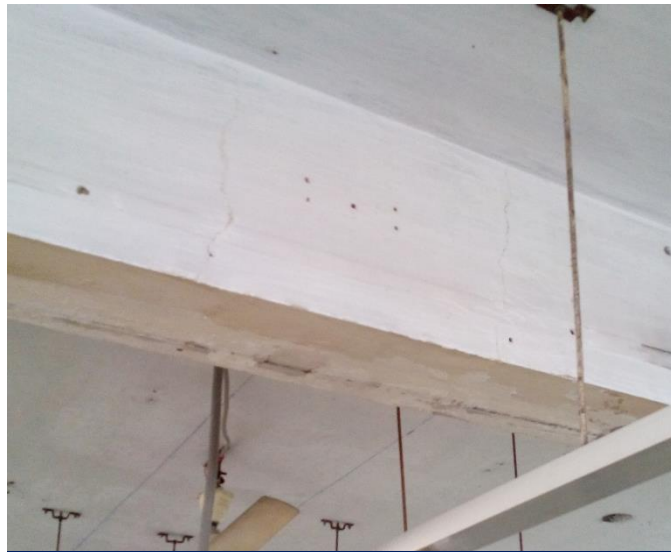
**Cracks on Beams of 5<sup>th</sup> floor roof slab**

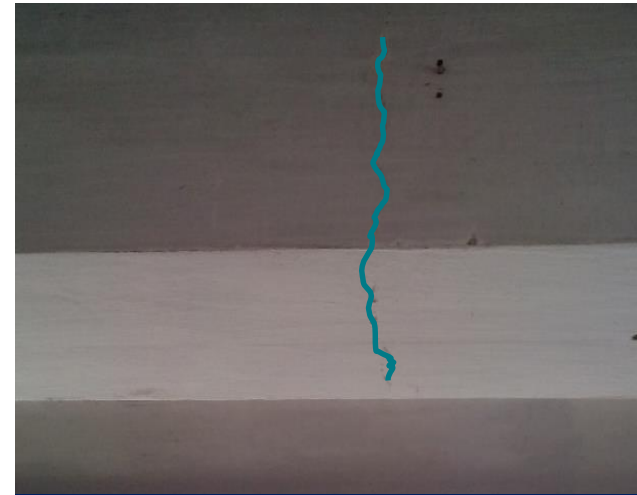
**Cracks on Beams of 5<sup>th</sup> floor roof slab**

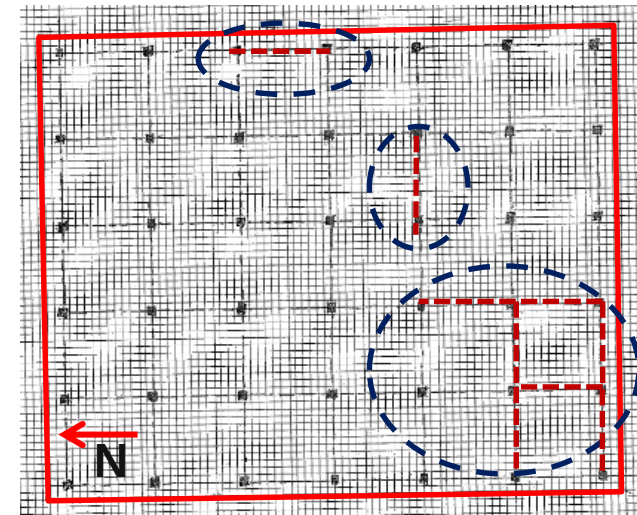
**Cracked Beams of 5<sup>th</sup> floor**

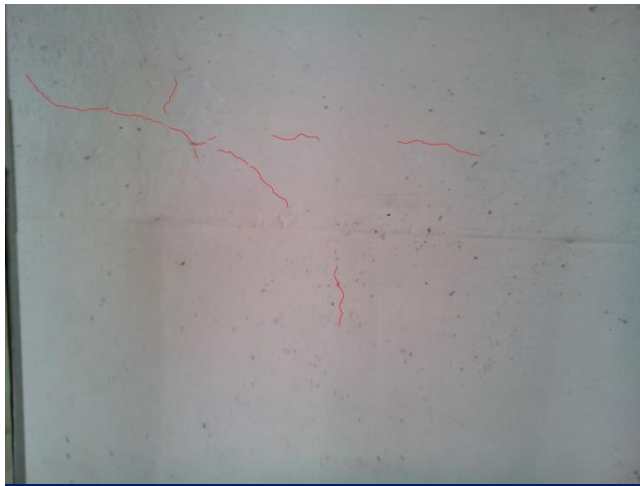
**Cracks on 6<sup>th</sup> floor roof slab**

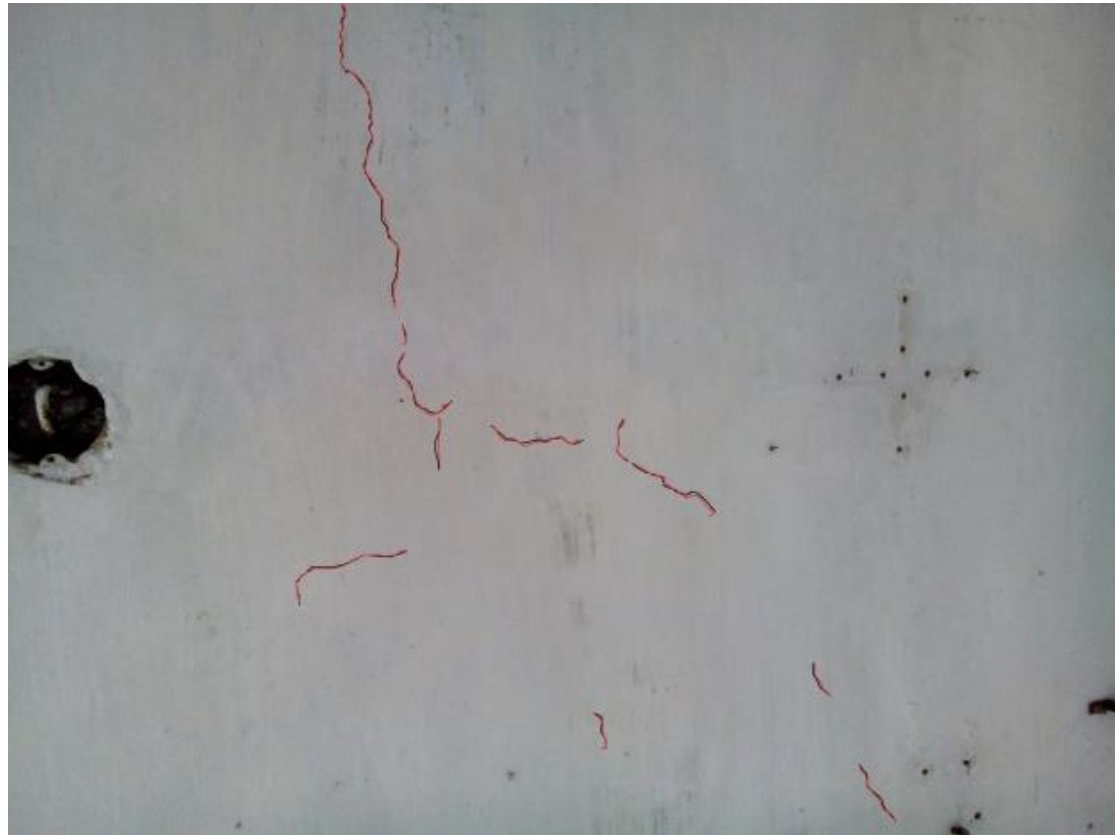
**Cracks on 5<sup>th</sup> floor roof slab**

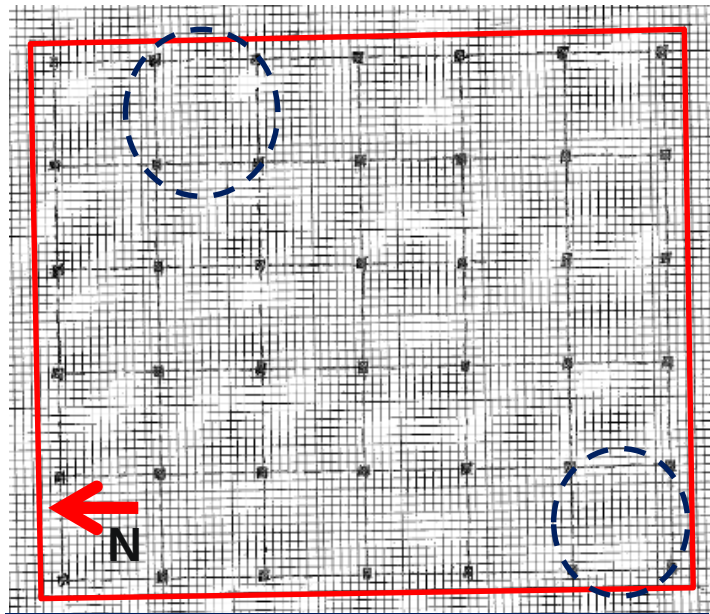
**Crack appears on 5<sup>th</sup> floor roof slab on east side and 6<sup>th</sup> floor roof slab on south west corner of factory building.**

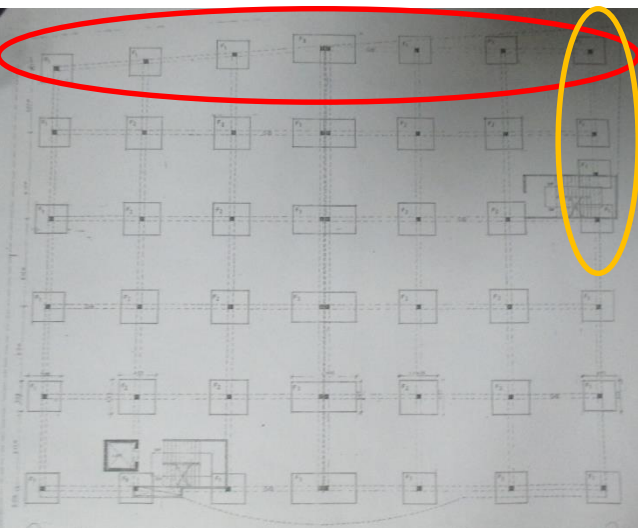
**Foundation Layout from structural drawing**

**Foundation layout from structural drawing and Column layout from permit drawing are not matched with each other. Even actual column layout is different from both of them.**

| Item No. | Observation | Recommended Action Plan | Recommended Timeline |
|---|---|---|---|
| 8 | <b>Inconsistencies between Record Information and existing structure</b> | The building engineer to survey the actual conditions and produce the As-build drawings as early as possible. | 6 – weeks |

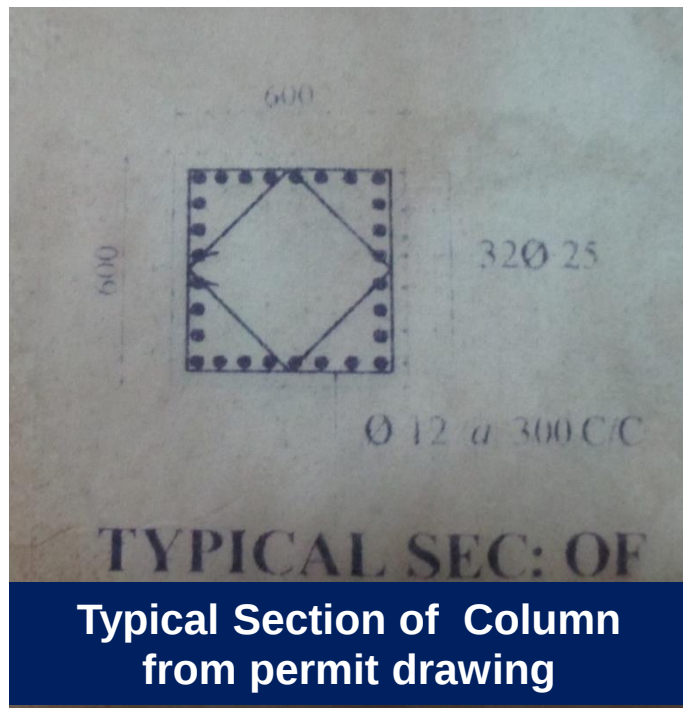
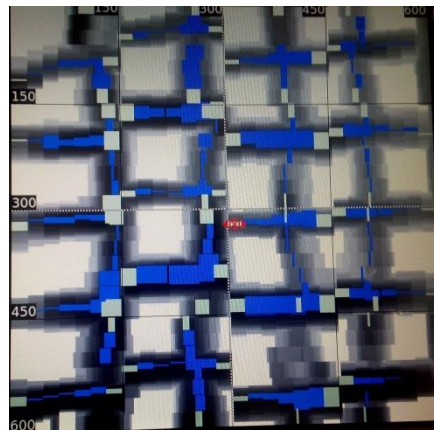
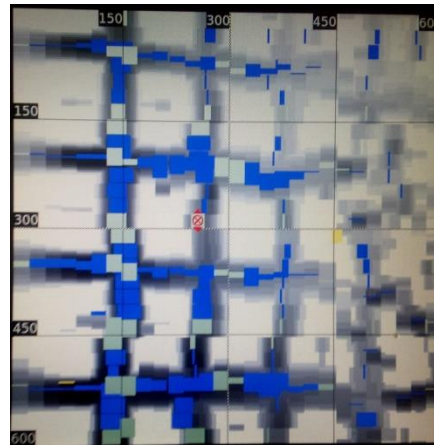
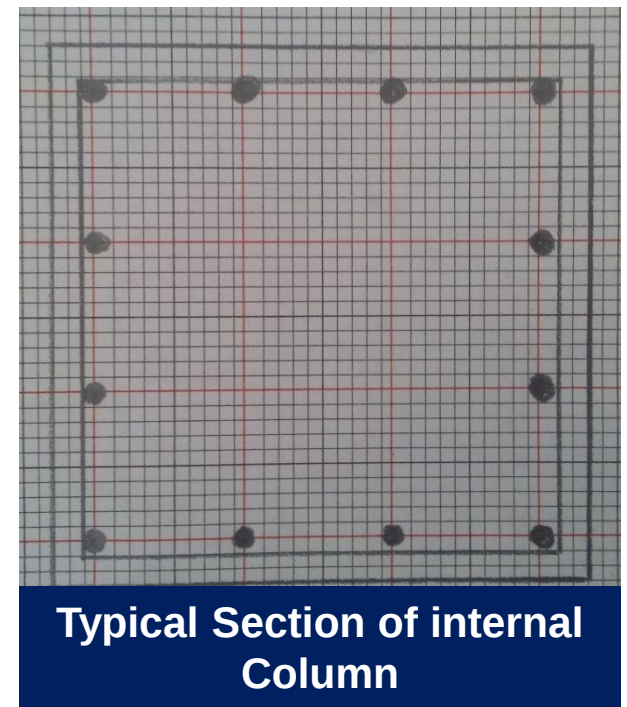
**Permit Drawing and structural drawing shows that internal column is 600X 600mm with 32, 25mm bar. From Ferro Scan and exposed column at top Floor found that internal columns are 600x600mm with 12, 25mm bar and Edge and corner columns are 550x500mm with 4, 20mm + 8, 25mm bar.**

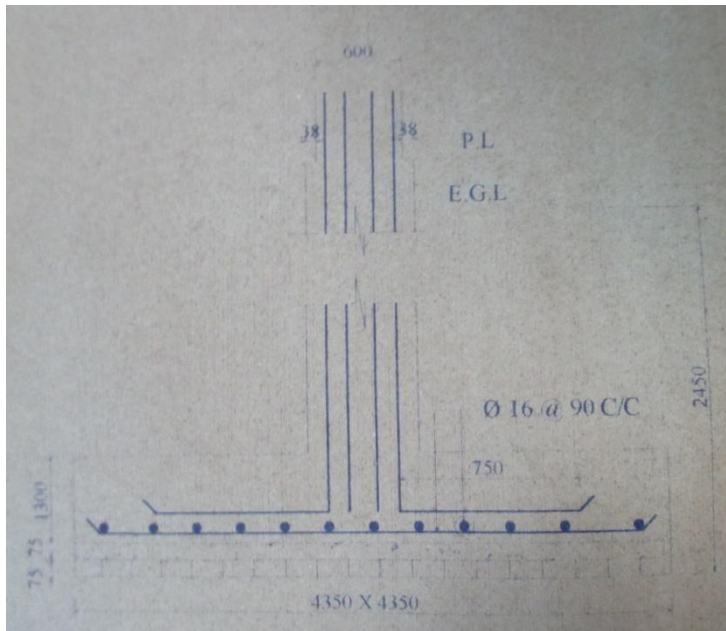
Typical footing section from permit drawing

Soil Test Report Recommend that Isolated column footing at 12 ft depth below existing ground level. From Structural Drawing recommend isolated Column Footing at 8 ft depth below existing ground level.

| Item No. | Observation | Recommended Action Plan | Recommended Timeline |
|---|---|---|---|
| 9 | <b>Inconsistencies between Record Information and existing structure</b> | Check the foundation system. Building Engineer to provide evidence of as constructed foundation type by digging trial pit. | 6 – weeks |

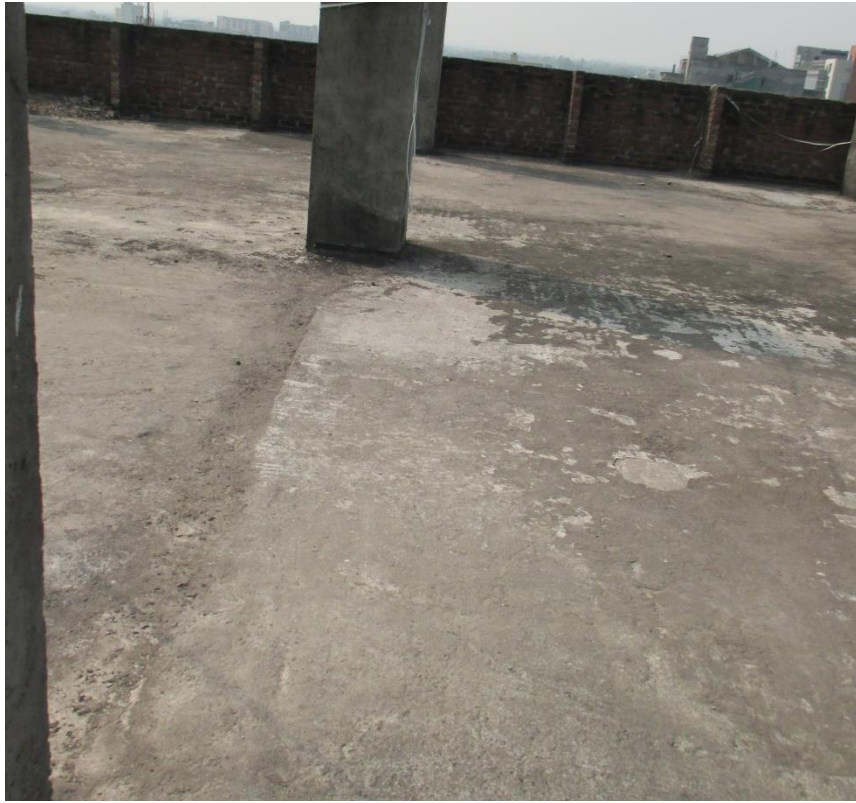
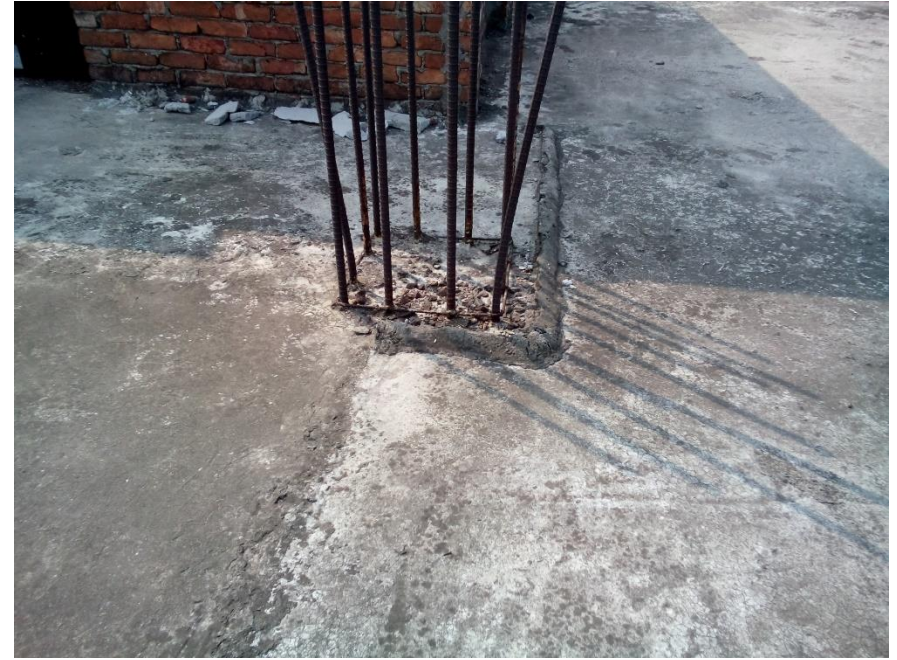
No waterproofing membrane was visible on the roof of the main factory building. This means that any cracks in the surface finishes on the roof will allow water to seep into the concrete slab beneath the finishes, and cause corrosion of the reinforcing steel.

| Item No. | Observation | Recommended Action Plan | Recommended Timeline |
|---|---|---|---|
| 10 | <b>Water Ingress at Roof Level.</b> | Provide a proper water proofing layer or Membrane on the roof floor. | 6 – weeks |
| 11 | <b>Water Ingress at Roof Level.</b> | Provide water proofing paint or layer on extended reinforcement. If no extension is necessary or planed then cut them all. | 6 – weeks |

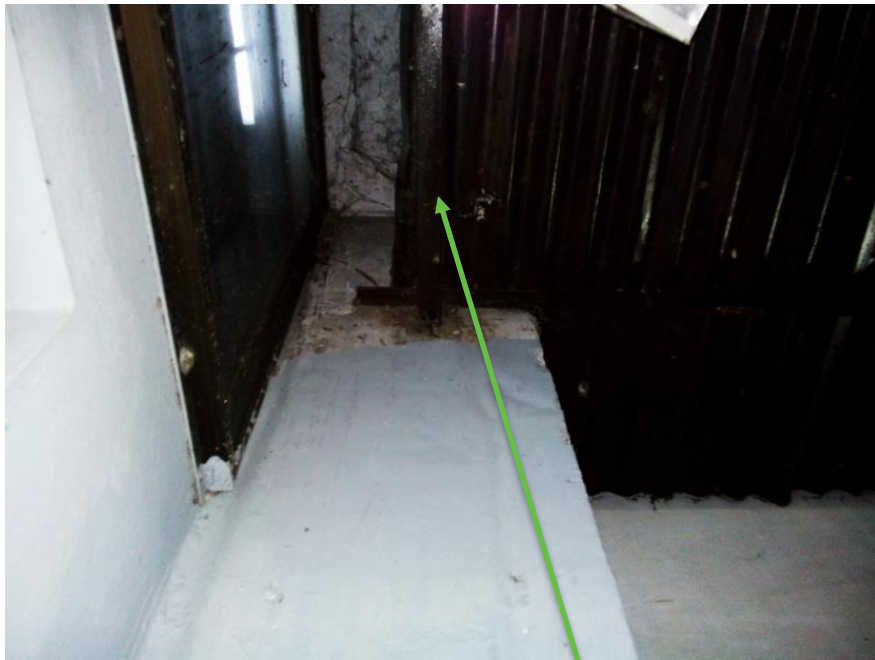
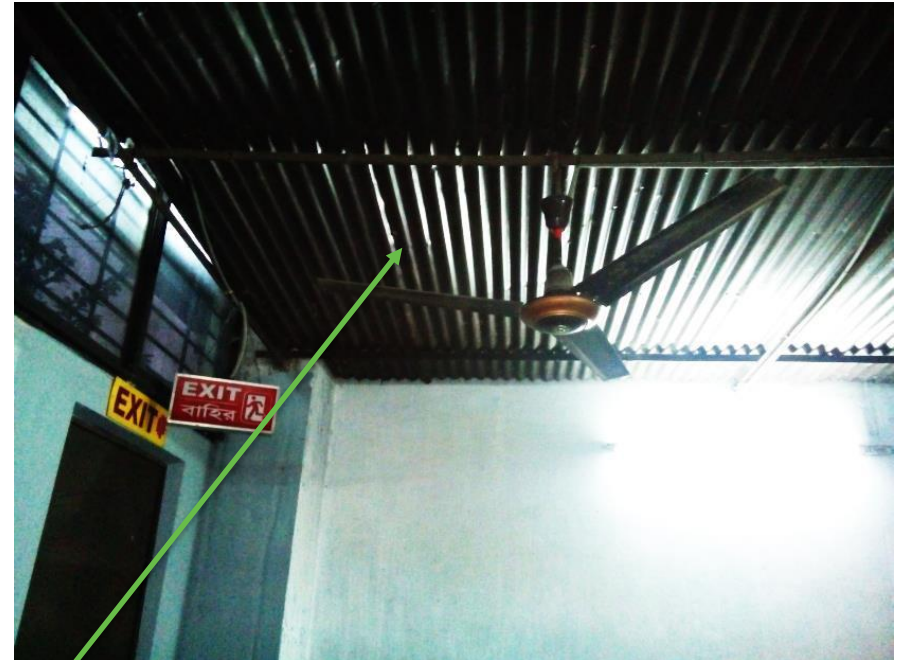
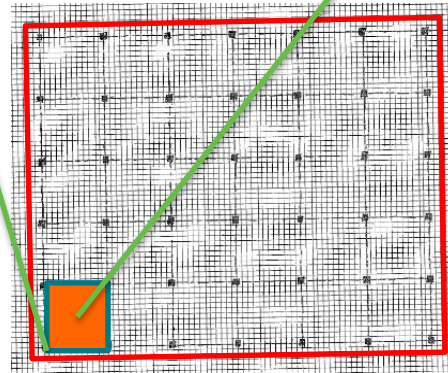
A weird simple steel shade under concrete slab is observed on north west corner at ground floor which is used as canteen and the supports are anchored with column.

| Item No. | Observation | Recommended Action Plan | Recommended Timeline |
|---|---|---|---|
| 12 | <b>Weird light weight steel roof under concrete roof on north west corner.</b> | Building engineer to define why this steel roof was provided ? and remove that, if it's not necessary. | 6 – Month |
