# Ananta Casual Wear Ltd. (Extension)

Kunia, National University, Gacha, Gazipur

3 July 2025

## Structural Inspection Report

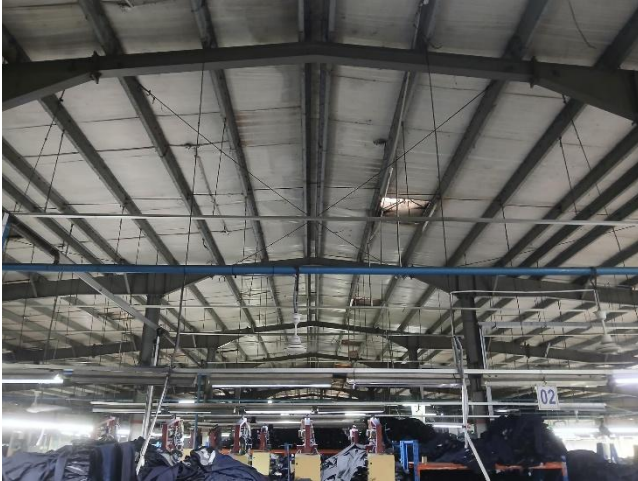
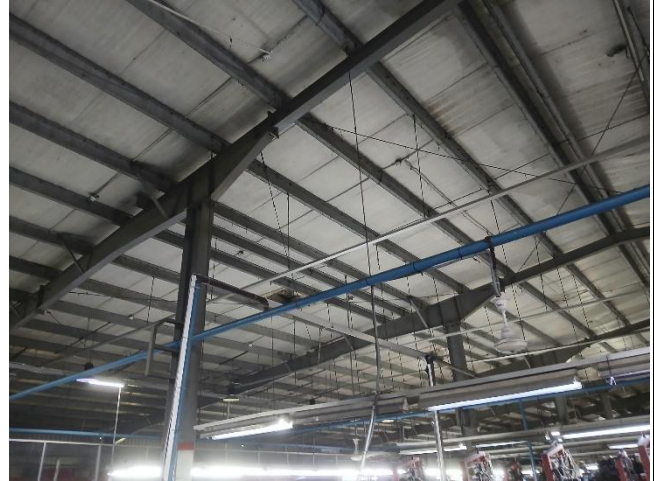
### Observation-1: Incomplete lateral stability system (Laundry Building).

**Description:** No load transfer media is provided along the long direction. So lateral stability in the long direction is incomplete. Improper connection between structural members was also observed. The building engineer is required to check the stability system and connection adequacy for the existing structure.

| Item No | Observation | Action Plan | Timeline |
|---|---|---|---|
| 1. | Incomplete lateral stability system (Laundry Building). | The building engineer is required to check the stability system and connection adequacy for the existing structure as part of the EA and submit to RSC for review. | within 6 weeks |
| 2. | | Implement remediation work if required. | within 6 months |

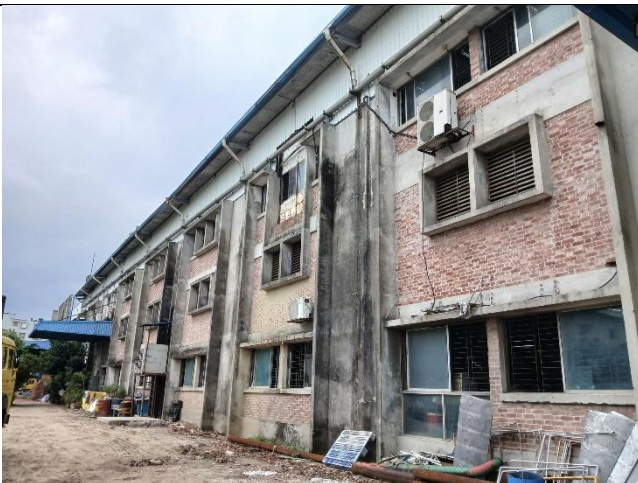
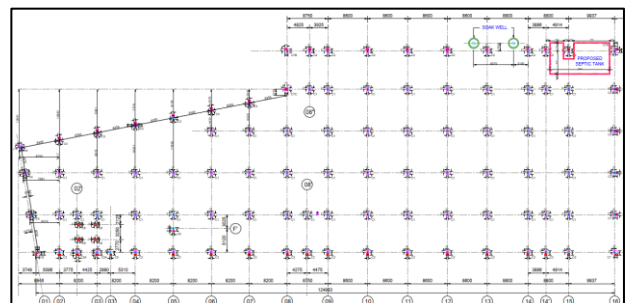
### Observation-2: Lack of information in the as-built drawing (Laundry Building).

**Description:** During the Inspection, the column layout plan with column schedule was not shown in the available structural drawing. The building engineer is required to survey the structures and prepare a comprehensive as-built drawings.

| Item No | Observation | Action Plan | Timeline |
|---|---|---|---|
| 3. | Inadequate as-built drawing (Laundry Building). | The building engineer is required to survey the structures and prepare comprehensive as-built drawings. | within 6 weeks |

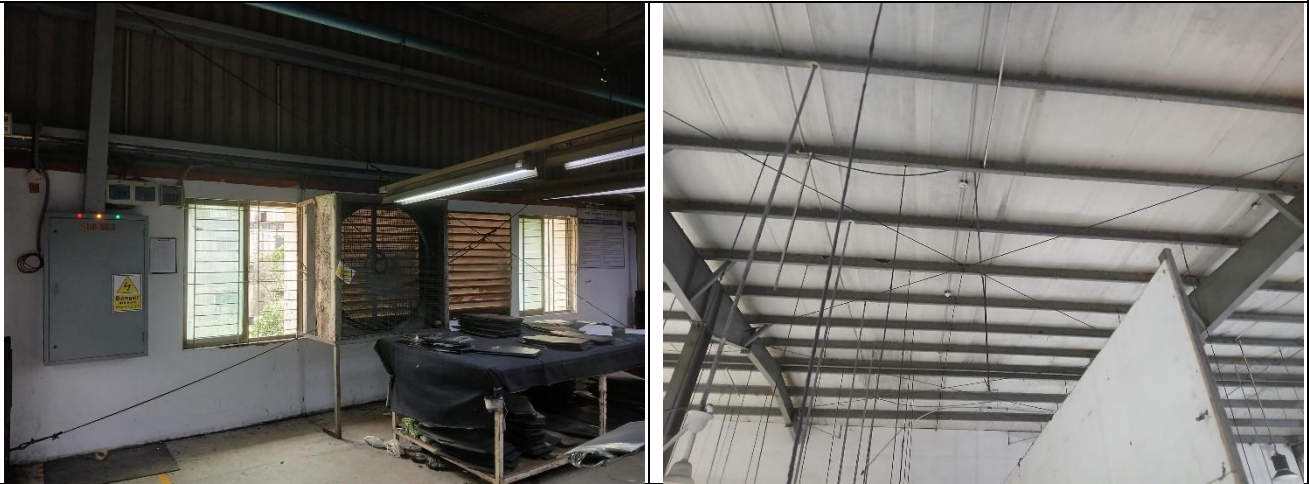
**Observation-3:** Loose cable bracing (Laundry Building).

**Description:** During the Inspection, loose cable bracing was observed on the Laundry Building. The building engineer is required to tighten all loose cable bracings.

| Item No | Observation | Action Plan | Timeline |
|---|---|---|---|
| 4. | Loose cable bracing (Laundry Building). | The building engineer is required to tighten all loose cable bracings. | within 6 weeks |

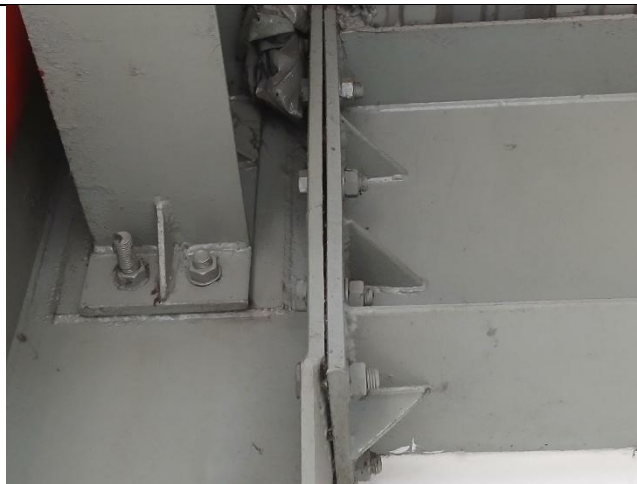
**Observation-4:** Connection gap between steel connections (Laundry Building).

**Description:** During Inspection, connection gap was observed between steel connections in different locations of the Laundry Building. The building engineer is required to fill the connection gaps with proper methodology.

| Item No | Observation | Action Plan | Timeline |
|---|---|---|---|
| 5. | Connection gap between steel connections (Laundry Building). | The building engineer is required to fill the connection gaps with proper methodology. | within 6 weeks |

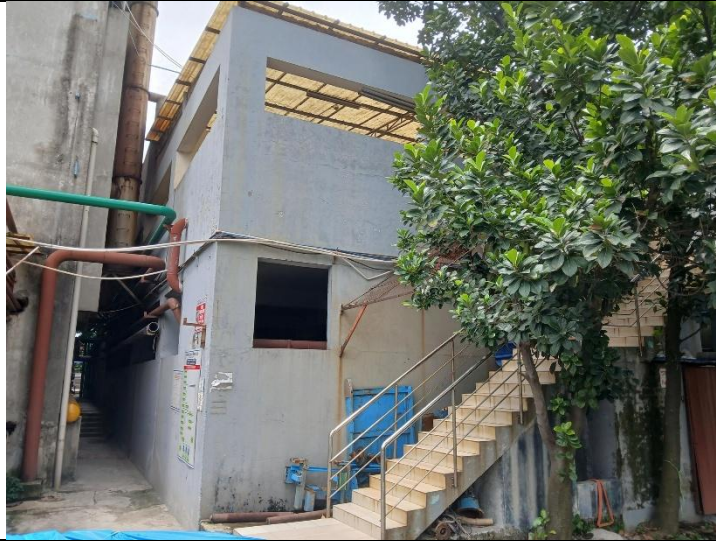
**Observation 5:** Lack of design report, in situ material test report (ETP Building).

**Description:** As per BNBC, every building or structure designed shall have its design documents prepared in accordance with the provision of Section 1.9.1. The design document shall include a design report, and a set of structural drawings, which shall be prepared in compliance with section 1.9.1.1 and section 1.9.1.2 as per BNBC. At the time of inspection, a set of partial construction drawings was available. However, no design report was available. Also, no in-situ material test report (cylinder test report, rebar test report) was available. The building engineer is required to verify in situ material test for concrete and steel and prepare an Engineering Assessment (EA) report with proper remediation plan (if required) and submit to RSC for review.

| Item No | Observation | Action Plan | Timeline |
|---|---|---|---|
| 6. | Lack of design report, in situ material test report (ETP Building). | Verify in-situ concrete material strength by taking concrete cores (minimum 4 nos and 100 mm diameter) from lower-tier building columns and prepare a steel rebar test report. | within 6 weeks |
| 7. | | The building engineer is required to check the design against lateral forces, stress and serviceability's and prepare a full set of design documents and submit it to RSC for review. | within 6 weeks |
| 8. | | Carry out remedial work if required. | within 6 months |

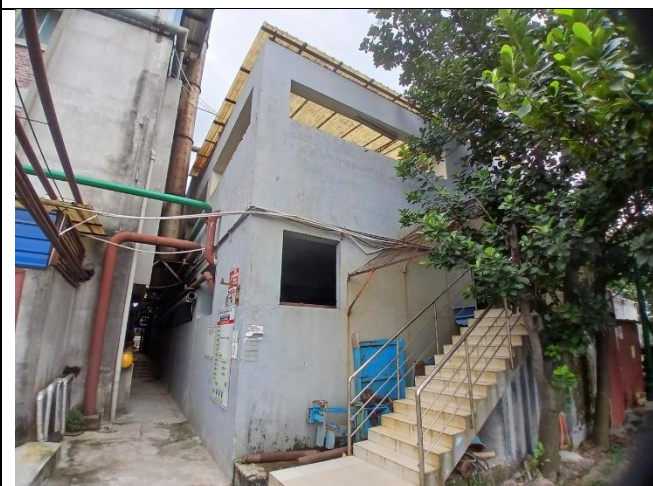
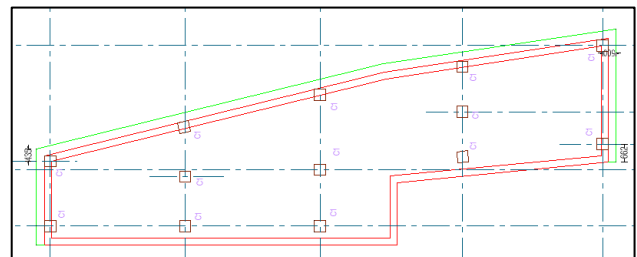
**Observation-6:** Inadequate as-built drawing (ETP Building).

**Description:** During Inspection, partial drawing was available for ETP control room only. In addition, no sectional elevational view was shown in available architectural drawings. The building engineer is required to survey the structures and prepare a comprehensive as built drawings reflecting the entire structure.

| Item No | Observation | Action Plan | Timeline |
|---|---|---|---|
| 9. | Inadequate as-built drawing (ETP Building). | The building engineer is required to survey the structures and prepare comprehensive as-built drawings. | within 6 weeks |

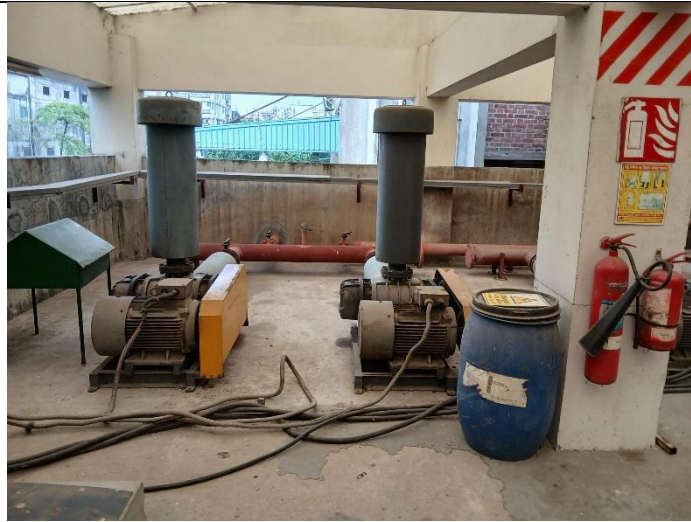
**Observation-7:** Perceivable vibration on the floor (ETP Building).

**Description:** During Inspection, perceivable vibration was observed on the 1<sup>st</sup> floor slab due to the vibration from aeration pumps.  
The building engineer is required to investigate the source of vibration and use proper damping methodology to reduce vibrations.

| Item No | Observation | Action Plan | Timeline |
|---|---|---|---|
| 10. | Perceivable vibration on floor (ETP Building). | The building engineer is required to investigate the source of vibration and use proper damping methodology to reduce vibrations. | within 6 weeks |

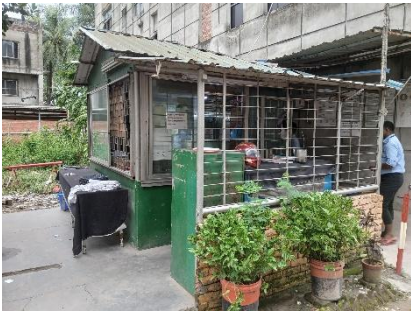
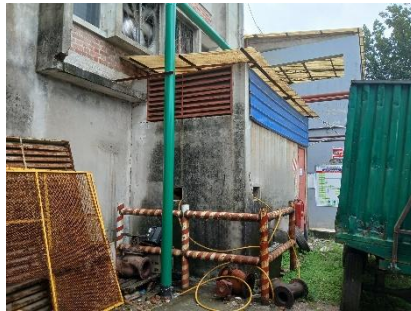
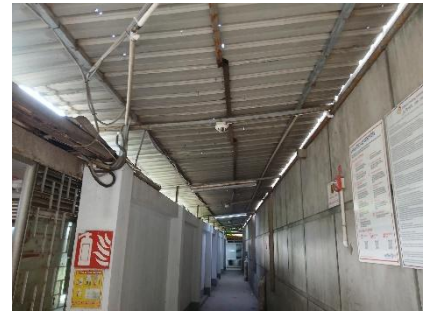
**Observation-8:** Lack of as-built drawings (CS Shed -4, Security Room (Laundry), RCU room).

**Description:** During inspection, no as-built drawing was available for (CS Shed -4, Security Room (Laundry), RCU room).  
The building engineer is required to survey the structures and prepare a comprehensive as built drawings reflecting the entire structure.

| Item No | Observation | Action Plan | Timeline |
|---|---|---|---|
| 11. | Lack of as-built drawings (CS Shed -4, Security Room (Laundry), RCU room). | The building engineer is required to survey the structures and prepare comprehensive as built drawings. | within 6 weeks |

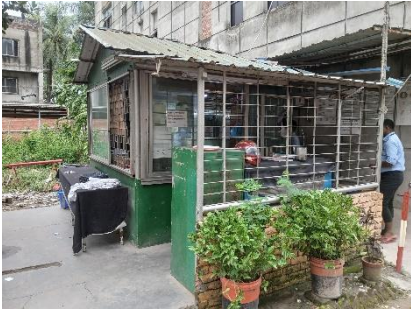
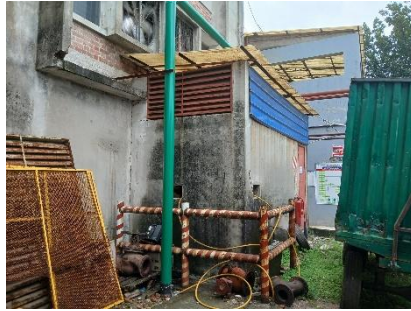
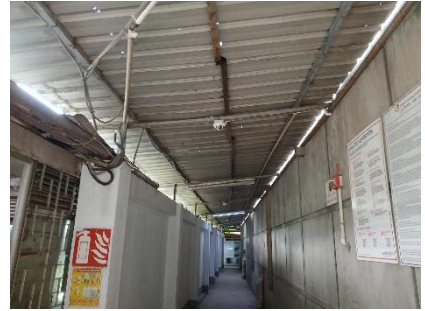
**Observation-9:** Inadequate members with poor connections (CS Shed -4, Security Room (Laundry), RCU room).

**Description:** During inspection, inadequate members with Improper connection details were observed for (CS Shed -4, Security Room (Laundry), RCU room). The building engineer is required to prepare safety check reports considering the ACCORD building standard and submit to RSC for review.

| Item No | Observation | Action Plan | Timeline |
|---|---|---|---|
| 12. | Inadequate members with poor connections (CS Shed -4, Security Room (Laundry), RCU room). | The building engineer is required to prepare safety check reports considering ACCORD combination and submit to RSC for review. | within 6 weeks |
