# **ELECTRICAL SAFETY INSPECTION REPORT**

## **SATURN TEXTILES LTD.**

**2/6, Darul Ahsan Road, Ausepara, Tongi, Gazipur, Bangladesh**

**Inspected on April 30, 2014**

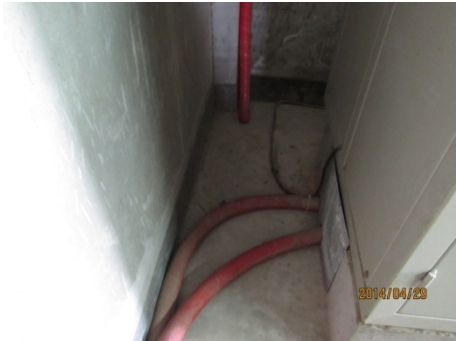
| <b>Finding #:</b> E- 1 | <p>HT cable is entering the panel.</p> |

| <b>Finding:</b><br><br>HT cable is laid on concrete floor without protection. | |

| <b>Recommendation:</b><br><br>Install a cables tray with protective cover to route and protect the HT cable from physical damage due to falling objects and stepping of maintenance personnel during maintenance work. | |

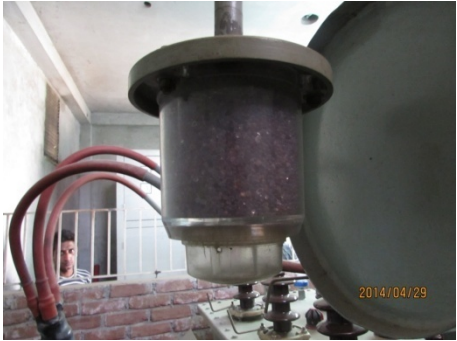
| <b>Finding #:</b> E- 2 | <p>Silica gel get moisturized</p> |

| <b>Finding:</b><br><br>Silica gel in transformer breather contaminated with moisture as a result it's color has been changed. | |

| <b>Recommendation:</b><br><br>Shut down the transformer and replace the silica gel or perform maintenance to remove moisture from it. Establish a routine maintenance checklist for the transformer to keep all the accessories of the transformer operable. | |

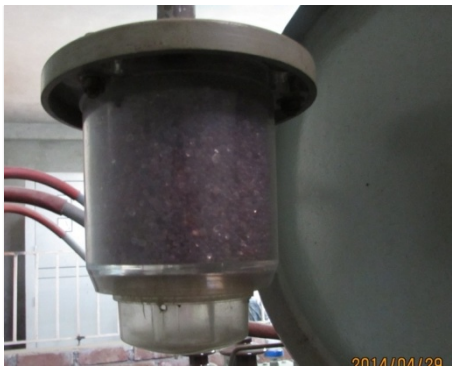
| <b>Finding #:</b> E- 3 | |

| <b>Finding:</b><br>Transformer breather oil cup found empty. | |

Empty oil cup

| <b>Recommendation:</b><br>Fill-up the oil cup with new transformer oil. | |

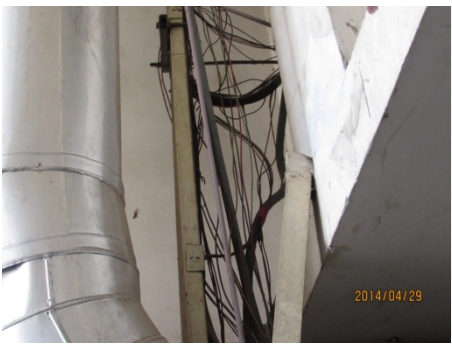
| <b>Finding #:</b> E- 4 | |

| <b>Finding:</b><br>Cables terminated from one floor to another not supported and protected. | |

Cables on cable ladder not supported

| <b>Recommendation:</b><br>Cables should be supported and fixed to the cable ladder tightly by using suitable fittings e.g. cable tie. | |

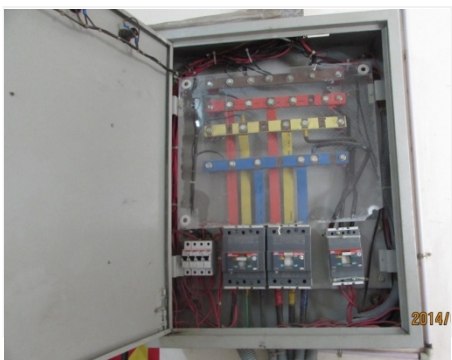
| <b>Finding:</b><br>Panel door not connected to earth. | |

Panel door not earthed

| <b>Recommendation:</b><br>Panel enclosure including its door must be connected to earth using green cables preferably earth braid so that the metallic door remains at zero potential all the time. Practice earth continuity test to insure earth continuity to panel and loads enclosure and keep record. | |

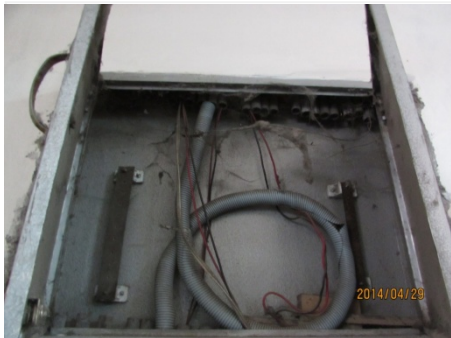
| <b>Finding #:</b> E- 6 | |

| <b>Finding:</b><br><br>Excessive dust and lint deposit found inside panel. | |
| <b>Remediation Timeframe:</b> Within 1 month | Dust and lint inside the panel. |

| <b>Recommendation:</b><br><br>Clean the panel and establish a routine cleaning program to keep all the panels neat and clean. | |

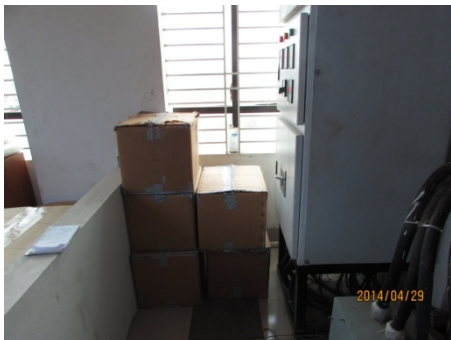
| <b>Finding #:</b> E- 7 | |

| <b>Finding:</b><br><br>Carton box placed in front the panel i.e. access to the panel not convenient. | |
| <b>Remediation Timeframe:</b> Within 1 month | Storage in front the panel. |

| <b>Recommendation:</b><br><br>Access to all kind of electrical panel should be kept obstacle free. Keep 1 meter clearance in front the panel for proper operation and maintenance. | |

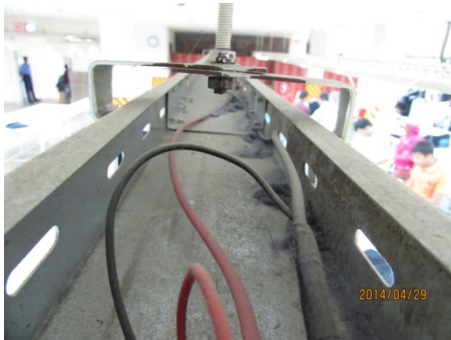
| <b>Finding #:</b> E- 8 | |

| <b>Finding:</b><br><br>Excessive dust and lint deposit in cable tray run over production floor. | |
| <b>Remediation Timeframe:</b> Within 1 month | Uncovered cable tray in production floor. |

| <b>Recommendation:</b><br><br>Provide metallic cover on the cable tray throughout it's whole length to keep it free from dust, lint and vermin. Establish a routine cleaning program to keep the cable tray neat and clean. | |
