# Romo Fashion Today Ltd.

Vannera Road, Mouchak, Gazipur  
(24.0306084 N, 90.2981527 E)

1<sup>st</sup> December 2015

# Observations

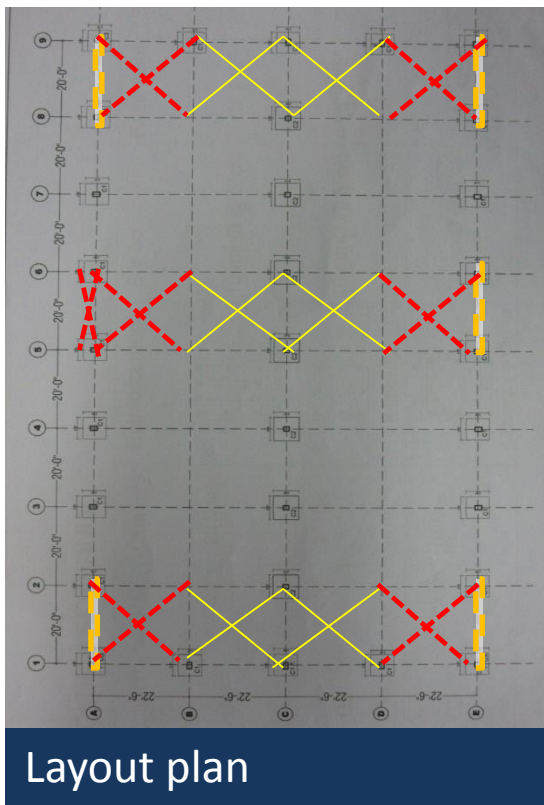
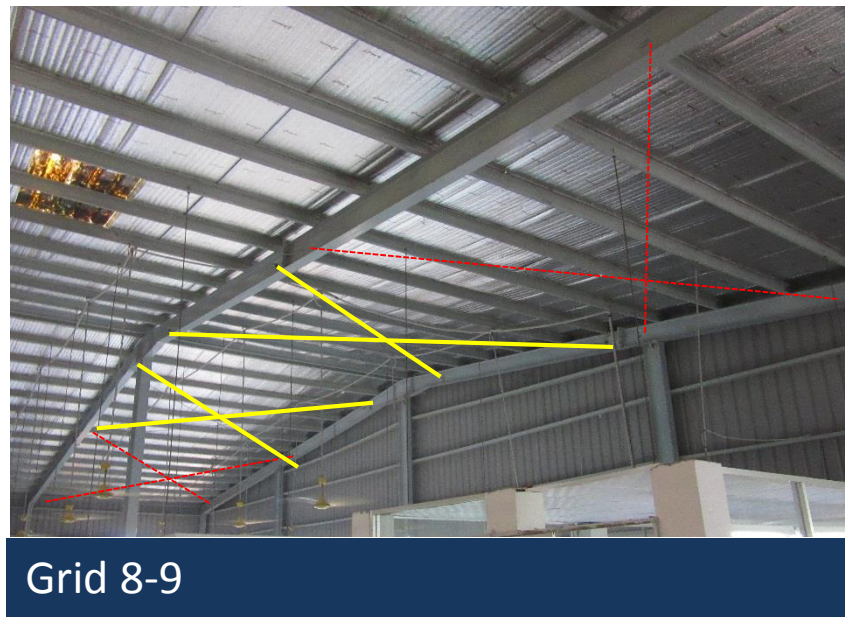
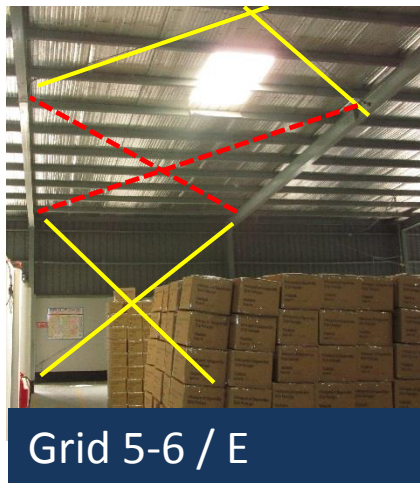
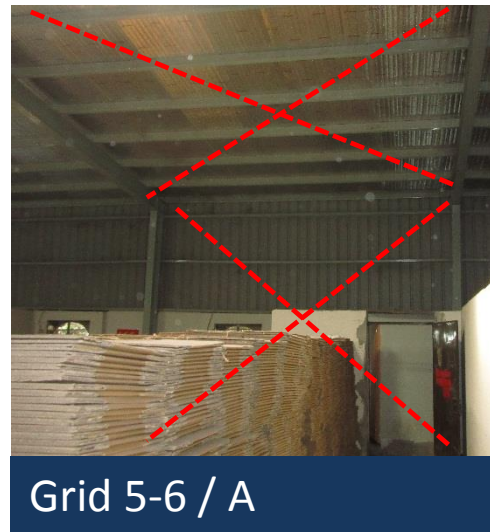
# Missing and loose cable bracings

Diagonal Cable bracings were not installed at marked locations. Note that also vertical bracing is not installed between on grid A /5-6 (Connection holes are already provided in beam and stanchions elements).

| Item No. | Observation | Recommended Action Plan | Recommended Timeline |
|---|---|---|---|
| 1 | Missing and loose cable bracings | Lateral stability of the moment frame system of the steel building to be checked and verified by the Building Engineer. | 6-months |
| 2 | Missing and loose cable bracings | Missing lateral bracing to be provided accordingly. | 6-months |

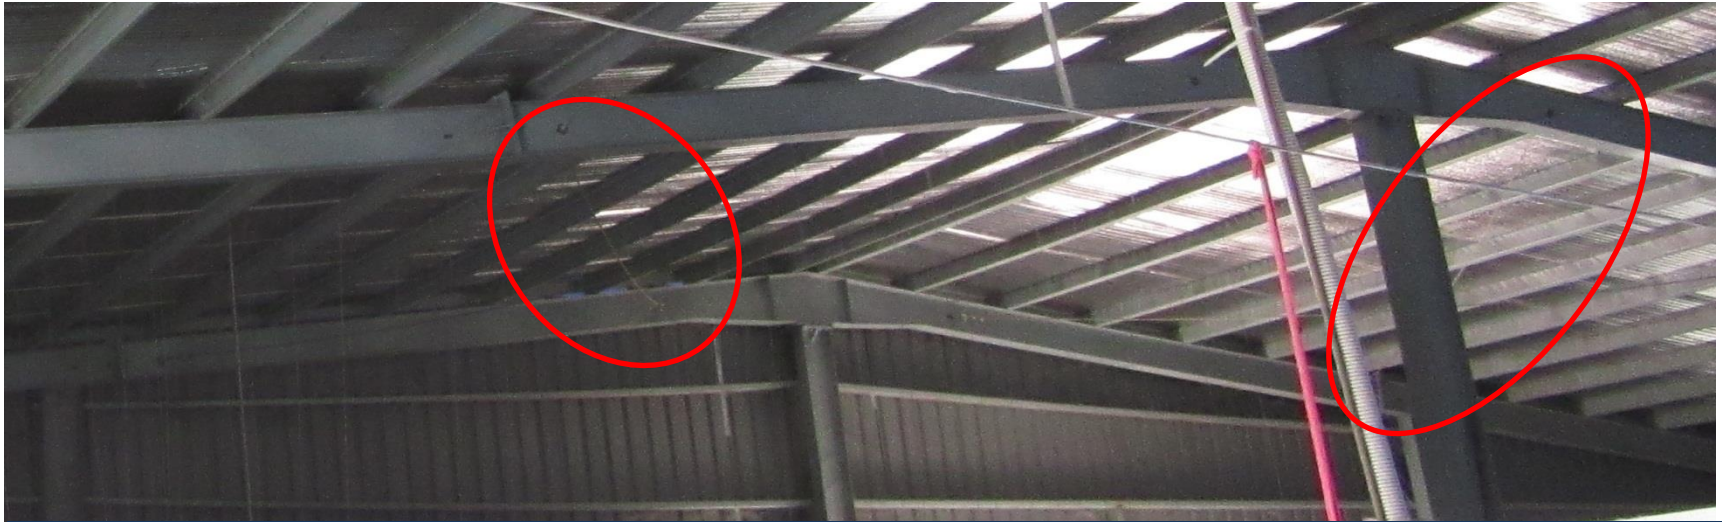
Some of the cable bracings are loose and are not properly tensioned. Sagging was evident.

| Item No. | Observation | Recommended Action Plan | Recommended Timeline |
|---|---|---|---|
| 3 | Missing and loose cable bracings | Loose cables to be tensioned properly. | 6-months |

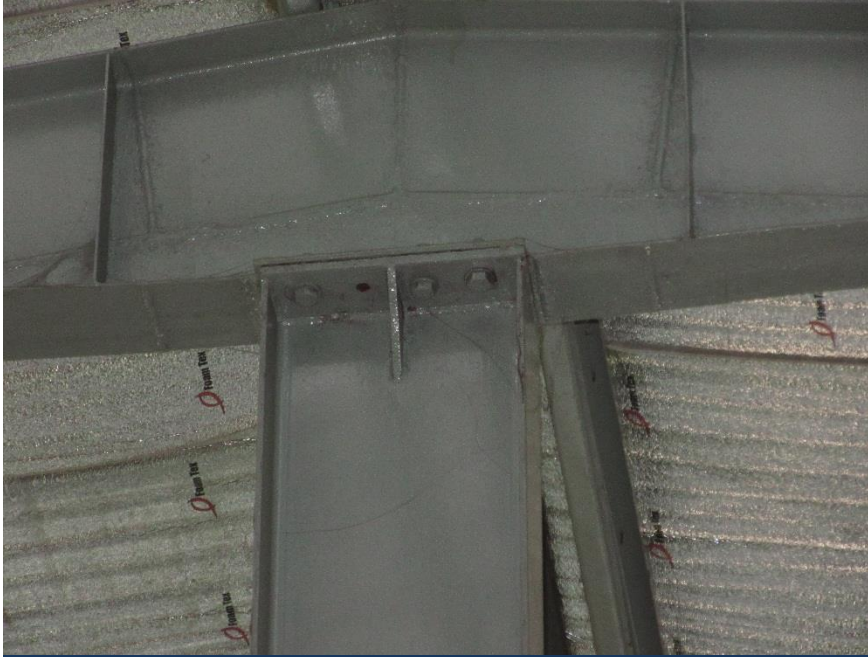
# Missing bolts at steel connections

Missing bolts are detected at several locations.

Inspect all connections and provide missing bolts.

| Item No. | Observation | Recommended Action Plan | Recommended Timeline |
|---|---|---|---|
| 4 | Missing bolts at steel connections | Inspect all connections, provide proper detailing by completing inadequate bolts. | 6-months |

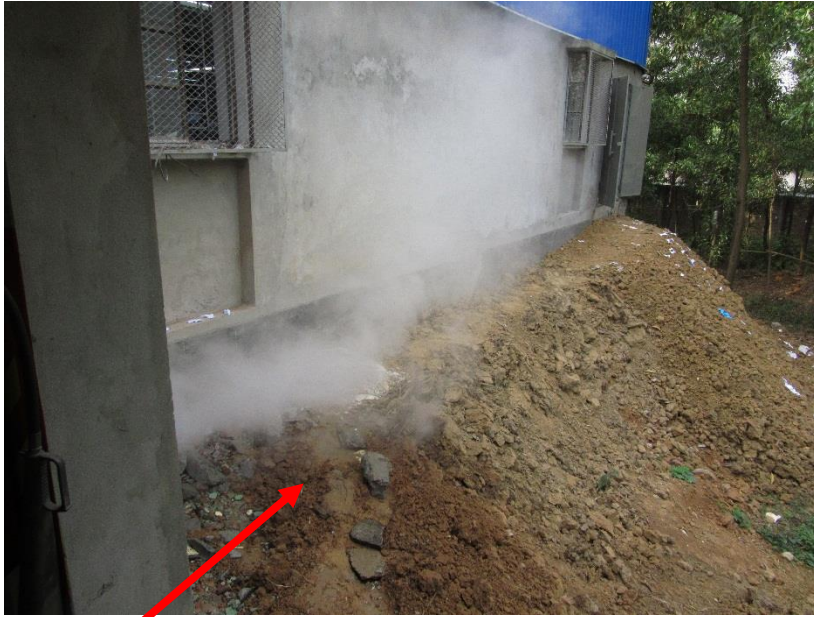
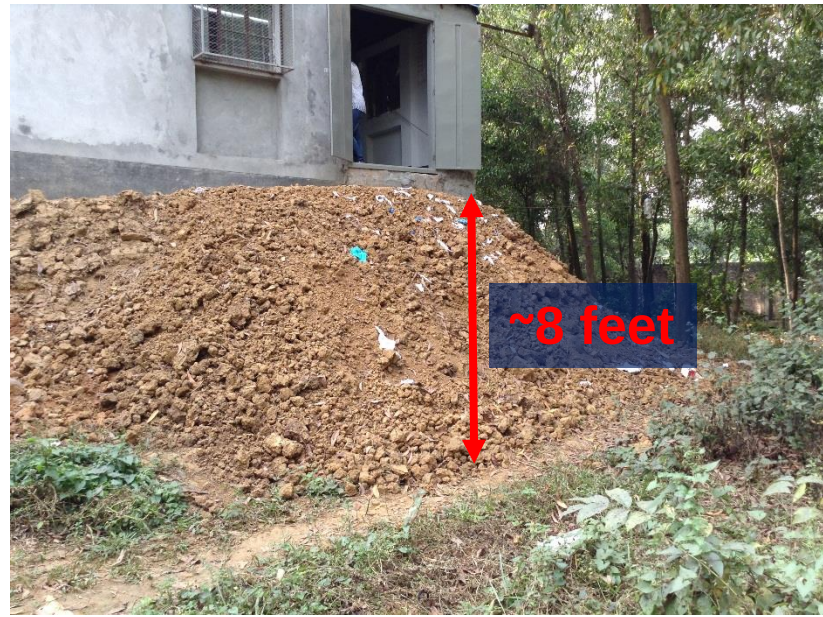
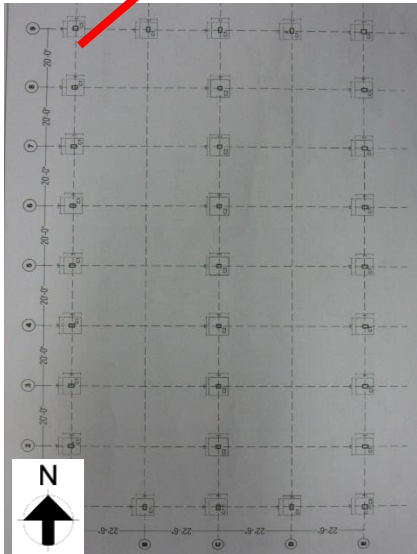
# Footings located on fill at sloping site location

West and North-West side of building is resting on soil fill.  
A notice in soil report for this issue was not provided.

| Item No. | Observation | Recommended Action Plan | Recommended Timeline |
|---|---|---|---|
| 6 | Footings located on fill at sloping site location | Building engineer to ensure stability of soil fill. | 6-months |

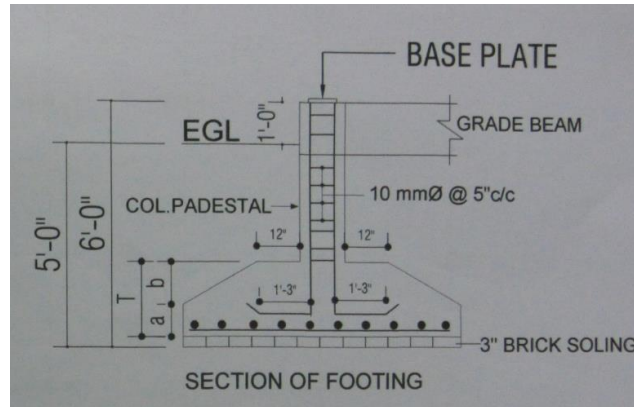
Footing section provided in drawings for these columns appears to be inaccurate.

| Item No. | Observation | Recommended Action Plan | Recommended Timeline |
|---|---|---|---|
| 5 | Footings located on fill at sloping site location | Update foundation plan and details considering as-built condition of foundation at North-West end of building. | 6-months |
